## Science and Art: A Future for Stone

**Proceedings of the 13<sup>th</sup> International Congress on the  
Deterioration and Conservation of Stone – Volume I**

**Edited by  
John Hughes & Torsten Howind**

6<sup>th</sup> to 10<sup>th</sup> September 2016, Paisley, Scotland

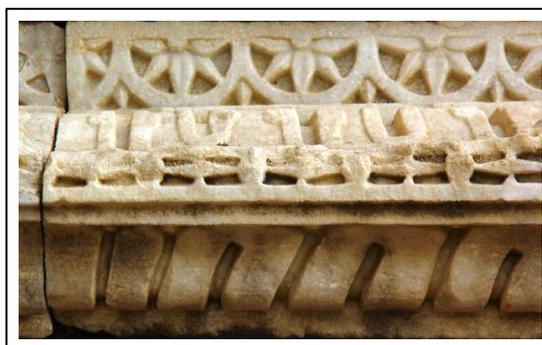
*Fig. 8: Sugaring of carved marble.*

Calcareous stones including marbles have a characteristic pattern of weathering by granular disintegration, which is known as ‘sugaring’. The marble cladding used in the monument is exposed to urban pollutants and deterioration of the surface layers has resulted in a granular, sugary texture because of dissolution along the calcite grain edges (McGee, 1991). The original, smooth surface finish is lost due to dissolution around the edges of individual grains of calcite in the stone and minerals, that are more resistant than the calcite, protrude above the dissolved calcite surface. Sharp edges and carved details have become rounded as the exposed surface of the stone is dissolved by polluted rainwater. The overall surface of marble has accumulated a brownish accretion particularly in the areas that are hidden from washing effect of the rainwater (Fig. 8). This accretion may be formation of gypsum crust from the chemical transformation of calcitic minerals from the stone.

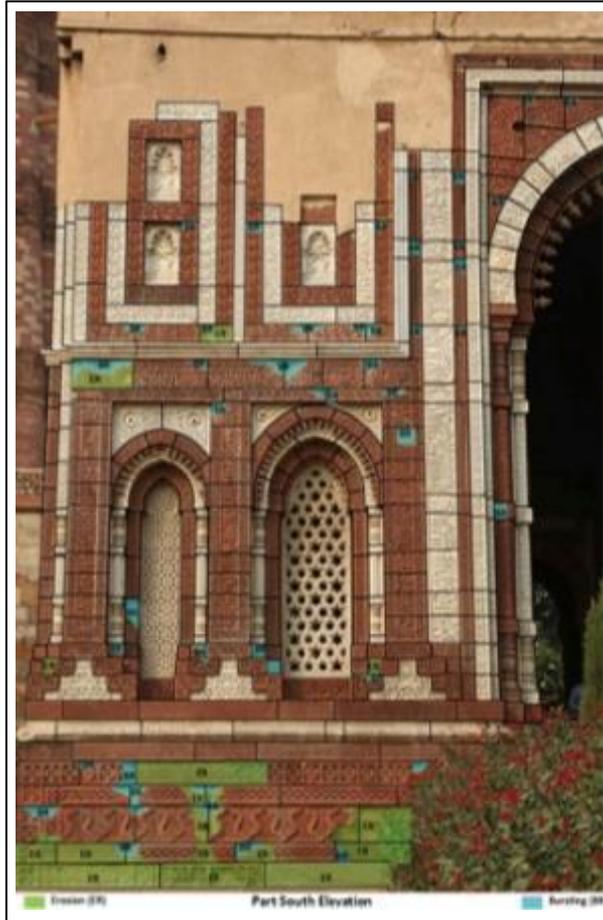
Figure10: Condition mapping of deteriorated stone in Alai Darwaza.

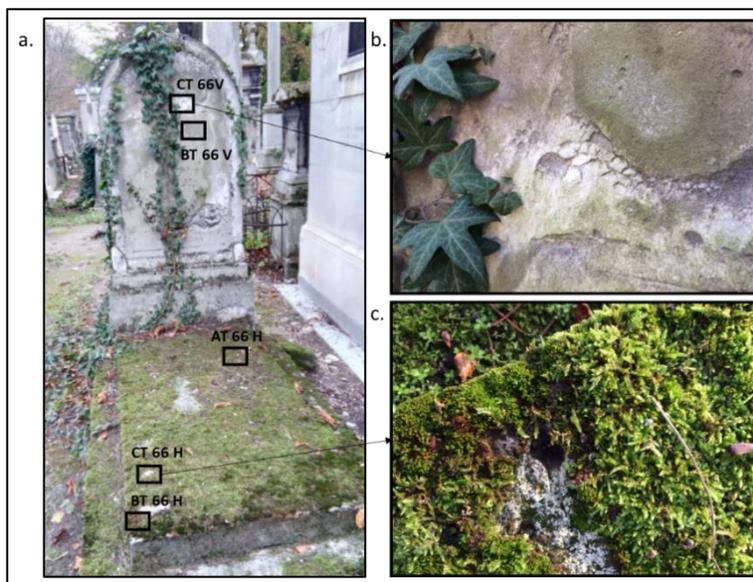
Fig. 1: Photography of the tomb 66 located in the 25th division of the Père-Lachaise Cemetery (a), of the sampled zone CT 66 V in the vertical part (b) and zone CT 66 H in the horizontal part (c); Dimensions: 1.8m long, 0.8m wide and 1.8m high.

A tomb located in the Romantic area of the Cemetery (division 25, n°66) was selected. This area is a green zone with the presence of numerous plants and trees. The monument is out of a Lutetian limestone and presents a sole, a bedrock, a horizontal tombstone and a vertical stele (Fig. 1). The back of the stele is South-East oriented. Two zones were sampled on September 11<sup>th</sup> 2015. The temperature mean and pluviometry of this month in Paris were 19.6°C and 72.2 mm, respectively. For the biological sampling, three samples were collected using a sterile scalpel and placed into a 2 mL sterile tube (Eppendorf®) before freezing until analysis: one in the green vertical part (BT 66 V) and two in the horizontal part under two different genus of mosses: *Grimmia* (BT 66 H) and *Pleurochaete* (AT 66 H) (Fig. 1). For the mineralogical characterization, the sampling was performed on the vertical (CT 66 V) and the horizontal part (CT 66 H).

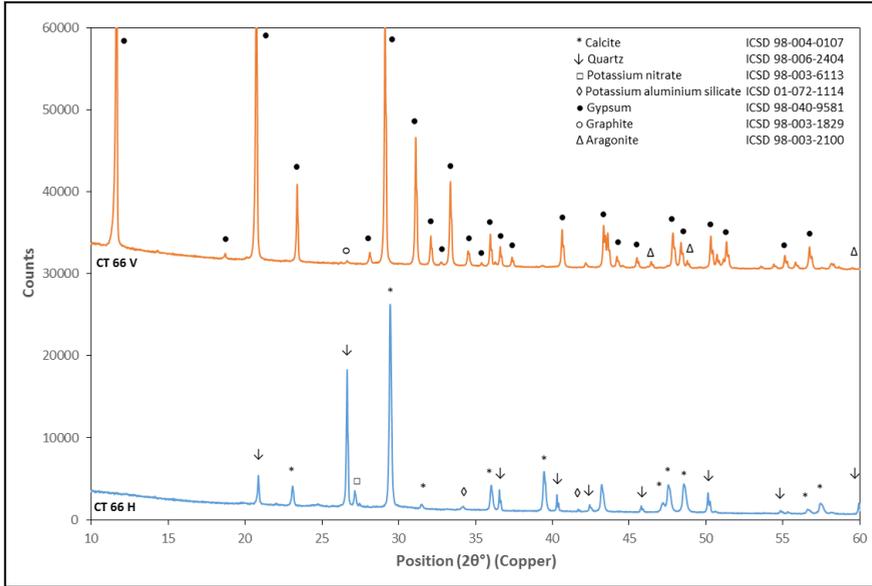
Fig. 2: XRD analyses on powder sampled from the vertical (CT 66 V) and the horizontal (CT 66 H) part.

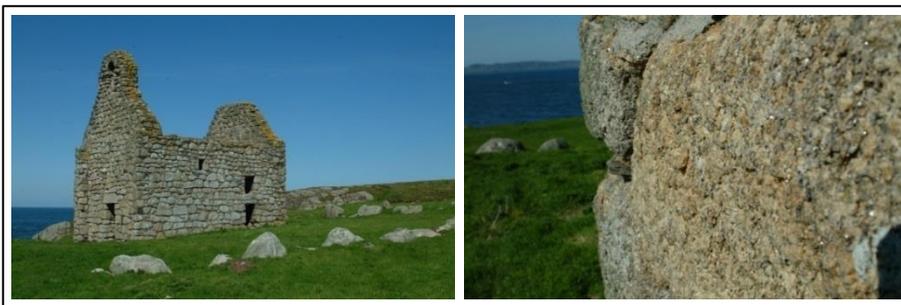
*Fig. 1: a) The tenth century church of St. Begnet, Dalkey Island, Co. Dublin; b) Scaling of the granite masonry surface, St. Begnet's Church.*

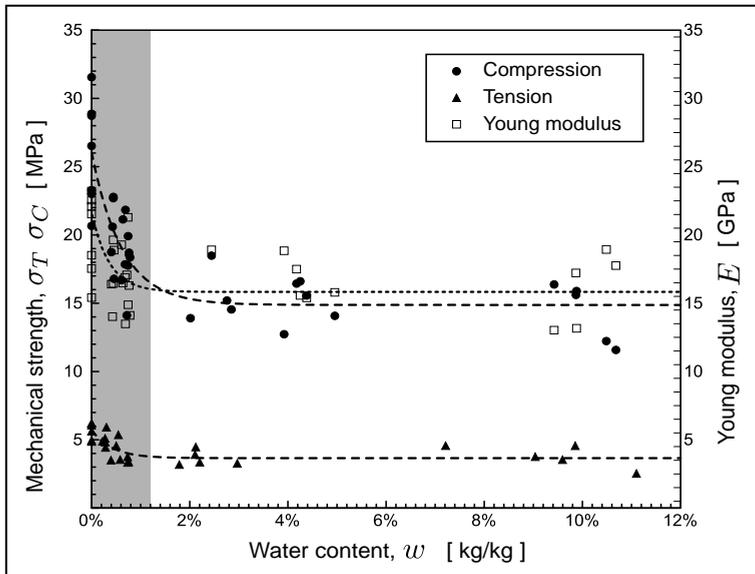
Fig. 2: Mechanical characteristics of CY limestone as functions of the water content.

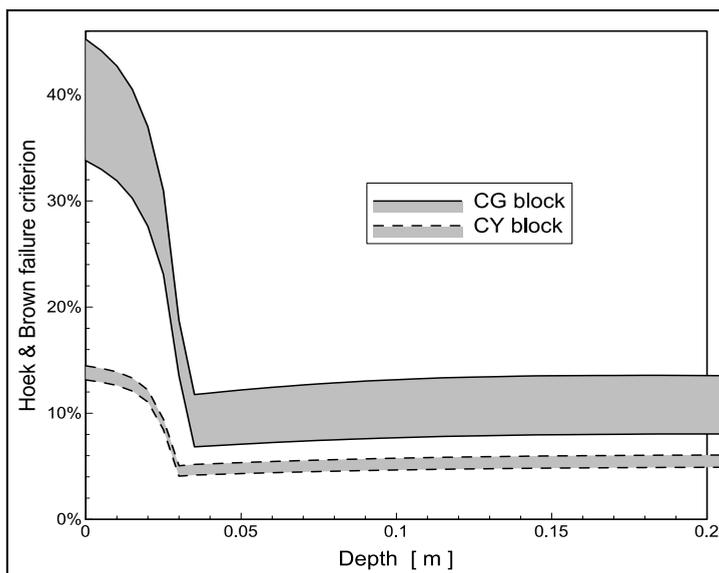
Fig. 4: Hoek & Brown failure criterion along the depth of stone blocks at  $t = 4000$  s.

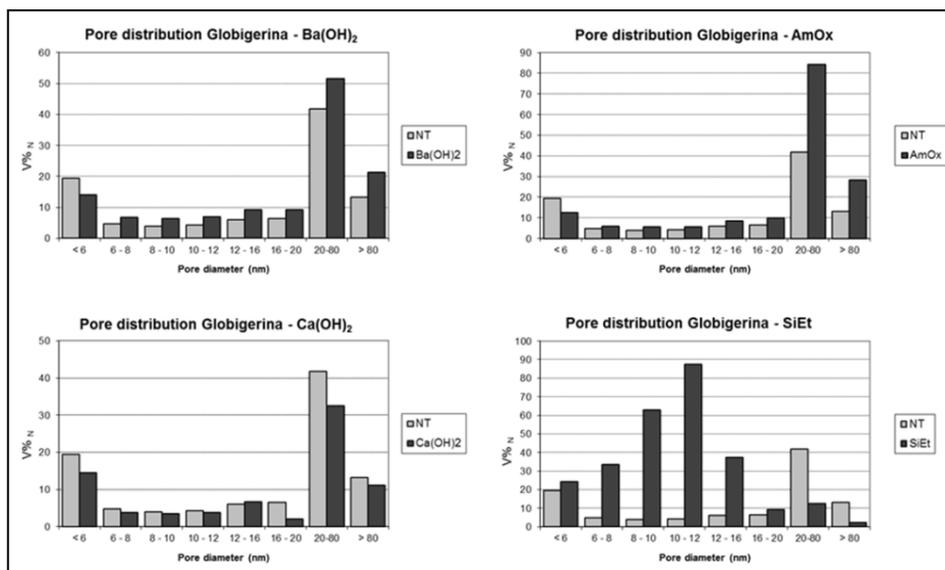
Fig. 4: Pore distribution in inorganic, SiEt treated and untreated samples of Globigerina Limestone.

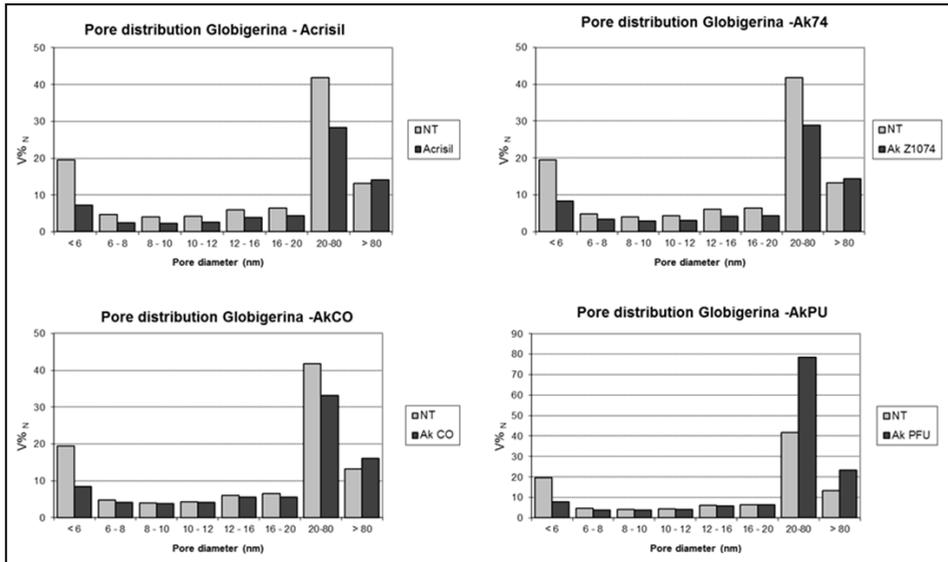
Fig. 5: Pore distribution in organic treated and untreated samples of *Globigerina* Limestone.

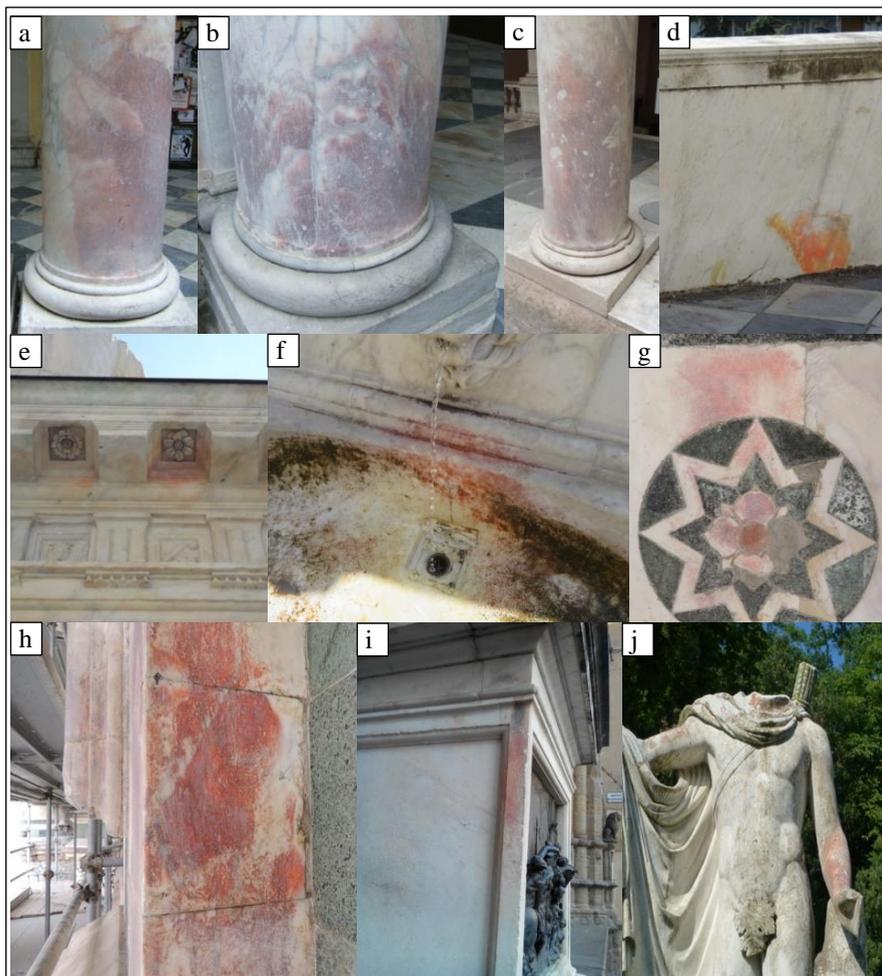
*Fig. 1: Some red chromatic alterations on monuments in Genova (a-d) and Florence (e-j), such as: the columns of cloister of the University of Genoa, Balbi Street (a-b), Villa DurazzoPallavicini, Pegli (c), Villa DurazzoPallavicini, Pegli (d), monument to Giovanni delleBandeNere (e-f), Santa Maria del Fiore Cathedral (g-h), statuary complex of Rattodelle Sabine by Giambologna (i) and a statue in the park of Villa Demidof in Pratolino, near Florence (j).*

It was observed that in Italy the red alteration on marble occurs on different types of marbles (like Apuan marble, Montagnola Senese marble.etc.) and its presence is not related with the closeness to the sea, being observed both in Genoa, Palermo, Florence, Siena, Milan, Pavia, Orvieto.

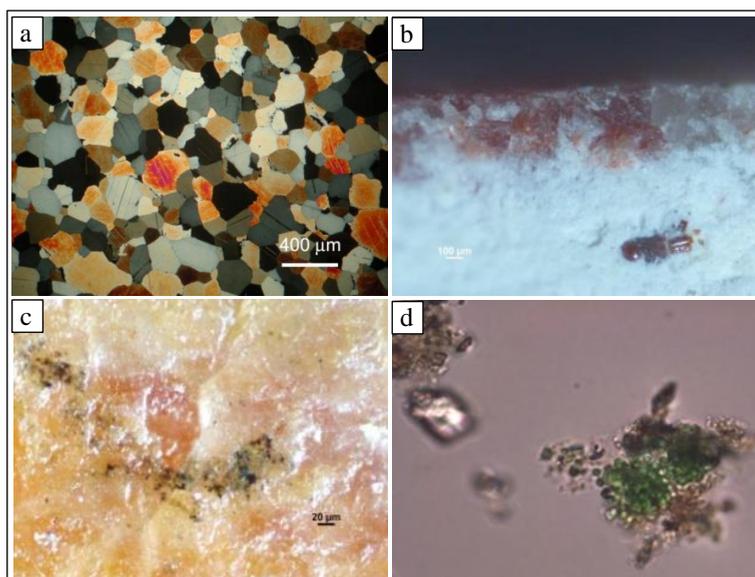
*Fig. 2: Petrographic section of Apuan marble (a) and microscopic observations in reflection (b and c) and transmission mode (d) of the sample coming from Florence Cathedral Santa Maria del Fiore.*

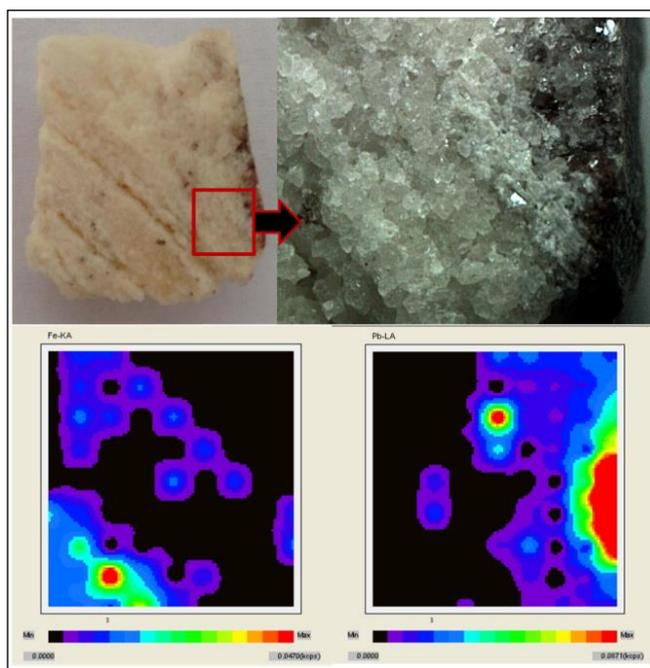
Fig. 3: XRF mapping of Fe (left) and Pb (right). A square of DF sample (in red) was analyzed.

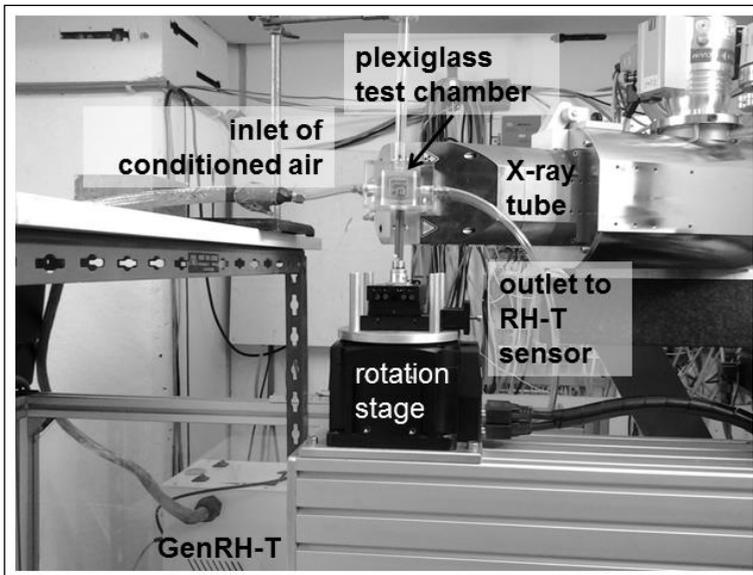
Fig. 1: Experimental setup at the X-ray  $\mu$ CT scanner HECTOR of the UGCT for performing dynamic scans of salt weathering cycles.

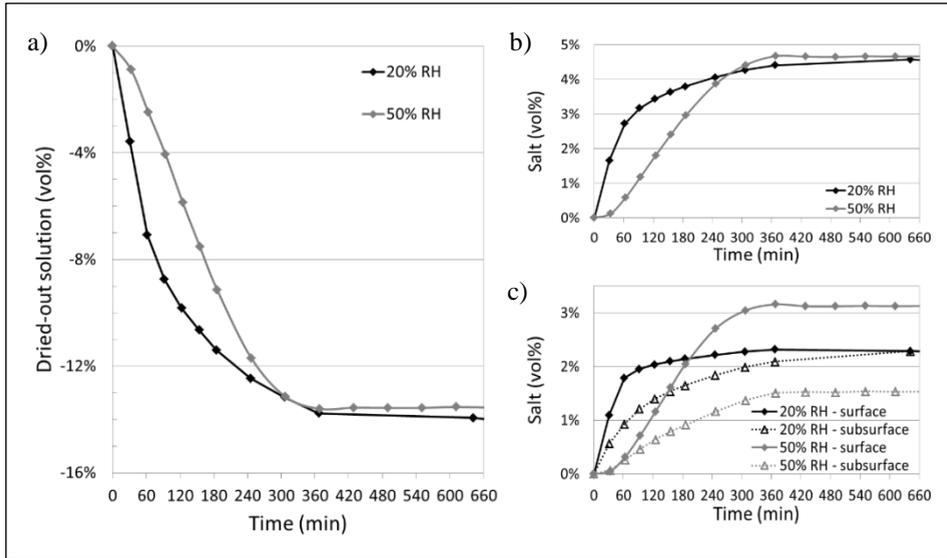
Fig. 2: The drying (a) and crystallisation dynamics (b and c) of Mšené sandstone at 20% RH and 50% RH. Fig 2c distinguishes between the salt crystals forming on the outer surface (efflorescence) and the salt crystals precipitating just below, in the pores of the subsurface.

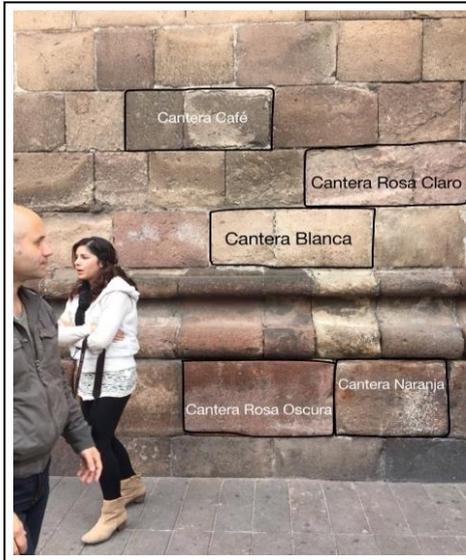
*Fig. 2: North wall of the Templo del Carmen. Five variations of the Cantera Rosa can be distinguished here. Cantera Café (brown), Cantera Rosa Claro (light pink), Cantera Rosa Oscura (dark pink), Cantera Naranja (orange) Cantera Blanca (white).*

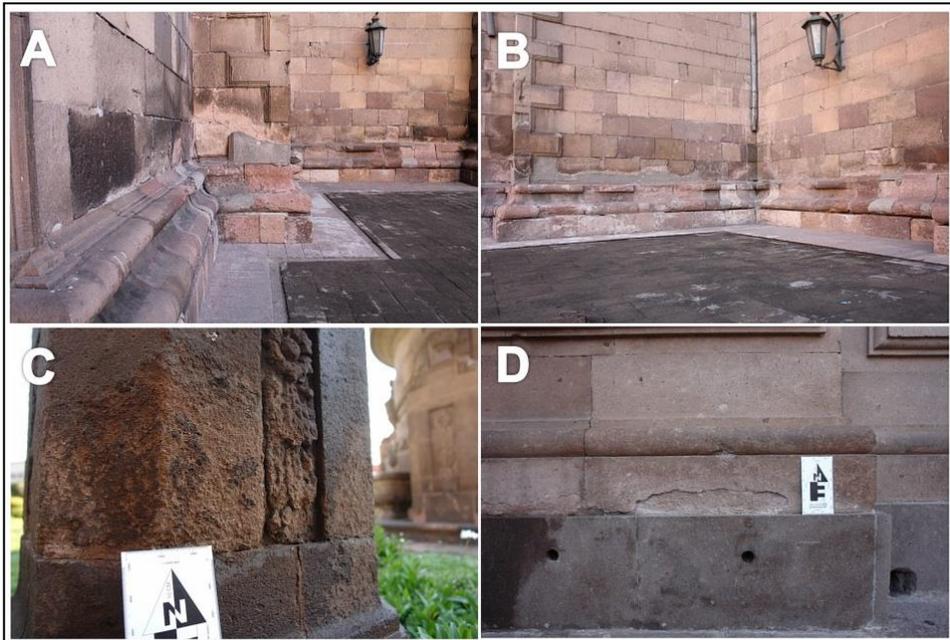
*Fig. 3: Appearance of the different damage and deterioration types observed in the Cantera Tuff; a and b) Sanding, back weathering and coloration/discoloration in the San Carmen Church; c) Scaling and lost material in the Caja de Agua monument; d) Extensive flaking in lower parts of the south wall of the cathedral of San Luis Potosí.*

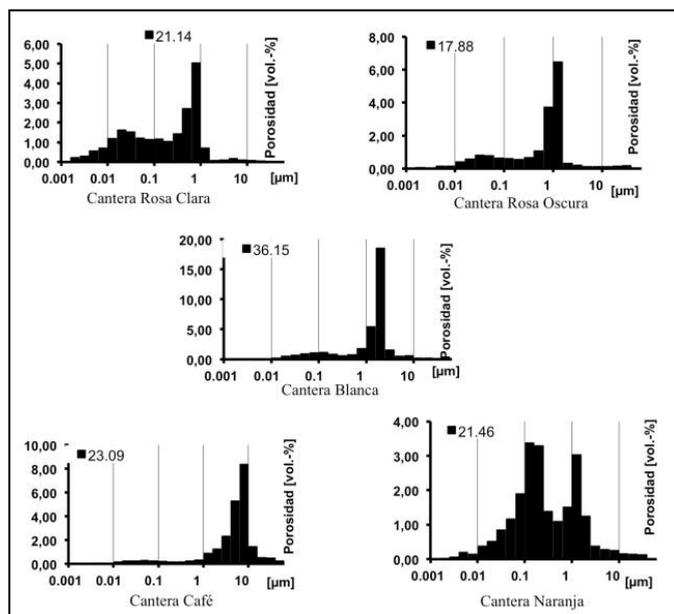
Fig. 6: Pore size distribution (MIP) of the five studied tuffs (López Doncel et al. 2016).

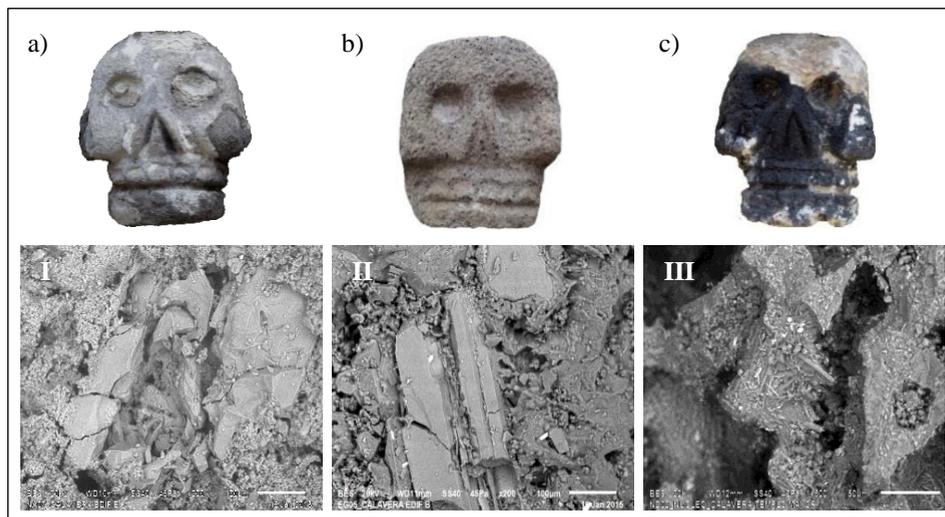
Fig. 4: Different weathering effects macroscopically and microscopically. SEM images; a/I) dacitic tuff skull in the North façade ( $200\times 100\ \mu\text{m}$ ); b/II) dacitic tuff skull in the East façade ( $200\times 100\ \mu\text{m}$ ); c/III) tezontle skull in the North façade ( $500\times 50\ \mu\text{m}$ ).

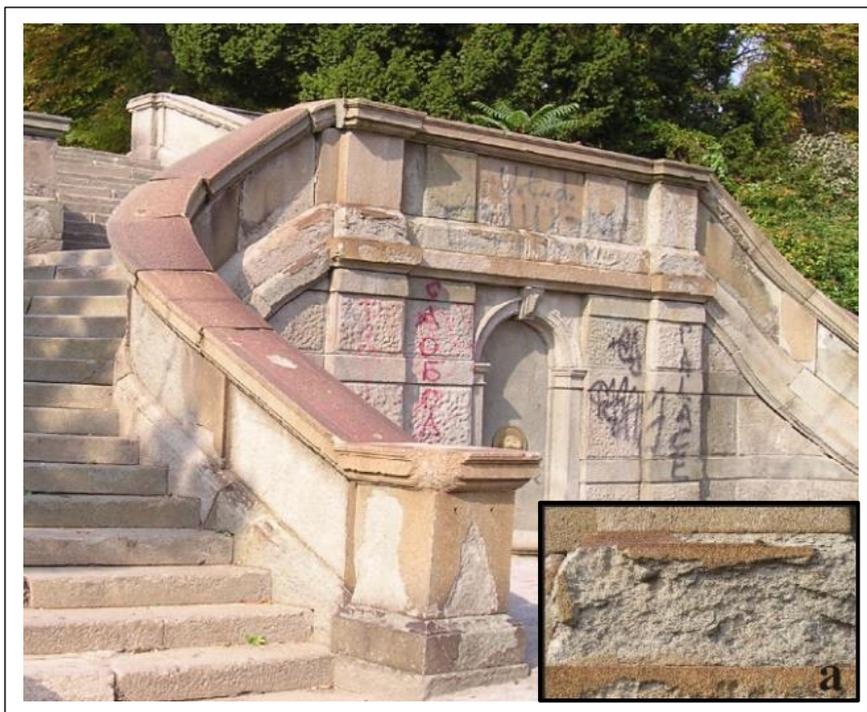
*Fig. 5: Decay forms of the kersantite stone elements: loss of stone mass as missing corner part, scaling and detachment of the surface crust, discoloration; a) detail of flaking and sanding of stone surface.*

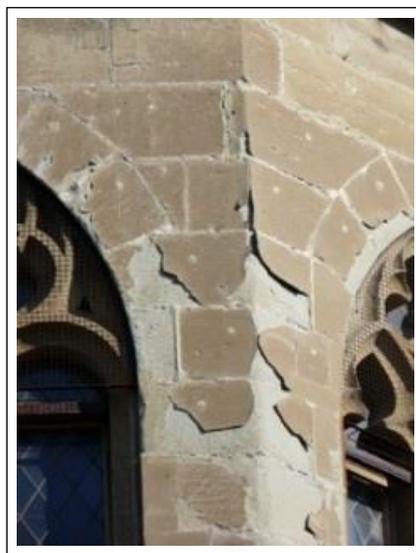
*Fig. 1: Desquamation pattern developing on Villarlod molasse at the Fribourg city hall.*

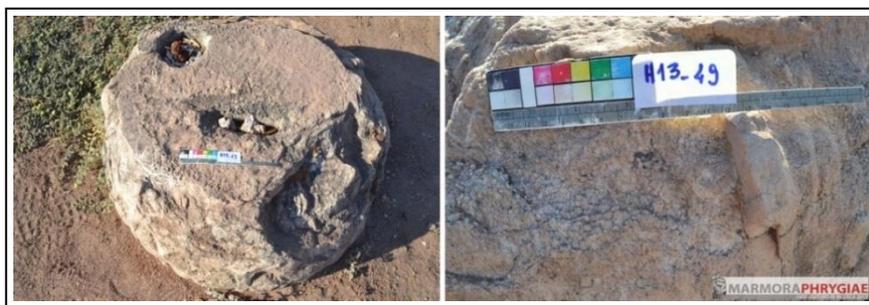
Fig. 3: Blocks of marbles with granular disintegration at Civil Agora.

The description of phenomena was done according to ICOMOS glossary (2008). The main decay phenomena observed in the monument are strictly linked to exposition of environmental conditions. The granular disintegration is particularly evident in the area subjected to relevant thermic excursion (Sanctuary of *Apollo*, *Ploutonion*, *Stoà* near the Springs) and was also influenced by grain size distribution and microfabric of marbles. In some cases it is particularly intense creating a strong and deep detachment of aggregates of grains from the substrate (Fig. 3).

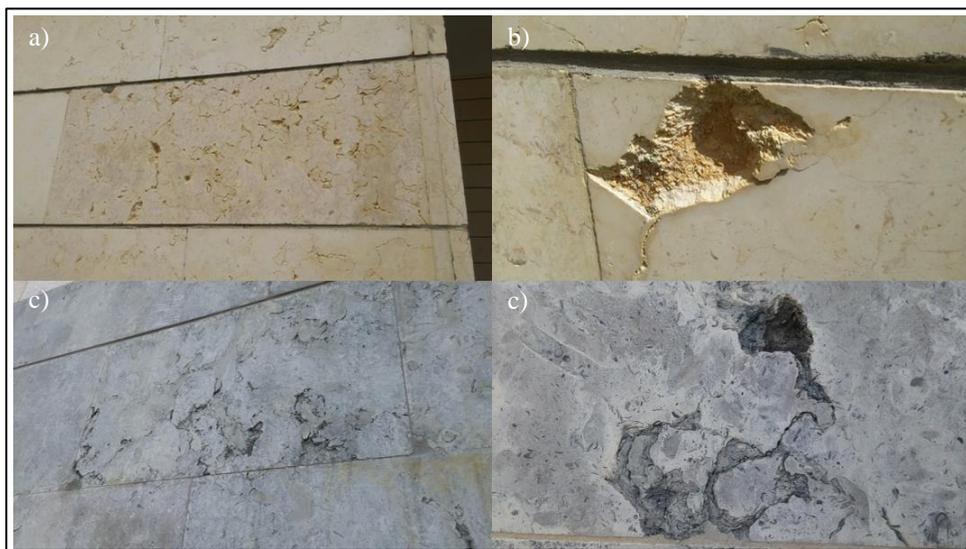
*Fig. 1a-d: Cream coloured limestone (top) and light gray coloured limestone (bottom) showing typical damage. Blocks are approximately 15 cm in width and 40 cm in length.*

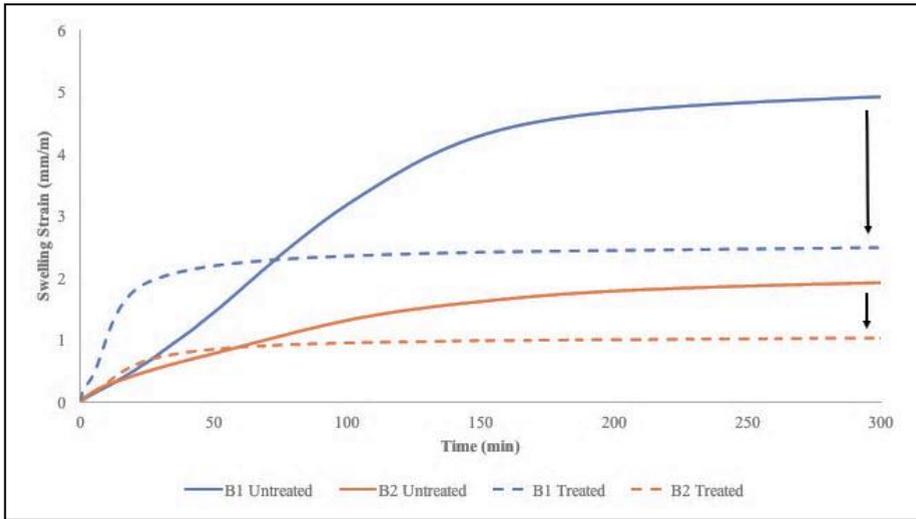
Fig. 6: Moisture expansion experiments for two samples of the light gray coloured limestone, pre- and post-treatment with swelling inhibitor (solid and dashed lines, respectively). Reduction in swelling indicated by arrows. Cream coloured limestone showed no moisture expansion.

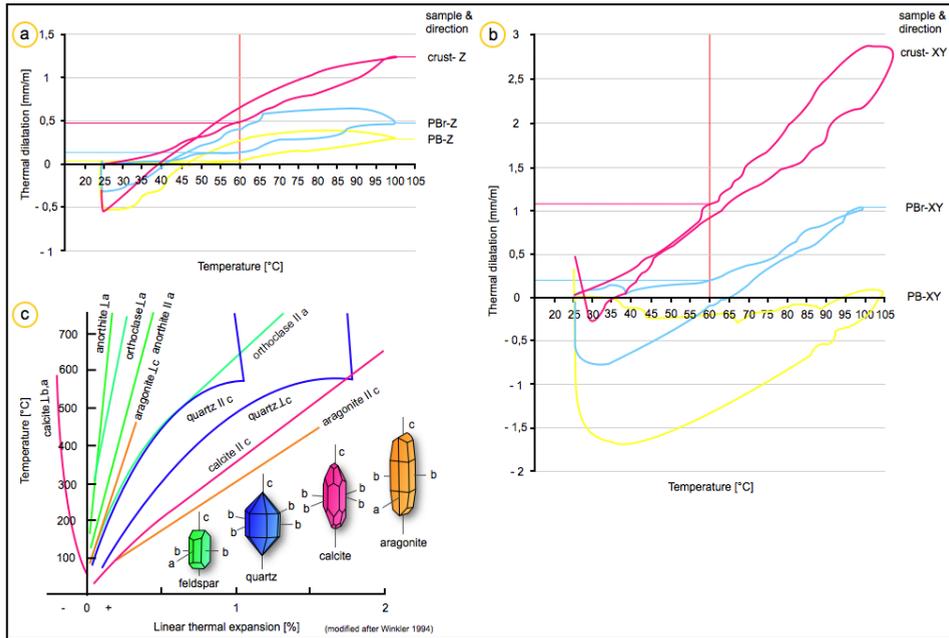
Fig. 5: Thermal dilatation of the crust, the PB building stone and the PBr stone in the Z-direction. b) Thermal dilatation of the crust, the BP stone and the stone used for restoration (PBr) in the XY-direction. c) Thermal expansion of different minerals.

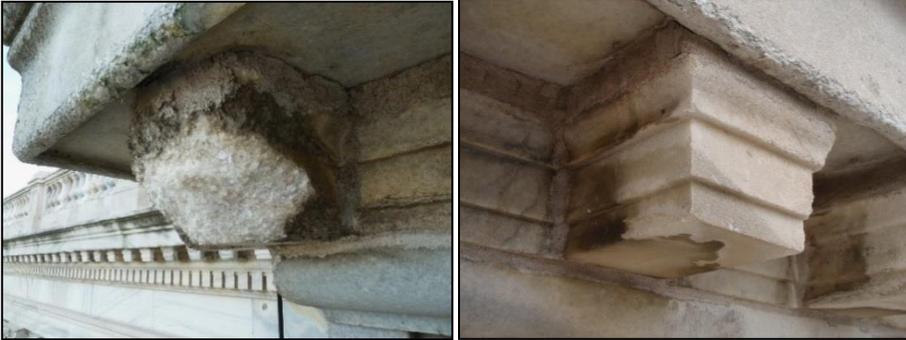
*Figure 1: The type 1 marble modillion on the left exhibits more extensive sugaring than the type 4 modillion on the right. Both units are located on the north facade of the capitol.*

Disintegration produced by hysteresis and other factors was strikingly more commonplace and advanced in marble units characterised as types 1 and 2, many of which had crumbled so extensively that they no longer resembled their original form. Conversely, type 3 and particularly type 4 marble appeared to be more resistant to these effects, with minimal sugaring and the original tooling marks often still evident, even at locations directly exposed to weathering. This pattern emerged further when marble repairs were assigned by the architects and it was recognised that repairs were being allocated with greater frequency to marble that was whiter in colour, with less prominent veining and accessory minerals (types 1 and 2). Repair assignments for 350 of the original modillions at the main cornice of the capitol were tabulated and grouped by marble type to look for statistical support of the link between composition and durability. Modillions were selected for this part of the study because they are a repetitive element that occurs at the same location on all four primary orientations. Modillions were also well-suited for comparison because their small size made them more likely to consist of a single type of the four identified marble groups. Three repair options were available for modillions, based on the existing condition of the unit: (1) *No repair* - Modillions exhibiting little or no sugaring or other significant deterioration, as shown on the right in Fig. 1, were left intact with no repairs beyond

occasional cleaning with hot water; (2) *Light surface refinishing* - Modillions exhibiting moderate levels of disintegration, yet retaining the recognizable form and dimensions of the original unit were lightly redressed to restore visual consistency; and (3) *Replacement* - Modillions exhibiting an advanced degree of sugaring to the extent that the original form of the unit was no longer recognizable, as shown on the left in Fig. 1, were replaced with new units that matched the original profile and dimensions.

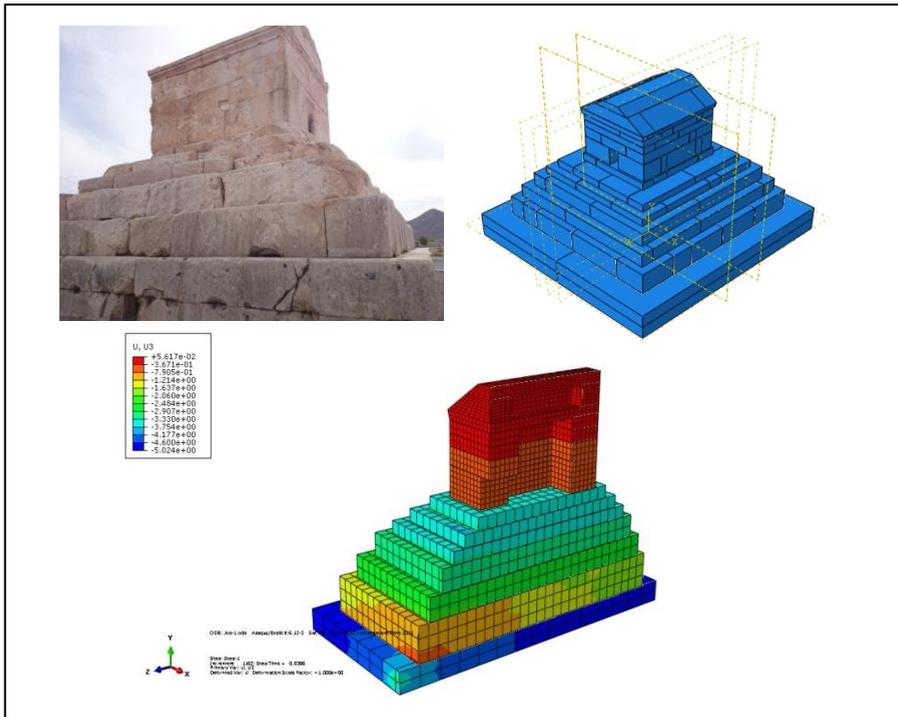
Fig. 6: a dynamic resistance able structure, Cyrus tomb with frictional interface dampers.

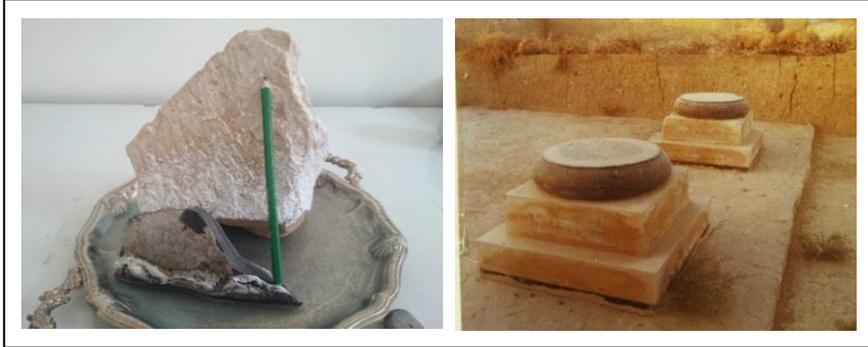
*Fig. 9: Comparison of white stone and black stone (with low permeability), showing the different the different behaviour for the height of rising damp and salinity in Pasargad monuments.*

Different properties and different applications for two types of stones (black and white, Fig. 9) were prepared in Pasargad and also Persepolis. The black stones are chosen as an 'isolator', they are hard to work and are not quarried any more. The white limestone, is relatively easy to work, has high permeability, is not stable to weathering. Protection against rising damp (and the weathering it causes) is achieved by the use of an impermeable, isolating black sandstone and also the use of ventilation channels between stone blocks in the finishing layer (the 3<sup>rd</sup> layer of the stone layered mat, Fig. 10).

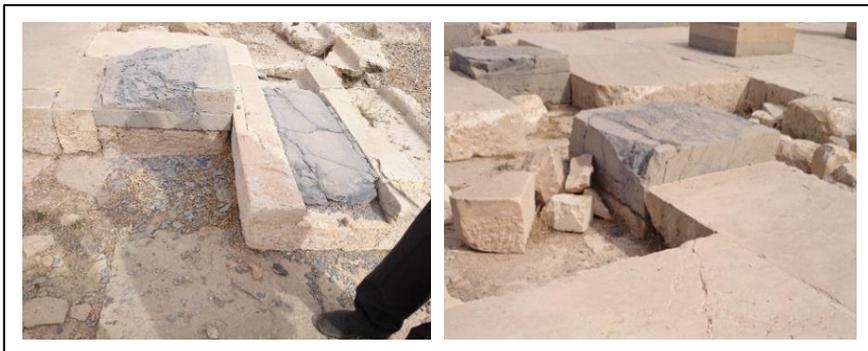
*Fig. 10: Details of smart engineering at Pasargad, showing the combination of black and white stone with different physical properties.*

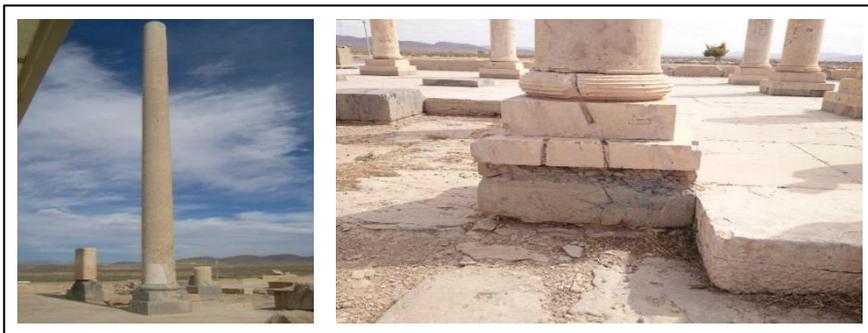
*Fig. 11: Frictional interface without any mortar (Damper), base isolation and also the curved stone base plate to prevent stress concentration.*

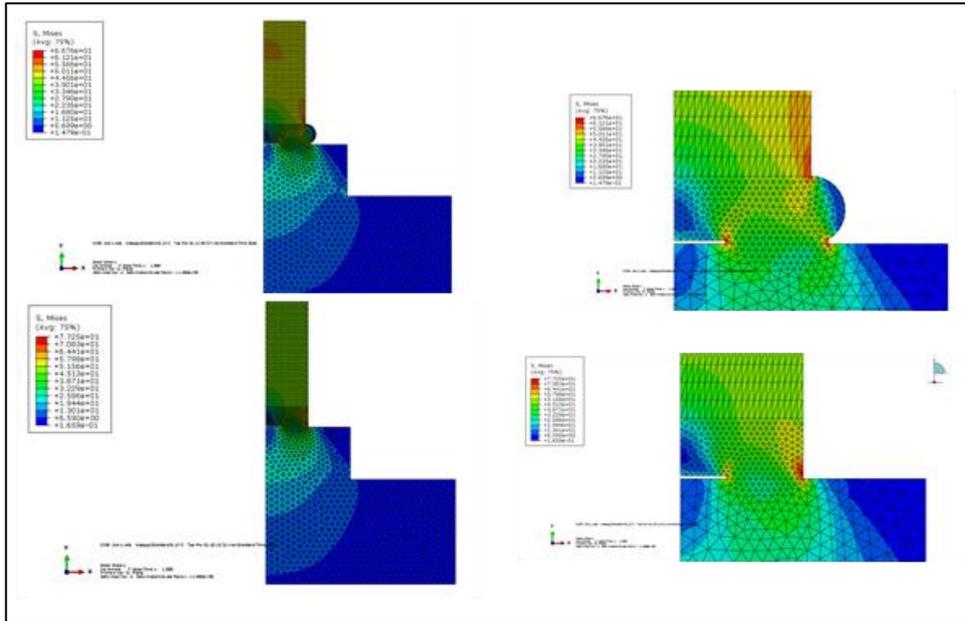
*Fig. 12: Comparison of Von-Mises stress distribution with and without curved section stone base plate.*

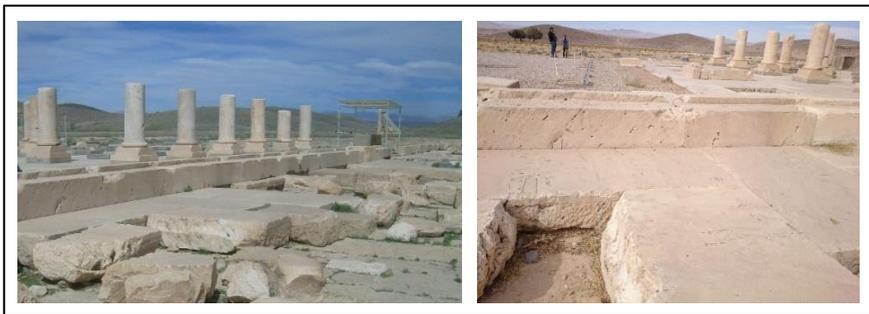
*Fig. 13: Differential settlement protection, using more layers as a continuum layered isolator mat foundation.*

Weathering and also differential settlement protection are solved together with proper detail.

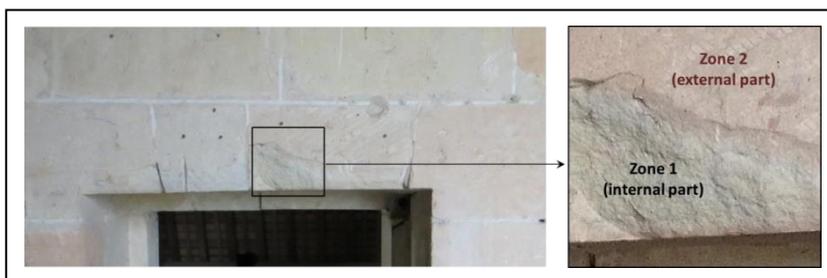
Fig. 3: Zones of the attic that suffered from a fire and that were submitted to colorimetric measurements (Castle of Chambord).

Tab. 3 shows the values of the coordinates  $L^*$ ,  $a^*$ ,  $b^*$  corresponding to the colorimetric measurements performed on zone 1 and zone 2. The values were averaged over a minimum of five measurements. The lightness  $L^*$  was nearly the same value (about 77) for both areas, but the external part (zone 2) appeared slightly darker than the internal part (zone 1) of this stone. Coordinate  $a^*$  was the most differing between the internal part (around -0.4) and the external part (around 3.3), highlighting the pinkish surface appearance (Fig. 3). By comparing the *in situ* and laboratory colour measurements, we can confirm that it is

coordinate  $a^*$  which is the most relevant to record the temperature reached during a fire in the case of tuffeau. From these measurements, we estimate that the stone on the site damaged by the fire experienced a rise in temperature up to 700°C to reach the pinkish colour and a coordinate  $a^*$  close to 3. At this temperature, the P-wave velocity decreased by almost 30%, showing deterioration in the mechanical properties of the affected stone.

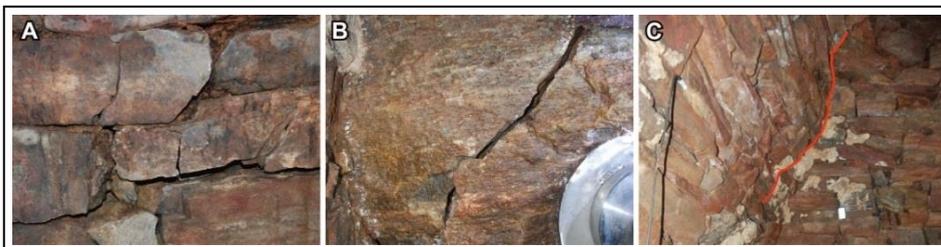
Fig. 1: Deterioration status of Songsanri tomb No.5. (A, B) Structural crack and fracture in rock properties. (C) Swelling phenomenon on west wall side.

Structural cracks and shear fracture with members dislocated by vertical structural cracks in rock properties were found to be the primary cause of damage in Songsanri tomb No.5 (Fig. 1). Particularly, the swelling phenomenon of rock properties can be clearly observed in upper part on the northern wall and south-western wall, creating an impression of structural instability.

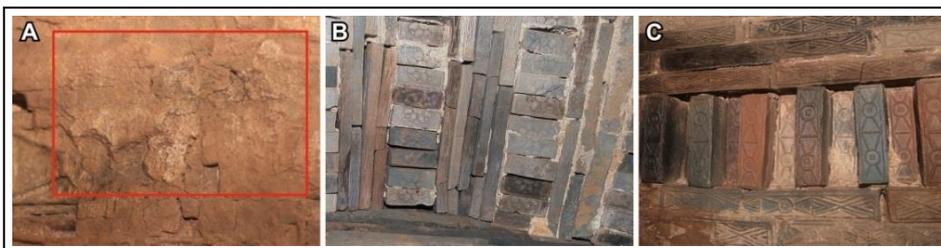
The Songsanri tomb No.6 has mural paintings on the wall of bricks. However, the mural paintings have only the trace of dim white-coloured layer on the background layer surface, and are undergoing the powdering process due to the loss of bond in white pigment layer. Physical damage in Songsanri tomb No.6 is concentrated in ceilings of burial chamber and dromos, such as cracks, fracture and separation (Fig. 2).

Fig. 2: Deterioration status of Songsanri tomb No.6 - a) Powdering of white pigment layer on the wall painting, b) Crack, separation and distortion on ceiling; c) Vertical bricks arranged unevenly.

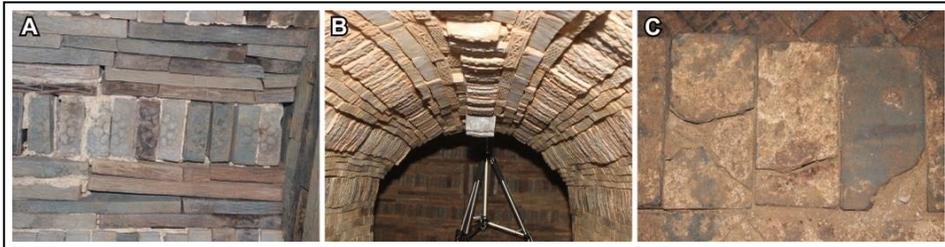
The physical and structural damages of Royal tomb of King Muryeong are more conspicuous, such as cracks, fracture, separation, exfoliation, twisting and etc., in overall way, compared to Songsanri tomb No.6 (Fig. 3). Particularly, bricks located at the center of ceiling of dromos are considered to have been moved downward.

Fig. 3: Deterioration status of Royal tomb of King Muryeong. (A) Crack, separation and distortion on ceiling of bricks. (B) Lack of dromos ceiling that looks to move downwardly. (C) Structural crack on floor of bricks.

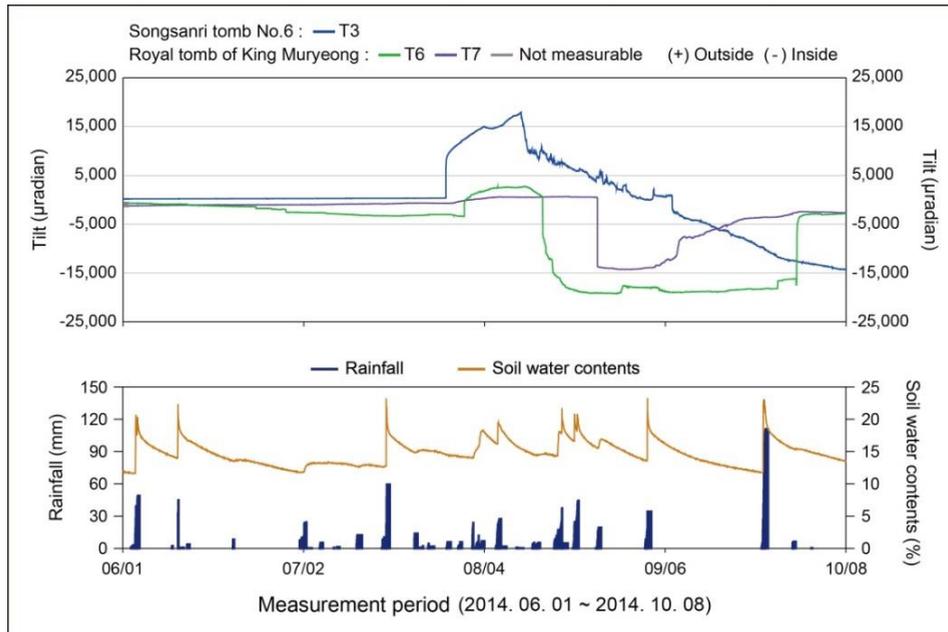
Fig. 5: Movement characteristics of T3, T6, T7 in the rainy season.

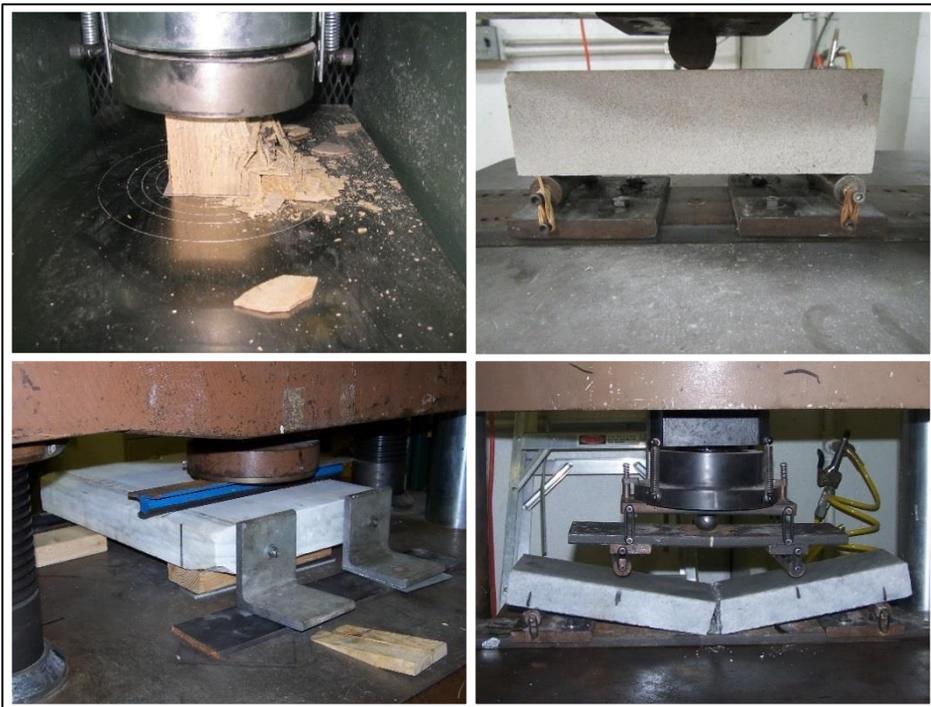
*Fig. 1: Tests for engineering properties. Clockwise from upper left: compressive strength, modulus of rupture, flexural strength, anchorage strength.*

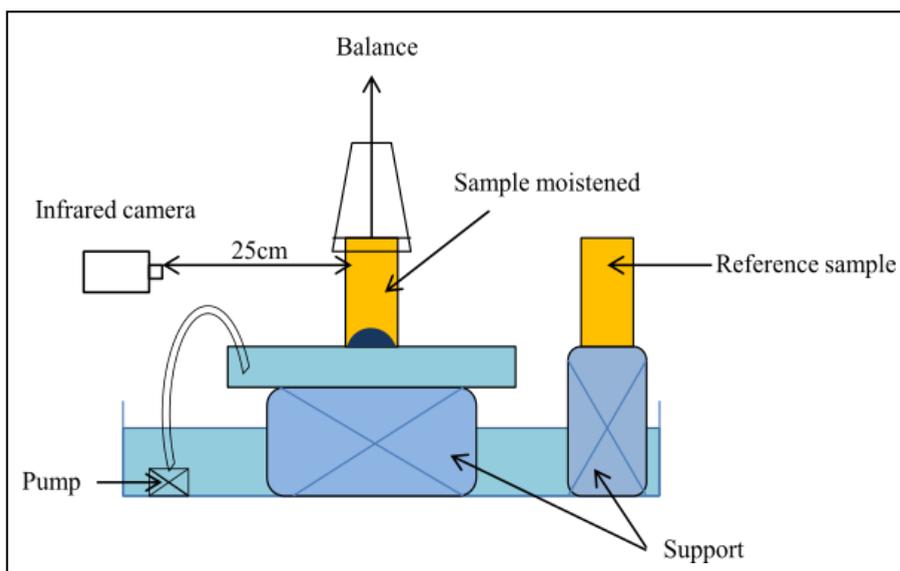
*Fig. 1: Experimental set-up. Mass evolution of the sample was monitored with a balance. Environmental parameters (air temperature, barometric pressure and relative humidity) were also monitored.*

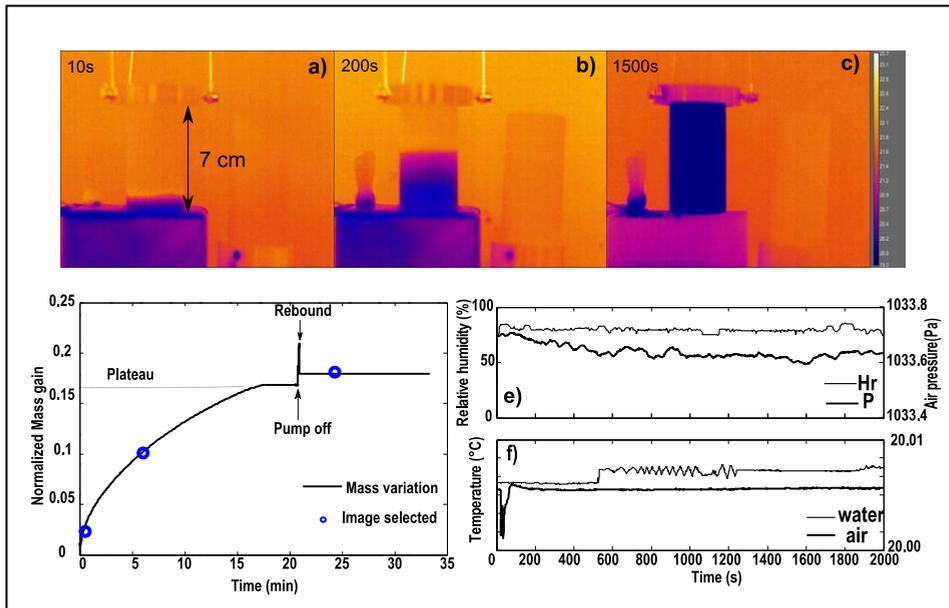
Fig. 2: a), b), c) IR images of temperature distribution at test time  $t=10$  s, 200 s and 1500 s respectively; d) Variation of mass water absorption during the test, with dots corresponding to the time of the images a), b), c); e) The variations of air pressure, relative humidity; f) The variations of reservoir water and air temperature.

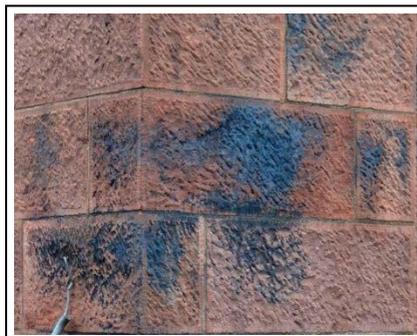
*Fig. 2: Patches of rock, varnish on the southwest corner of the Smithsonian Castle.*

Recently, visual inspection of the exterior of both the Castle and Gateposts identified patches of very thin adherent layers of bluish black material on the sandstone (see Fig. 2). Its distinctive appearance resembles desert varnish, which is thought to be associated with microbial action (Broecker and Liu, 2001). Nondestructive measurement of the set of patches in Fig. 2 using portable X-ray fluorescence (pXRF) showed a high enrichment in manganese (Mn) (Livingston *et al.*, 2014a), which is also a sign of rock varnish. This has led to further research using an array of analytical techniques to characterise the varnish, the sandstone and the environment around the Castle (Tab. 1).

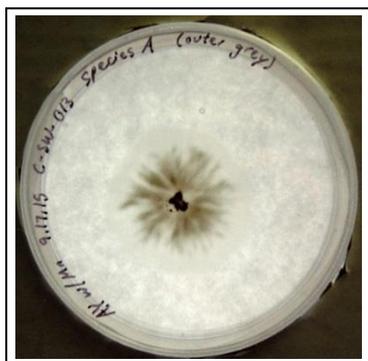
In order to determine the species of the Mn-oxidizing microbes responsible for growth of the varnish, swabs were taken at several locations on the Castle and Gateposts. The swabs were then applied to growth media on petri dishes to develop cultures. From these initial plates, active Mn-oxidizing microbes were isolated to produce the next generation of cultures. Fig. 8 is an image of the end result of several generations of this isolation process for a swabbed patch on the southwest corner of the Castle shown in Fig. 2. The colony has been identified as a fungus. The closest relative in the Genbank DNA database is *Leotiomyces* sp. (accession #JQ761063.1). The identification as a fungus is consistent with SEM imaging of the varnish from the gatepost, which shows hyphae that are characteristic of fungal growth (Fig. 9) which shows hyphae that are characteristic of fungal growth (Fig. 9).

Fig. 8: Colony of Mn-oxidizing fungus isolated from a Castle sample.

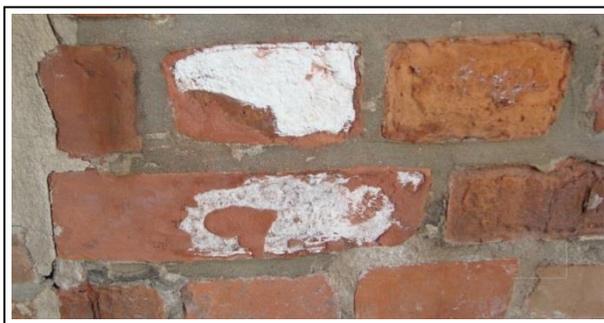
*Fig. 1: Fragment of Toruń old town ramparts (Vistula river side). The bricks have been damaged by salts. One of the sampling places (photo by W. Oberta).*

In the last step, the commonly present salt efflorescences, as depicted in Fig. 1, were analysed by the electrophoretic methods. However, there is no a clear relation between the salt content in bricks and it the efflorescence. The results of quantitative salt analysis present in efflorescences should not be treated as representative for the salt content in bricks. All the samples were taken from the ramparts and the Teutonic Order castle ruins in the Old Town of Toruń, from the Vistula river side. Similarly as in the brick sample analysis, only the common ions were identified and quantified. The results are collected in Tab. 3. As noticeable, the calculated sums do not amount to 100 %. This phenomenon may be explained by the presence of insoluble salts in the efflorescences or by the presence of other insoluble inorganic matter, e.g. brick powder, collected together with efflorescences. This hypothesis is confirmed by the presence of solid residues after sample dissolution. Brick powder as red dots are visible on the microscopic photo of one of the samples (Fig. 2).
