## Science and Art: A Future for Stone

**Proceedings of the 13<sup>th</sup> International Congress on the  
Deterioration and Conservation of Stone – Volume I**

**Edited by  
John Hughes & Torsten Howind**

6<sup>th</sup> to 10<sup>th</sup> September 2016, Paisley, Scotland

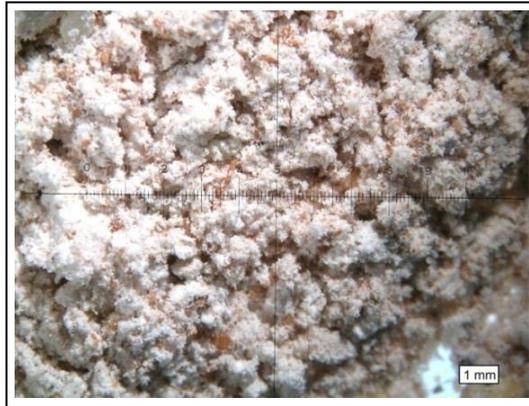
In the last step, the commonly present salt efflorescences, as depicted in Fig. 1, were analysed by the electrophoretic methods. However, there is no a clear relation between the salt content in bricks and it the efflorescence. The results of quantitative salt analysis present in efflorescences should not be treated as representative for the salt content in bricks. All the samples were taken from the ramparts and the Teutonic Order castle ruins in the Old Town of Toruń, from the Vistula river side. Similarly as in the brick sample analysis, only the common ions were identified and quantified. The results are collected in Tab. 3. As noticeable, the calculated sums do not amount to 100 %. This phenomenon may be explained by the presence of insoluble salts in the efflorescences or by the presence of other insoluble inorganic matter, e.g. brick powder, collected together with efflorescences. This hypothesis is confirmed by the presence of solid residues after sample dissolution. Brick powder as red dots are visible on the microscopic photo of one of the samples (Fig. 2).

Fig. 2: Microscopic photo of efflorescences, sample 4.3 (photo by W. Oberta).

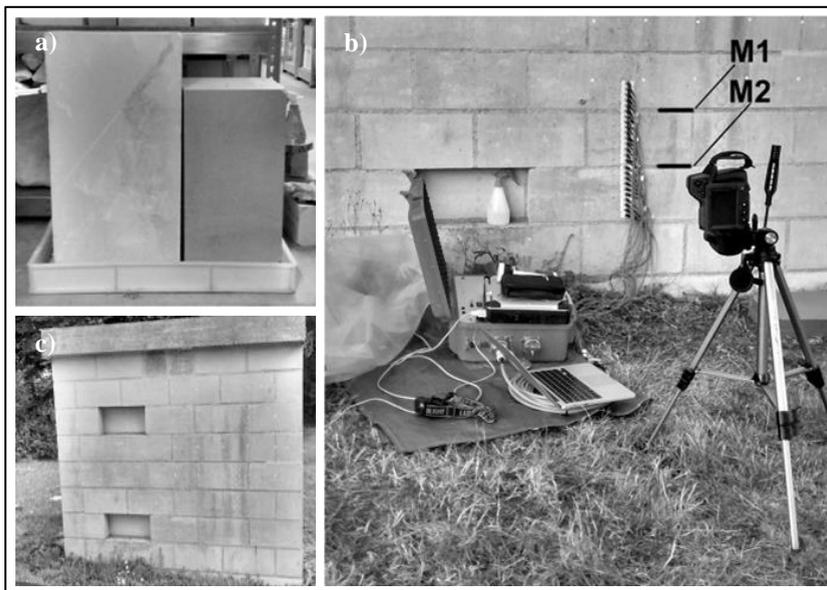
Two stone monoliths were used – a sandstone block measuring 55×32×25.5 cm (obtained from a quarry) and a limestone block (from a waste site) measuring 71×38 cm in height and length respectively (see Fig. 1a), with an uneven width varying from 9–20 cm. The limestone block has a discoloration running down the front surface suggesting near-surface physical inconsistencies, and could be indicative of defects at further depths.

*Fig. 1: The monoliths (left, limestone; right, sandstone) (a) and the traditional masonry construction (b). An example of the simultaneous instrument set-up with positions of the mortar joints: M1 and M2 (c).*

The masonry construction is 1.8 m high and 2.0 m wide, and comprises a single skin of Elm Park limestone ashlar blocks (20×20×40 cm) with 2 cm lime mortar joints (Fig. 1b). It is located in a field with sparse tree cover in Oxfordshire, England. Measurements were taken in July 2015. The wall has an exposed western façade that receives direct sunlight between 13:00–15:00 h and 17:00–19:00 h daily in summer if not obscured by cloud cover.

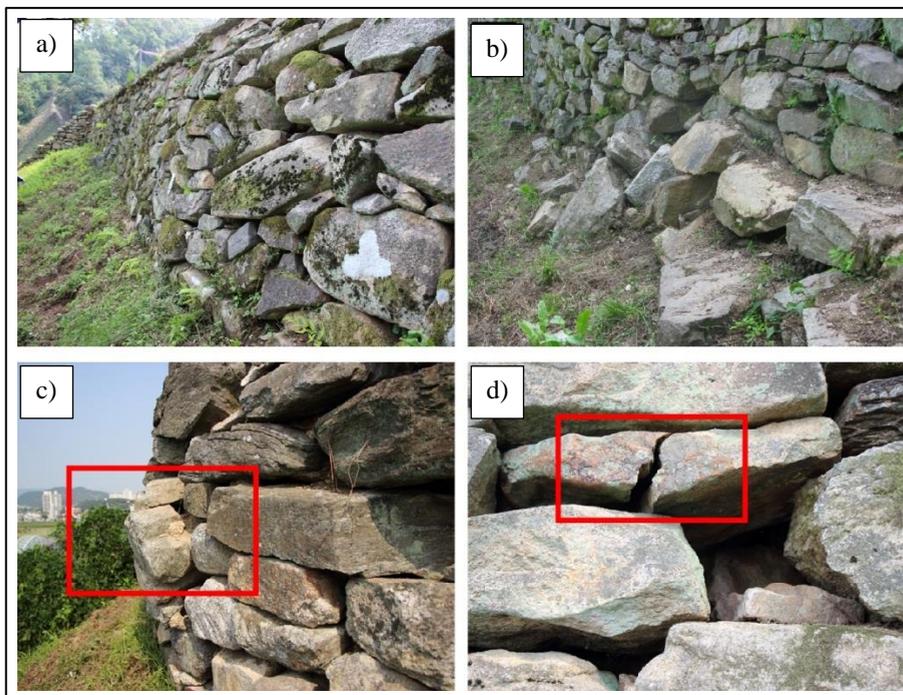
Fig. 1: Occurrences of various deterioration status: a) inflating phenomenon; b) unstable foundations; c) projection; d) crack.

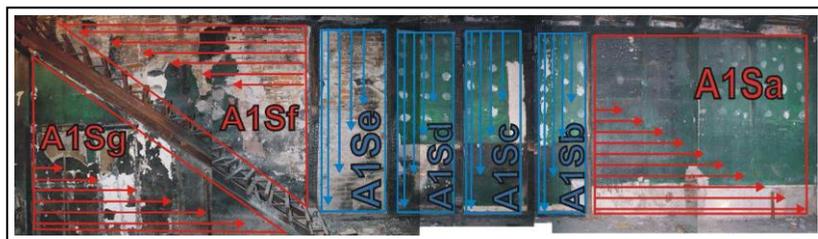
Fig. 4: 'Section A', longitudinal, ground floor, south wall. Markers merged into a photograph of the area in question.

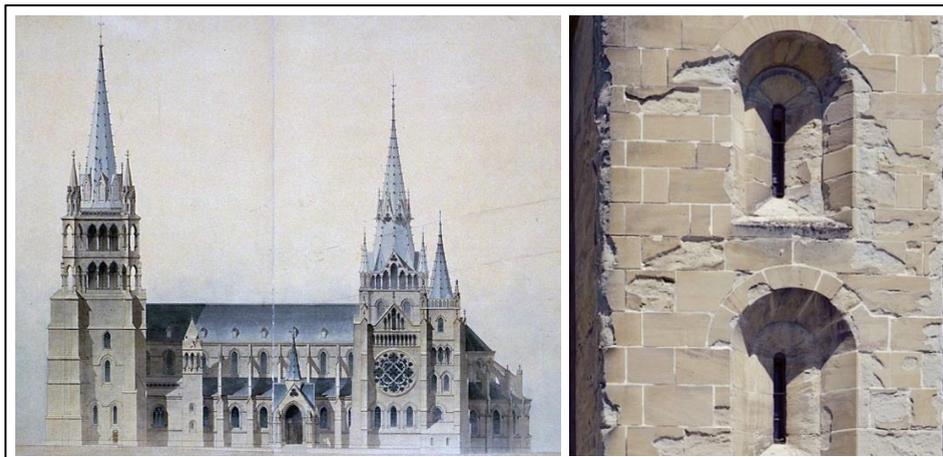
Fig. 1: Left. Sketch of the south façade of the Lausanne Cathedral (source: [http://www.patrimoine.vd.ch/no\\_cache/monuments-et-sites/eglises/cathedrale-de-lausanne/](http://www.patrimoine.vd.ch/no_cache/monuments-et-sites/eglises/cathedrale-de-lausanne/)); Right. Scaling damage observed on the south façade.

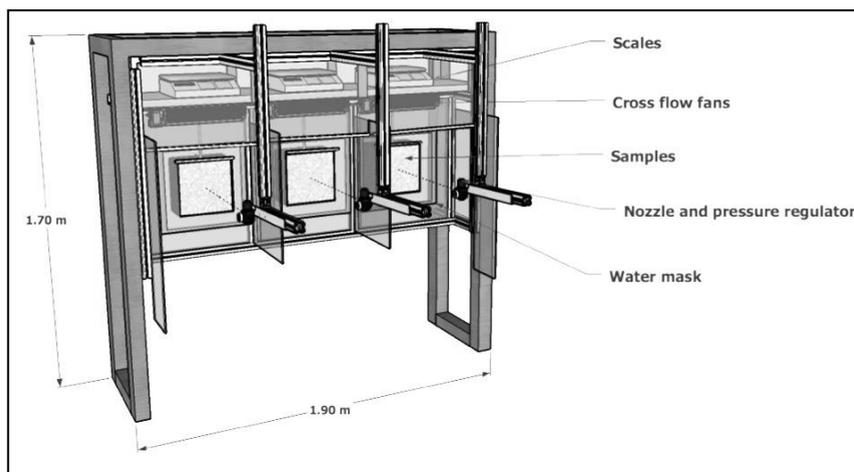
Fig. 2: Sketch of the experimental set up for accelerated laboratory testing.

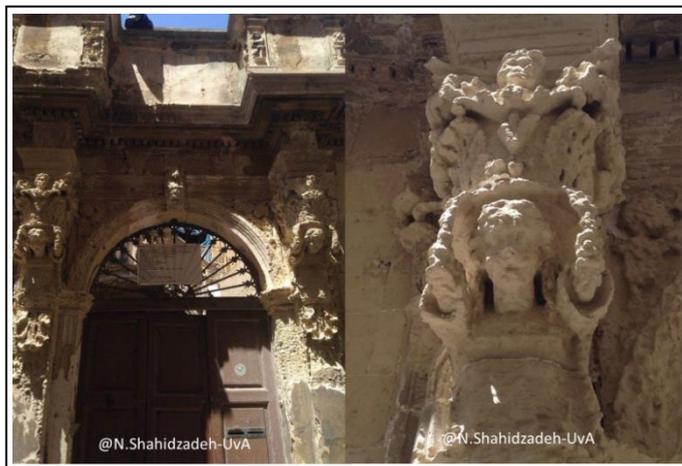
*Fig. 1: Granular disintegration of stone sculptures and historical monuments due to salt crystallisation (Lecce; Italy).*

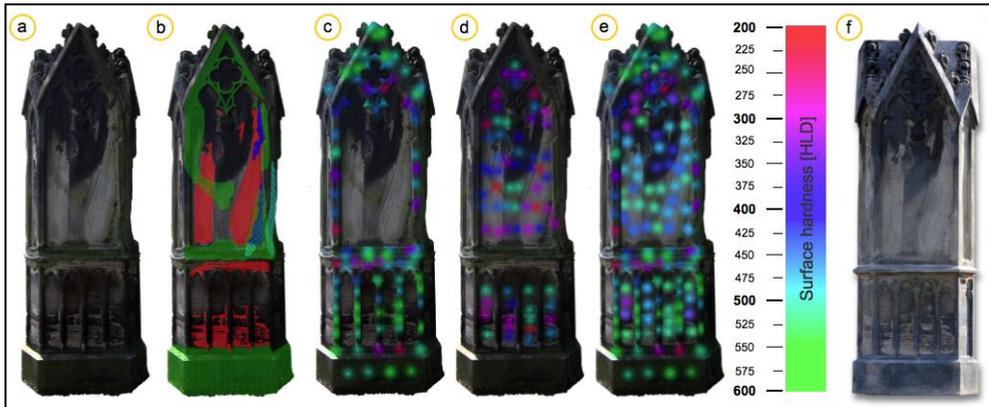
Fig. 5: a) The Pickardt tomb before consolidation and restoration. b) Damage mapping of the monument with indications of microbiology (green), sanding areas (red), gypsum crusts (blue) and delamination (light blue). c) Surface hardness of the exposed decorative parts of the monument. d) Surface hardness of the backside of the monument. e) Surface hardness after the consolidation treatment. f) The monument after conservation and restoration.

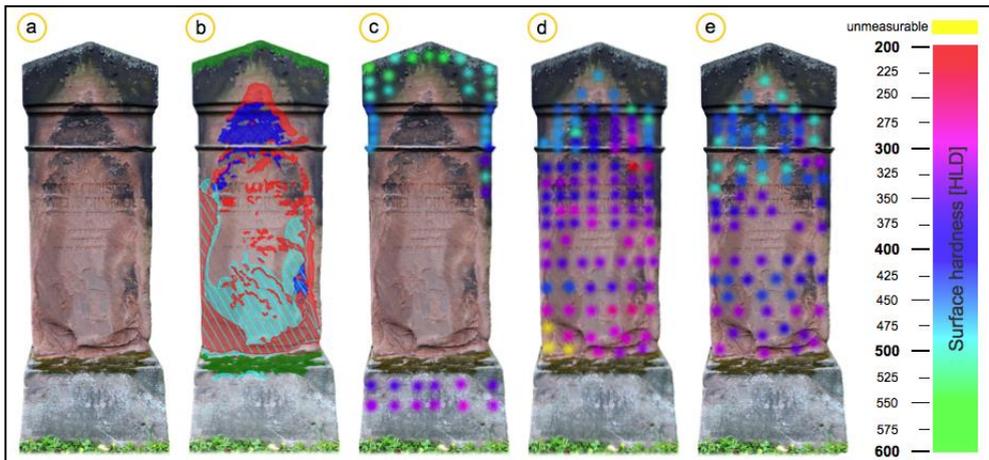
Fig. 6: a) The Schneider tomb before consolidation and restoration. b) Damage mapping of the monument with indications of microbiology (green), sanding areas (red), gypsum crusts (blue) and delamination (light blue). c) Surface hardness of the parts exposed to rain water, visible due to the dark discoloration. d) Surface hardness of the weathered areas of the monument. e) Surface hardness after the consolidation treatment.

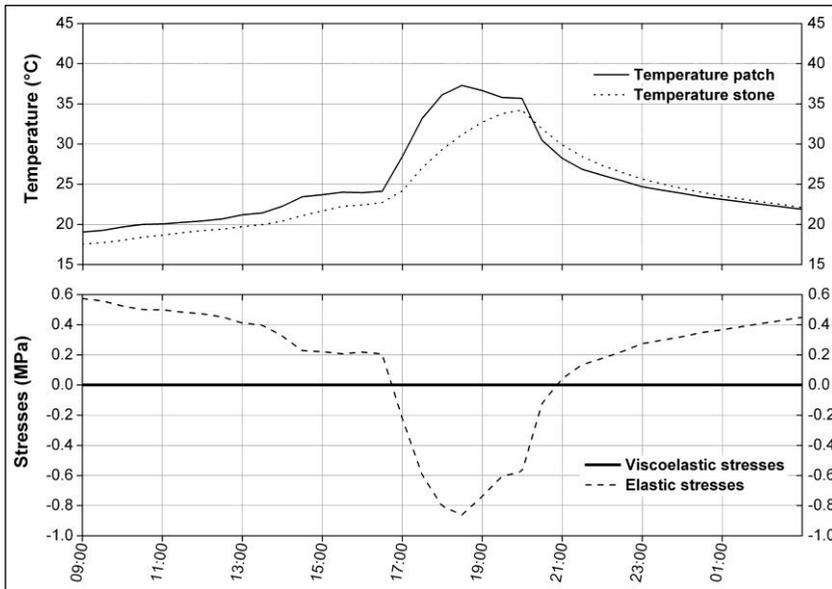
Fig. 2: On top, the temperature profile of the patch and of the stone, as measured in Vevey on July 31<sup>st</sup>, 2013. Below, the induced viscoelastic stresses, compared with the stresses calculated without considering the viscoelasticity of the mortar (elastic stresses).

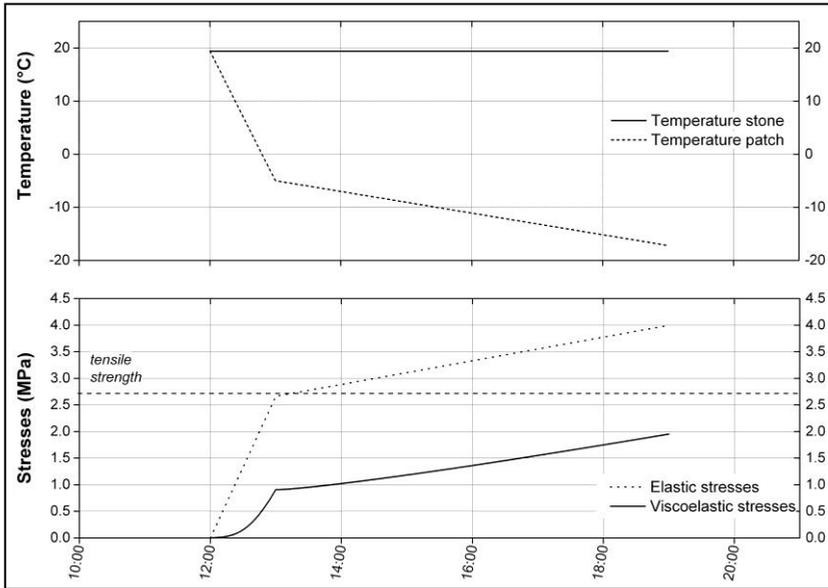
Fig. 3: On top, the temperature profile of the materials that could have been recorded after the extreme weather event of December 12<sup>th</sup>, 1919. On the bottom, the viscoelastic stresses that could have appeared in the repair layer, compared with the tensile strength of the mortar and with the stresses calculated without considering the viscoelasticity of the mortar (elastic stresses).

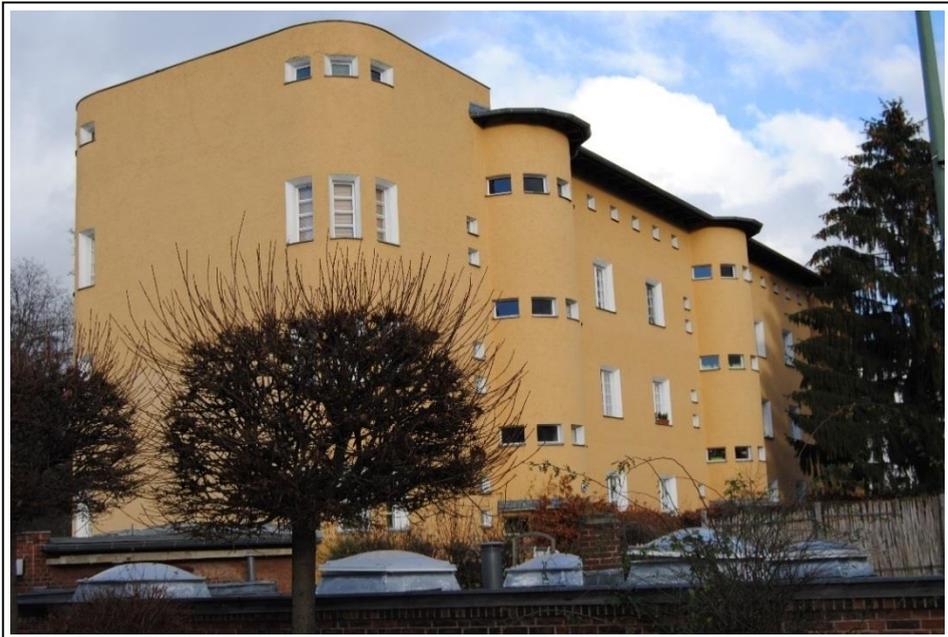
*Fig. 1: Example of a coloured plaster (yellow ochre) at the housing estate “Hufeisensiedlung” in Berlin-Britz.*

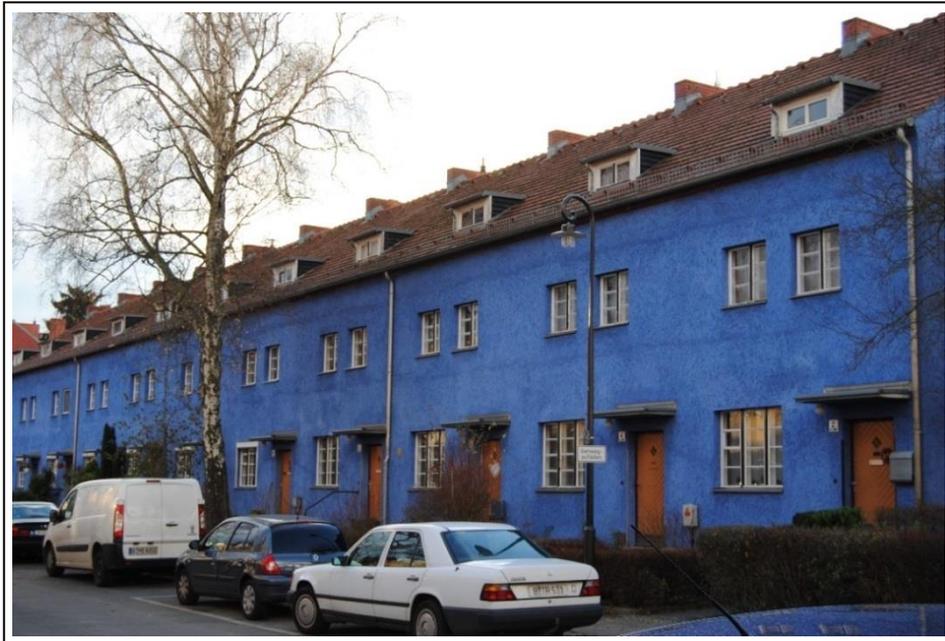
*Fig. 2: Example of a coloured plaster (blue) at the housing estate “Hufeisensiedlung” in Berlin-Britz.*

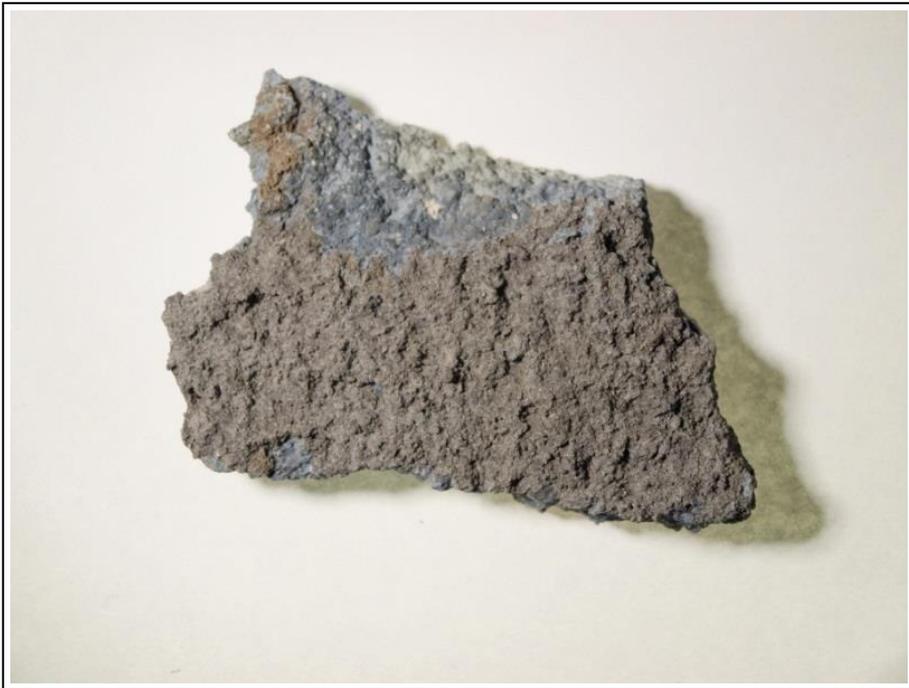
*Fig. 3: Example of a blue-coloured plaster from the housing estate “Hufeisensiedlung” in Berlin-Britz, on the surface where the colour turned to grey (grey crust contains gypsum).*

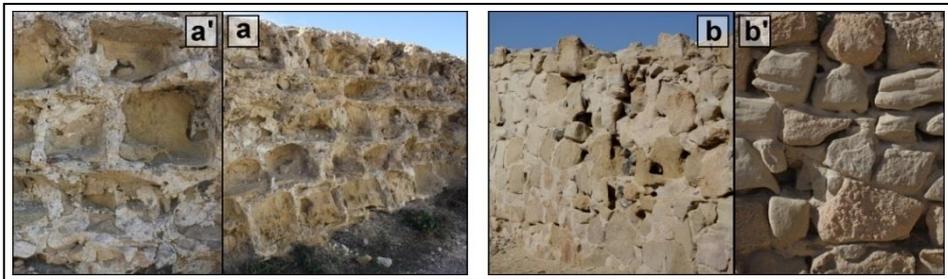
One of the weakest aspects of the last restoration work regards the repair mortar chosen. Fig. 2 shows the current situation of a non-restored city wall (a) and a rebuilt section during the 70's (b). In the original masonry (a) it is possible to appreciate how the original lime-mortar remains well preserved whilst the ashlars are completely eroded. The rebuilt part, instead, presents the opposite behaviour: the rock ashlars show a slight to moderate weathering, whilst the new lime-mortar is strongly deteriorated.

Fig. 2: examples of two parts of the city walls of Nueva Tabarca: original (a and a') and rebuilt masonry (b and b').

With the purpose to understand the reasons for the different durability of both the original and the repair lime mortars, a complete petrographic and petrophysical characterization of these materials has been carried out in the present work.

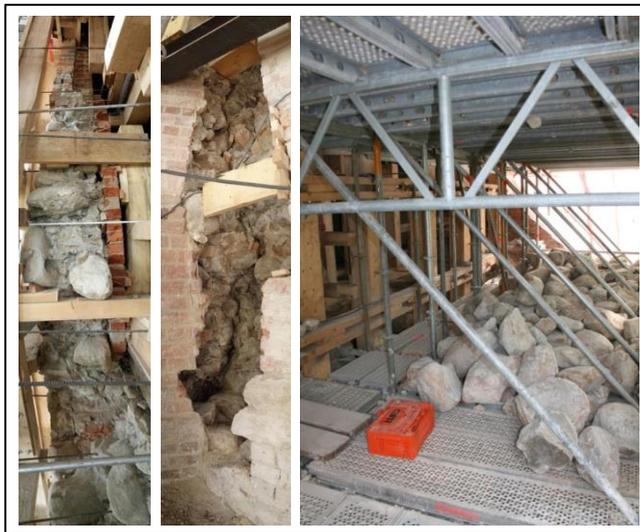
*Fig. 6: Masonry of the bell tower during restoration.*

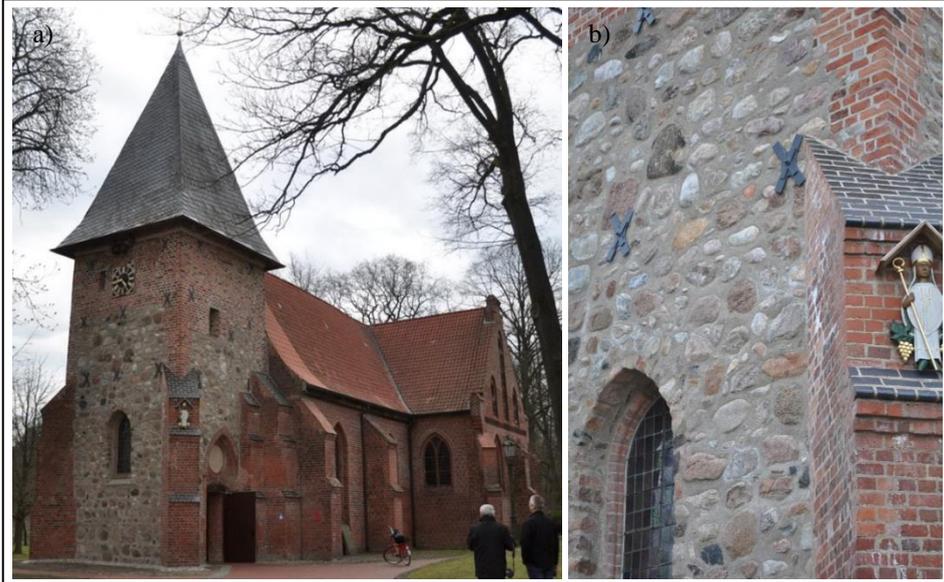
*Fig. 7: Restored St. Urbani Church in 2015: a) Total view of the St. Urbani; b) Restored field stone and brick masonry with gypsum lime mortar.*

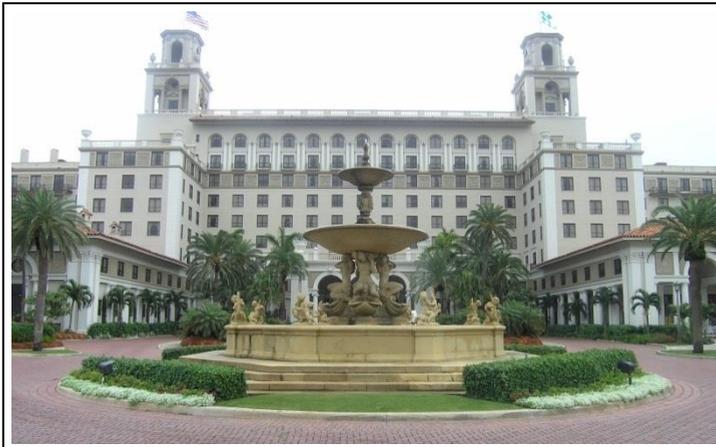
*Fig. 1: Breakers Hotel Main Fountain before restoration.*

The fountain consists of a central sculptural feature of four nymphs supporting two tiers of basins, spindles and a finial within an octagonal pool. There are eight putti holding either alligators or herons alternating around the fountain atop the corners of the pool copings. The pool is raised within a stepped plaza that is centrally sited at the terminus of the main entrance drive just west of the hotel entrance. The fountain was built during the construction of the current hotel in 1926. The Breakers fountain was created from designs by Leo Lentelli, a sculptor who contributed extensively to the decoration of the Panama - Pacific Exhibition in San Francisco in 1915, including the design for a fountain similar to The Breakers fountain. Both are based on a Renaissance original at the entrance to the Boboli Gardens in Florence, Italy.

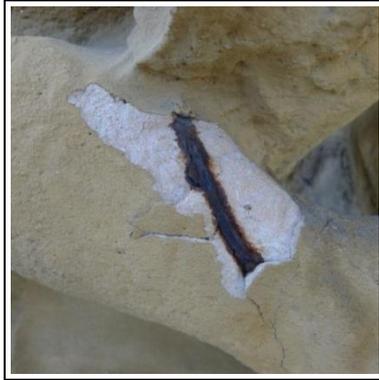
The high sand content, low depth of carbonation and high *pH* of the core samples indicated that the rebar throughout was not immediately threatened. Losses due to deteriorating rebar were confined to the arms of the nymphs and the putti where there was minimal cover of the iron that was placed close to the skin of the forms. This and other deterioration of rebar and subsequent spalling was tied to the high level of water soluble salts from both water treatment and aerosol exposure. As the quality of the cast stone mixture was determined to be inherently good, and deterioration was localized, stabilization and preservation of the majority of the elements was recommended with only selective replication required where details were either lost from erosion, obscured by parges, or where severe corrosion of the rebar had occurred. The best surviving examples were to be used as models for replication in new cast stone, while other elements were recommended to be retained.

*Fig. 2: Detail of a nymph showing rusting rebar, spalls and over-paint.*

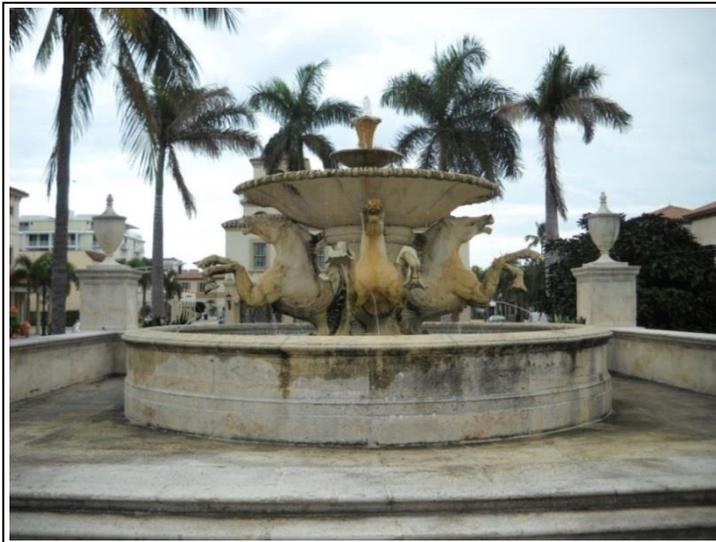
*Fig. 3: Overall view of Town Hall fountain before restoration.*

The fountain consists of a circular basin or pool approximately 16' in diameter. Within it there are a set of bowls and stems of diminishing size resting on four hippocamps or mythological sea horses. The design is based on the *Fontana dei Cavalli Marini* in the Borghese Gardens in Rome. All elements of the fountain are composed of cast stone intended to look like coral stone. The design drawings state that the stone is called 'Keyite', most likely a trade name for cast stone that mimics coral stone of the Florida Keys. It has a variegated color and intentionally pitted to resemble the porous stone. The fountain was surveyed by CSI in 2012 and found to be in poor condition. The cast stone suffered from heavy erosion from running water as well as direct spray that had removed extensive amounts of the sculptural detailing at the basin, stem, finial, and legs and heads of the hippocamps. Additional losses from deteriorating re-bar had substantially compromised the sculptural forms and structural integrity of the hippocamp legs and elsewhere.

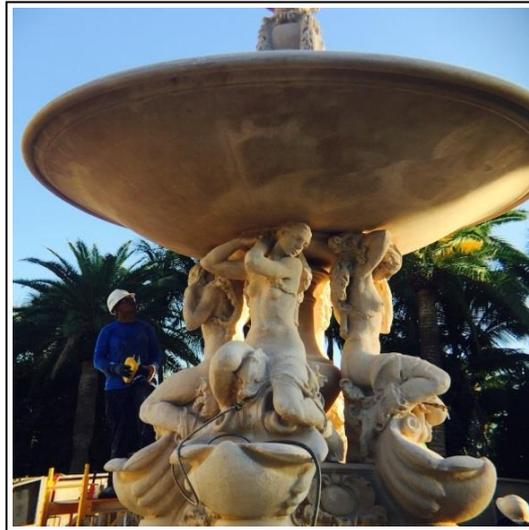
After documentation each fountain was disassembled and reconstructed. Work ran concurrently but under different contractors and artisans. In both cases, the detailed sculptural elements were salvaged and used as models for replication except for the hippocamps, which were restored and re-installed. Architectural elements such as the basins, stems, copings, walls, steps, etc, were profiled and measured before being demolished and entirely re-created from new models.

*Fig. 4: Breakers Hotel fountain after restoration.*

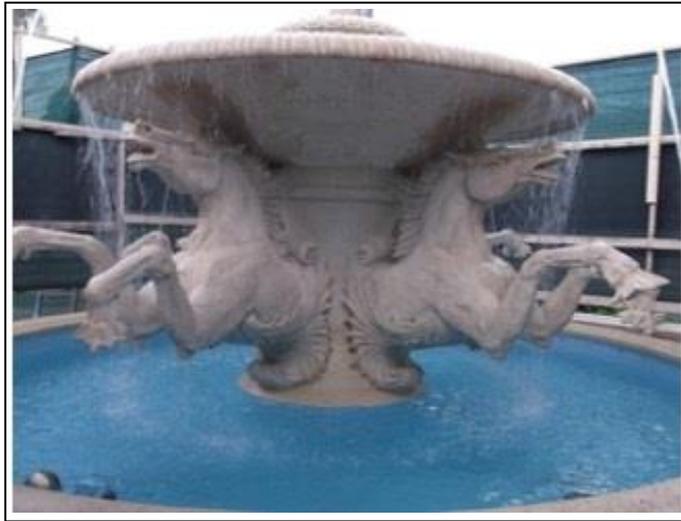
The hippocamps were cleaned of coatings and soiling and the legs were removed once the original mounting system was understood. These were re-created in new castings with stainless steel armatures. Mild steel rebar that could be accessed from the backs or areas of damage of the bodies was core drilled and removed. Rebar that could not be removed was cleaned and coated with a corrosion inhibitor-modified epoxy paint. A migrating corrosion inhibitor (MCI) was applied to the cast stone around the remaining embedded rebar. Losses were then reconstructed with a color-matched, naturally hydraulic lime mortar patching and the entire restored element was coated with a potassium silicate-based paint to blend with the new castings. Restored and new elements were then re-assembled at the site in a re-constructed pool.

*Fig. 5: Restored Town Hall Fountain.*

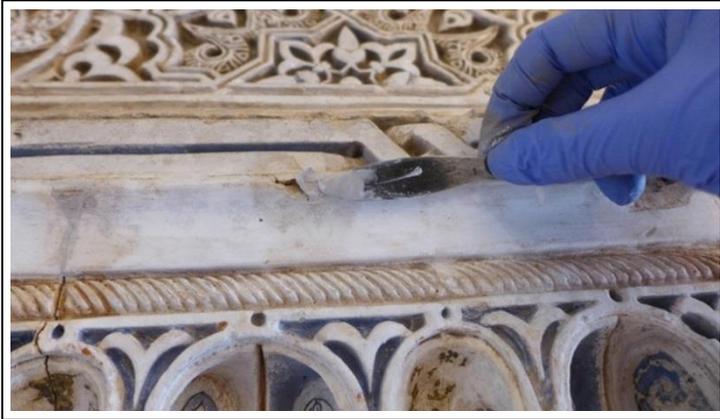
Cubic samples (5 cm approx.) of plaster have been prepared using a commercial gypsum normally employed on the Alhambra as joining or filling material to restore the gypsum plasterworks (Fig. 2). The gypsum has been mixed with water in a proportion 210 g gypsum/162 g water.

*Fig. 2: Restoration of plasterwork in the Alhambra*
