# The Handbook of Sustainable Refurbishment

Non-Domestic Buildings

## The Meyer Hospital, Florence

### Refurbishment and addition of large greenhouse to historic building in warm climate

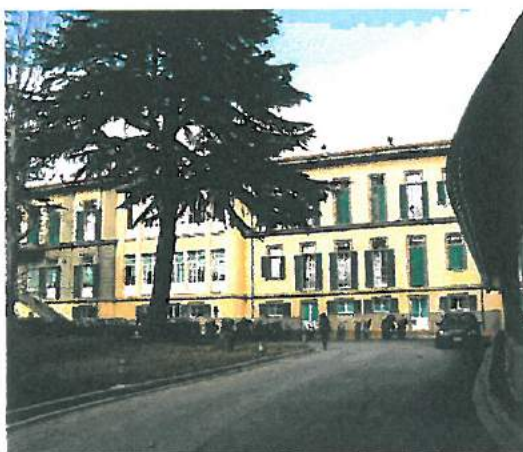
**Figure 13.1** South elevation of the Villa Ognissanti, the original Meyer Hospital

The building dates from the 1930s when it was a hospital for tuberculosis patients. It consists of a long three-storey terrace running east-west, of traditional construction with very thick walls and a tiled roof. A central corridor serves rooms on the north and south side (Figures 13.1 and 13.2). The total area is 10,480m<sup>2</sup>. The building had been semi-derelict for some years. A new paediatric hospital has been built on the site adjacent and the refurbished building forms the administrative and reception centre.

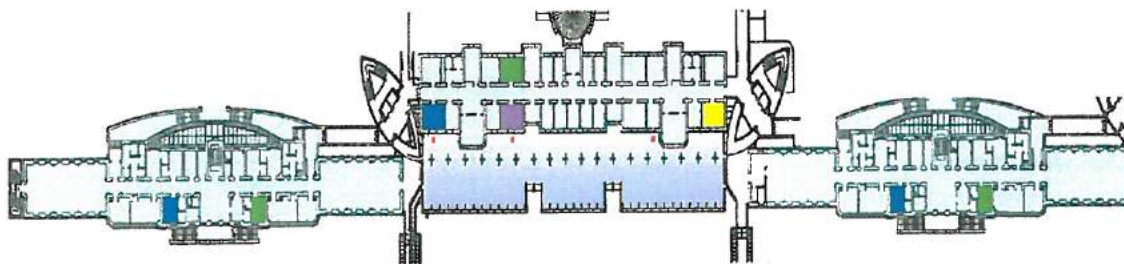
**Figure 13.2** Plan of the east-west running terrace showing the additional greenhouse (centre)

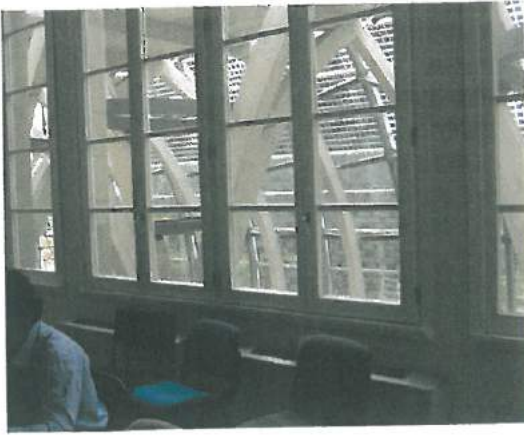
**Figure 13.3** Replacement timber windows with low-e glazing

Being of traditional construction the building was non-insulated and single glazed. The first consideration was how to insulate the envelope. The roof presented no problem, since during reconstruction insulation material was included, in this case mineral fibre quilt. The windows were also replaced giving the opportunity to incorporate low-e double glazing in timber frames, giving a U-value of 2.85W/°Cm<sup>2</sup>. This also reduced uncontrolled infiltration.

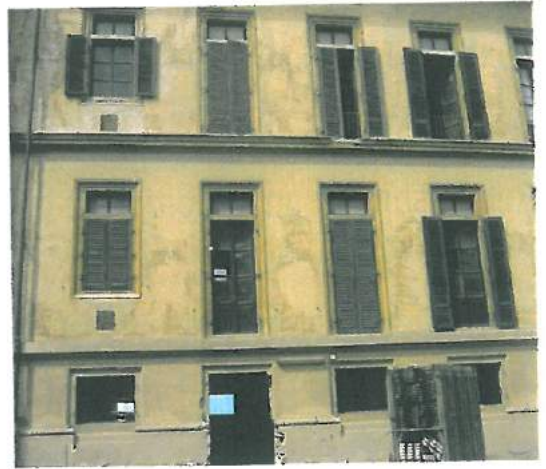
**Figure 13.4** Refurbished traditional louvre shutters on south elevation

Originally, the renewed south-facing windows were to have included an interpane shading system, magnetically controlled from outside the sealed unit. These were finally rejected on the grounds that since the external louvred casement shutters (Figure 13.4) had to be kept for historic reasons, the expense of the additional integral shading was not justified.

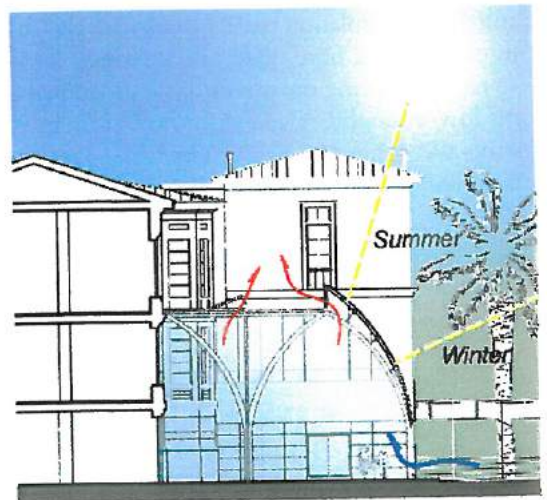
**Figure 13.5** Section of greenhouse showing shading and ventilation openings

The boldest intervention is the installation of a large greenhouse on the south side of the central pavilion abutting the lower two of the three storeys (Figures 13.5, 13.6 and 13.7). As an

is provided by semi-transparent photovoltaic panels. This, and the ventilation provision, are shown in Figure 13.5. The ventilation openings at the top and bottom of the greenhouse are controlled by the BEMS. A further open area can be obtained by leaving the main doors open.

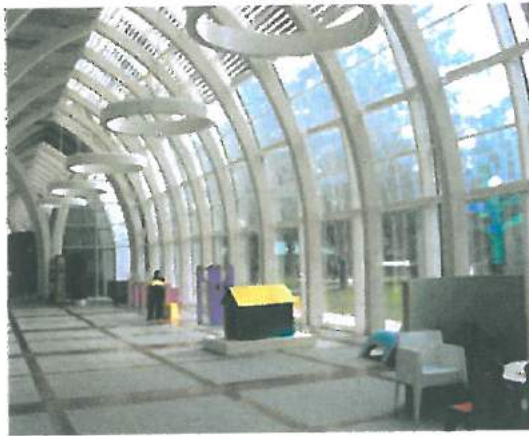
**Figure 13.6** Interior view of greenhouse showing semi-transparent PV shading

The structure is made from laminated timber columns and is a striking addition to the architecture. Its spatial function is as the arrivals foyer and reception area for the whole hospital complex.

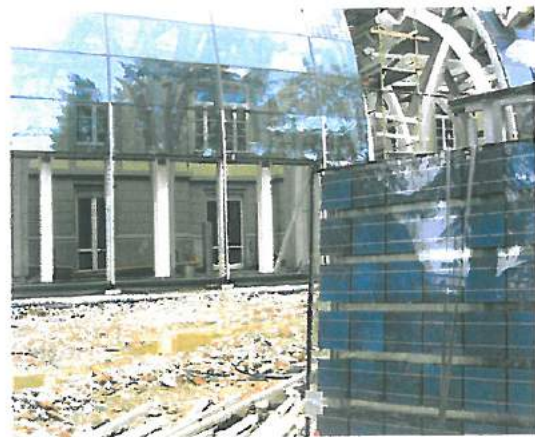
**Figure 13.7** Exterior view of greenhouse during construction

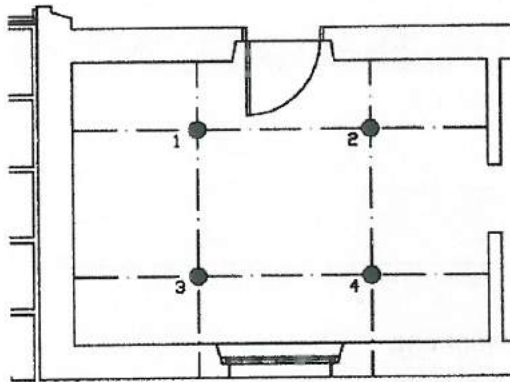
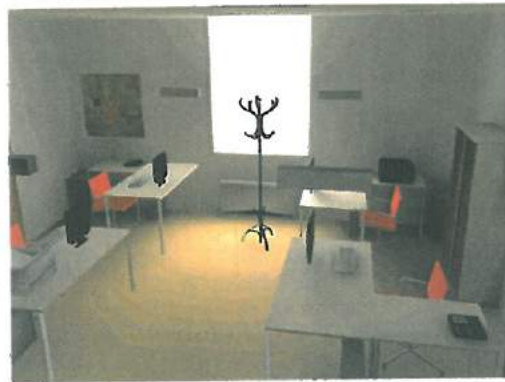
Position	Daylight Factor %
1	1.71
2	1.37
3	2.57
4	2.02
Average	1.91

**Figure 13.8** Simulated daylight results for office facing greenhouse

The impact of the greenhouse on the daylighting of the adjacent office rooms had been tested by simulation (Figure 13.8). The result shows a mean value of 1.91 per cent.

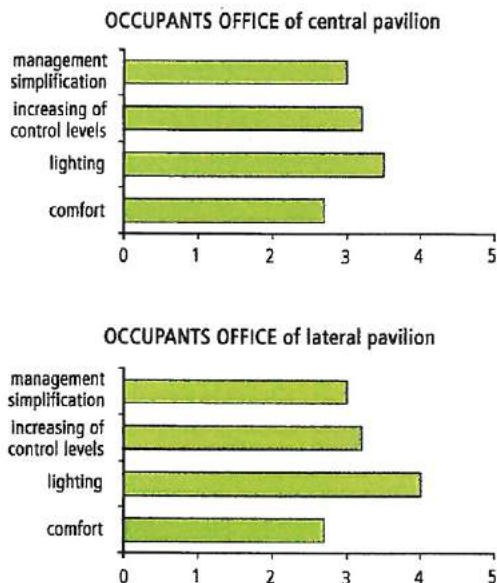
**Figure 13.9** Results of user survey for office facing greenhouse (central pavilion) and office facing open air (lateral pavilion). Scale ranges from 0 – very dissatisfied to 5 – very satisfied.

Occupants report a high level of satisfaction with the lighting, 4.0 on a 1–5 scale in the end pavilions, but slightly less, 3.5 in the central pavilion adjacent to the greenhouse (Figure 13.9).

Questionnaires were issued to occupants in the central wing adjacent to the greenhouse, and in the two lateral wings. The results are shown in Figure 13.10. These are consistent, with the exception of a slightly lower satisfaction for lighting reported in the central wing, which could be due to the presence of the greenhouse. Unfortunately the question does not distinguish between artificial lighting and daylighting.
