# THE MAYA SITE OF CALAKMUL: *IN SITU* PRESERVATION OF WALL PAINTINGS AND LIMESTONE USING NANOTECHNOLOGY

Piero Baglioni, Ramón Carrasco Vargas, David Chelazzi, Marinés Colón González, Alice Desprat and Rodorico Giorgi

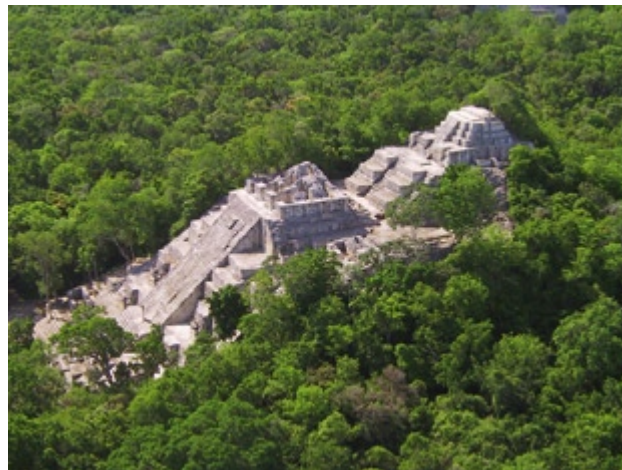
Fig. 2 Aerial view of Structure II.

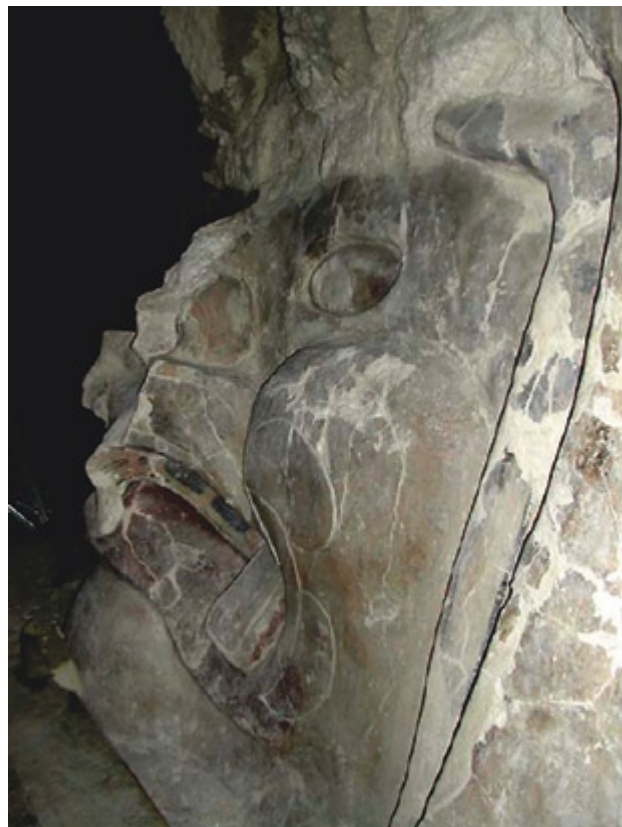
Fig. 3 Polychrome-modelled stucco mask in the sub-structure II c-1, in the inner part of structure II. The image was taken after re-adhesion of several detached fragments using autogenously air-setting mortar.

The mask from substructure II-c1 was found to have been part of the building's façade, flanking the main stairway that provided access from the *Gran Plaza* level to the inner part of the architectural compound that is behind, to the south. Another mask has been identified in the west part of the building's façade; it is expected that two additional masks will be found on the lower part of this façade. The general condition of the polychrome-modelled stucco mask found during the exploration process was good: some sections had separated from the support and, in some cases, cracked, but had remained *in situ*. The pigments decorating the modelled stucco were found to be in a good state of preservation. The exposure of these features to new environmental conditions (light, temperature and humidity) was monitored and controlled to minimize potentially adverse effects. This was achieved by the installation of covers, and limiting the presence of individuals to the minimum number necessary to perform the delicate excavation and restoration work.

Mortars with ammonium carbamate have been used for repairing detached stucco fragments and also for filling voids and re-adhering flaking layers. This paper specifically reports their use on the polychrome-modelled stucco mask in sub-structure II c-1 in the inner part of structure II, Fig. 3. In this case, the mortar was used for the re-adhesion of large pieces, Fig. 4. The degree of carbonation of the mortar used for the intervention was investigated by X-ray diffractometry (XRD) on reference material. Experiments showed that carbonation of autogenously air-setting mortar initiates a high-binding calcite capacity, while CO<sub>2</sub> from the air does not ensure a fast and efficient carbonation of the mortar, Fig. 5. A detailed description of the laboratory tests is reported in Appendix 1. The procedure for the application of autogenic mortars does not require any specific technical skill, and the costs for the preparation of mortar are modest, or lower than those of the materials commonly used for restoration (Appendix 1).

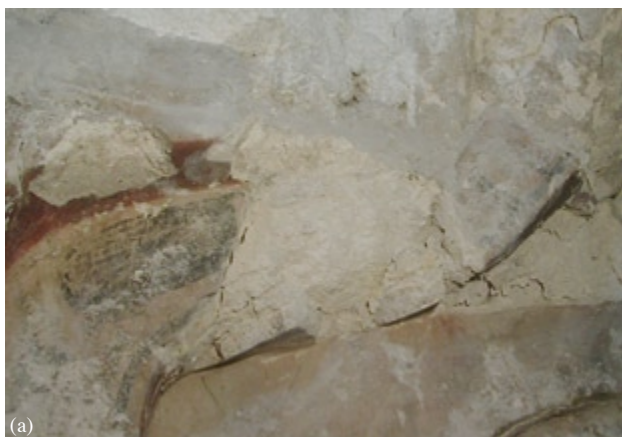
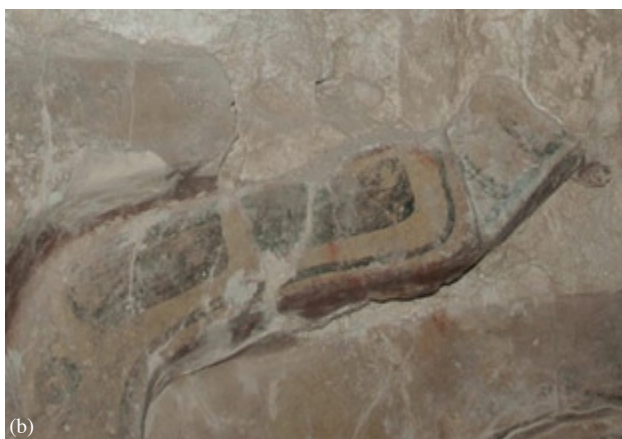
Fig. 4 Polychrome-modelled stucco in sub-structure II C-1 of the Gran Plaza: (a) before restoration; (b) post-restoration. Re-adhesion of detached fragments was performed using an autogenously air-setting mortar.

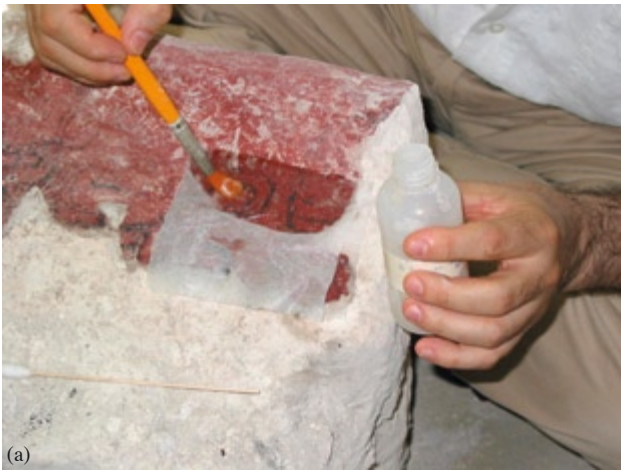
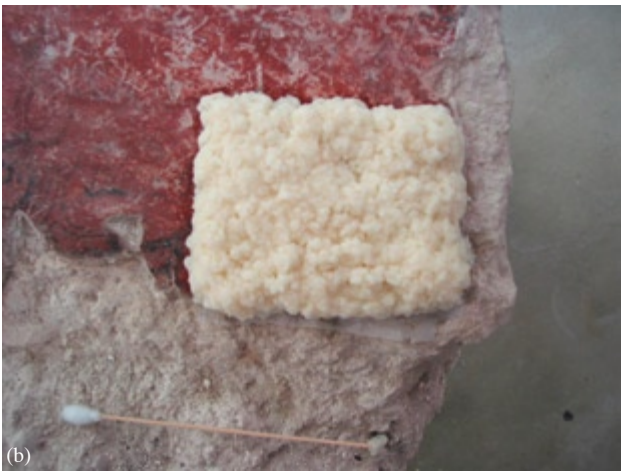
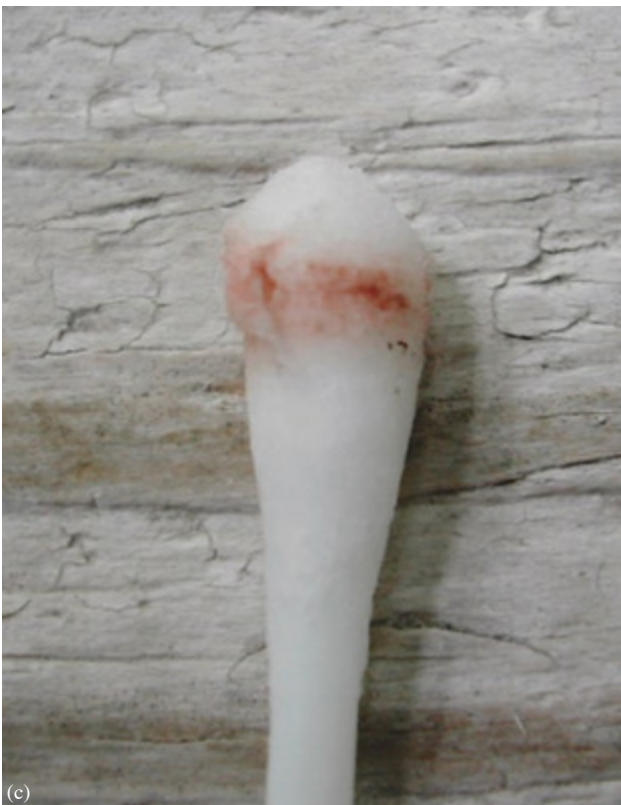
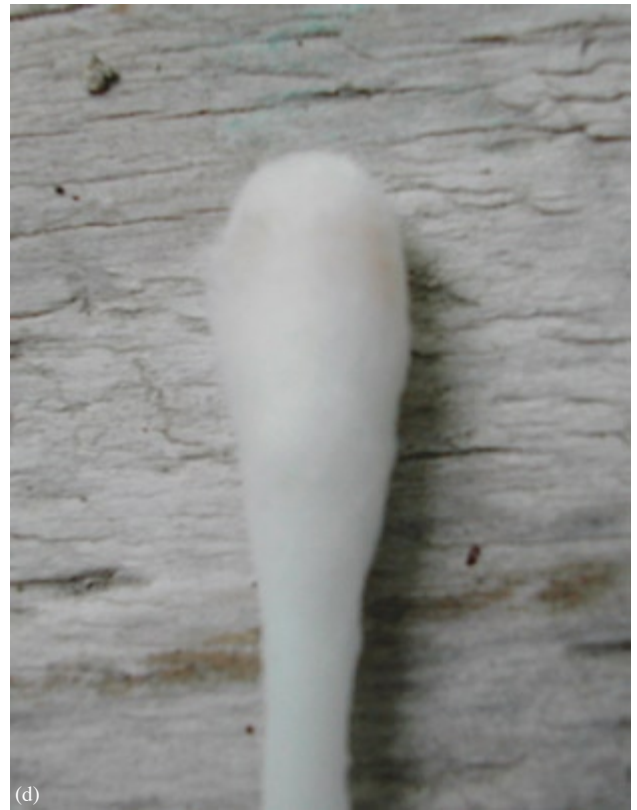
Decorative glyphs, painted over stucco plaster at the base of the columns, in Structure XX (the *Gran Acrópolis*) of Calakmul had a friable and powdered paint layer, which needed consolidation. The consolidation was performed using nanoparticle dispersions applied by gentle brushing, Fig. 6a. Following the application of nanoparticles, a wood-fibre poultice soaked with water was applied for eight hours in order to keep the upper paint layers wet, Fig. 6b. A few days later, a second application of nanoparticles was made. At the end of the whole treatment, a simple test with a wet cotton-wool swab demonstrated that the colour was now completely fixed, Figs 6c–d.

Fig. 6 (a) Application, by brushing, of nanoparticle dispersion on decorative glyphs; (b) wood-fibre poultice soaked with water applied for eight hours in order to keep the first paint layers wet; (c) powdered pigments removed with a wet cotton-wool swab before fixing of paint layer; (d) test repeated on the consolidated area (indicated by the box in Fig. 6e); (e) the paint layers a few days after the completion of the treatment.

Stable nanodispersions of calcium hydroxide have been successfully applied as fixatives to re-adhere lifted paint layers during many restoration programmes in Italy and elsewhere in Europe, and as a consolidant. The application of nanoparticles is equivalent to the application of an extremely concentrated solution of lime-water, but nanoparticles are well above the physico-chemical limit imposed by the solubility of calcium hydroxide in water. A detailed description of the synthesis and of the application procedure is reported in Appendix 2.

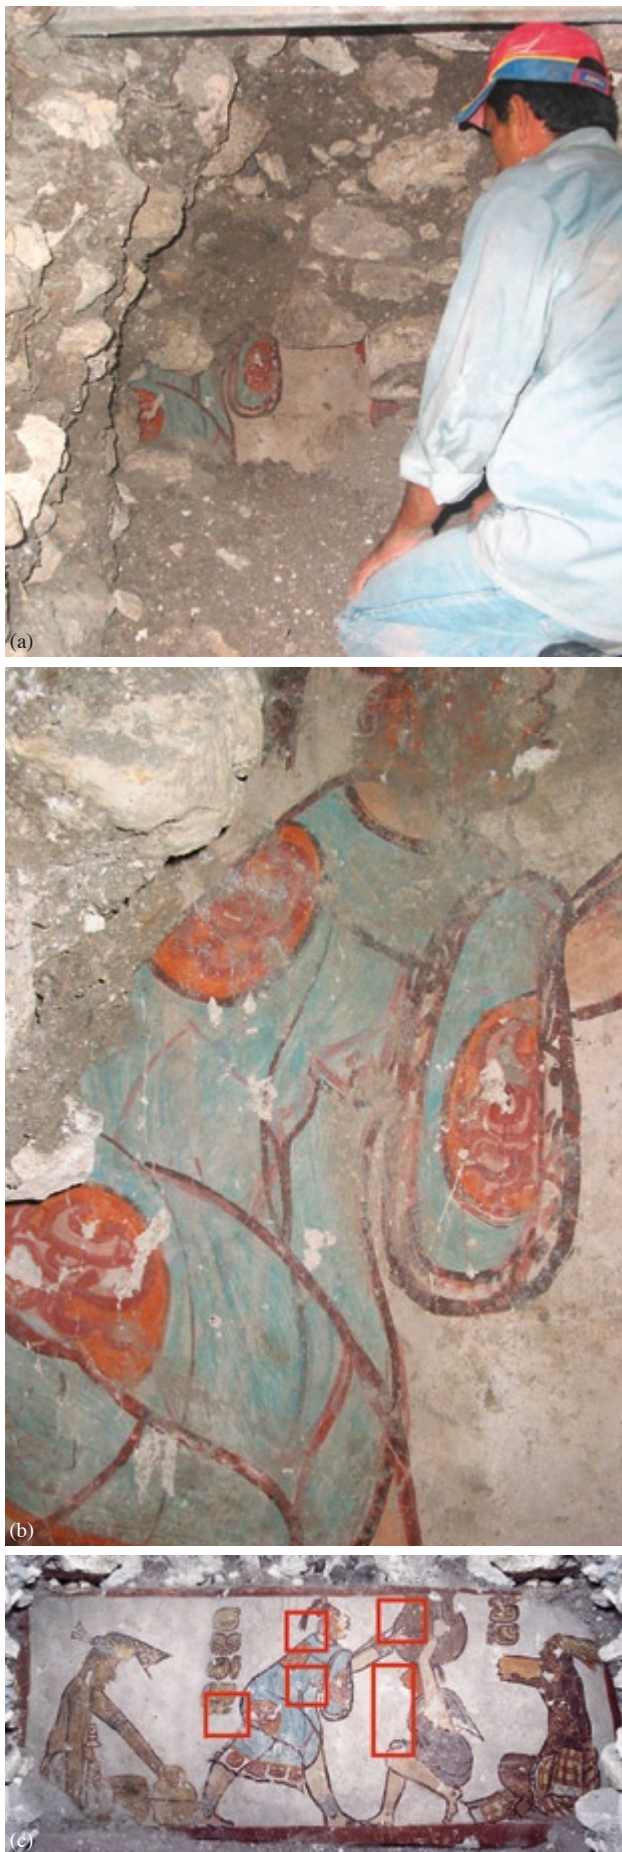
Nanoparticle dispersions were also used in Early Classic period wall paintings of the *Acrópolis Chik Naab*. Fig. 7 shows some steps in the excavation and an overview of the whole painting, which had several areas with powdering paint surfaces, where dispersions were used to fix the colours and to consolidate the painted layer.

Fig. 7 (a)–(b) Discovery and excavation of wall paintings of Structure I in the *Acrópolis Chik Naab*; (c) overview of the paint after consolidation treatment with nanoparticles.

The level of degradation of the paintings did not allow the extensive use of water, since the paint layers were in most cases very friable and weak. The use of alcohols as carriers for nanoparticles avoided possibly dangerous consequences of the restoration through the solubilization of salts in the painted layer. Furthermore, nanomaterials are characterized by a high surface area that influences the chemical reactivity of nanoparticles, producing a consistent consolidation of treated surfaces just a few days after application. These positive effects can be particularly important on archaeological sites where *in situ* conservation requires effective conservation and preservation treatments.
