Article

Terraced Landscapes and Hydrogeological Risk. Effects of Land Abandonment in Cinque Terre (Italy) during Severe Rainfall Events

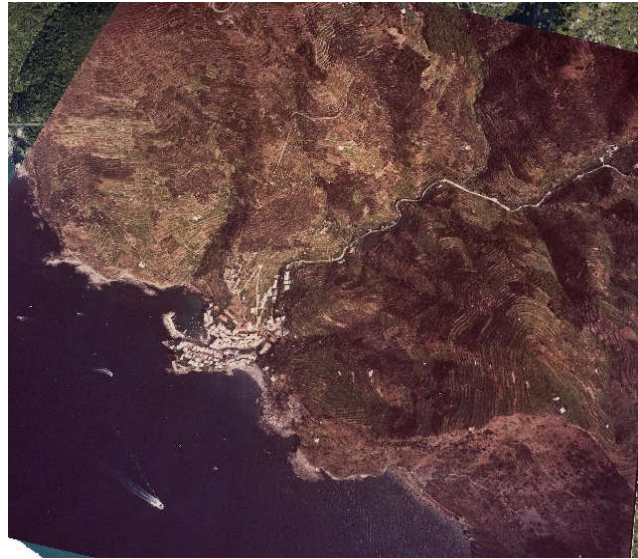
Figure 1. Coastal part of the Vernazza catchment in 1973. Almost the whole surface is terraced. The dark green areas were olive groves.

From the 1970s onward (Figure 1), Cinque Terre witnessed a more than 70% decline of its agriculture and fishing. The towns of Vernazza and Riomaggiore were those that experienced the worst decline of viticulture; for example, the loss of over 52 ha was reported in Riomaggiore between 1982 and 1990, and 24 ha in Vernazza [35]. This decrease of vineyard surface can be regarded as a constant trend over the last thirty years. The depopulation of the countryside has determined a constant reduction of the maintenance required by the terraces. Terraced viticulture in the Cinque Terre area is an economic, historical, and cultural heritage, a landscape modeled by human beings with the sweat of their brow to guarantee their livelihood. But if the population declines, this heritage is placed in jeopardy.

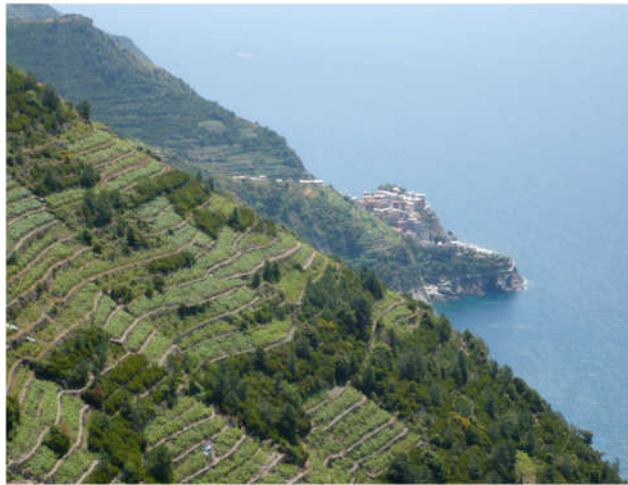
Figure 3. In the Cinque Terre area, terracing, besides having great historical and aesthetic value, plays a fundamental role in agricultural production and in the reduction of hydrogeological risk.

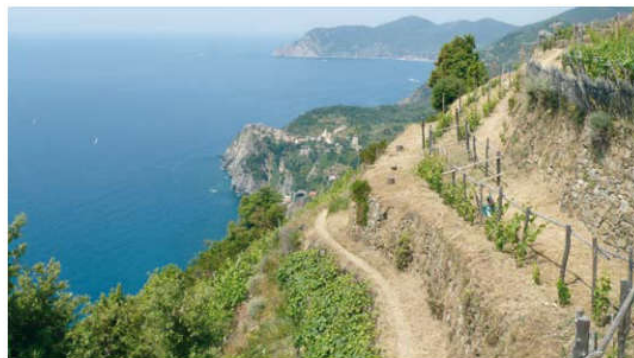
Figure 4. Terracing models the slopes of Cinque Terre, preserving many traditional practices not only as regards building materials, but also grape-growing techniques (photo by Agnoletti).

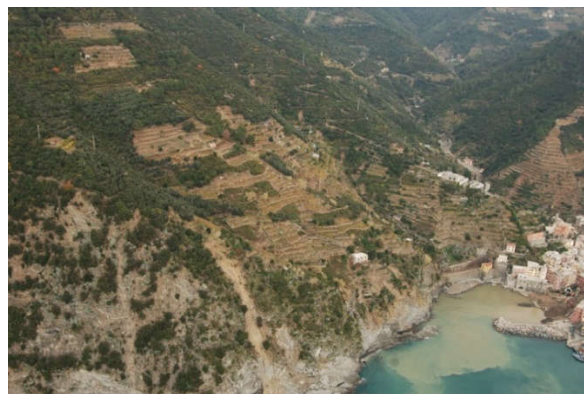
Figure 5. The settlement of Vernazza. The picture highlights the magnitude of the landslide that dragged solid material all the way down to the sea.

On 25 October 2011, in less than 24 h, a high intense rainstorm affected the northern part of Tuscany and the eastern part of Liguria, in the provinces of La Spezia and Massa-Carrara. The rain gauges located in the surroundings of the terraced area of Cinque Terre show cumulative rainfalls ranging between 111 and 382 mm/24 h, with peaks of 111 mm/h, 195 mm/3 h and 350 mm/6 h [30,38]. The consequences were dramatic in terms of loss of lives (13 casualties), and structural and economic damages. Hundreds of shallow landslides, debris and mud flows triggered from the very steep slopes facing the sea, caused the flooding and the partial burial of the famous settlements of Monterosso and Vernazza (Figure 5).

Landslides mainly occurred because of the failure of the layer between debris and bedrock [38], bringing high amounts of sediment into the streams. Consequently, debris-floods reached the settlements located at the mouths, causing fatalities and severe damages to structures and business activities. During the event, several agricultural terraces failed; the relationship between land use and proneness to landslides has been investigated by Cevasco et al. [28], Galve et al. [29], and will be further discussed in this paper.

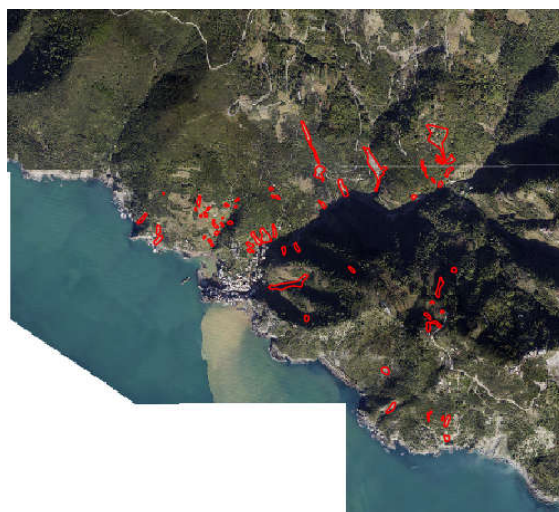
Figure 6. The same area of Figure 1 on November 2011 after the rainfall event of 25 October 2011. The landslides are emphasized in red. It's clear how woodland substituted agriculture in the last 40 years.

The current ongoing deterioration of terracing is an issue at the district level, due both to the extension of the terraces and to the fact that they lie uphill and downhill of roads and settlements on hills and mountains (Figure 6). Large areas are presently in critical conditions. Action is necessary for hydrogeological and cultural reasons. With the industrialization of agriculture and the migration away from the countryside from the 1960s onward, there has been a gradual drop in terrace building and maintenance, as a consequence of the introduction of tractors capable of tilling the soil along the

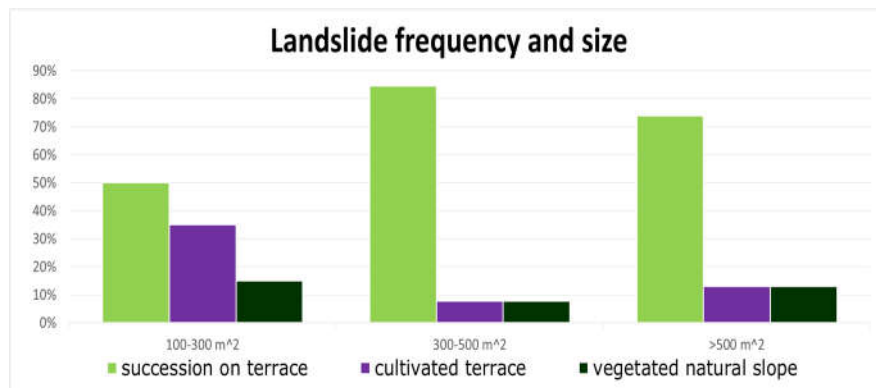
In Figure 7 the landslide frequency is sorted by size and land use macro-classes. We used a dataset of 62 landslides that occurred on 25 October 2011 within the Cinque Terre area. As presented in the graph, the frequency of failures on cultivated terraced land is higher for the smallest class. The category “succession on terrace”, which is composed by both wood and shrub cover on terraces, resulted in the most unstable land use for all the three classes of size. For non-terraced wooded areas, the percentage of failures is equal to or lower than that for cultivated terraces. The distribution seems to be not strongly related to the size. The frequency of wider failures is lower for cultivated terraces, but it has to be considered that the extent of cultivated lands is considerably smaller than the abandoned or wooded ones.

Figure 7. Landslide frequency distribution and size. The frequency for cultivated terraces is higher for small failures, while the frequency of bigger failures is higher on abandoned terraces. The minimum considered size was 100 m², due to the impossibility of recognizing smaller landslides by aerial images.
