Article

Electroluminescence Test to Investigate the Humidity Effect on Solar Cells Operation

Keywords: photovoltaic; electroluminescence; humidity; climatic chamber

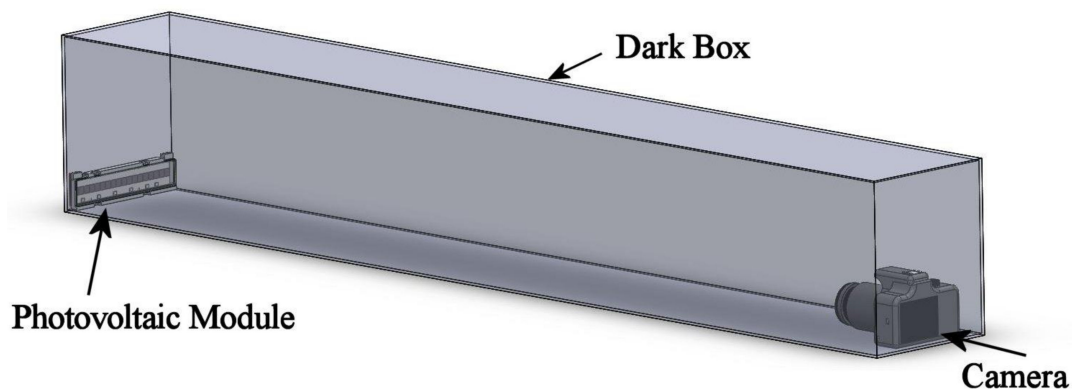
To perform tests based on the electroluminescence technique, a black box was constructed specifically for this purpose. The requirement of a dark environment arises from the fact that the light emission of the photovoltaic cells under test takes place in the visible spectrum but with a low intensity. Therefore, a dark environment is needed to properly observe and evaluate the test results. The test bench is presented in Figure 1: it consisted of a black plastic box (length 1650 mm, width 220 mm, and height 260 mm) with a camera at one end and the photovoltaic module at the opposite end. Both sides of the box had accesses to place the module under test and the camera.

The camera used was a Canon EOS Rebel T2, with shooting time of 1/5 s; diaphragm f/2.8; 1600ISO sensitivity; focal length of 70 mm; and USB interface. The camera was connected to the PC in “live view” mode and the photo was acquired using a remote shutter controlled by the PC.

Figure 1. Test bench for electroluminescence tests.

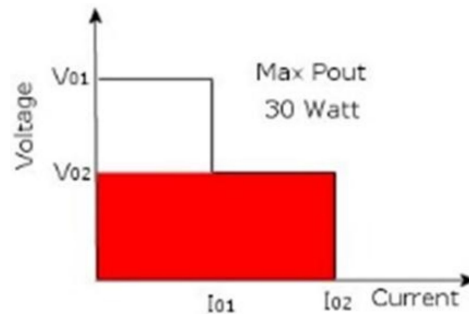
Figure 2. Features and maximum power of the HP E3612A power supply.

The DC power supply can be used by setting voltage and current values separately. The features of the HP E3612A power supply are represented visually in Figure 2, in a voltage–current diagram. As shown in Figure 2, the choice of the maximum voltage value ($V_{02} = 60 \text{ V}$) defines the maximum current intensity that can be supplied ($I_{02} = 0.5 \text{ A}$) and consequently the maximum power supplied, represented by the area subtended by the graph (red zone in Figure 2). With the values chosen for the EL test, the maximum power that can be provided by the HP E3612A power supply (by Hewlett-Packard Company, Englewood, CO 80112 - USA) is 30 Watts.

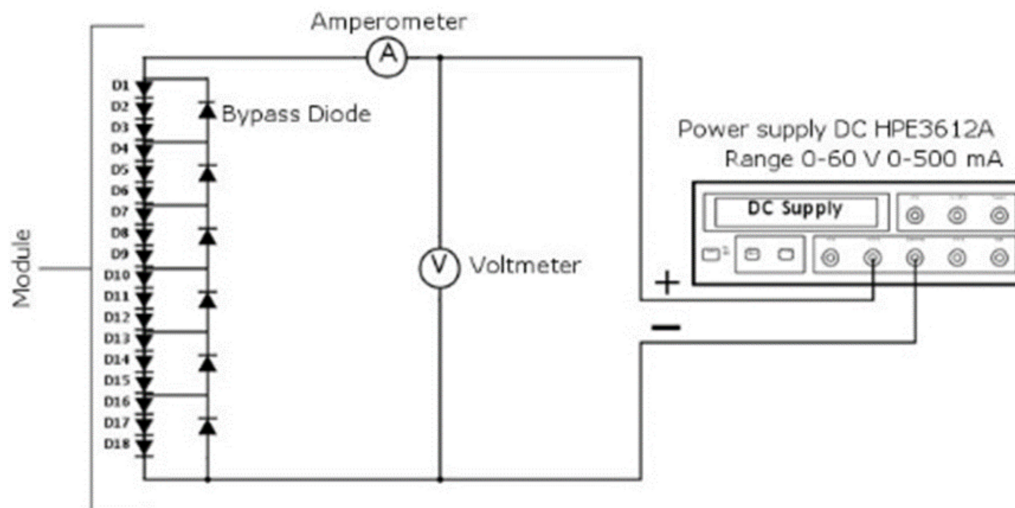
The circuit diagram of the test circuit is shown in Figure 3; it is important to remember that if powered from the outside, the single photocells behave like diodes, allowing the passage of the current only along one direction.

Figure 3. Diagram of the test circuit.

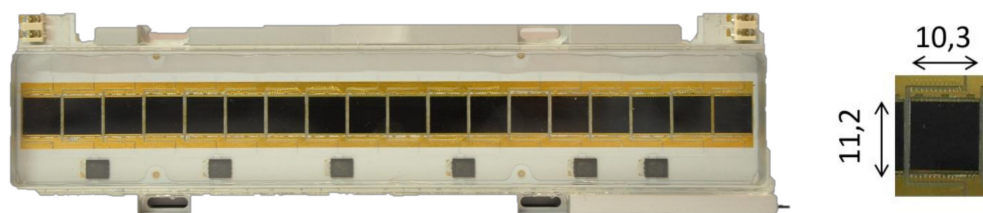
Photovoltaic cells cannot be individually tested because they are grouped into preassembled modules of 18 cells each. Figure 4 reports a representative image of a module (length 204 mm, width 53 mm, and height 14 mm), in which each photocell measures 10.3 mm × 11.2 mm × 1 mm. The electrical contacts used to connect the module are visible at the upper ends.

Figure 4. A photovoltaic module under test and a photocell.

Six bypass diodes were integrated into each module: the diodes are visible in Figure 4 at the bottom of the module. Each bypass diode served three photocells and was located under the cells. These diodes had the task of electrically bypassing an inoperative cell during regular use, thus closing the circuit without affecting the operation of the entire module. Regular utilization of the photocells can be considered their use in solar concentration plants for the energy production.

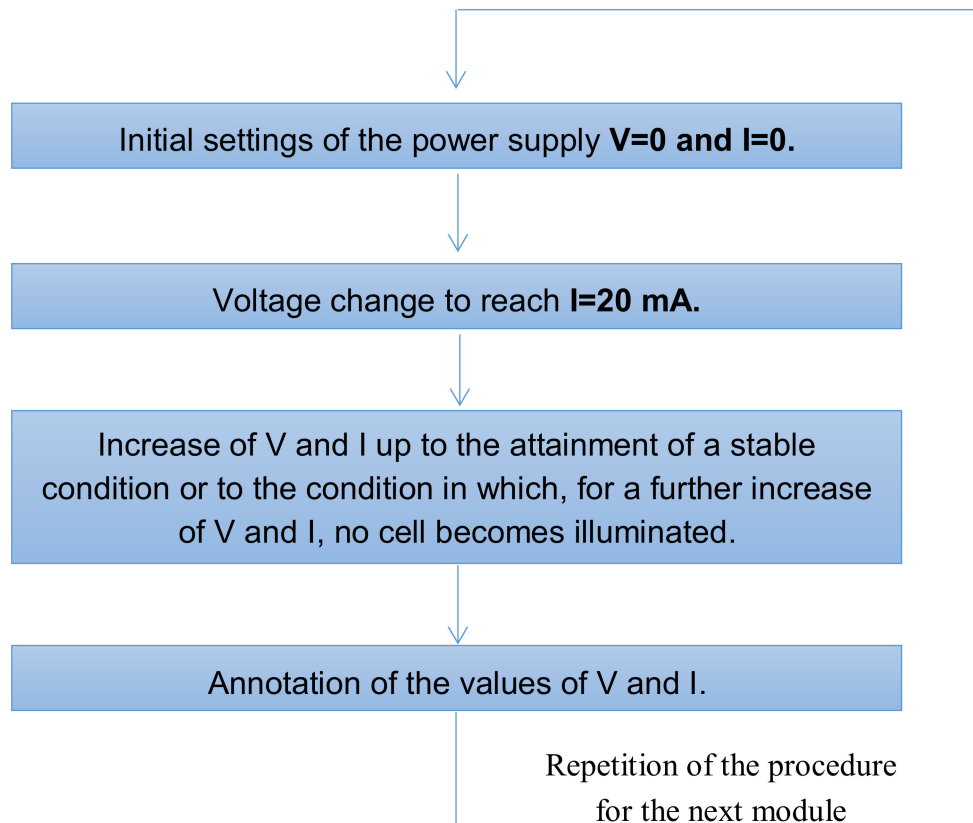
The choice of voltage and current values used to supply the cells was not always constant but varied from module to module. However, the methodology followed, shown in the diagram of Figure 5, was always the same.

The diagram reported in Figure 5 represents the power supply procedure.

Figure 5. Methodology to choose the voltage and current values for the cells power supply.

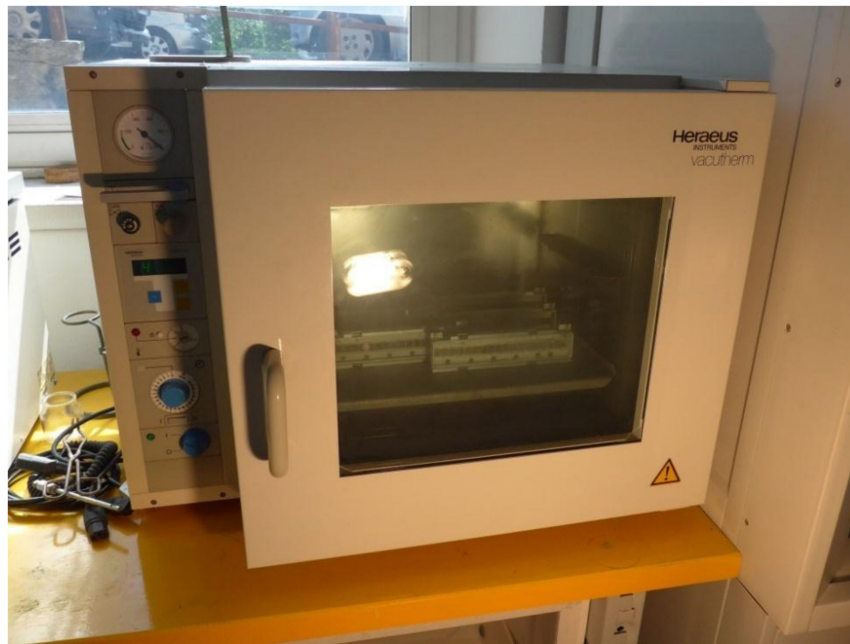
A climatic chamber was used to remove moisture inside the modules. In the interior of this device, in Figure 6, the pressure and temperature could be controlled. In particular, it allowed water to be brought to the steam state at temperatures below 100 °C. Referring to the temperature–pressure diagram of water, this condition corresponded to a point in the yellow zone in Figure 7.

Figure 6. External view of the climatic chamber.

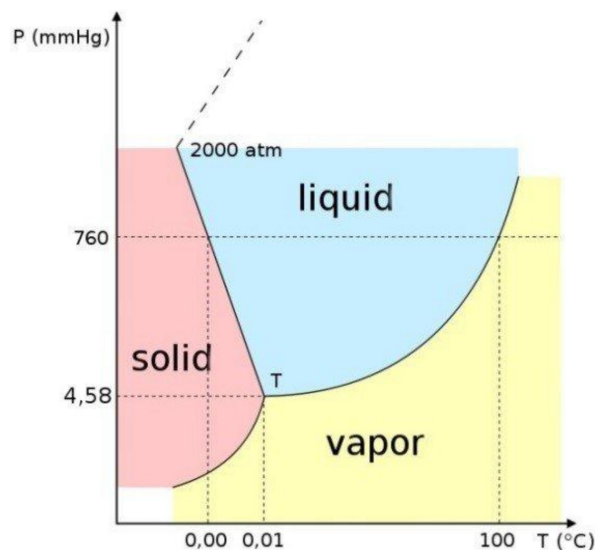
Figure 7. Pressure–Temperature diagram of water.

In fact, in the climatic chamber, it was possible to reach an absolute pressure of 1 ± 0.1 mmHg and a temperature of 200 ± 1 °C. However, it was decided not to exceed 50 °C to avoid thermal stresses of the modules and to prevent damage. With these values, it can be seen from the graph that the condition fell widely in the steam area. Pressure regulation was provided by a rotary vacuum pump in an oil bath, which operated continuously. Figures 6 and 8 present two photos of the climatic chamber used to dry the modules, and some of them are visible inside.

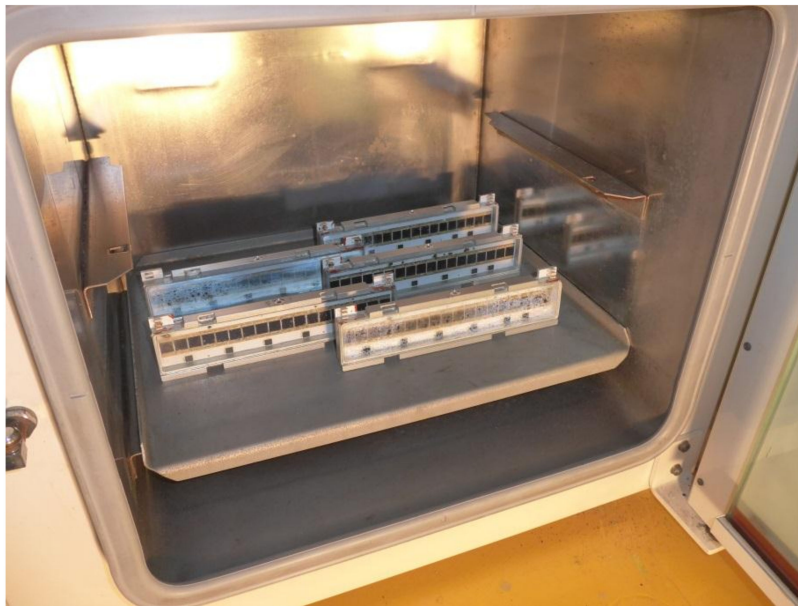
Figure 8. Placement of the modules in the climatic chamber.

After having checked the resistance under pressure, the modules were dehumidified by bringing the temperature inside the climatic chamber to $50\text{ }^{\circ}\text{C}$. Once the temperature was reached, all the modules were placed on the inside shelf, with the module opening hole facing up, in groups of five as shown in Figure 8.

The total duration of the dehumidification treatment was 55 min. Step 1 is illustrated in Figure 8, where the presence of moisture inside the PV modules is visible as droplets on the covering glass of the first module on the right. Observing the modules during the treatment, it was seen that the water droplets disappeared almost completely during step 11.

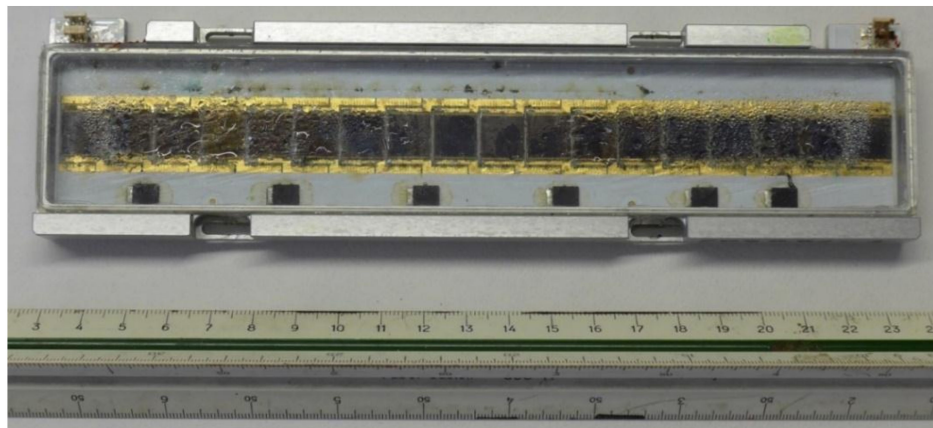
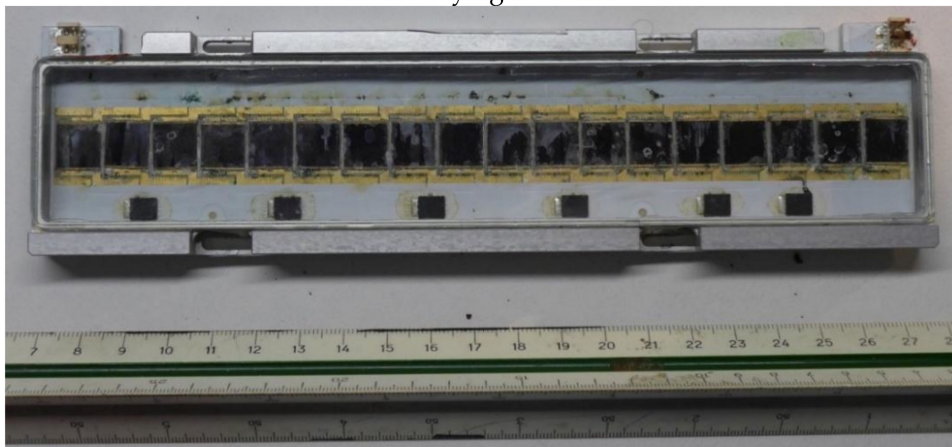
To illustrate the consequences of the drying treatment, Figures 9 and 10 present the photos of the same module before and after dehumidification. Two examples are given: module 202mg51-1 in Figure 9 and module 203mg71-2 in Figure 10.

Before drying treatment

After drying treatment

Figure 9. Module 202mg51-1 before and after the dehumidification treatment.

The effect of the dehumidification treatment is visible to the naked eye: the comparison of each pair of photos evidences how the droplets disappeared, while the other characteristics seemed unaltered. For example, considering the white spots on them, they always had the same dimensions and had not undergone alterations. Different details of the modules are examined in Section 4, with some sample photos of various defects and some notes on their visual observation.

In practice, dehumidifying the PV modules allows the elimination of possible short circuits due to the presence of water droplets.

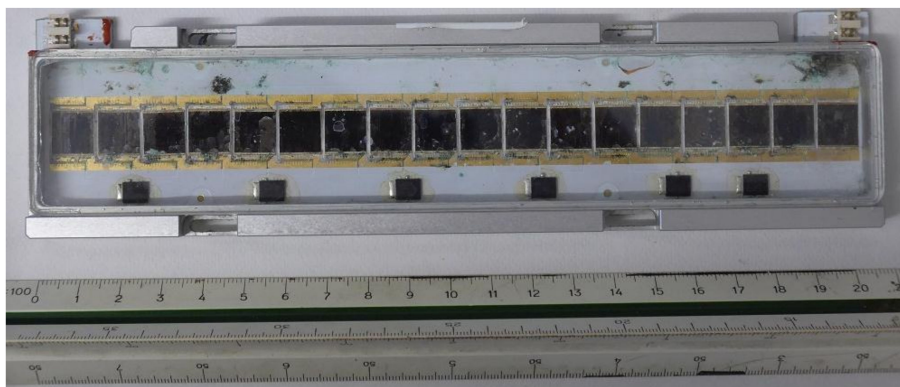
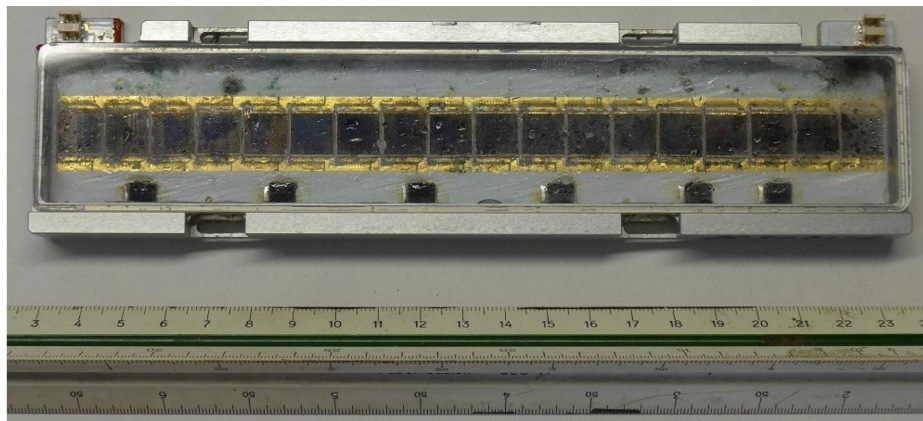
After drying treatment

Before drying treatment

Figure 10. Module 203g71-2 before and after the dehumidification treatment.

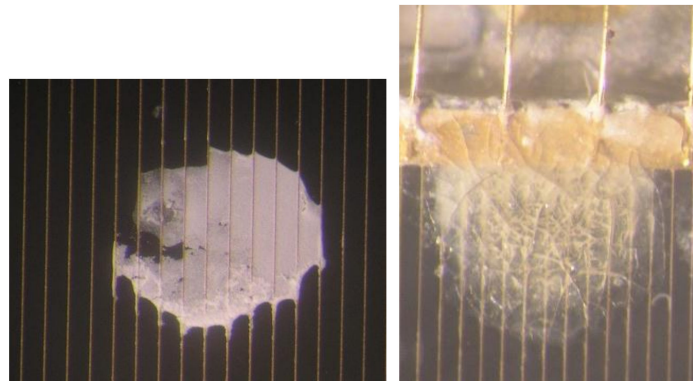
Sample photos of white spots, copper oxides, and detached wires are presented in Figures 11–13, respectively.

Figure 11. Examples of white spots.

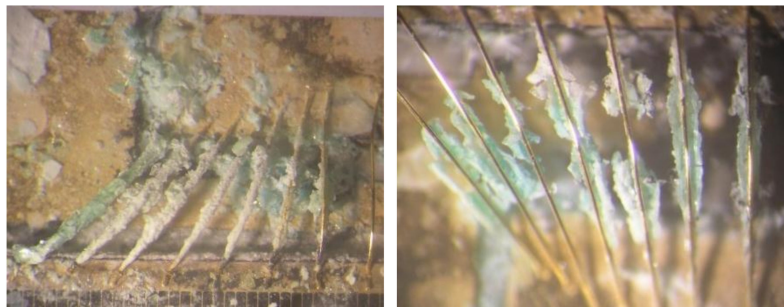
Figure 12. Examples of copper oxides.

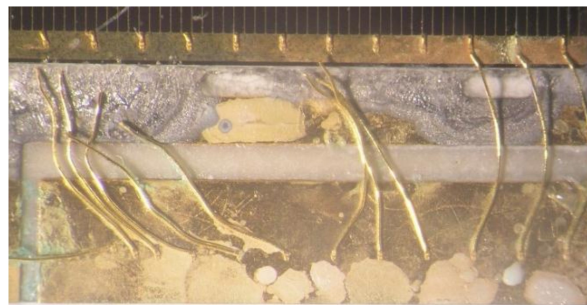
Figure 13. Example of detached wires.

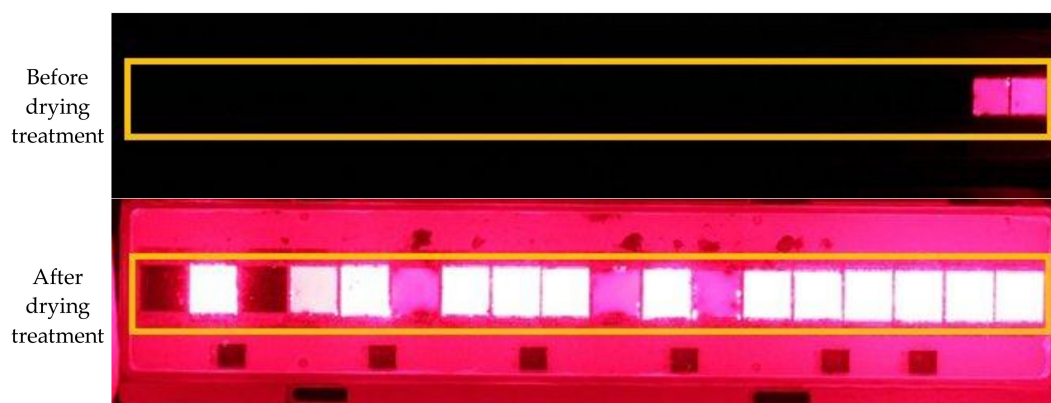
Two real photos of the electroluminescence test applied on the 203g11-2 module are presented in Figure 14. The photo above is the image of the untreated module under EL test, while the photo below is the EL test image of the same module after application of dehumidification treatment. A yellow rectangle encloses the 18 photocells in both photos of Figure 14 to identify the cells positions, especially in the photo above where most of the cells are dark. The comparison of the two images shows that cells 1 to 16 are dark before being treated, while most of the cells appear illuminated after the drying treatment.

Figure 14. Electroluminescence test before and after the dehumidification treatment of the 203g11–2 module.

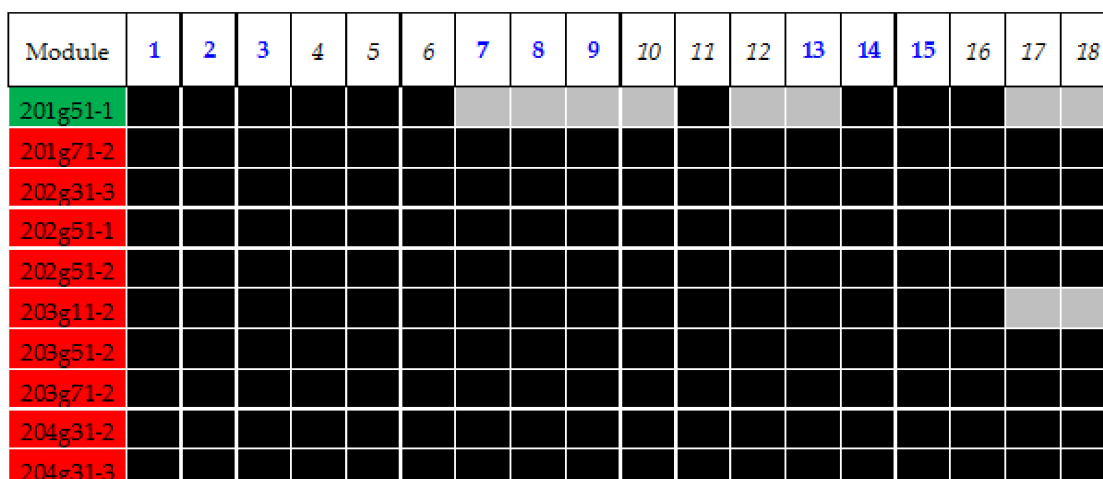
The diagrams in Figures 15 and 16 show visually which cells were working within the ten modules. The label of each module is reported in the first column of the diagrams. Columns 1–18 specify the cell situation using grey for a working cell and black for an inoperative cell. The active modules are indicated with the label highlighted in green, while the fully deactivated ones are in red. A module that has at least one group of three active cells is considered to work.

Figure 15. Diagram of the working (grey) and inoperative (black) cells inside the modules before dehumidification.

It is important to remember that the cells were mounted with a protection diode every three photocells: the groups of three cells connected together are recognizable because their number in row 1 is alternatively written in bold blue or italic.

Figure 15 presents the condition of the cells before the dehumidification treatment, whereas Figure 16 reports the situation of the same cells after having dried the ten modules.

Comparing the functionality of the cells shown in Figures 15 and 16, it is possible to notice that the behavior of the ten modules after dehumidification changed from 1 working module to 6 working modules.

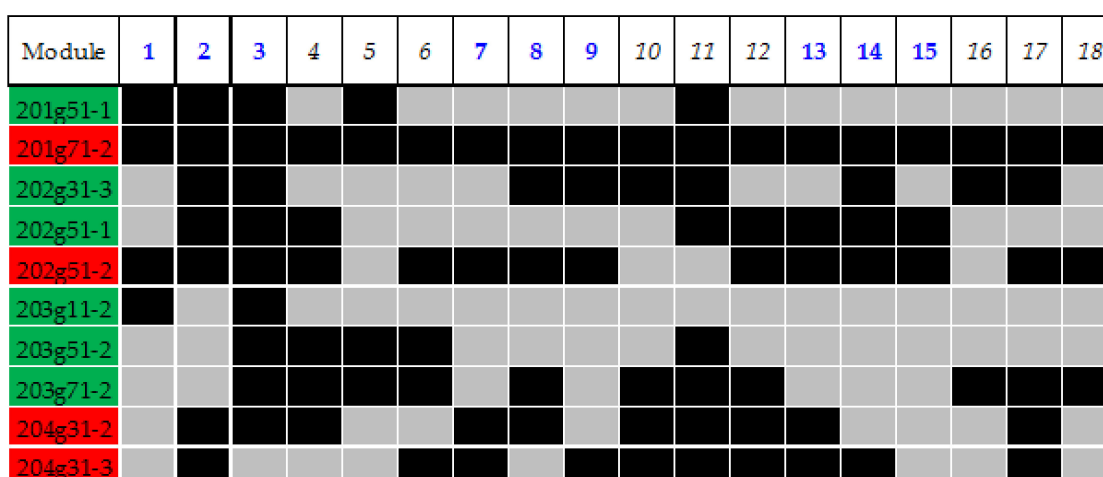
Figure 16. Diagram of working (grey) and inoperative (black) cells inside the modules after dehumidification.
