T.Bechtel, S.Ivashov, V.Razevig, V.Zhuravlev, L.Capineri, P.Falorni
USA Russia Italy

**Using of holographic subsurface radar at the surveying
and reconstruction of cultural heritage objects
in Russia and Italy**

Second International Workshop, “Analyzing Art: New Technologies - New Applications”
Saint Petersburg, July 25-27, 2018

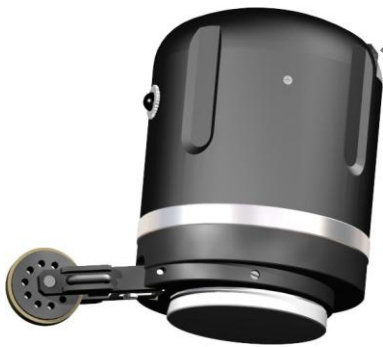
RASCAN-4/2000
2 GHz

RASCAN-5/4000, 4 GHz
RASCAN-5/7000, 7 GHz

RASCAN-4/2000	RASCAN-5/4000	RASCAN-5/7000
Frequency band, GHz		1.6 – 2.0	3.6 – 4.0	6.4 – 6.8
Number of frequencies		5		
RF output, W		$6 \cdot 10^{-3}$ (*)		
Sensitivity, W		10^{-9}		
Resolution in the plane of sounding at shallow depths, cm		4	2	1.5
Maximum sounding depth (depends on medium properties), cm		35	20	15
Dimensions, mm	Antenna	160 × 310 × 210 handle length – 1030	95 × 148 × 119	
	Control unit	157 × 63 × 200		
	In package	570 × 230 × 390	380 × 460 × 130	
Weight, kg	Antenna	w/o handle – 2.0 with handle – 2.5	0.6	
	Control unit	0.7		
	In package	9	5.5

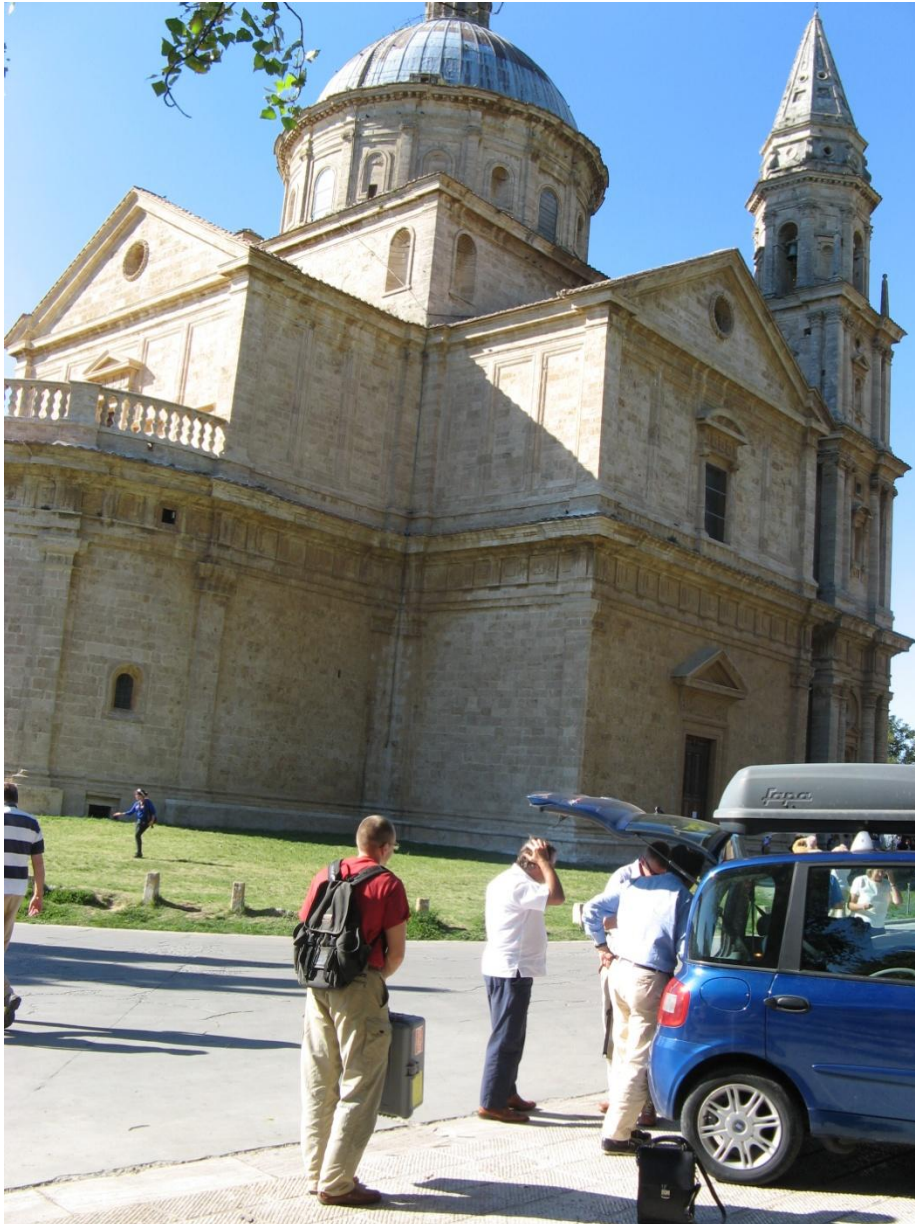
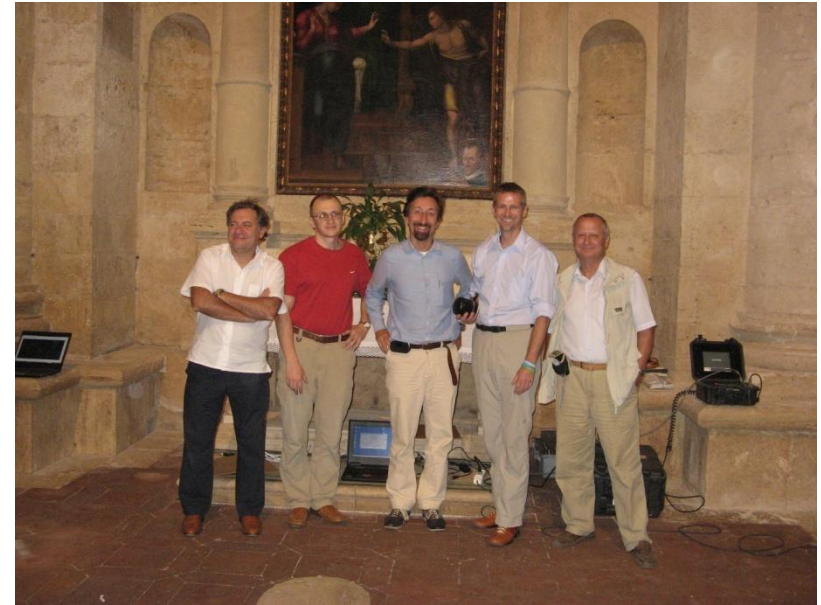
Inspection of the Church of San Biagio near Siena, Italy

The Church of S. Biagio was built near the city of Siena by Antonio da Sangallo during the 15th century.

The international team of Italian, American, and Russian scientists conducted an inspection of the floor in the Church of S. Biagio.

Aim of this experiment was to search for hidden cavities underneath the floor by using commercial GPRs – RASCAN and GSSI radars.

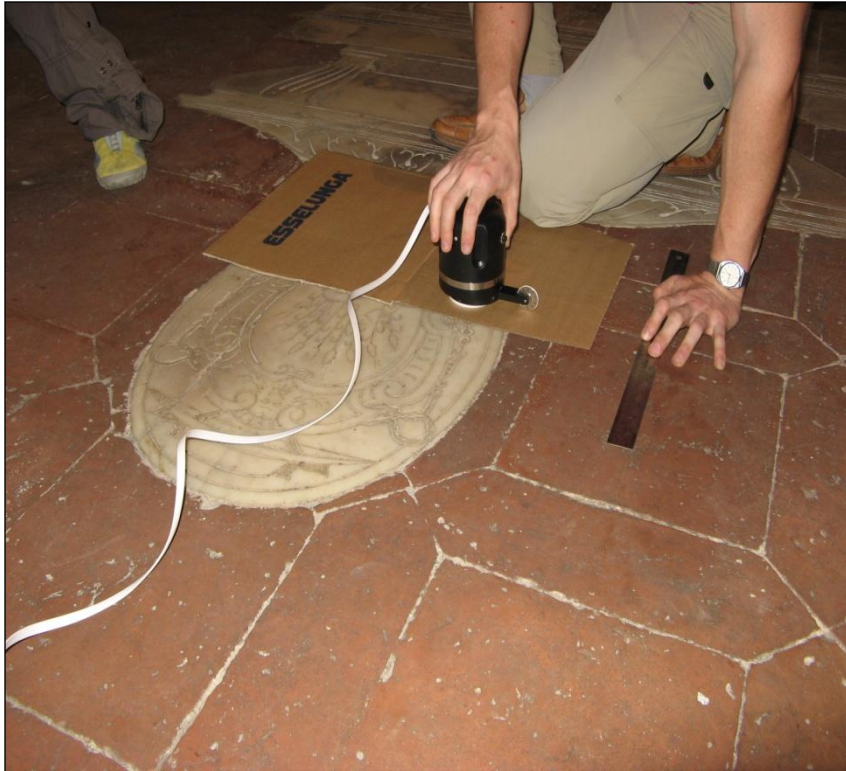
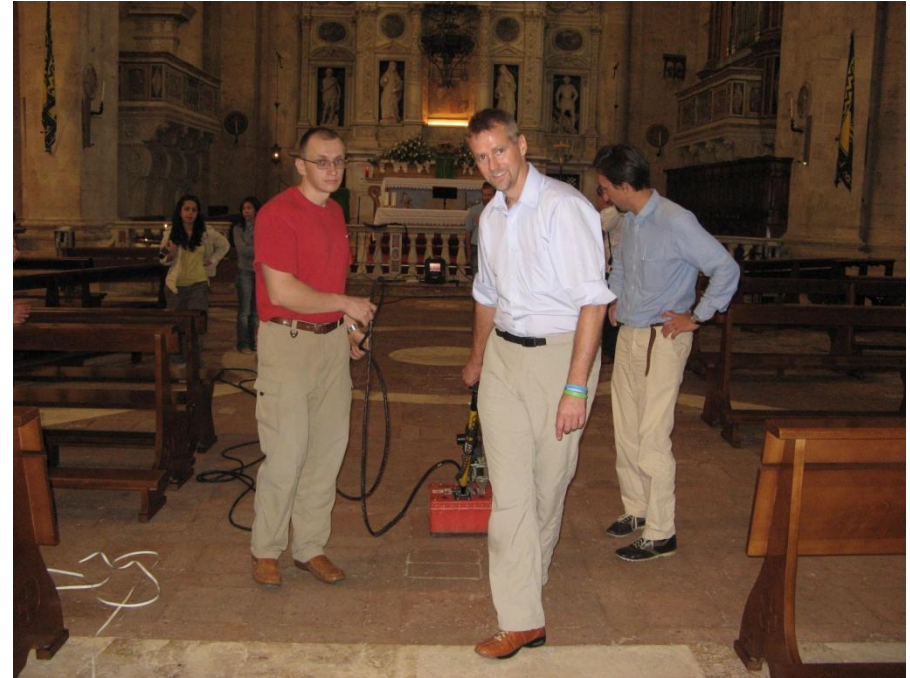
The aim of this experiments was to search for hidden cavities underneath the floor by using commercial GPRs – RASCAN and GSSI radars.

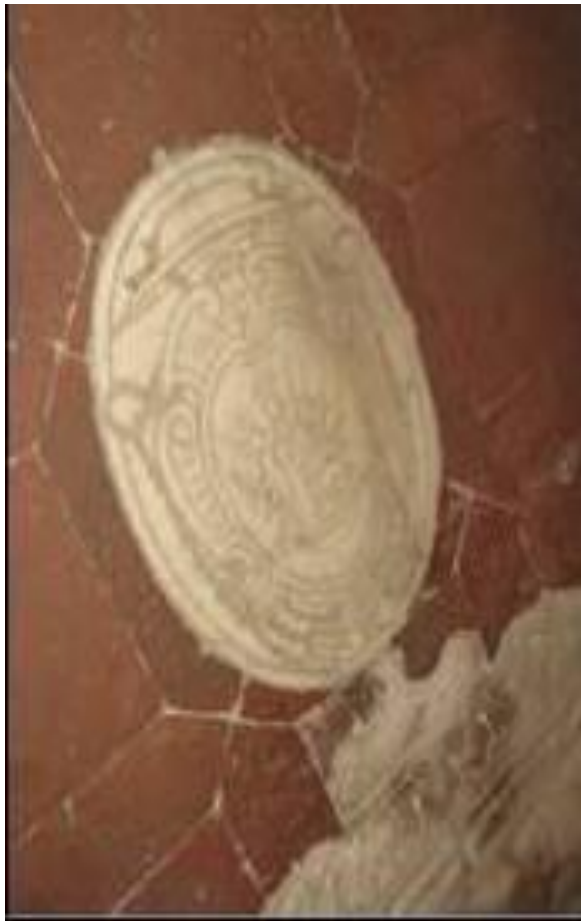
A marble medallion on the floor

Searching in archives results that ancient burial of XVI century has place under medallion.

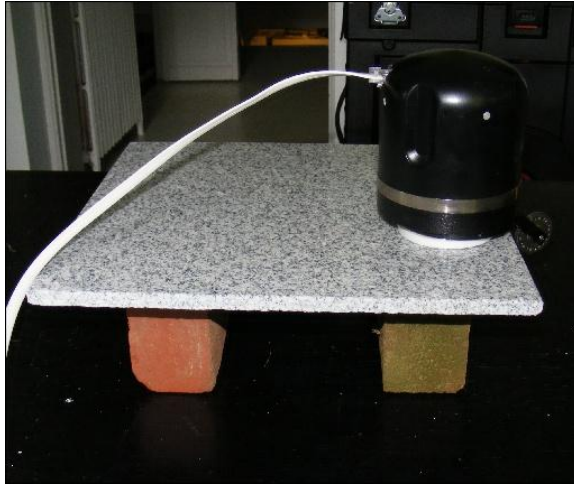
Laboratory Model of the Medallion

Laboratory model of the medallion supports

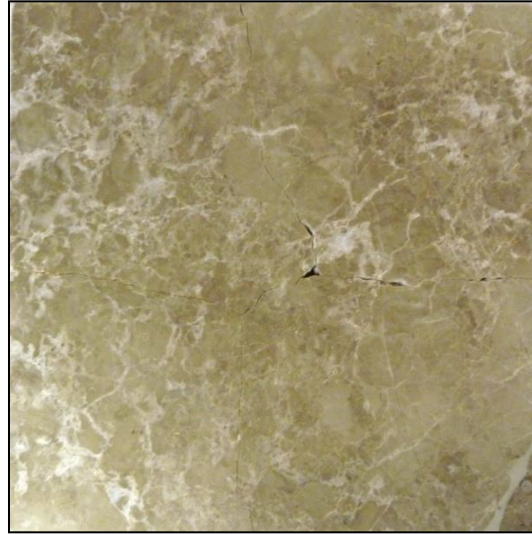
A 30cm by 30cm piece of marble contains two nearly invisible, hairline cracks; one vertical and one horizontal. At left is a RASCAN-4/4000 image of the slab with the cracks barely dampened using a fine paint brush, and right shows an IRT image of the same. In both cases, the moisture highlights the cracks. IRT image spans 1.8°C.

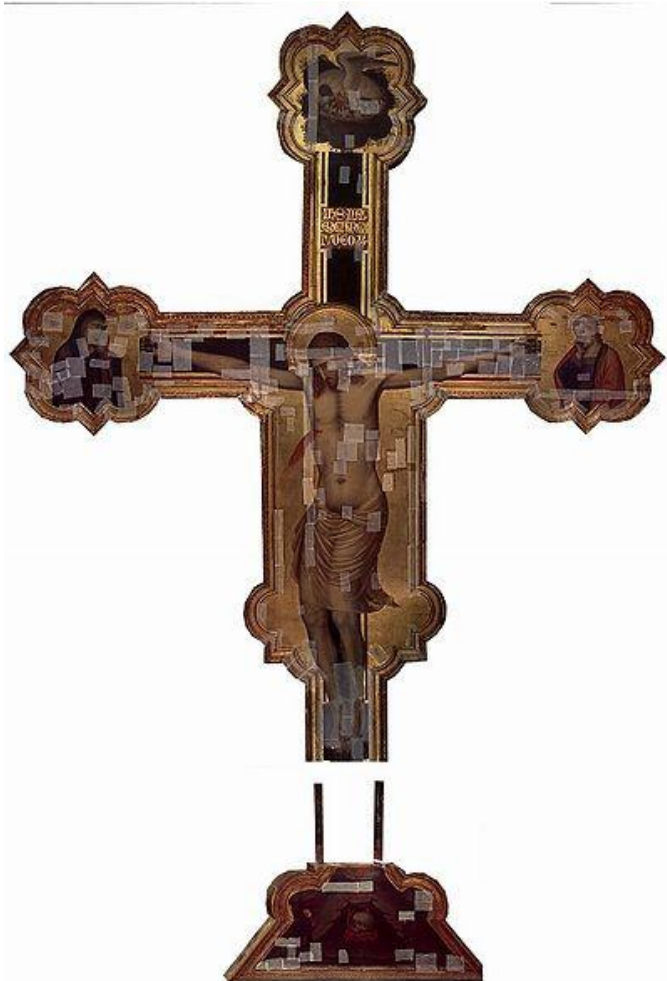
The investigation on the Croce di San Marco with Rascan 4/4000

The Cross of San Marco dates back to the mid-fourteenth century and is attributed to Puccio di Simone.

The work can be considered one of the greatest of Florentine painting: it reaches a total height of 6.30 meters. The plank is made up of a vertical part, the upright of a cross, and a horizontal part, the arm, which are joined together by a joint between wood.

The thickness of the poplar planks is 7 cm and the entire support, including the crosspieces, reaches a thickness of about 25 cm for a total weight estimated at around 500 kg.

For this first phase of measurements it was decided to scan three areas that cover the areas of the supporting infrastructure and the area of the relief insert for the aureole.

The work was protected with a green cloth supporting a plexiglass sheet provided with numbered scan lines. If necessary, the plexiglass plate was blocked by pressing it with a wooden vice.

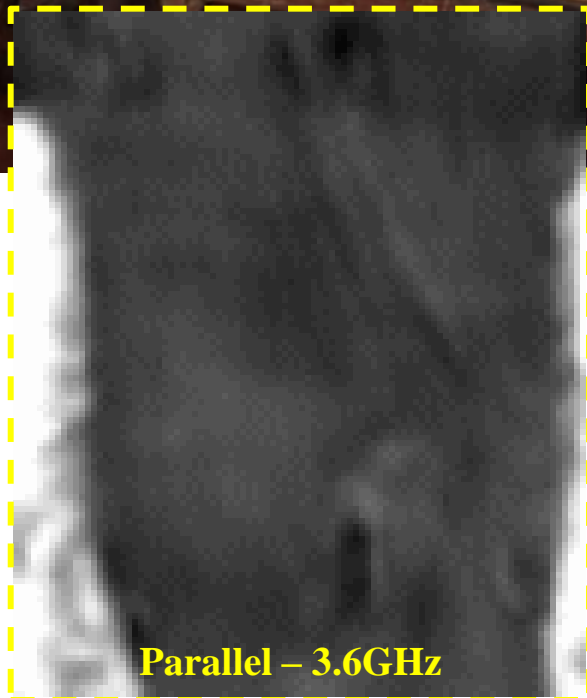
Parallel – 3.6GHz

Also in this scan the images of the fixing nails are confirmed, this time better visible in the images related to the PARALLEL polarization. Note that this scan is done in an orthogonal direction with respect to the previous one.

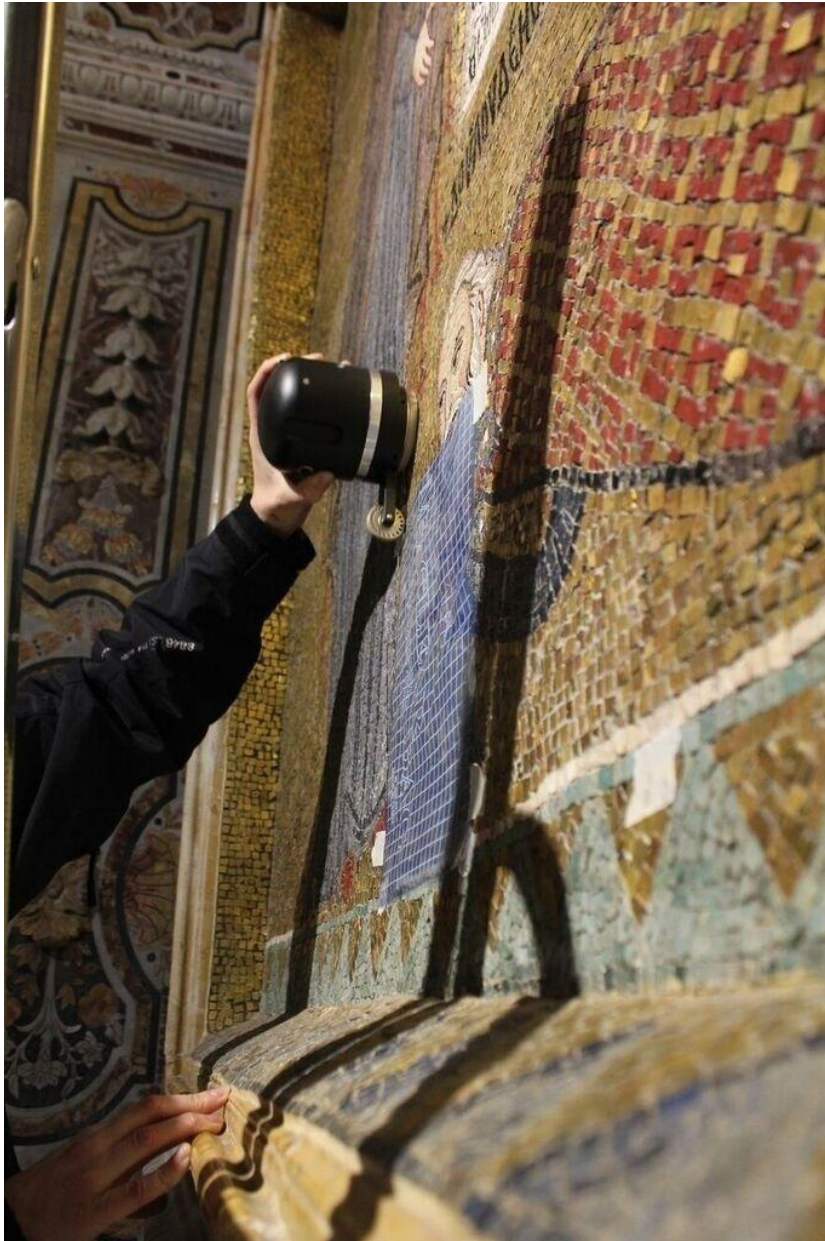
Wall mosaic "Dedication of the Church to the Virgin" investigation by RASCAN radar of the University of Padua (Italy).

The church of Santa Maria dell'Ammiraglio (La Martorana) in Palermo, Sicily.

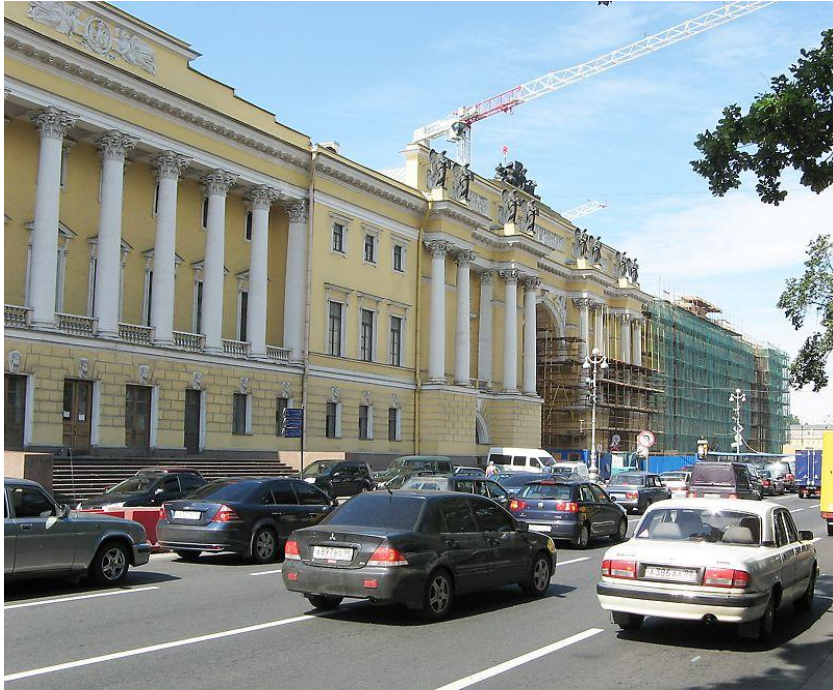
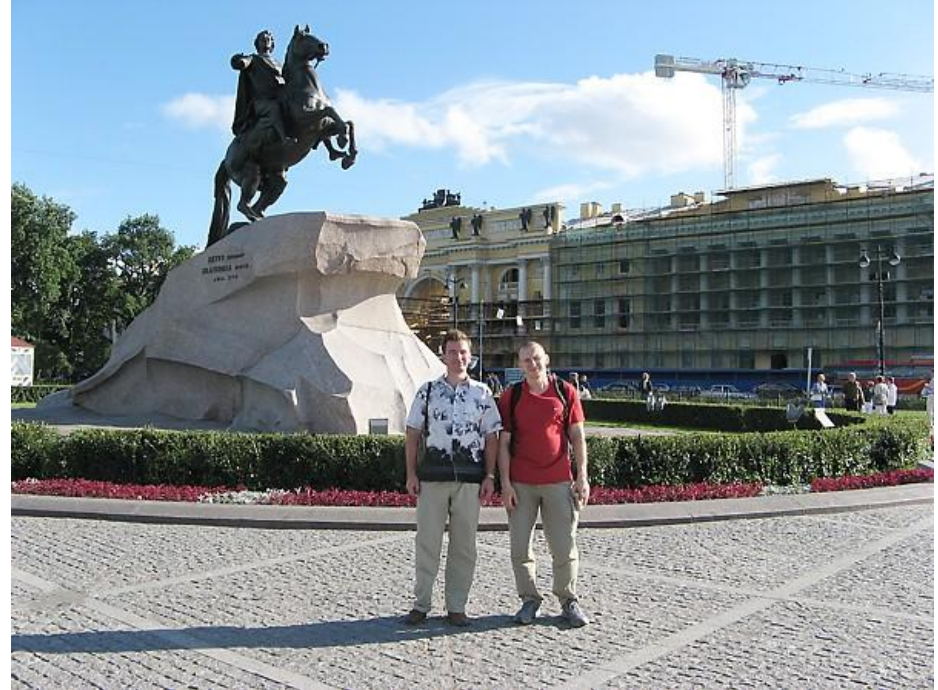
Survey of the Senate Building in St. Petersburg

In St. Petersburg, the famous Senate building, which was built by Italian architect Carlo di Giovanni Rossi in 1829–1834, had been under reconstruction and parquet had to be laid. Heating pipes, electricity and communication wires were laid under floor of the building. Their location was not documented. According to the technology, before the laying of the parquet on the concrete floor, plywood sheets should be nailed to its surface. But this could not be done because of fear to damage the pipes and other communications. Our laboratory was asked to search location of the pipes and communications.

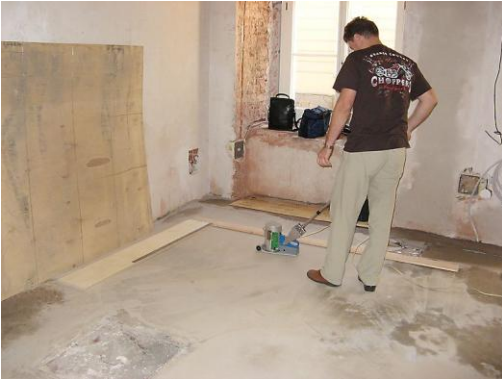
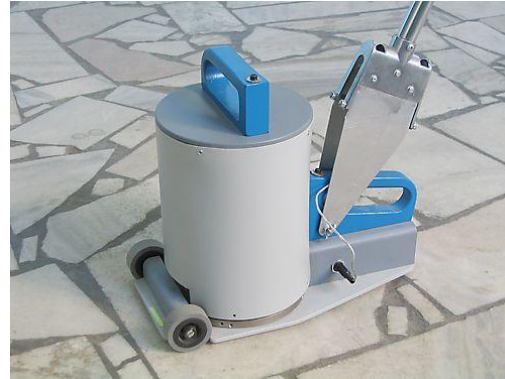
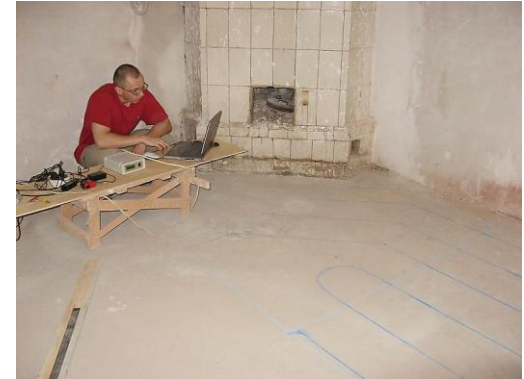
The survey was performed by holographic subsurface radar RASCAN-4/2000

Holographic subsurface radar RASCAN-4/2000in work.

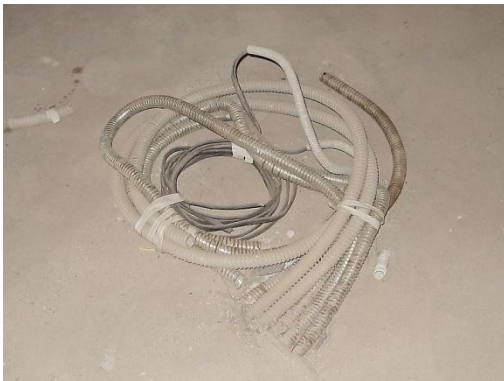
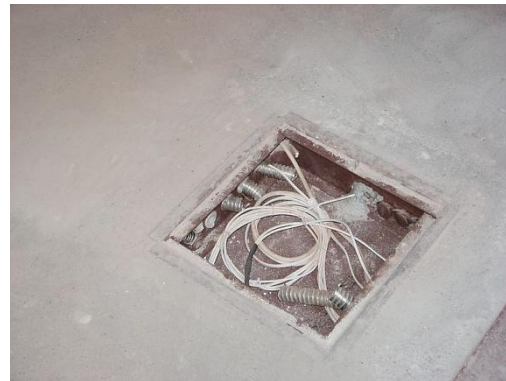
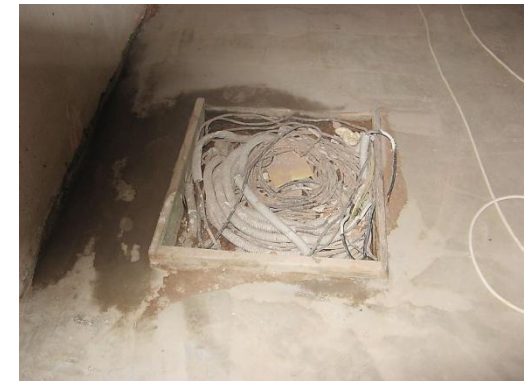
Wells with cables in the concrete floor.

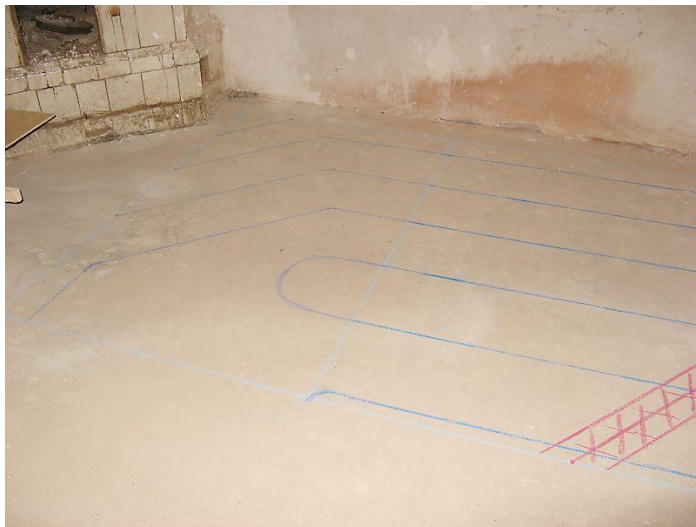
The result of surveying was drawn on the floor surface by chalk.

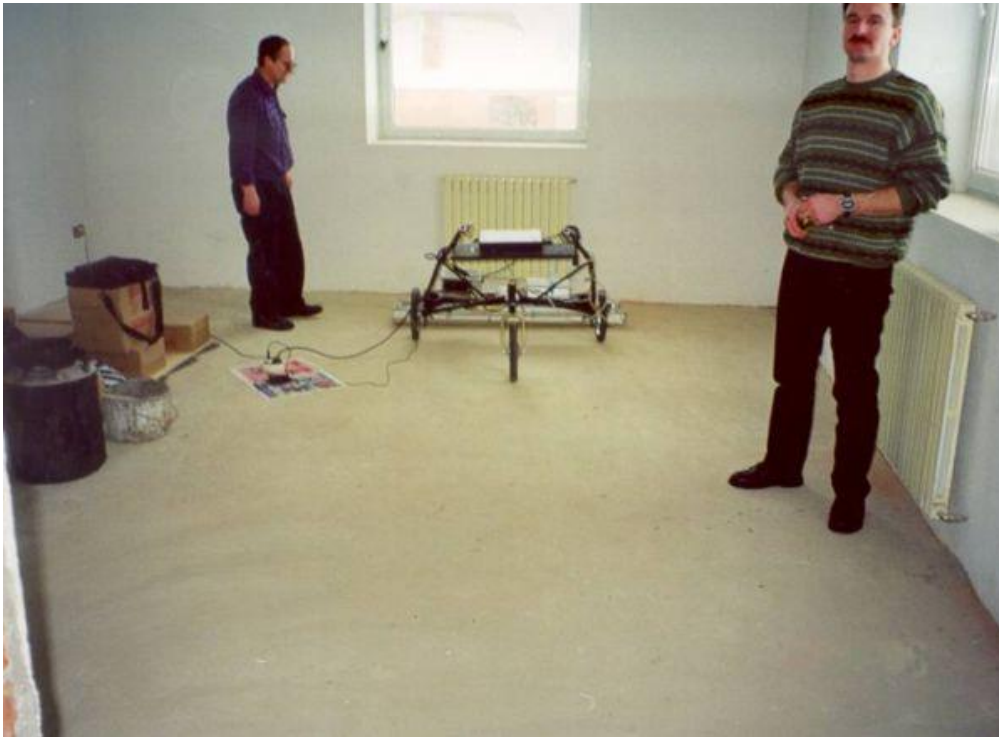
Surveying of a Concrete Floor

Concrete floor inspection

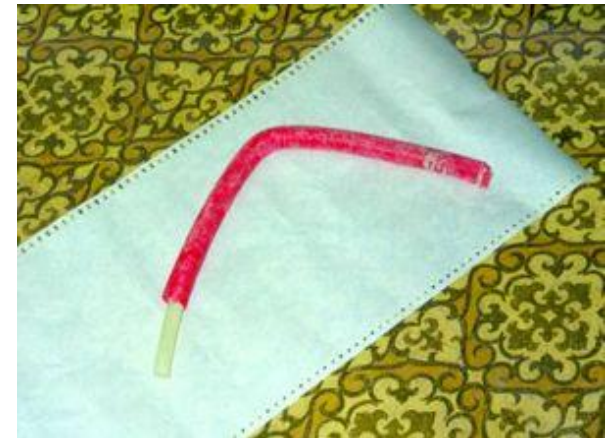
Heating plastic pipe

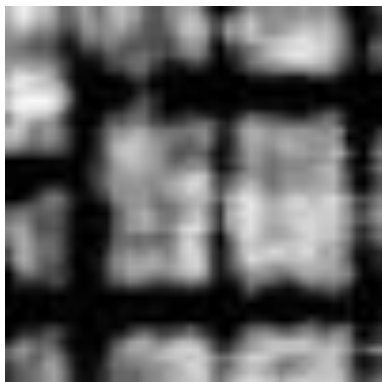
Radar images of the ferroconcrete walls

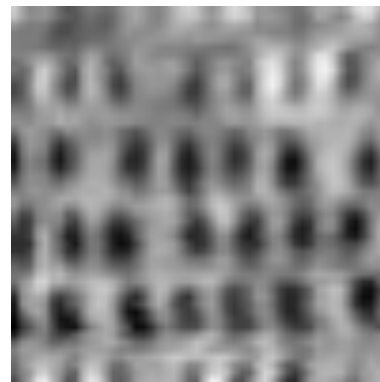
Radar images of the cinder concrete bricks walls.
Black spots are voids in the bricks.

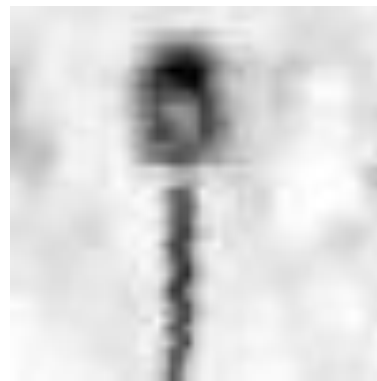
An electrical socket and
wire in concrete wall

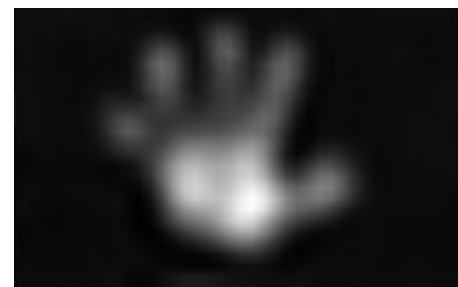
A hand under table

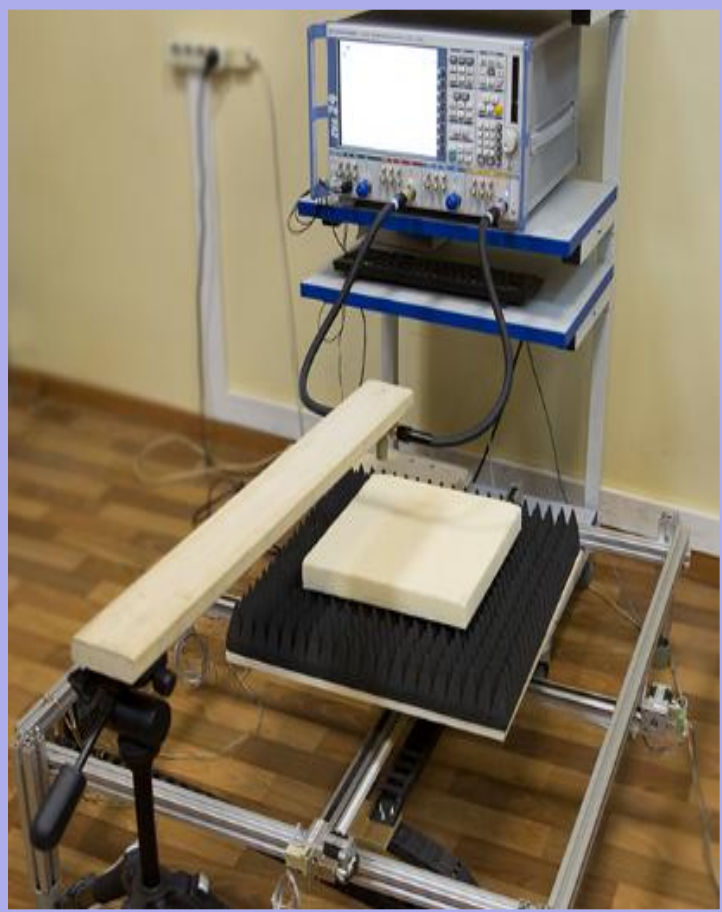
Experimental Setup

- A special experimental setup designed for subsurface radar imaging was applied, it allows sampling at arbitrary programmable points, testing various scanning and sounding parameters.
- The data acquisition is accomplished by automatic scanning.

- For the reconstruction of the MW holograms back-propagation technique was applied, based on the Fast Fourier Transform.

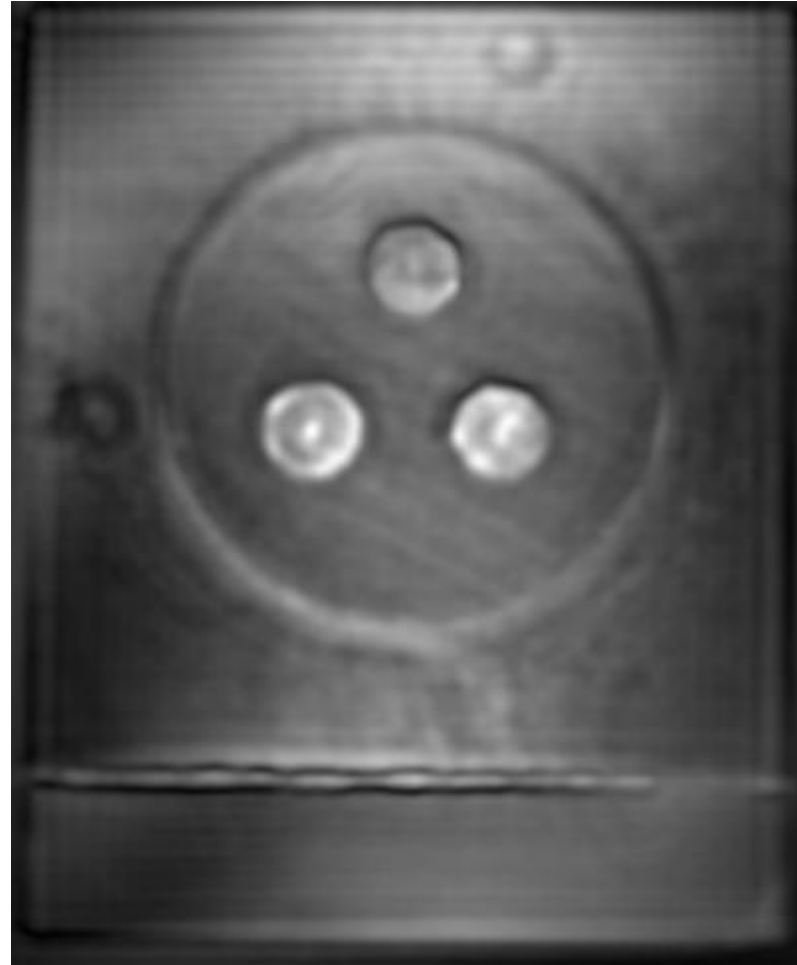
MW hologram reconstruction

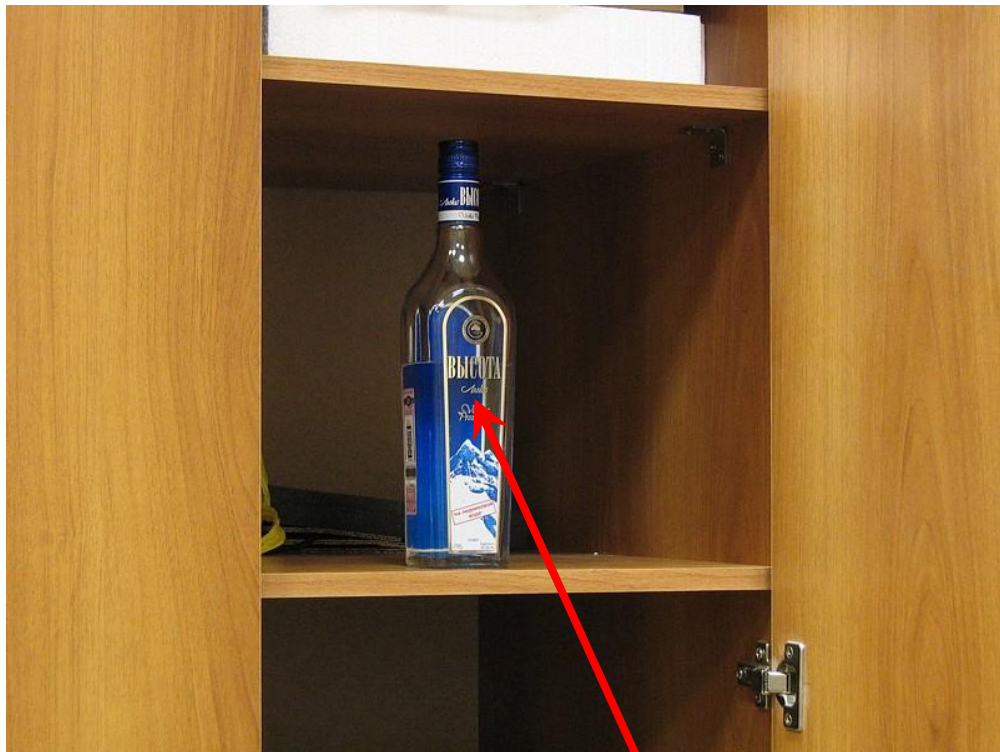
Vodka level

**The radar image of vodka bottle
is obtained by RASCAN-4/4000
inside of cupboard**
