## THE DISCOVERY OF “MAROUFLAGE” ON DECORATED STRUCTURAL TIMBER IN A VILLA OF THE XV CENTURY

*A restoration project on the ancient Villa Rucellai in Quaracchi, Florence (XV century, project attributed to Leon Battista Alberti), kicked off the on-site inspection of the wooden structures, as basic way for the assessment of historical timber buildings. During the inspection of the two-trusses timber roof, some significant remains of pictorial decorations were found and, on many surfaces of the timber elements, some fragments of fabric were discovered. In front of these facts, by means of a multidisciplinary approach, the trusses were deeply investigated according to the following examinations: image analysis to recognise all the surfaces covered by textile materials; <sup>14</sup>C dating on fabric and wood, in particular applying wiggle-matching for the latter material; microscopic analysis to identify the textile fibers and the wooden species. The results of the analyses, combined with the relevant information obtained by the on-site technological inspection, confirmed historical information on the Villa and proved the use of mercerised flax fibers, derived from pre-existing fabric

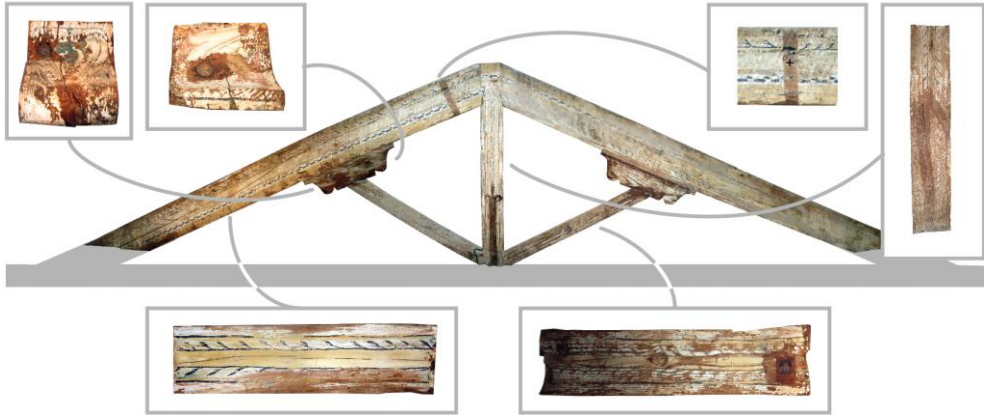
**Fig. 1.** Decorated truss n. 1. Picture rearranged by mosaic composition. The sign of king-post stirrup (+) in its original position, rotated and centred onto the tie-beam (nowadays under the floor)

Technological inspection revealed some interesting information, thanks to the residual pictorial decoration too: in unknown historical period, the tie-beams of the two trusses (cross sections 28x18cm), were disassembled, shortened and reused to substitute two top-chords, one on each truss. Probably some wood decay due to bio-deterioration on the heel joint (connection between the top- and the bottom-chord) forced the heavy restoration of the roof, with the shortening of bottom-chord to cut away the decayed portion. Signs of the symmetric paintings and the decoration gap, with raw and dark wood (under the central stirrup in the original truss, Fig. 1), revealed the preceding use of the timber members. The two original tie-beams were replaced with more recent fir beams, which evidently had not any sign of decoration nor any piece of fabric glued on. The two replaced original top-chords, their textile materials and decorations, have been definitely lost.

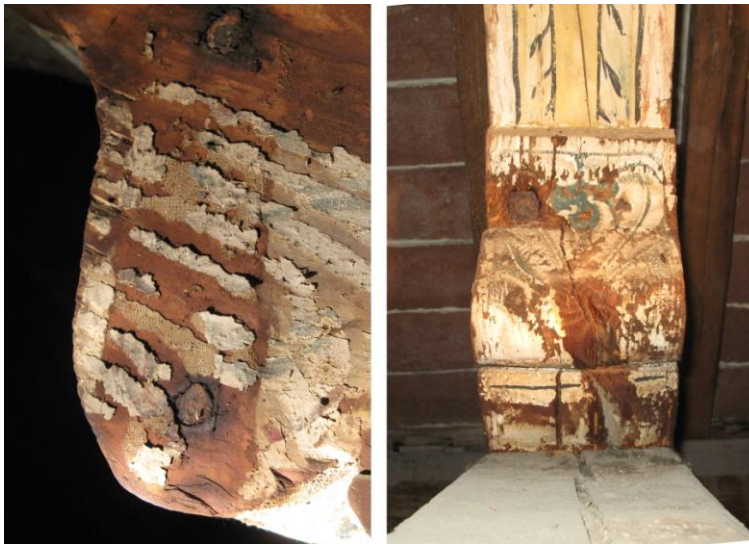
After the investigation we found that the fabric was originally present with 37 strips on the remaining part of the two trusses, 16 in the first truss and 21 in the second one (Fig. 2).

**Fig. 2.** Example of fabric on structural timber. Left: strip of fabric, residual on earlywood, to cover two nails. Right: end-grain of a cantilever with fabric (still present, with gaps) to upholster nails and a shrinkage fissure

The strips of fabric which maintain a sort of continuity are around a total of 0,23 m<sup>2</sup>, which correspond to the 16% of original glued fabric. Earlywood is the portion of annual rings, grown during the springtime, less dense and with larger cellular elements, so that the adhesion of the preparation layer and fabric had been more effective and durable in comparison to latewood (particular in Fig. 2).
