# The discovered painting decoration of the Vorontsov` Palace in St. Petersburg: Spectroscopic characterization in support of conservation

**Abstract.** The paper reports about the unique discovery of fragments of wall painting of the middle of the XVIII century from the Vorontsov` Palace in St. Petersburg and its study by means of laser and IR spectroscopic techniques. The history of creation and reconstruction of the palace as well as technical and technological features of paintings are described.

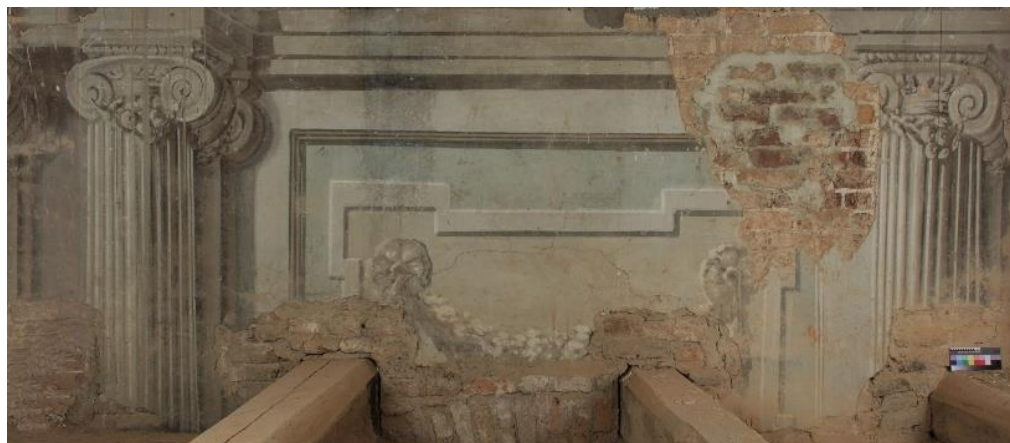
**Figure 2.** The area upon which the pilaster sided entablature was leaned

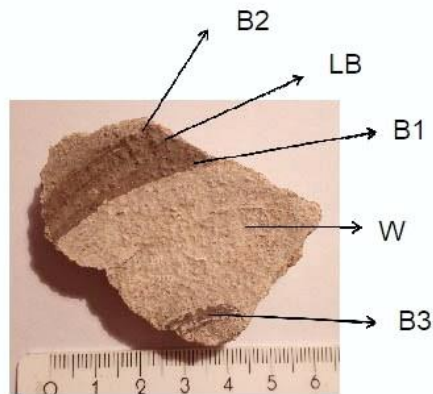
**Figure 3.** The plaster sample representative of the mural decoration used in this work

Raman spectroscopy data were mostly useful for identification of the materials used for the wall decoration [3] Figure 3 shows the image of the plaster sample taken from the decoration and Figure 4 shows Raman spectra obtained in the different colored area. The list of materials that we have found on the samples is presented in Table 1.

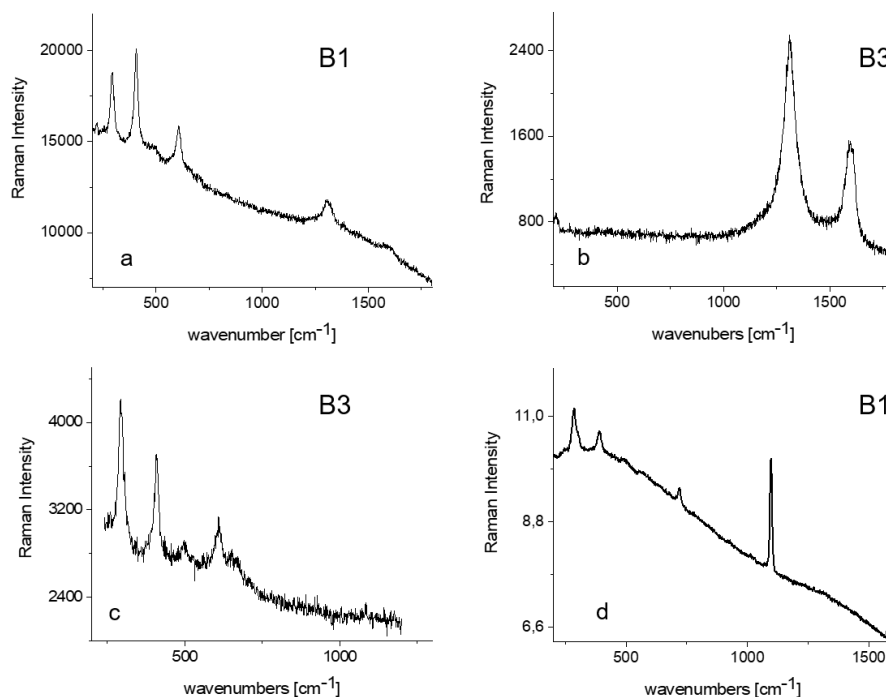
**Figure 4.** Some representative Raman spectra obtained from different points in the sample: (a) hematite, (b) amorphous carbon, (c) hematite and manganese oxides and (d) calcite

All brown paints revealed the presence of hematite ( $\alpha\text{-Fe}_2\text{O}_3$ ), which gives a well-recognizable Raman signal and the yellowish hydrated form goethite,  $\alpha\text{-FeOOH}$ . [4] Some representative spectra are shown in Figure 4.

Instead, in the spectra obtained in the brown bent strip decoration a broad band was observed in a spectral range which is typical of Mn-O and Mn-OH stretching vibration frequencies ( $450\text{--}750\text{cm}^{-1}$ ). [5] The presence of manganese oxides-hydroxides were thus assumed. The identification of such manganese compounds by means of Raman microscopy is known to be quite problematic. No clear Raman signature is often obtained probably because of the low Raman activity of the manganese-based pigments, low crystallinity and high degree of chemical heterogeneity (different manganese compounds can be present simultaneously at the microscopic level). Firstly, manganese oxides/hydroxides tend to undergo thermal transformations under high laser power values, in a manner similar to analogous iron compounds, but in a stronger way. Secondly, manganese exists in several oxidation states and exhibits a lot of hydro-oxides modifications, many of them being non-stoichiometric and disordered compounds. Consequently, only a tentative assignment can be done. The stronger band at  $585\text{--}610\text{cm}^{-1}$  was assigned to bixbyite ( $\text{Mn}_2\text{O}_3$ ), while the presence of the Raman signal at  $643\text{--}652\text{cm}^{-1}$  was attributed to a variable contribute coming from a spinel structure ( $\text{Mn}_3\text{O}_4$ , haussmanite). The spectrum in Figure 4c shows an additional band at  $553\text{cm}^{-1}$ , which may be ascribed to groutite sites ( $\text{MnOOH}$ ). Moreover, black drawings appeared as homogeneous phases in which no distinctive grains could be observed, so that a fine mixture of different Mn(II), Mn(III) and Mn(IV) oxides and hydroxides has to be assumed.

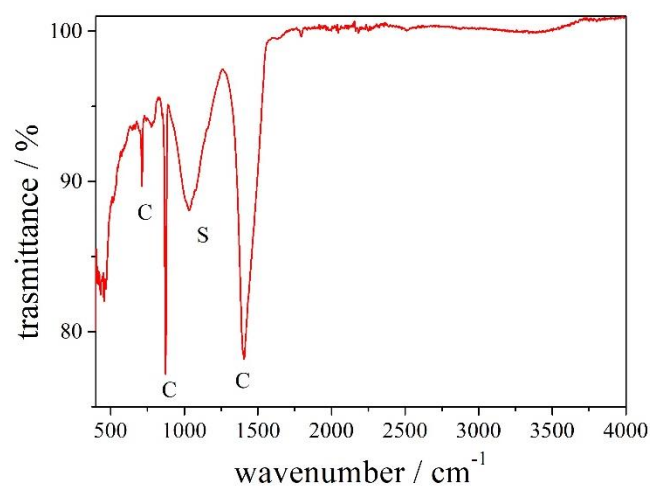
**Figure 5.** ATR-FTIR spectrum of mortar; the symbols C and S correspond to the principal bands of calcite and silicate, respectively

Instead, infrared spectroscopy was used mostly to characterize the mortar which was used to create the plaster layer of mural paintings. The analysis performed on this preparatory layer of the painting has positively identified calcite in the binder structure (calcite is the result of reaction while drying, calcium hydroxide is what supposed to be actually used as binder), and the absence of harmful crystalline salts, such as nitrates and sulfates (see Figure 5).

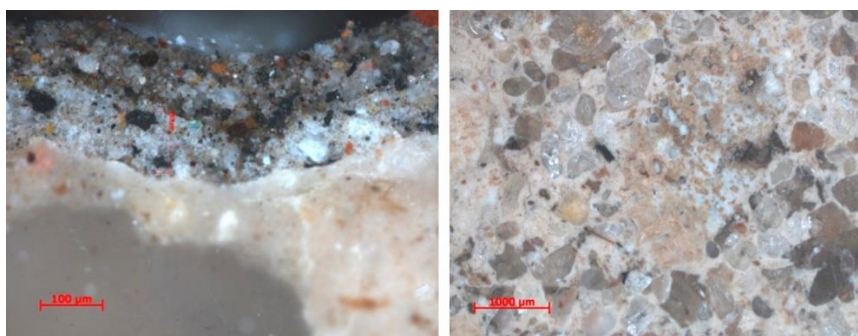
**Figure 6.** Optical microscope images of a samples's cross section at different magnification

The optical microscopy analysis of the sample stratigraphy was very helpful to gain insights on the preparation method of the plaster and its decoration. A simple analysis of these images reveal that the painting was made in layers (see Figure 6). These layers are partially mixed, which suggests that the top paint layer was applied on the incompletely dried out background color.

Thanks to the combination of optical images and spectroscopic analysis it was possible to understand the technical execution of the paintings: lime binding material was found in the pigment part, and the paint layer was applied directly on the lime plaster without additional layers of soil, we can conclude that the murals were created using the “*secco*” or “*semi-secco*” mural technique.

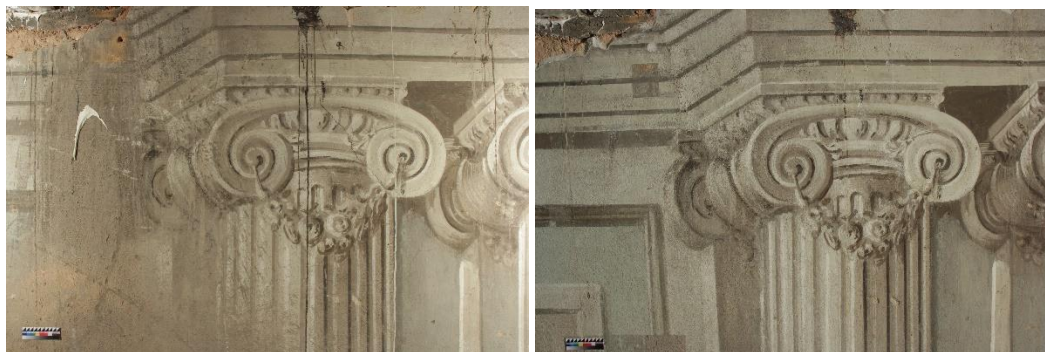
**Figure 7.** A detail of the wall decoration before (left) and after (right) the cleaning and conservation

The results of the research were helpful to select the necessary materials for the conservation and the following cleaning of the painting surface from the persistent dust pollution. According to the investigations, the consolidation of the plaster structure was carried out with the materials found in the original lime binder. Given the mineral nature of the constituents of the decoration, vulcanized latex sponges Akapad (hard and soft) were used for the dry cleaning of the mural from the contamination of dust and soot. Spots and smudges of later color layers were taken away mechanically, with scalpel. The mortar based on hydrate of white lime KalkInjektionsmörtel was used for the grouting of detached plaster layer. The solution was injected in the hollows of the stucco lags and that parts were then pressed to the basement. The edging repair of the exposed plaster along the lacunae was made with the lime mortar prepared with Kalk-Kontor lime filler and quartz sand 1:2. In Figure 7 we show a portion of the wall decoration before and after the cleaning and conservation process.
