Article

Combining InfraRed Thermography and UAV Digital Photogrammetry for the Protection and Conservation of Rupestrian Cultural Heritage Sites in Georgia: A Methodological Application

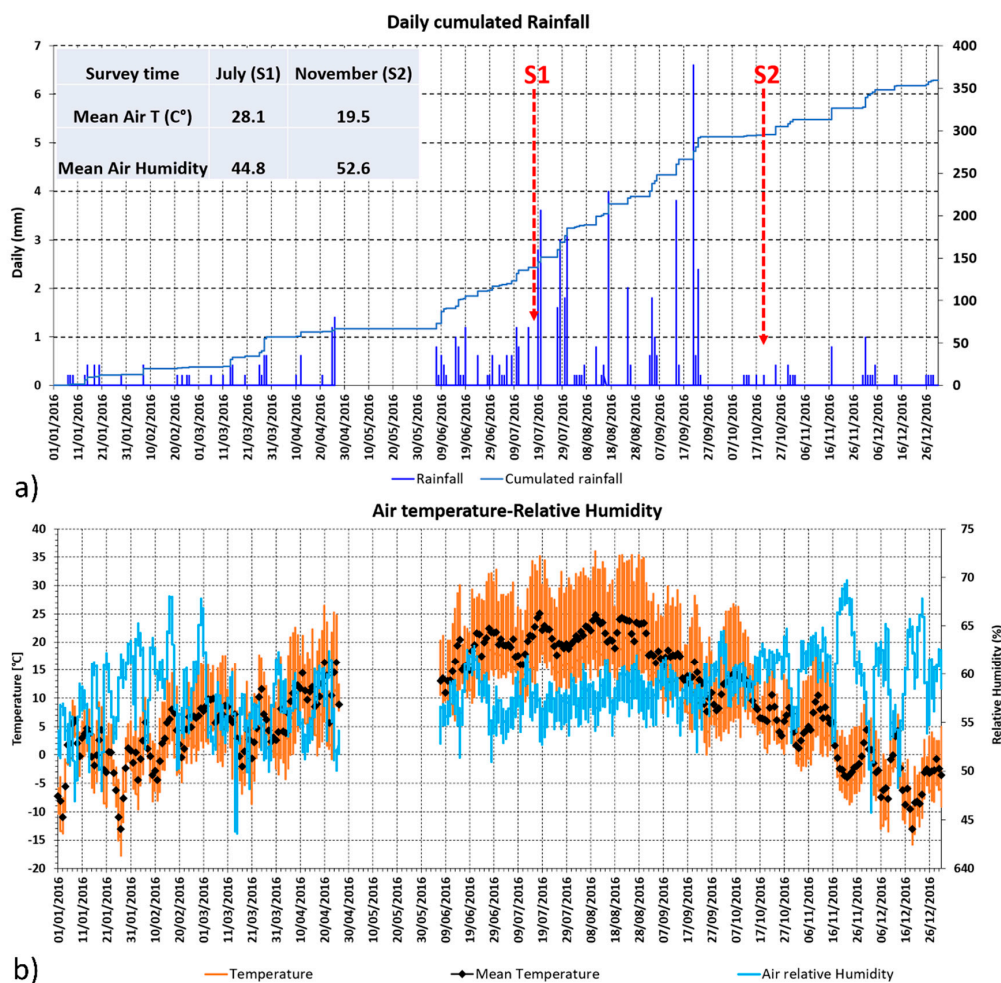
Figure 4. Weather microclimate data recorded by the Weather Station of Vardzia: (a) Daily cumulated rainfall recorded during 2016 in Vardzia and weather conditions during IRT surveys S1 and S2, (b) Air temperature and relative humidity recorded during 2016.

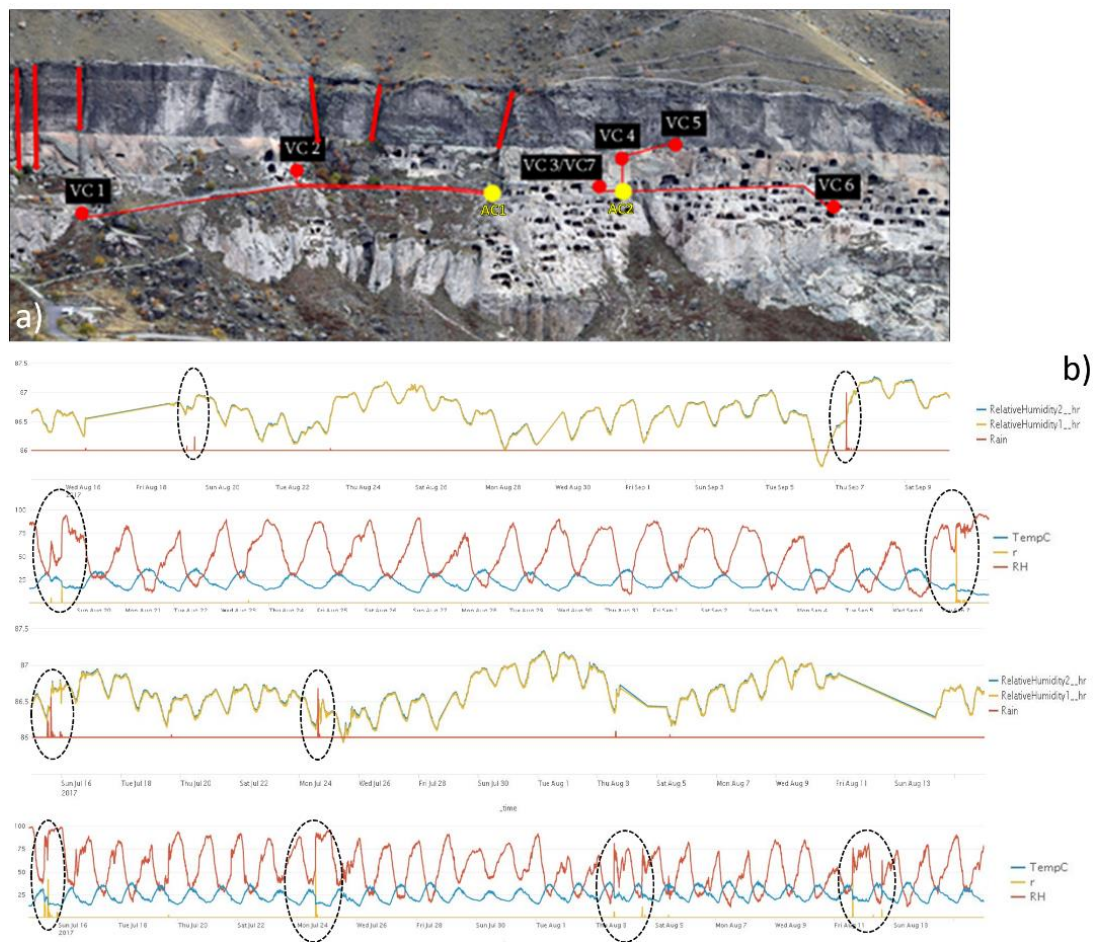
Figure 7. (a) Moisture stations, (b) VC4 Microclimate observation station data.

Several rain events were selected and analyzed: the criteria for selecting the rain events were time between two of the events and quantity of precipitation. Time between the rain events was considered favorably to be maximum for minimizing the influence of previous rainfalls. Due to the large amount of data, a special algorithm was developed in the Python environment in order to process the data and construct graphs of precipitation in correspondence to the monitored caves (the example of VC4 station is shown in Figure 7). Visual correlation of pikes in rock humidity with rain dates allowed us to estimate the average time periods needed for rainwater to be converted into rock humidity at different levels and depths of Vardzia rock (black dashed ovals in Figure 7). The results of the analysis among all the cave stations clearly shows the difference between the upper breccia (Layer 1), and the lower tuff level (Layer 2): VC6 and VC2 monitoring locations show more than 2 weeks needed for rainwater infiltration, While VC5 and VC located closer to the top of Vardzia require only 4–6 days intervals (Table 3).

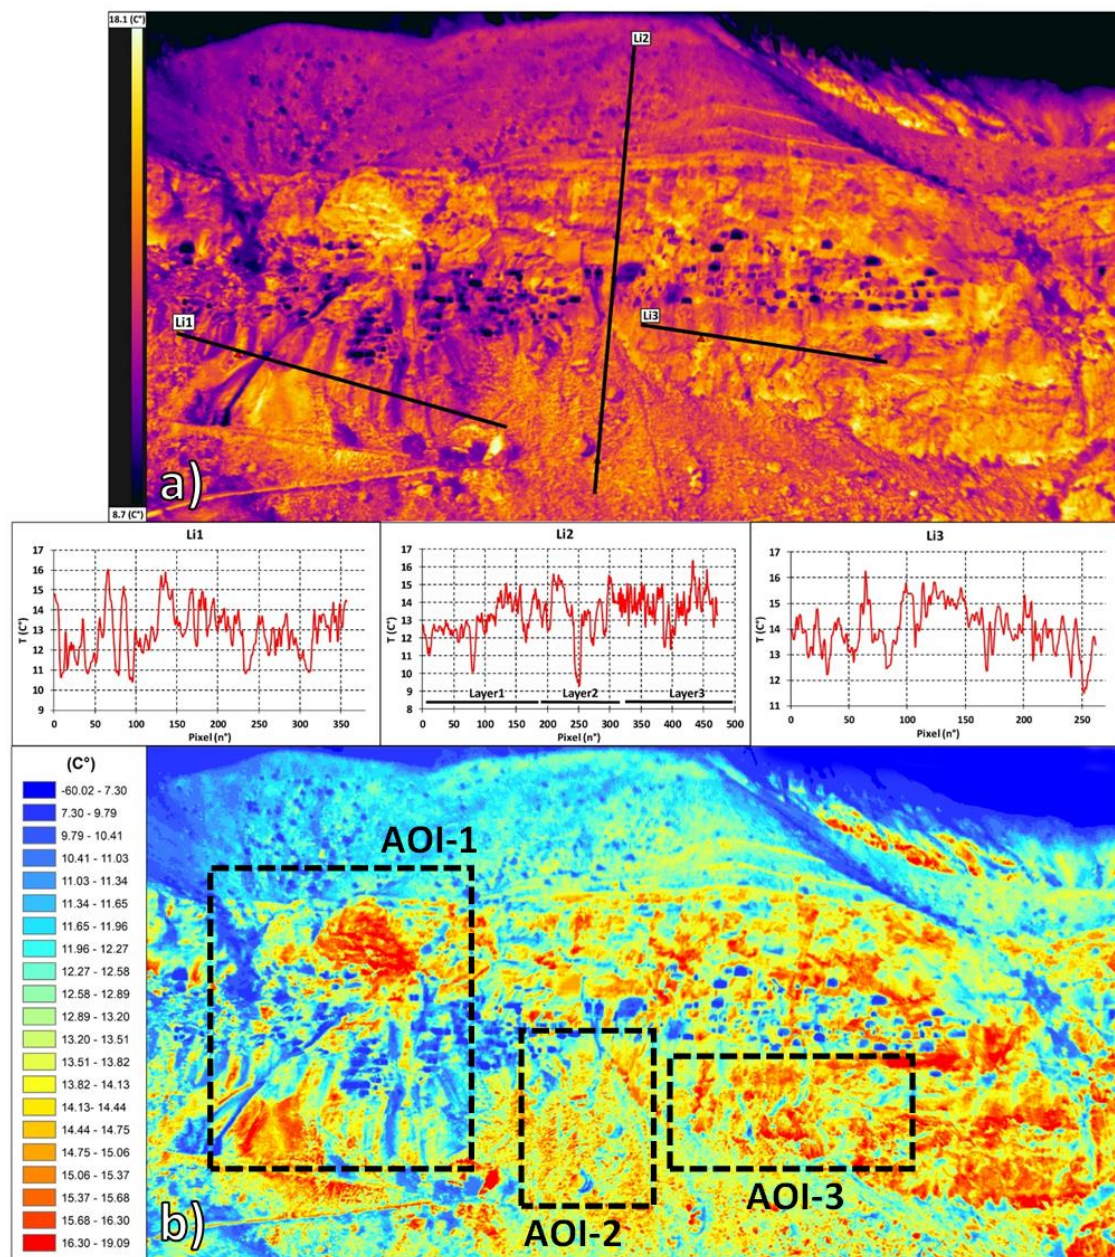
Figure 9. IRT data acquired in S2: (a) Mosaicked thermograms acquired on November 20th at 18:40, including ST profiles Li1-3, (b) corresponding classified image. Corresponding visible image (c).

From a general point of view, the IRT data (Figures 8 and 9) during both surveys show lower surface temperatures in the upper slope sector, due to its widespread vegetation cover (mean values: 23.2 C° during S1 and 11.1 C° during S2, Table 4).

Based on their pattern, location and interpretation of the visible images these can be described as follows: the cave system carved in Level 2 and 3 (mean values of 21.1 C° during S1 and 8.9 in S2), vegetated sectors located on both the eastern and western edges (22 C° mean ST value during S1 and 9.6 in S2), and high-angle linear-like sub-vertical anomalies intersecting (21.6 C° mean ST value during S1 and 10.2 in S2). These latter in particular were detected in both surveys in correspondence to open decametric persistent sub-vertical fracture system orthogonal to the cliff face intersecting mainly all of the layers (Area of Interest AOI-1), while only in the cliff eastern sectors starting from Layer 1 down to Layer 4 (AOI-2) (see profile Li1-Li2 in Figures 8a and 9a). Considering their pattern and the continuous rainfall occurring before both surveys, they were interpreted as areas that are connected to the presence of moisture. In particular, the sharper of these anomalies within AOI-1 is connected to a water pipe seepage, which was used for excavating purposes by the local group of archeologists. More cold thermal anomalies are also located within the slope toe sector (AOI-2-3): they are localized mostly along the contact with the cliff face, showing moisture sectors within the top sector of the debris talus. Others have a vertical linear pattern and are due to minor rivulets.

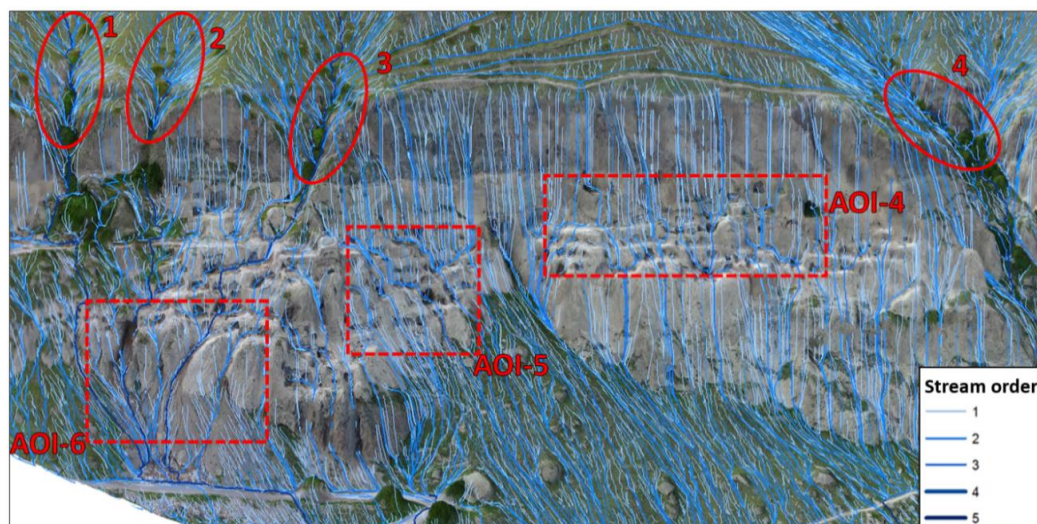
Figure 10. Front view of the modeled drainage network on the Vardzia slope 3D surface.

The Hydromodelling analysis allowed us to map the spatial distribution of water runoff within the monastery complex of Vardzia. Streams were categorized by order and catchments were identified, as well as areas of concentration (Figures 10 and 11). The 3D model provides a clear frontal view of the water runoff patterns on the cliff face and the slope toe (Figure 10). Four areas of water concentration are visible at slope break between upper slope and cliff: these act as main areas of water runoff concentration, acting as areas of enhanced linear erosion, especially in correspondence to Layer 1. In the middle-lower cliff sector, the slope morpho-structural setting creates three other areas of interest with respect to water concentration: (i) AOI 4, localized between Layer 2 and 3, (ii) AO5 and AO6 at the contact between Layer 3–4 and the slope toe. Results of the 2D orthoprojection show three main catchments on the eastern sector (Streams 1–2 and 3) and one located at the western edge of the complex (Stream 4), all of them showing streams up to the fifth order (Figure 11). In the central section, it is possible to observe the effect of the water-diverting structures, constituted by a runnel-retaining wall-system (red lines in Figure 11). These were built as part of the preliminary management plan, for the double purpose of preventing site runoff and erosion, as well as mitigating the risk of rock falls, due to the presence of potentially unstable scattered rock boulders on the slope's topmost sector. The runnels effectively channelize minor streams towards the two adjacent main order catchments to the west and the east, although in some sectors they have been damaged by the impact of some detached boulders, therefore in some points water flows directly along the slope.

Moisture sectors are localized within the main open cracks. This confirmed the relationship between the localized AOI: water runoff and moisture are concentrated in the slope western sector, where water-diverting structures are absent and stream erosion has deeply cut the volcanic breccia and part of the tuff (AOI 1 and 5) (Figures 10–12).

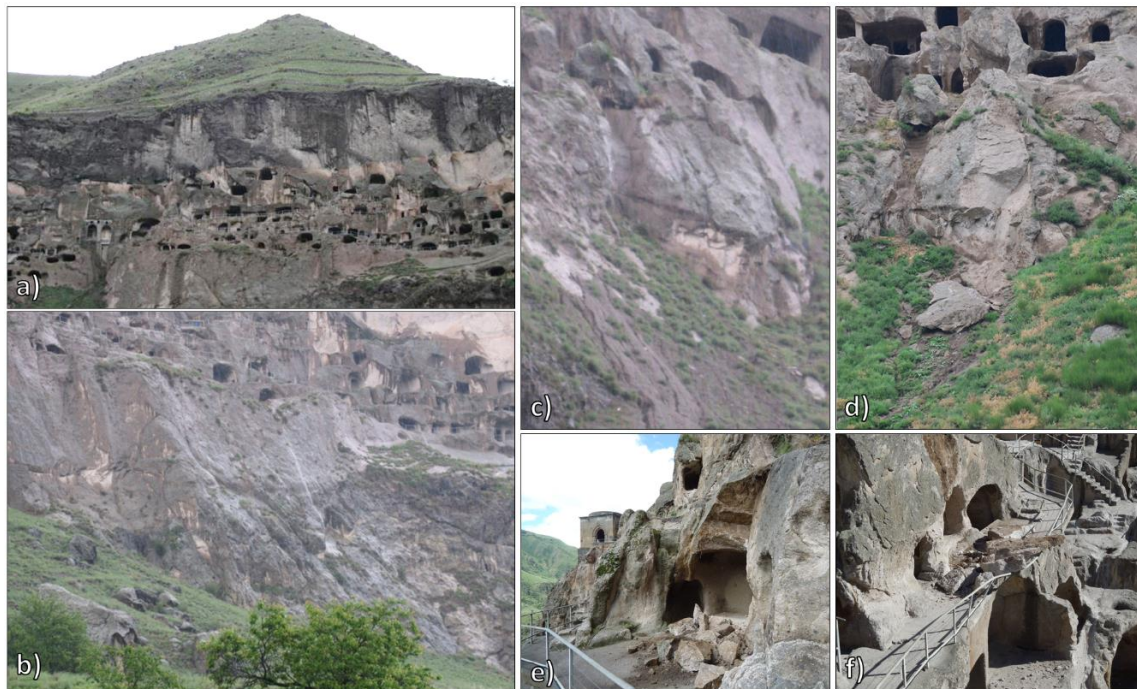
Figure 14. Conservation criticalities due to water runoff-infiltration: intense water runoff during a rainfall event in 23 May 2014 on the slope face (a) and slope toe (b) (courtesy of the director of the site), detail of collapsed block in AOI5 (c: before the collapse – photo taken on 25 May 2015) and after the collapse (d). Details of rock collapses occurred after rainfall events: 11 July 2016 (e) and 19 September 2016 (f).

The stratigraphic position and the geomechanical properties of the volcanic breccia (Layer 1) play an important role in the current geological structure of the complex: located on top of the tuffs, their higher density and hardness have protected the lower, soft and weak tuffs from erosion. Nevertheless, this layer is currently being deeply undermined by stream erosion, with special regards to the western slope sector. In Layers 2 and 3, the mineralogical analysis showed the widespread presence of clay minerals such as Ca-montmorillonite, formed by the chemical weathering of the volcanic glass which constitutes the tuff cement. This is responsible for the fast surface chemical weathering of the rock mass. The sub-vertical and high-angle dipping joints intersect the horizontal bedding of the volcanoclastic units along the entire Vardzia cliff, causing several instability phenomena whose type, dimension, and kinematics depend on local orientation, mechanical properties of volcanoclastic layers, spacing and persistence of joints [15–17,56,57] (Figure 6). Moreover, moisture expansion due to water runoff and concentration further exacerbates this scenario. Therefore, water flow and infiltration were assessed as one of the most important predisposing factors of slope instability in the site of Vardzia, since it negatively affects the material's geotechnical properties and the strength of discontinuities [72] (Figure 14). This is extensively proved by the geotechnical data: rock moisture decreases by depth, demonstrating the effectiveness of water infiltration from the surface, while the density increases, as the rock, is less weathered in depth (Table 2). At the same time, Water Absorption and Saturation is also higher on the surface in the weathered part of the rock. As an additional proof, the cohesion and resistance of the rock layers, in terms of uniaxial compressive and tensile strength, also decreases in wet conditions. The microclimate data confirm this scenario, as water infiltration affects the relative humidity within the rock layers more effectively from the top (Layer 1, VC5) to the lower Layer 3 (VC6) (Figure 7–Table 3). The strong alteration of the clayey mineral cement is also responsible for the strong reduction of the strength of both the rock and the discontinuities (especially the system parallel to the slope). As a matter of fact, the excavated caves are highly critical slope sectors that experience fast surface deterioration, raveling, and spalling (Figure 15) [13,56]. The significant reduction in the strength of the tuff due to moisture, poor to very poor durability, and the adverse effects of joints on the structural stability need to be considered during future management activities. This is proved by the recorded rock collapses in recent years (Figure 16).

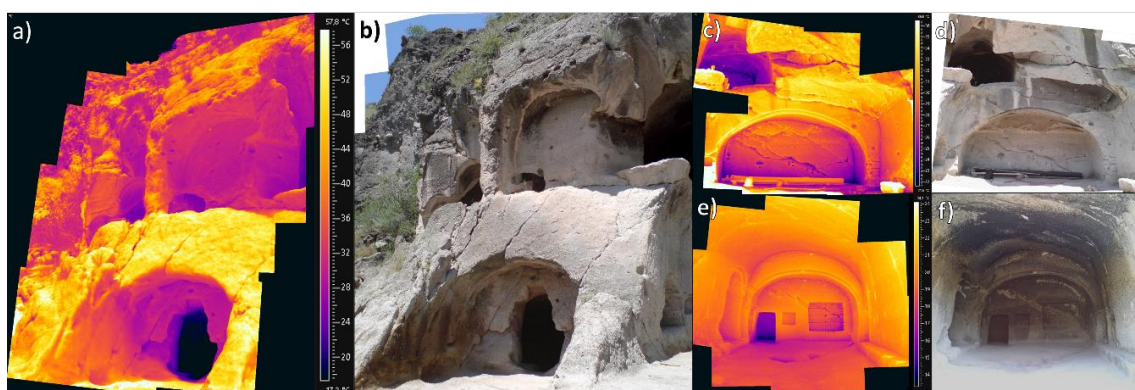
Figure 15. Close-ups of the criticalities in the cave systems acquired on S1: Mosaicked thermogram (a) and correspondent photo (b) of cave system characterized by persistent and spaced fracture system, mosaicked thermograms of intensively fractured cave system (c) with correspondent photo (d), mosaicked thermogram of single cave (e) and correspondent photo (f) characterized by spalling of the rock surface in the roof of the room, controlled by rock weathering and stress degradation.
