HBIM for the preservation of a historic infrastructure: the Carlo III bridge of the Carolino Aqueduct.

HBIM for the preservation of a historic infrastructure: the Carlo III bridge of the Carolino Aqueduct

The research on Carlo III bridge in Moiano (Benevento, Italy) has been an opportunity for testing the HBIM methodology to the architectural heritage in terms of not only gathering information but as a design tool. The bridge, almost without previous drawings and documents, was surveyed with an integrated approach using laser scanner, photogrammetry and topography. Data produced a metrically reliable HBIM model, complete with graphical and non-graphical information, to be used in a maintenance and restoration project.

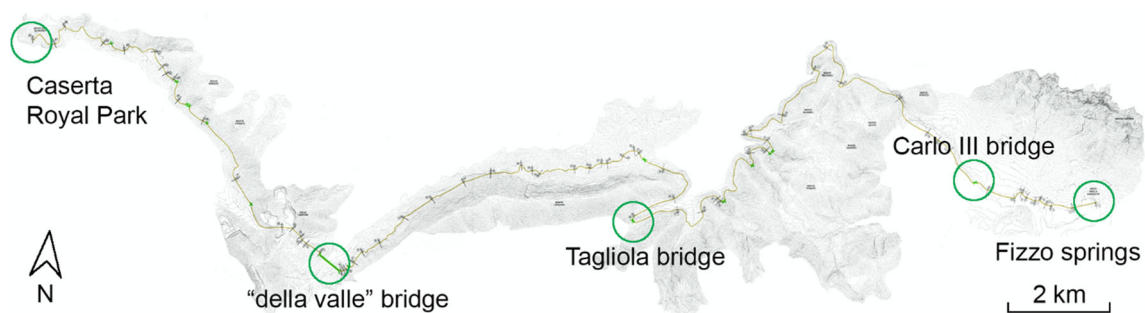
Fig. 2 The route of the Carolino aqueduct from the Fizzo springs to the Royal Park of Caserta, with the indication of the three monumental bridges

The Carolino Aqueduct is underground for 37 km and emerges in some sections only, that are the “della Valle” bridge (in the Maddaloni Valley), the Tagliola Bridge (at Durazzano) and the Carlo III bridge, which is the closest to the Fizzo springs, where the water that feeds the Royal Park and Palace is collected (Fig. 2).

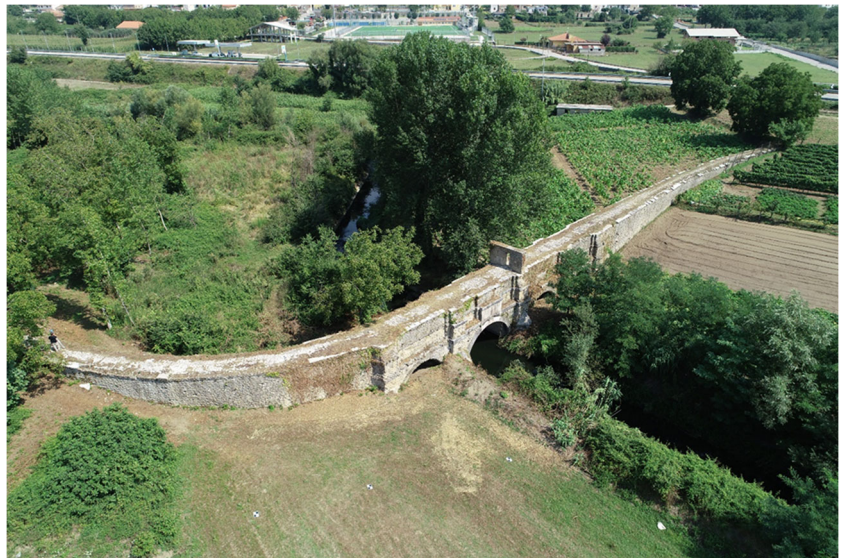
Fig. 3 Carlo III bridge, Moiano (BN), aerial image showing the crossing of the Isclero river

The Carolino aqueduct and therefore also the Carlo III bridge are certainly infrastructures, but their design, which combines technology and forms typical of classical culture, are a clear manifestation of a far-sighted government that expressed its power by marking and designing the territory (Fig. 3).

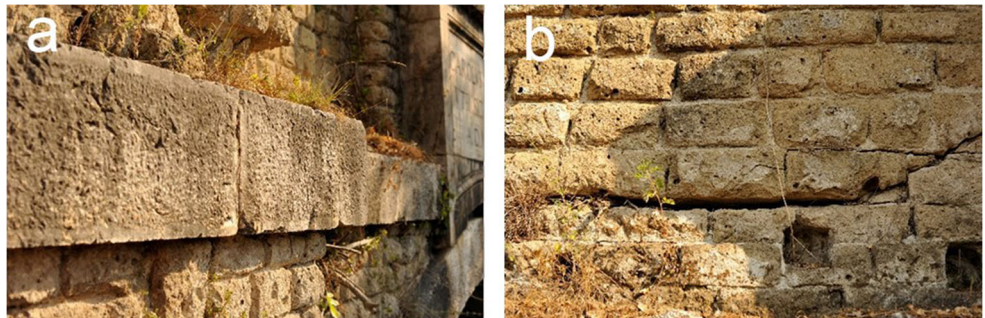
Fig. 4 The main materials of the Bridge: **a** the local limestone with the presence of a disintegration phenomenon and a superficial patina; **b** the yellow tuff, and the clear lesion on the South elevation

The bridge was built in order to cross the aqueduct over the river Isclero and without any connection with the local road network. It is about 150 m long above ground and almost 7 m high. The structure is entirely made of local yellow tuff, which is certainly extracted in the nearby quarries, while the perimeter ashlar, the plaques, some elements of the curb and the pavement are made of limestone, also local, characterized by a lighter, almost white colour (Fig. 4).

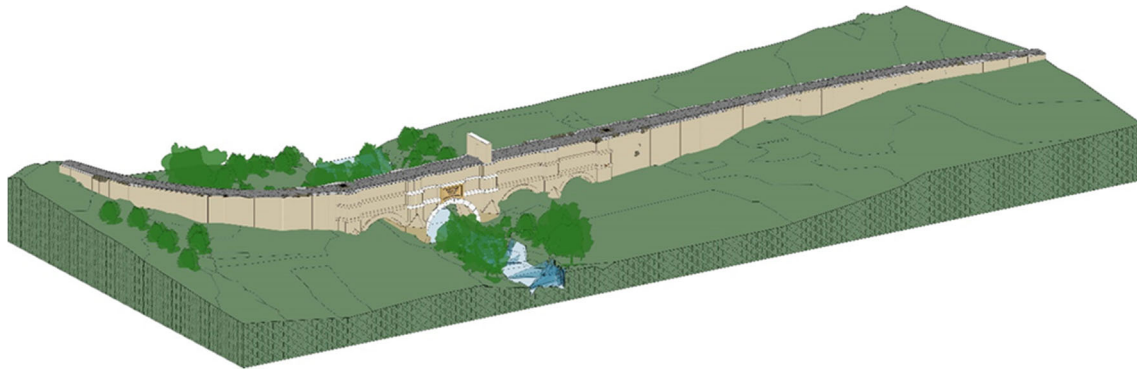
Fig. 5 Carlo III bridge, the HBIM modelling of the geometry, the surrounding terrain and the watercourse

Carlo III bridge is made up of four round arches separated by buttresses and two “shoulders” connecting and gradually entering into the ground, following the natural slope. Horizontally, it can be considered divided into a lower level (which includes the arches), an intermediate level, externally delimited by two limestone string courses (strongly degraded but still clearly recognizable), and an upper level, walkable but without parapets (Fig. 5).

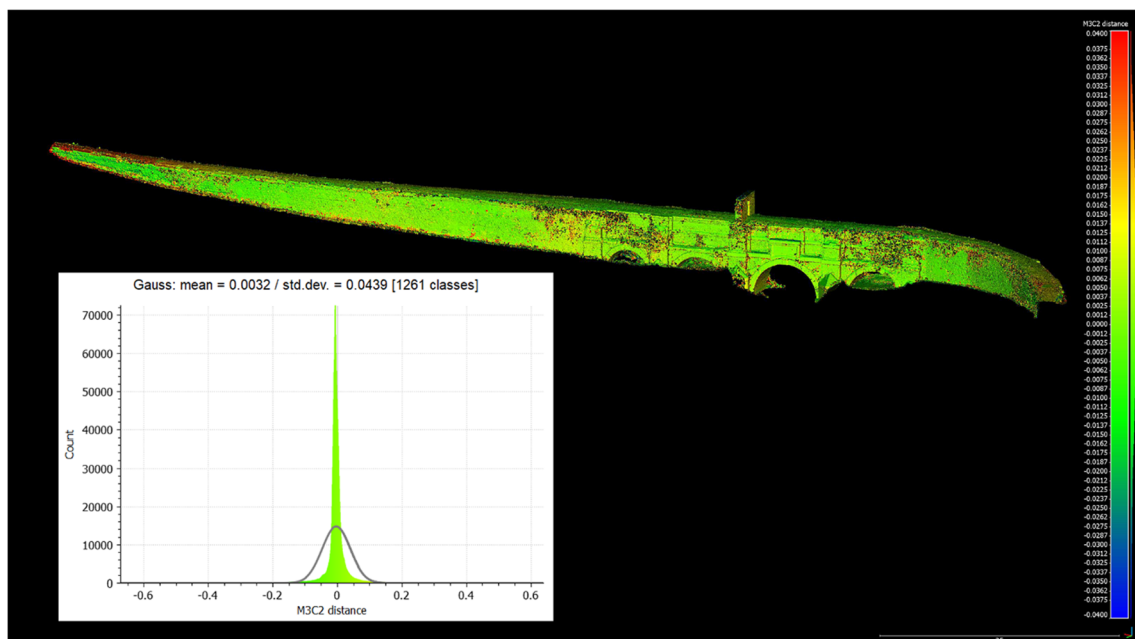
Fig. 6 Comparison between point clouds acquired by laser scanning and photogrammetry

After registration, the mean distance between the point clouds obtained by laser scanning and photogrammetry resulted 3 mm, being the outliers referred to the parts covered by vegetation (Fig. 6).

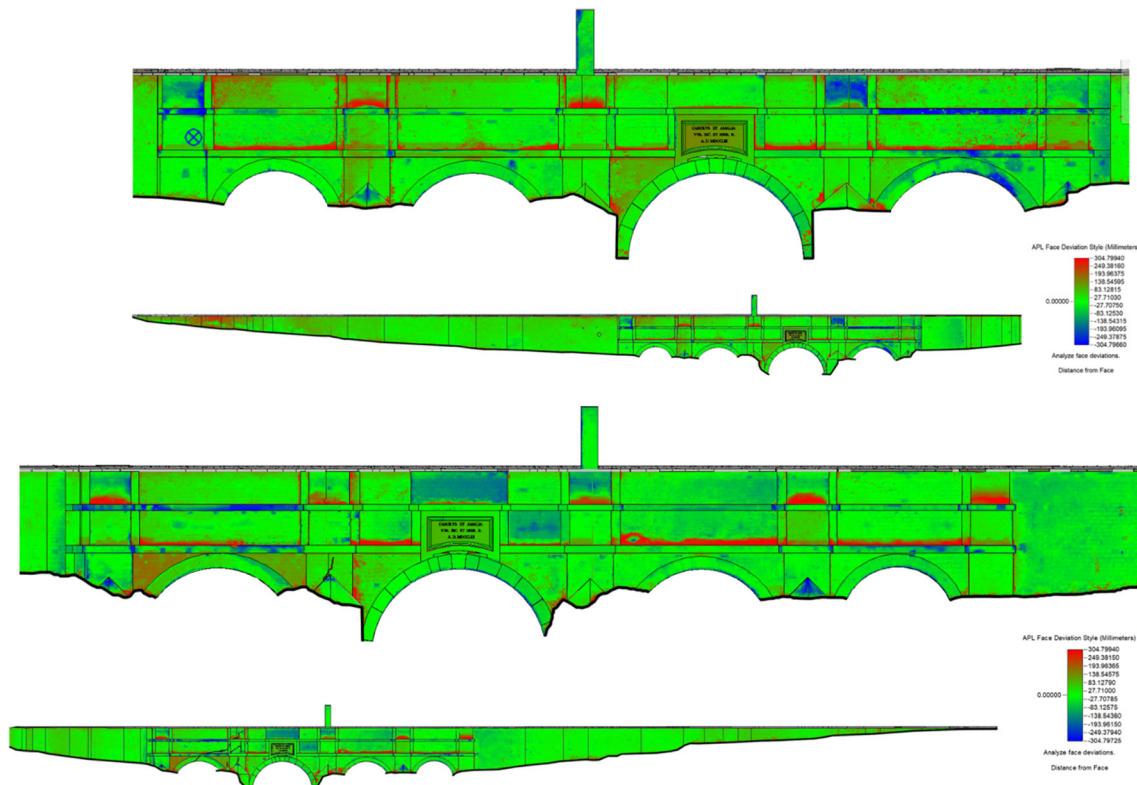
Fig. 7 Point cloud and BIM model deviation map. The diffused modelling error is about 2.7 cm, mainly related to masonry ashlars. Red areas are related to infesting vegetation (not included in the 3D model); blue areas to very irregular portions or missing parts

Due to the irregularity of the surveyed object, it was necessary to use so-called “in-place models” to represent the existing geometry as closely as possible, but without all the parametric properties of a standard family (Fig. 7).

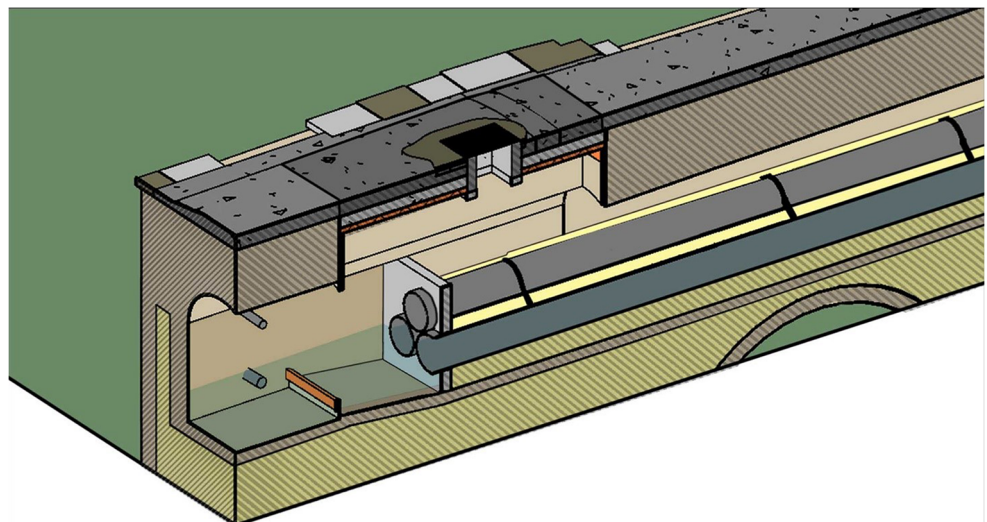
Fig. 8 The inner duct, modelled according to the currently available data

HBIM modelling also must face another issue which is not present in new constructions. Often the inner texture of a building is not completely known, so there is the risk to build a dumb model. Trying to overcome this issue, every kind of information was linked to Carlo III bridge basic components. Technical data include materials, their characteristics and processing techniques. The main materials used for building the bridge, which are Neapolitan yellow tuff and limestone, have been added to the materials library. They are linked to a brief description, an indication of the presumed origin and to informative websites. Other information includes all historic data useful to reconstruct phases and interventions, like archival or printed sources, images and also oral history, with testimonies of local people on the works occurred in last decades. Finally, in absence of other data, also the working hypotheses aroused during the research were included. As example, it was possible to inspect only a limited portion of the interior of the conduit through a manhole above the bridge in the straight

portion of the eastern side (Fig. 8). Data about dimensioning, materials and pipes have been, temporarily, extended to the entire bridge.

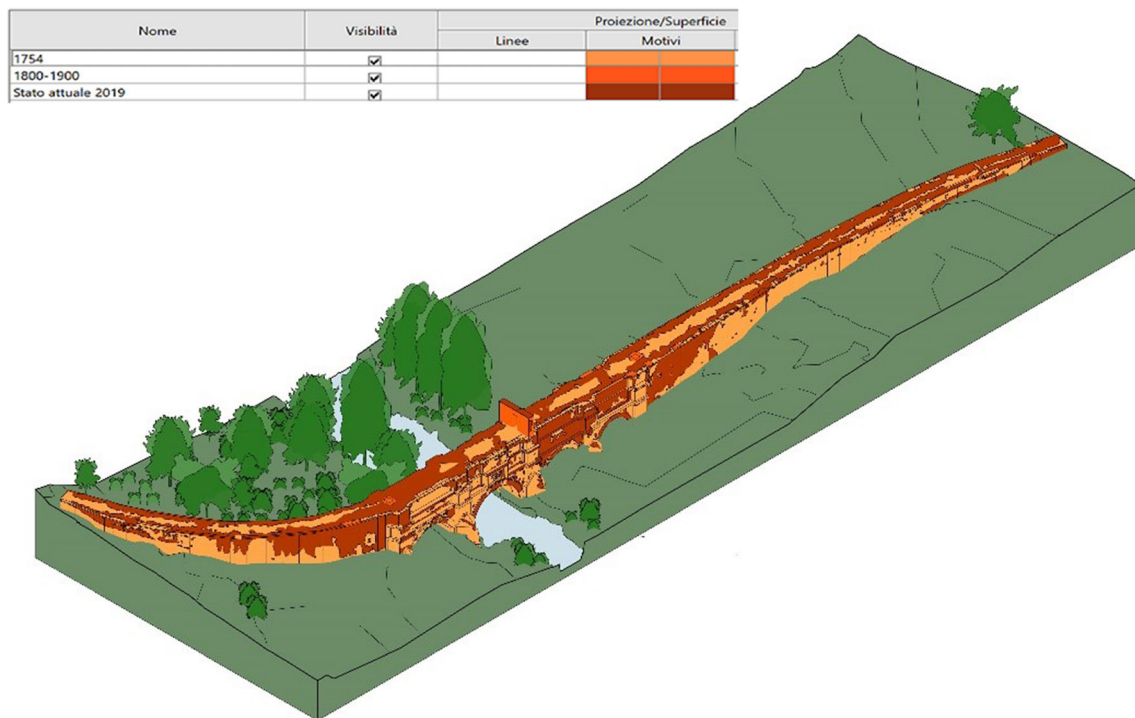
Fig. 9 Time sequence of the bridge, obtained filtering the construction phases in the HBIM model

Other information concerns the date of the interventions. All phases after the construction (about 1754) were identified and attributed to bridge elements. Cross-correlating the above-mentioned data, it is possible to create thematic maps, for showing, as example, the construction phases of the parts of the building (Fig. 9).

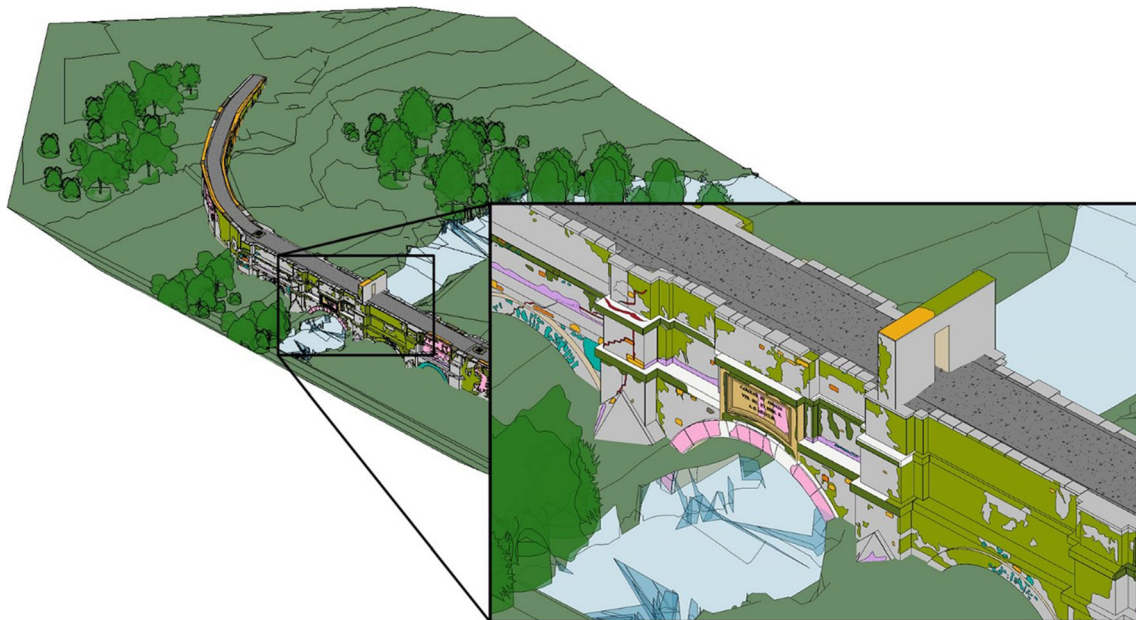
Fig. 10 Representation of decay using “in-place” models

BIM software and vectorizing the different pathologies on the flat surfaces of the model (included the parallel ones to the horizontal plane). The selected areas were modelled as millimetre-thick surfaces and classified by degradation pattern. This manual process is undoubtedly accurate but is very time-consuming (Fig. 10).

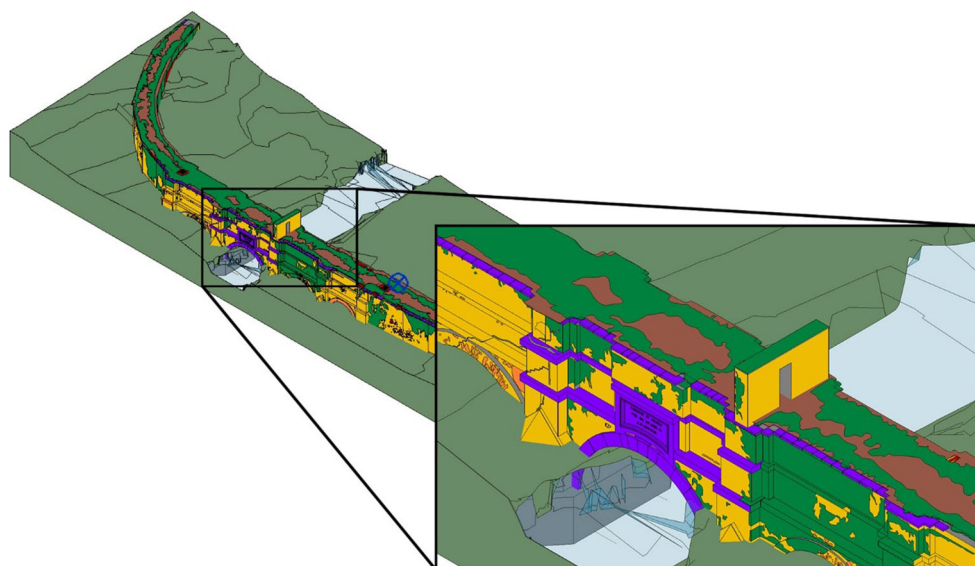
Fig. 13 Representation of interventions on the HBIM model

Once the characterization of materials, the localisation of every kind of deterioration and its quantity, is known, the conservation and structural reinforcement plan can be represented and computed on the model (Fig. 13). As described about decay representation, interventions can be attributed to

single objects or portions of surfaces, indicating the corresponding surface of the model and associating all the necessary information, e.g. name, steps, images, technical data sheets and tutorials. As for decay, it is possible to create schedules containing the quantity of the surfaces on which every intervention is required, together with detailed procedural descriptions, products to be used and other working solutions. As in the traditional restoration practice and in building sites printed drawings are still very common; it is also possible to export the 2D views in usual CAD formats or other data included in schedules for producing proper bills of quantities.
