## Montfort

History, Early Research and Recent Studies of the Principal Fortress of the Teutonic Order

## The Building Below the Castle

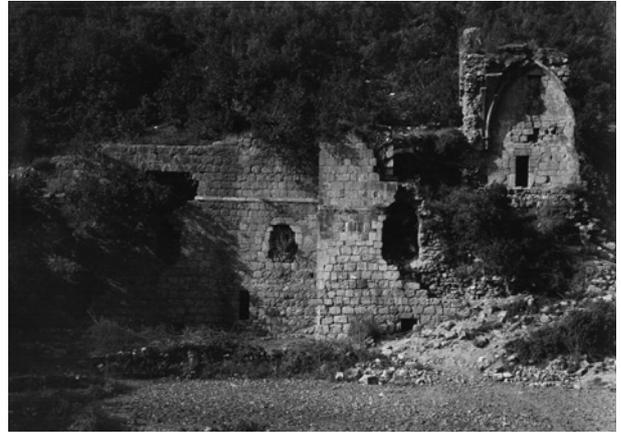
PLATE 10.1 *Mill and hall in Nahal Kziv in 1926.*  
COURTESY OF THE METROPOLITAN MUSEUM OF ART, ARCHIVES OF THE DEPARTMENT OF ARMS AND ARMOR, IMAGE © THE METROPOLITAN MUSEUM OF ART.

The structure below Montfort Castle included a large industrial component with a complex water piping system, still partly recognisable, and quite different to the other mills along the stream (Plate 10.1, 10.2). In the past, visitors have commented mainly on the romantic nature of this imposing structure with occasional suggestions regarding its possible use.<sup>2</sup> More recent research has focussed on the architecture and functional aspects of the building which consists of a large Gothic hall constructed over a mill.<sup>3</sup> A geometric as well as metric analysis was carried out at the site by the team from the University of Florence in November 2009.<sup>4</sup> It has shown that the mill was originally of a rectangular plan, built on a modular base using the royal cubit (Plate 10.3). A detailed discussion on the layout of the building and on the use here of the royal cubit was published by the authors of this chapter in 2012.<sup>5</sup>

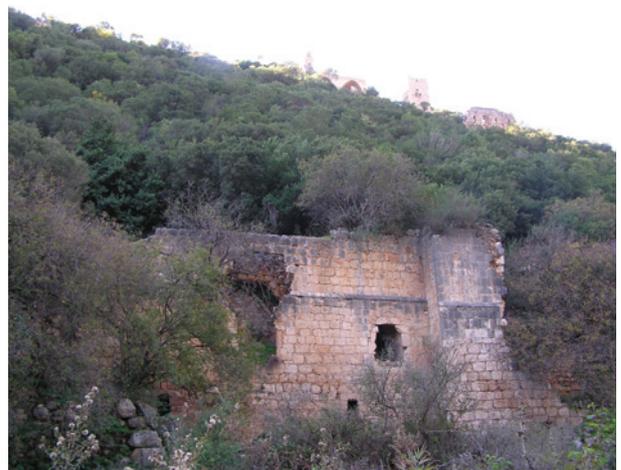
PLATE 10.2 *Mill and hall in Nahal Kziv today.*  
PHOTOGRAPH BY ADRIAN BOAS.

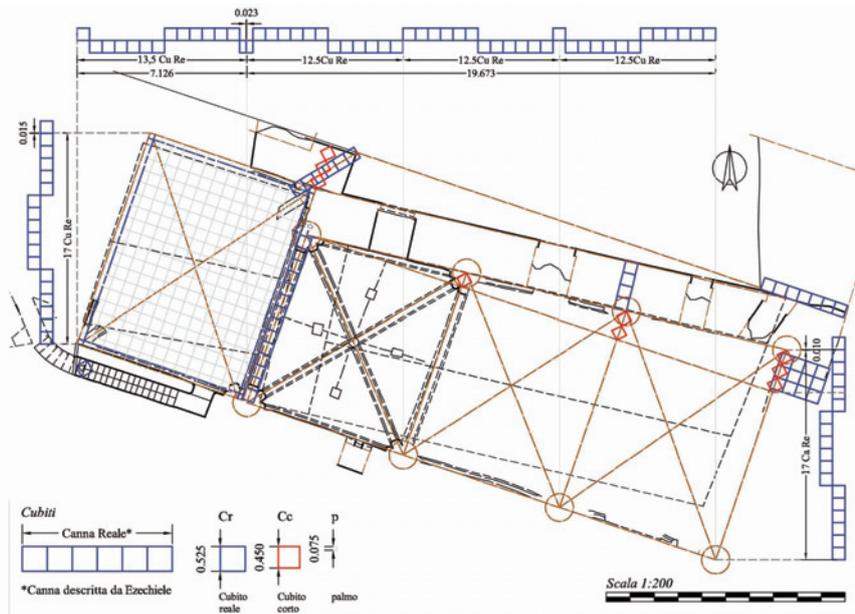
PLATE 10.3  
Plan of the mill.  
DRAWING BY LAURA AIELLO.

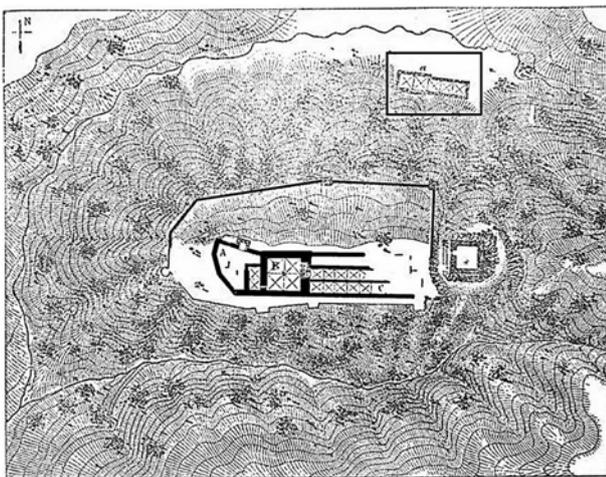
PLATE 10.4 Rey's plan showing the mill building (Rey, 1871).

The earliest documented survey carried out by Rey in 1865 included a 1:2500 scale plan (Plate 10.4).<sup>6</sup> It shows the mutual relationship between the castle and the building under discussion. A more detailed survey was carried out in September 1982 by Pringle, on behalf of the British School of Archaeology in Jerusalem (BSAJ)

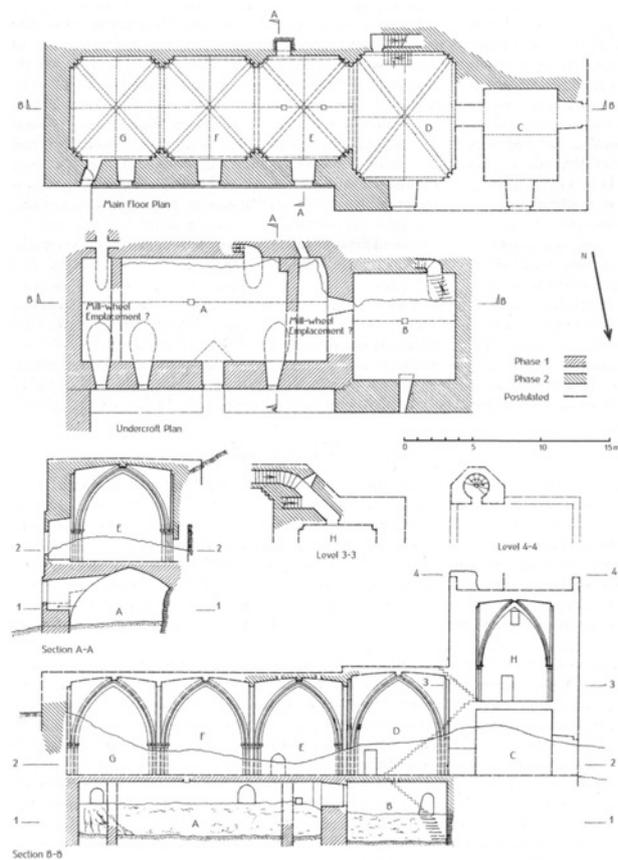
PLATE 10.5 Pringle's plan of the mill building (after Pringle, 1986, pp. 58–59).

(Plate 10.5).<sup>7</sup> The publication of this survey included a theoretical reconstruction of the west wing (tower), derived from photos taken before the collapse of the remaining southern side of this tower in 1940–1942 (Plate 10.6). Pringle referred to the building as “a thirteenth century hall” and as a mill, over which was built “a guesthouse, dependent on the castle of the Teutonic knights and intended for the use of important secular or ecclesiastical visitors and their households”.<sup>8</sup> We have chosen to apply here the neutral term—“building”—to describe the structure.

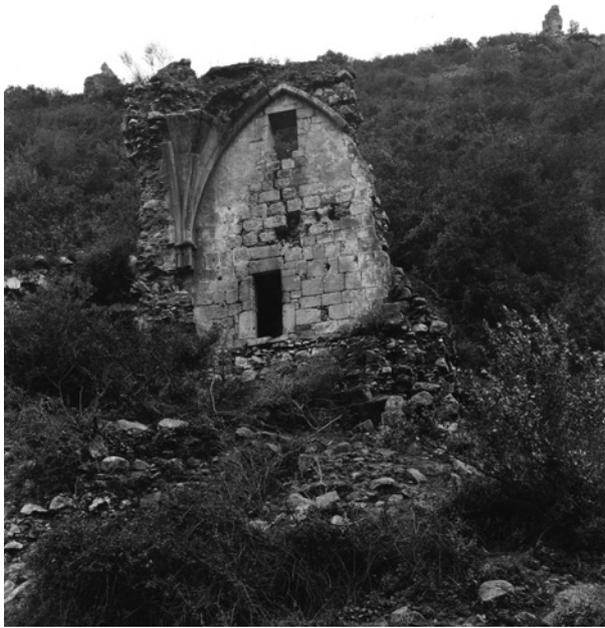
PLATE 10.6 *Photograph of remains of the mill tower.*

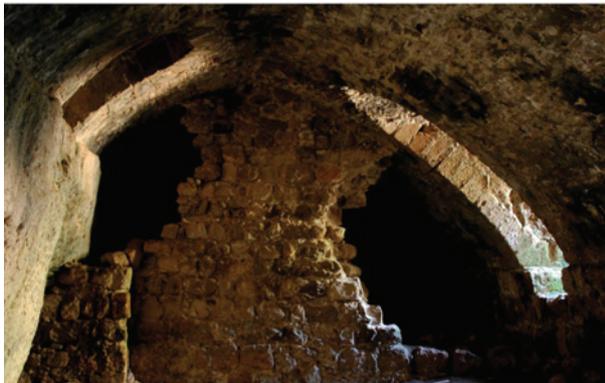
PLATE 10.7 *Barrel-vaulted ground floor level.*

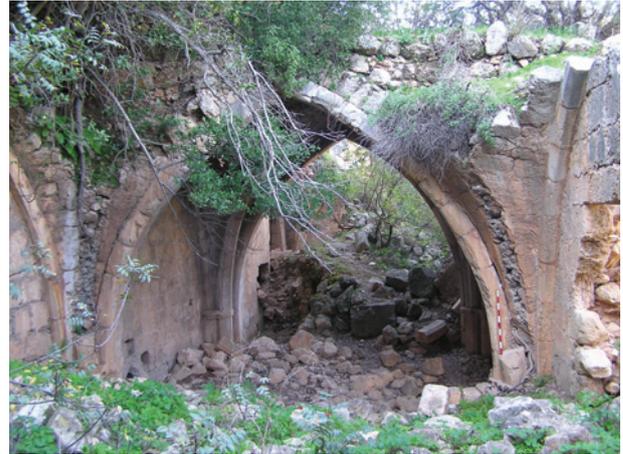
PLATE 10.8 *Standing bay of the upper storey hall.*

Our survey has revealed the high standard and quality of its architectural composition. The surviving remains of the building are of a nearly rectangular structure of two storeys, with an appendage, originally of three storeys, extending west of the main block. The lower level of the structure is a large semi-underground chamber cut into the bedrock on the mountain side and roofed with a pointed barrel vault (Plate 10.7). The vaulting of the upper storey has largely collapsed but, as can be seen in a single standing bay, was of rib-vaulting on square spans (Plate 10.8).

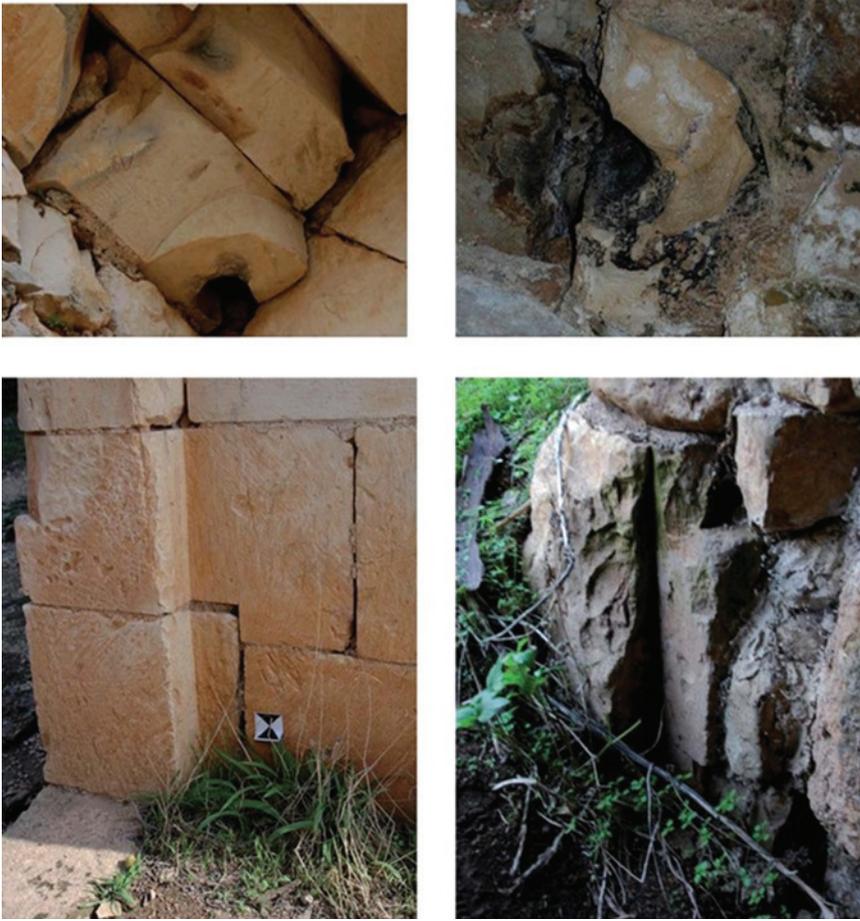
PLATE 10.9  
*Hearthstones and doorposts in the castle and building in the valley.*  
 PHOTOGRAPHS BY LAURA AIELLO.

that the construction of the building in the valley was contemporary with that of the central wing of the castle with its two aisles and cruciform piers. This is supported by several factors: a comparison of technological details, an analysis of the style and technical details of the structures such as the cutting and processing of the stones, and a proportional study of the two structures. The first point of comparison can be observed in hearthstones and doorposts (Plate 10.9). In both structures we can see a clear resemblance in parts of the doorposts which have incisions for wooden bolts and axels. The examination and measurement of the surviving elements of entrances in the castle has allowed us to make a comparison with the access to our building (Plate 10.10) revealing a precise correspondence between the openings of the two structures.

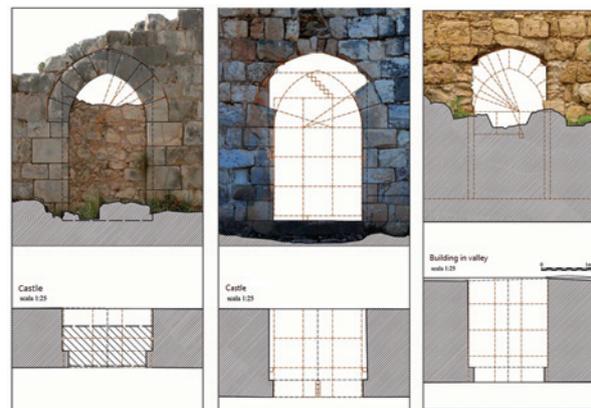
PLATE 10.10 *Doorways in the castle and building in the valley.*  
 DRAWING BY LAURA AIELLO.

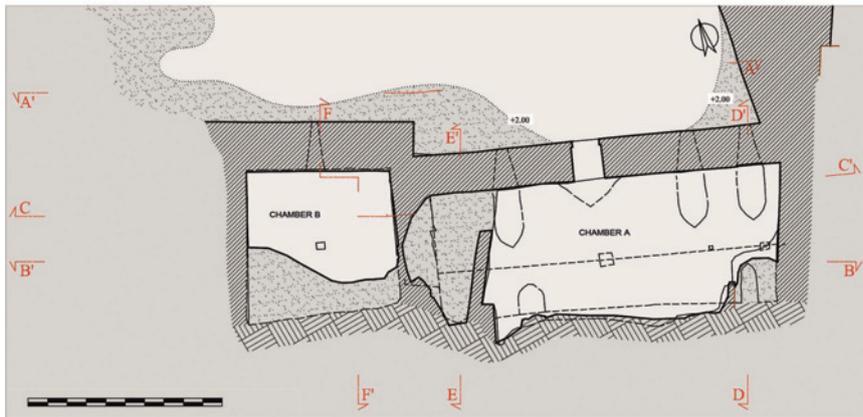
PLATE 10.11  
*Plan of the mill vault.*  
 DRAWING BY LAURA AIELLO.

The ground floor of the building is currently accessible through the original main doorway which was partly altered at a later date. It leads into three barrel vaulted rooms with pointed arches running parallel to the slope of the hill against which it is built (Plate 10.11). The floor is covered by a large amount of debris so that

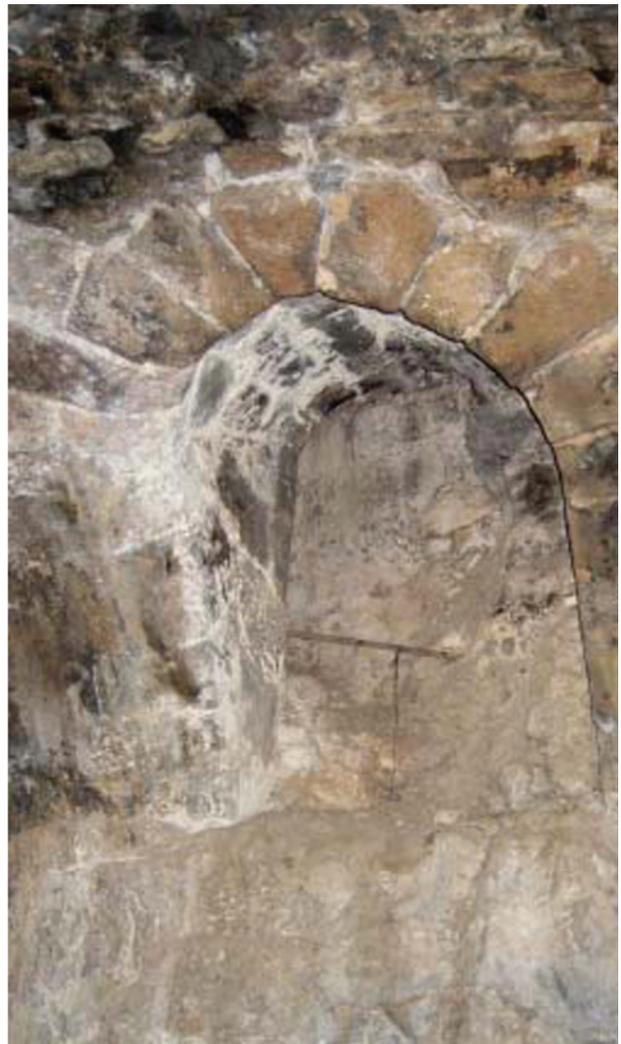
PLATE 10.12 *Stairway in the ground floor vault.*  
 PHOTOGRAPH BY LAURA AIELLO.

stairway and two channels. The stairway is positioned opposite the entrance, in a raised position (approximately  $\frac{2}{3}$  of the estimated overall height of the chamber) and is at  $90^\circ$  with the vault (Plate 10.12). In the middle of the debris, an entrance with steps can be observed, in the same direction as the stair opening, leading to the upper floor. The two channels connect horizontally to a duct cut in the rock. The first channel, located to the east, shows traces of a vertical shaft at its top and four branches, one of which could still be inspected today (see the undercroft plan, above, Plate 10.4). From our initial analysis these look like air vents or water pipes. The only channel we were able to examine has an almost square section with a side of about 50–60 cm and we measured it to a depth of about 14 m (Plate 10.13). A careful examination has enabled us to state that this channel extends to just below the gate of the above mentioned staircase, before reaching the second section which is also connected to a vertical shaft. The last chamber has an opening that reveals (among debris) the entrance to a second staircase. Of the same quality of workmanship as the rest of the building, it opens at the base of the vault. Specially carved stone blocks form an entrance at  $45^\circ$ , which curves and then continues parallel to the vault.

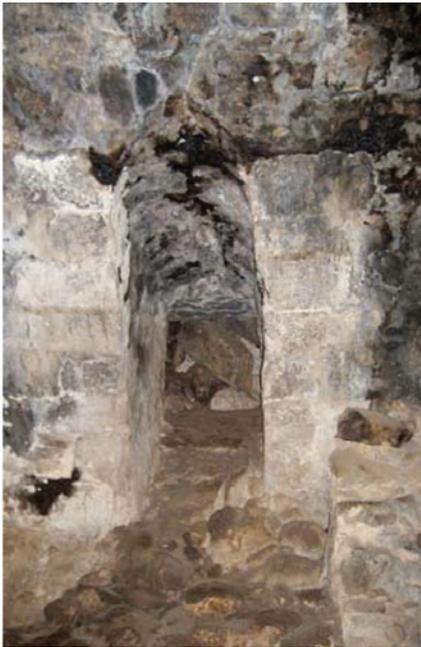
PLATE 10.13 *Water mill channel in ground floor vault.*  
PHOTOGRAPH BY LAURA AIELLO.

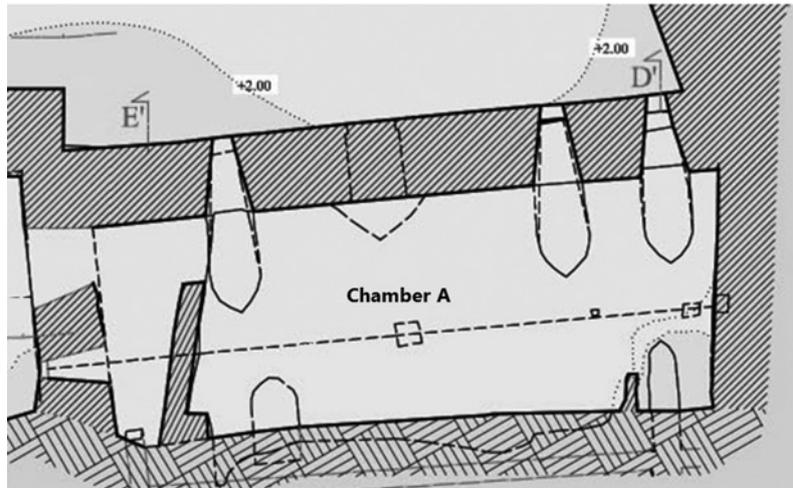
PLATE 10.14 *Plan showing the main vault of ground floor level.*  
DRAWING BY LAURA AIELLO.

The first important result, derived from our examination of the stratigraphic relationships between parts of the structure, was the identification of the original core—chamber A (Plate 10.14).

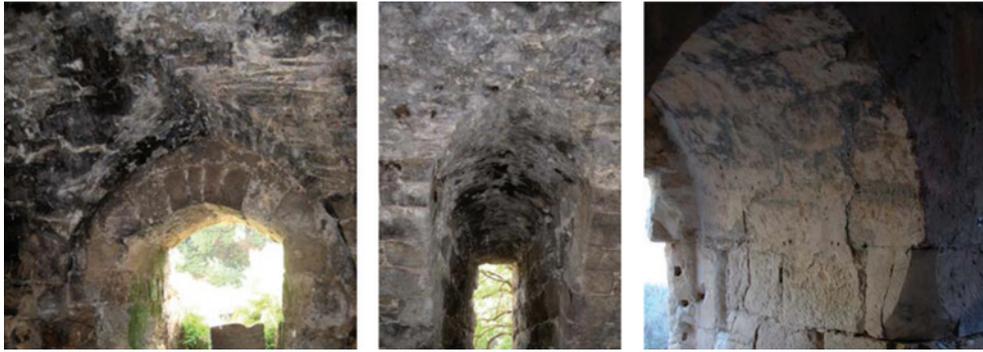
PLATE 10.15 *Door and windows on ground floor level.*  
PHOTOGRAPH BY LAURA AIELLO.

The first room (chamber A) is illuminated by three tall windows, one to the left and two to the right of the entrance, all of the same type (Plate 10.15). The second room (chamber B) has a single window of similar form and dimensions.

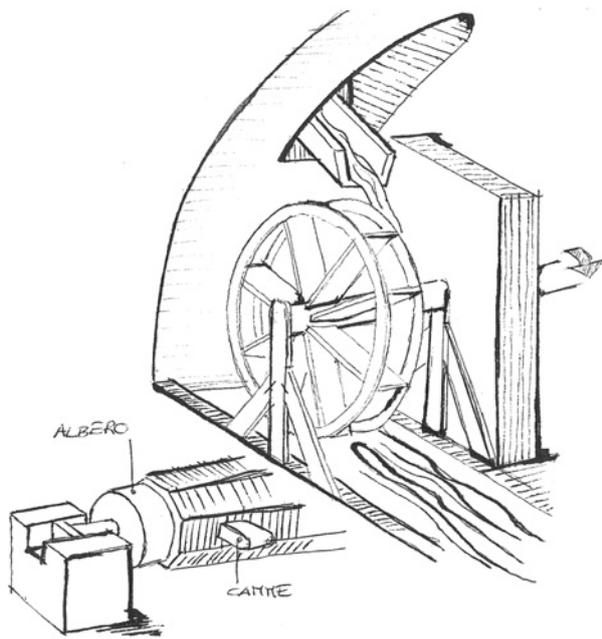
PLATE 10.16 *Reconstruction of a vertical mill wheel.*  
DRAWING BY LAURA AIELLO.

The design of these rooms where the waterwheels would have been located is not compatible with the employment of horizontal wheels, as is usually the case in mills in the Latin East, and we need to consider the possibility here of the use of vertical wheels (Plate 10.16) which were more complex and more advanced. The main requirements of vertical mills, which indeed can be observed here, are: a) a high posi-

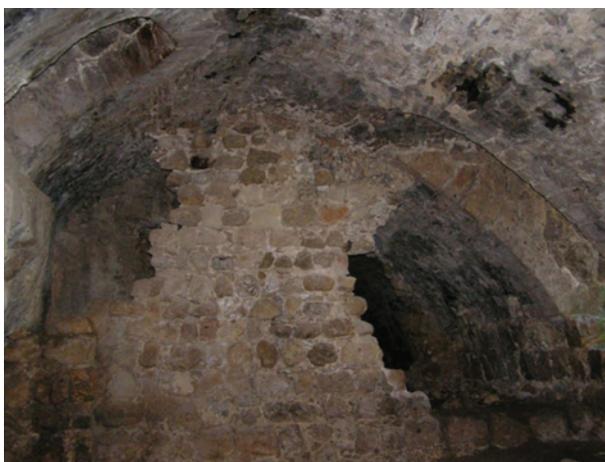
PLATE 10.17 *Dividing wall in ground floor vault.*  
PHOTOGRAPH BY LAURA AIELLO.

The two dividing walls are slightly oblique from the vault walls and are constructed of stones which are smooth on the visible part (Plate 10.17). As they were not constructed at the time of the vault construction, but at a later date, it is unlikely that they were intended to serve also as reinforcements for the first floor. If they had been intended to strengthen the vault they would have been constructed using well-squared blocks, to resist vertical pressure. Rather, it would appear that these walls were built to house the wooden structure of the wheels and to keep them in place. The outflow canal has not yet been found, and is probably buried beneath the massive debris present here.

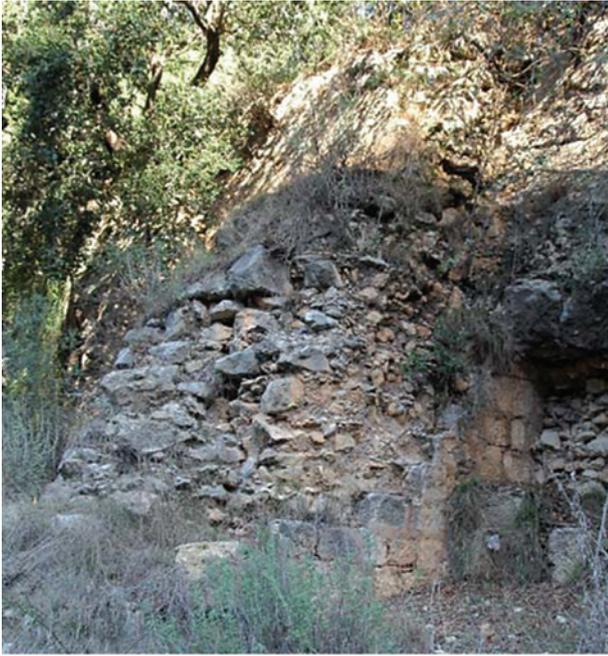
PLATE 10.18 *Dam, north bank.*  
PHOTOGRAPH BY LAURA AIELLO.

Careful analysis has been made of what is commonly identified as a dam (Plates 10.18, 10.19).<sup>9</sup> The thick vegetation makes it difficult to examine and the poor state of preservation does not allow us to identify the water input system, hence we cannot at present go beyond a hypothetical model. It functioned as a dam or possibly a bridge with a hydraulic system which is connected to the lower part of the building. If indeed this dam functioned also as a bridge it could probably have been reached by a connecting door from the first floor of the building. The major preserved portion of the dam is on the southern side of the stream. It is

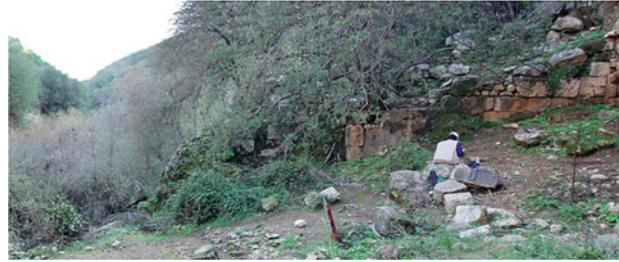
PLATE 10.19 *Dam, south bank.*  
PHOTOGRAPH BY LAURA AIELLO.

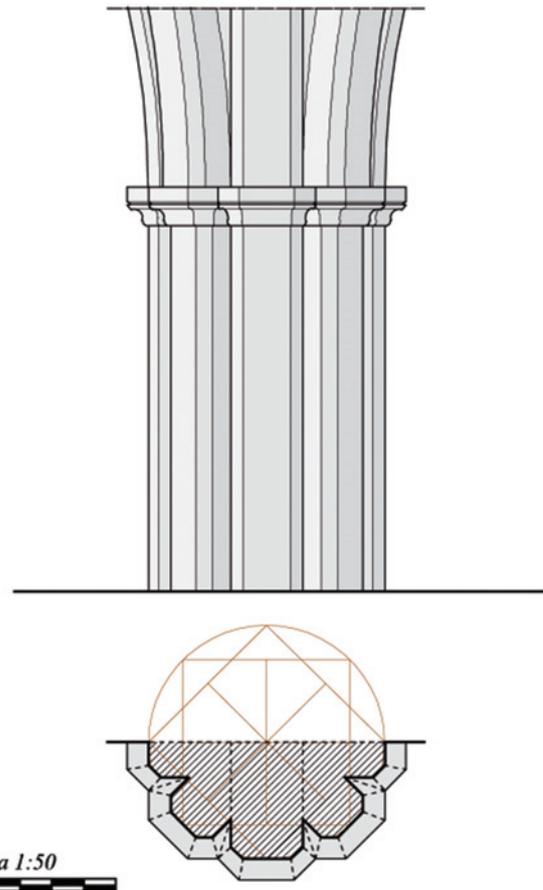
PLATE 10.20 *Pilasters in first floor hall.*  
DRAWING BY LAURA AIELLO.

The first floor has three rib-vaulted bays, only one of them standing, although severely deteriorated. Pilasters sustain arches with ogival ribs (Plate 10.20). The design is a distinct, archaic Gothic style. Decoration is basic and geometrical but well-cut in contrast with the rough, course stonework of the facade, and its remodelled openings.
