THE TIMBER ROOF OF THE CENTRAL NAVE IN THE BASILICA OF SAN MICHELE IN PAVIA

Emanuele Zamperini¹

Keywords: Timber structures, timber trusses, San Michele in Pavia, history of construction, critical survey

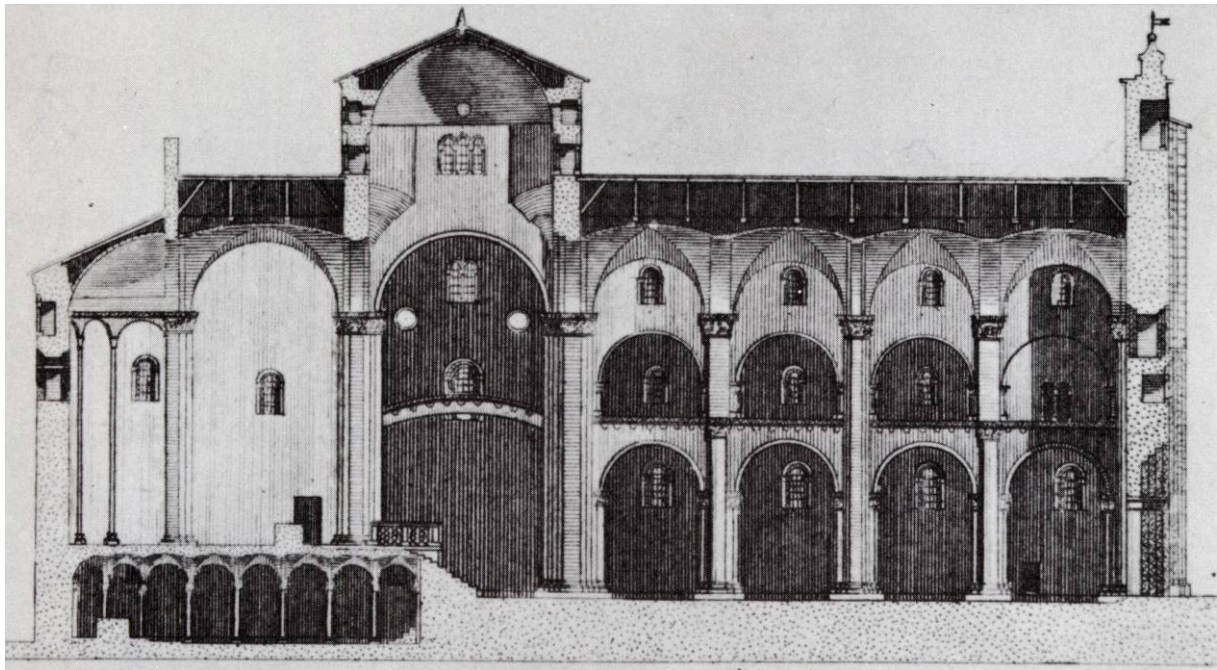
Figure 2: Longitudinal section of the Basilica by Seroux d'Agincourt published in 1823 [2].

In the plates enclosed in the *Histoire de l'art* published posthumously in 1823 by Jean Baptiste Louis Georges Seroux d'Agincourt (1730-1814) [2], the roof of the central nave is depicted with nine trusses, but there is a large number of inconsistencies with coeval representations (e.g. number and shape of windows) and with the current state of the building. These incongruities are probably due to an attempt to reconstruct the original state of the building but denounce the freedom with which the building has been reinterpreted and it makes the representation unreliable.

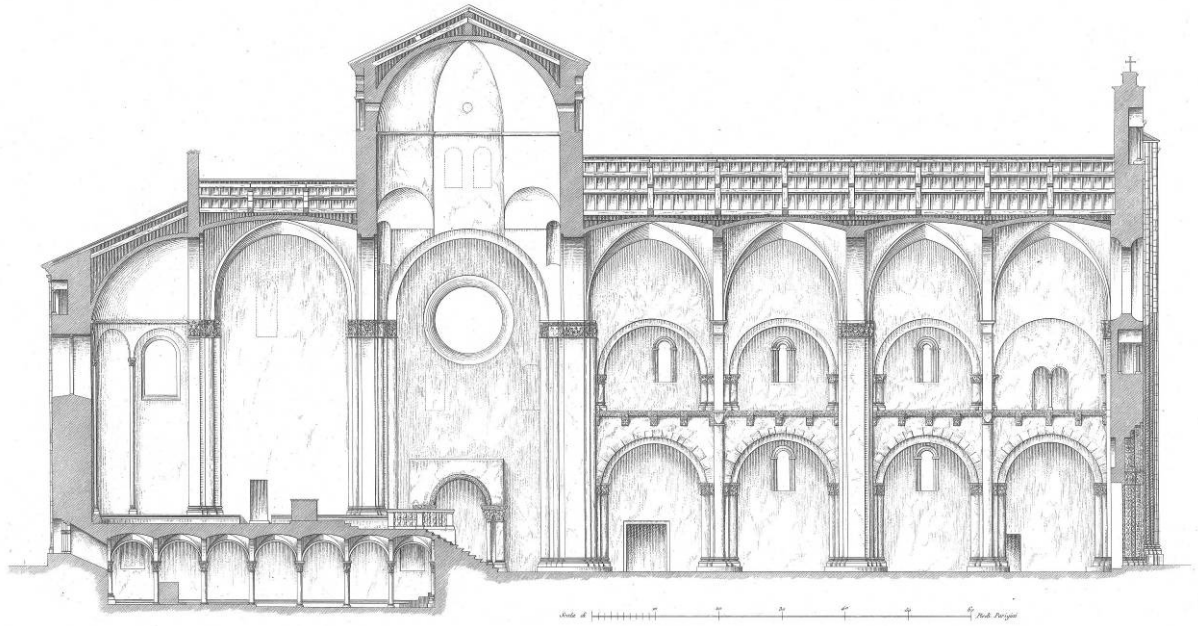
Figure 3: Longitudinal section of the Basilica published by Giovanni Voghera in 1828 [3].

The surveys published by Giovanni Voghera in 1828 [3] seems to be more reliable, because of fewer discrepancies in respect to other coeval documents and to current state; even the representation of the roof of the central nave seems more trustworthy (e.g. there are seven trusses as at present), however it's not possible to deduce from the longitudinal section any meaningful information about the construction type of the trusses. All the trusses are equal and schematically represented, in each of them we can see three sectioned elements: one at the bottom, the tie-beam; one at the top, the rafter; the third at half height. It's impossible to state with certainty if this member represents a straining beam or a strut, however – since the height of the element is smaller than that of the tie-beam and of the rafter – we can favour the second hypothesis.

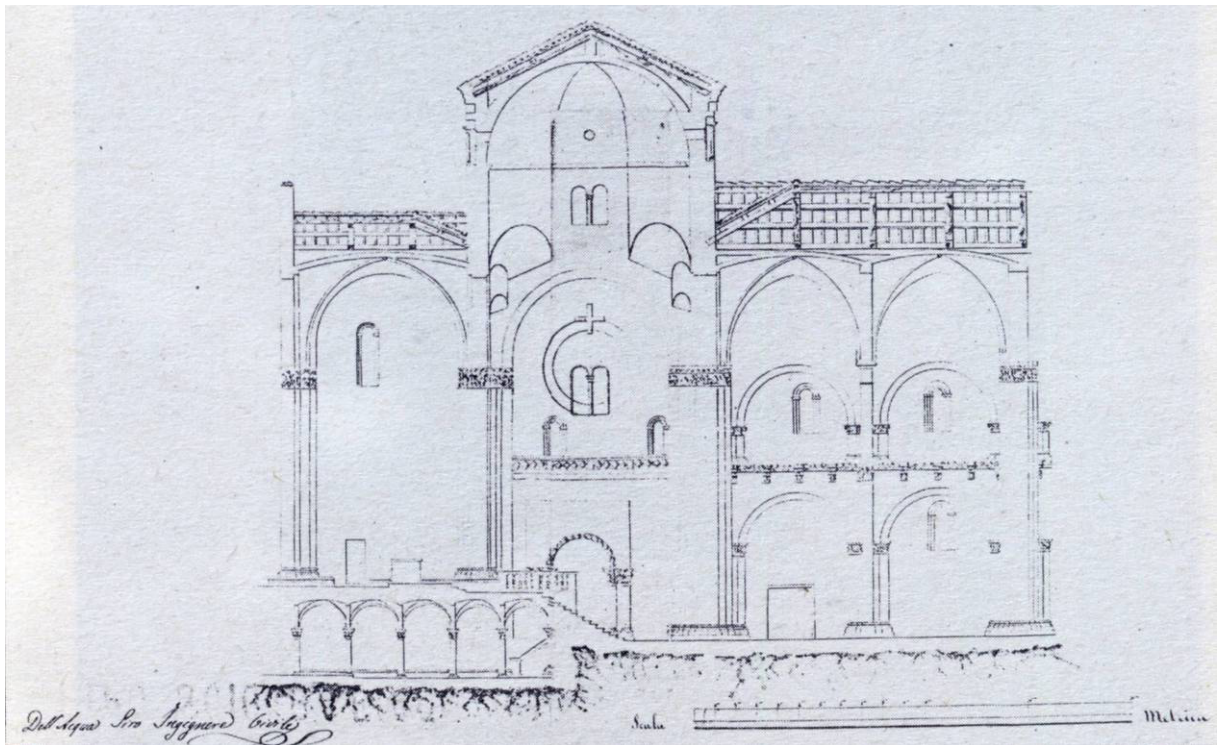
Figure 4: Longitudinal section of the Basilica sketched by Siro Dell'Acqua in [4].

At first instance a greater reliability could be attributed to the drawing by Siro Dell'Acqua – sketched out on the occasion of the restoration works directed by himself – due to the greater knowledge of the building related to his own professional activity [1]. However, this drawing is actually only an adaptation of the draft by Giovanni Voghera, of which it repeats some information (e.g. the wooden structure covering the presbitero) that the study of documents has proven to be incorrect.

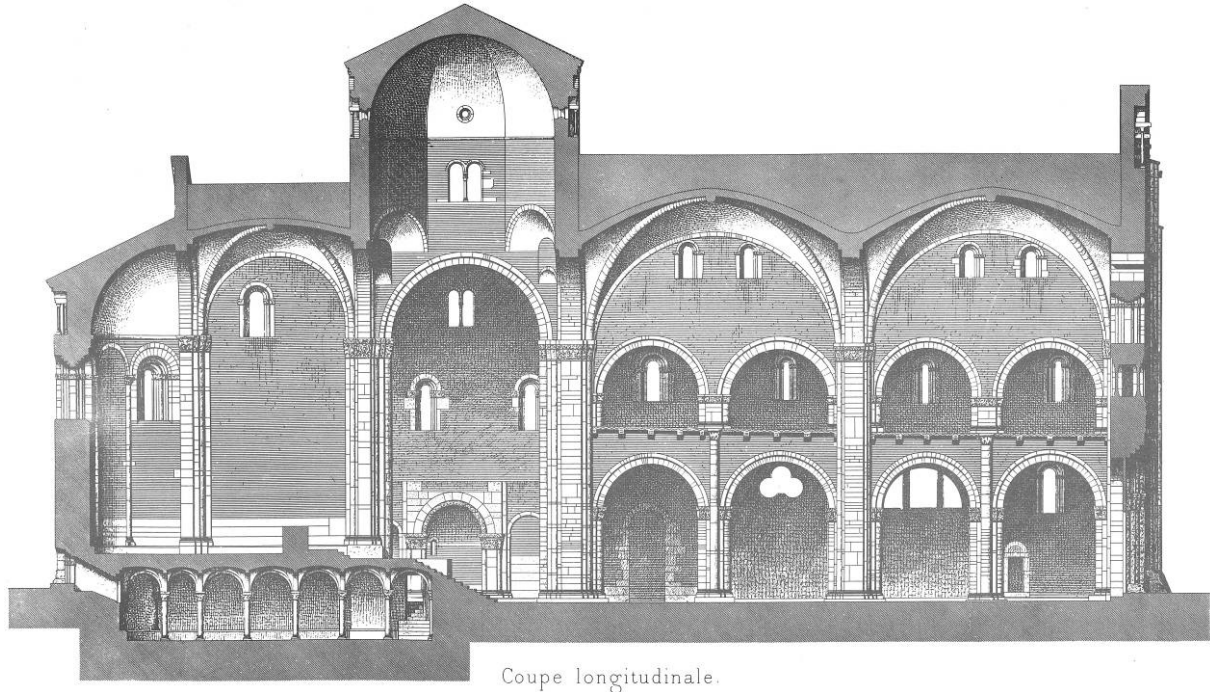
Figure 5: Longitudinal section of the Basilica drafted by Fernand De Dartein [5].

The drawings drafted by Fernand De Dartein [5] have a completely different nature: they represent a reconstructive hypothesis of the ancient vaults of the central nave on the basis of traces present in the attic, therefore De Dartein expunged the existing vaults and didn't represent the structures bearing the roof covering.

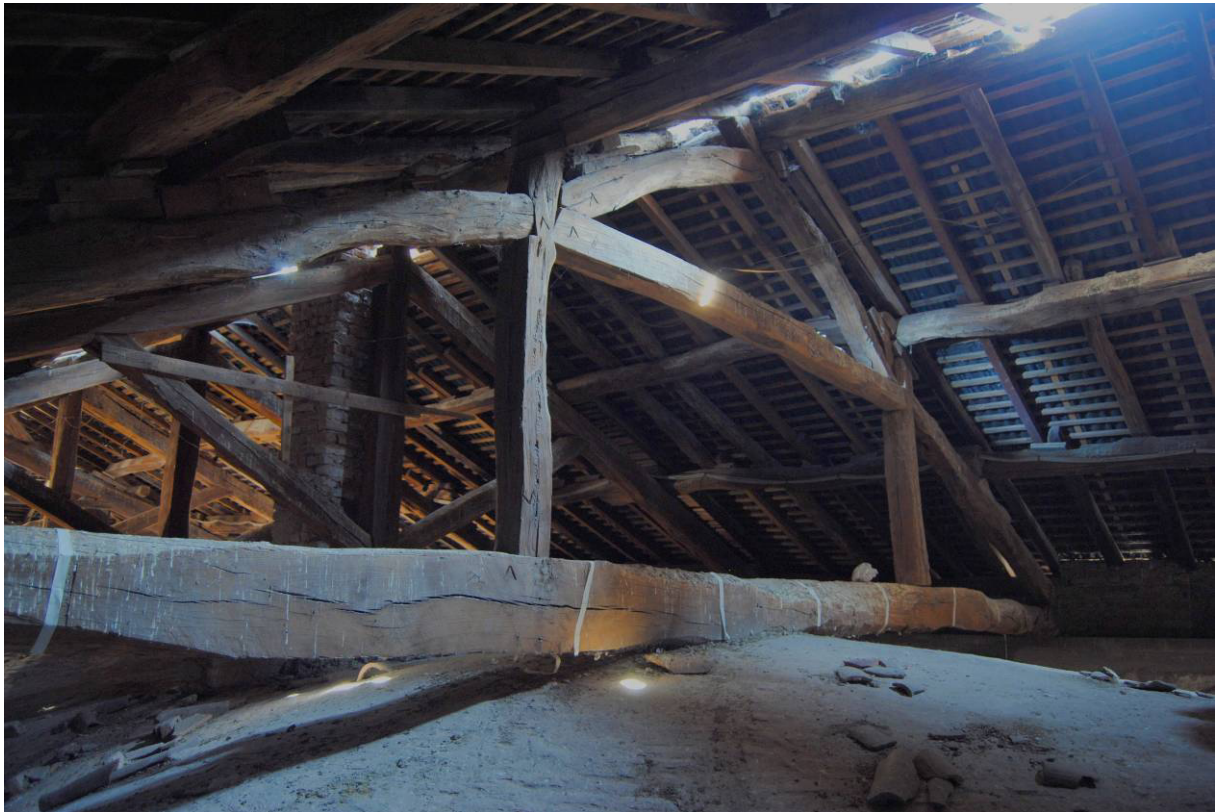
Figure 6: Truss number 3 (photograph by the author).

Existing trusses of the central nave may be divided into three categories. The first category consists of the truss number 3 only (see fig. 1), which is the most different from the others:

it's a queen post truss without king post; the tie-beam is made of a single and quite irregular beam; the queen posts are joined to the tie-beam with a half dovetail tenon-mortise joint probably originally locked with a wedge (now absent); the rafters are discontinuous at the joint with the queen posts. The second category consists of trusses number 4 and 5: they are king post trusses with struts; the tie-beams are made of two beams joined with a hooked scarf joint with nibs reinforced with planks nailed to the side faces of the beam; the king posts are in direct contact with the tie-beams, to which they were previously linked with a stirrup strap. The third category consists of trusses number 1, 2, 6 and 7: they are king post trusses with struts; the tie-beams are made of two beams joined with a key locked scarf joint with nibs, reinforced with square head bolts. In the third category trusses number 1 and 2 differ from number 6 and 7 due to the different design of the joints between rafters and king post.

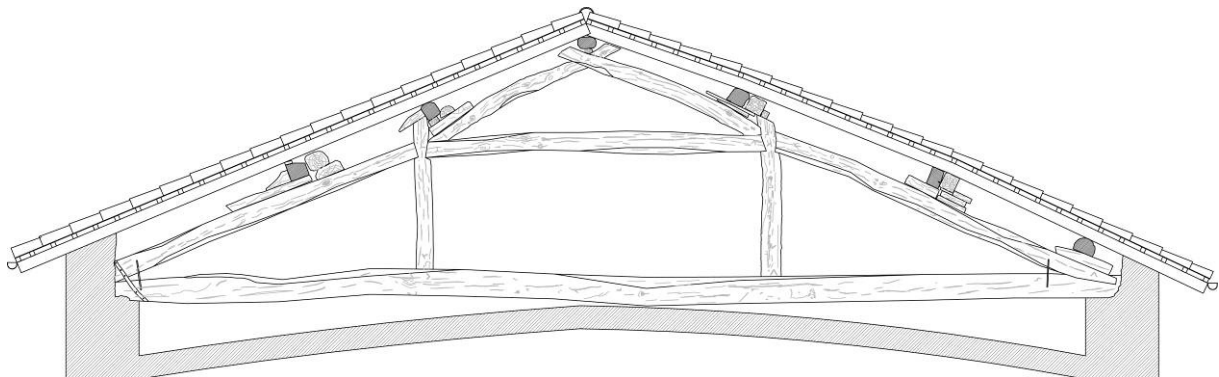
Figure 7: View of truss number 3 (survey by Giorgio Aivazopoulos, Stefania Bertagnolli, Federica Lana, Santo Occhiuzzi, Teresa Oddi and Antonella Semeraro, under the supervision of the author).

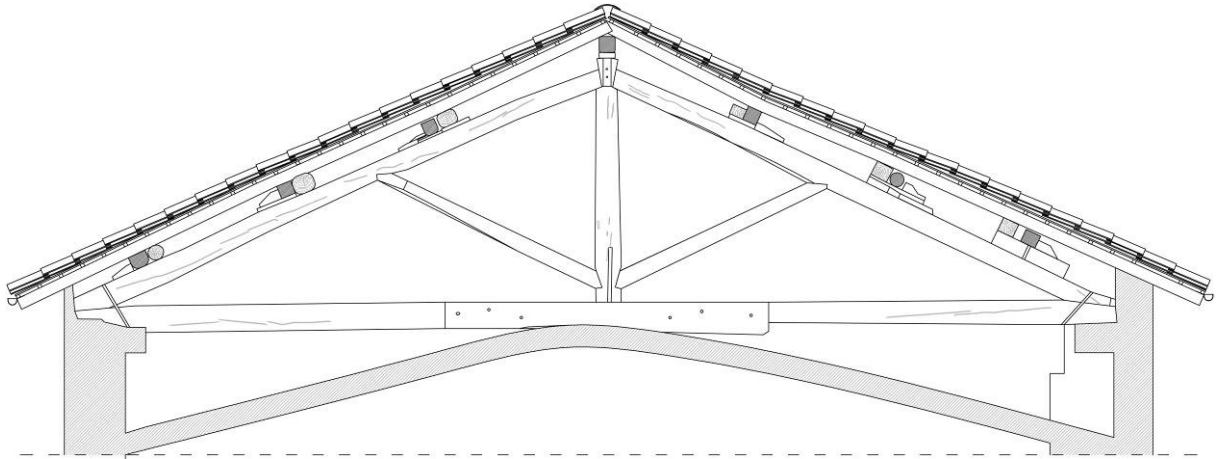
Figure 8: View of truss number 5 (survey by Leandra Farruggio, Eleonora Mitruccio, Salvatore Morgante, under the supervision of the author).

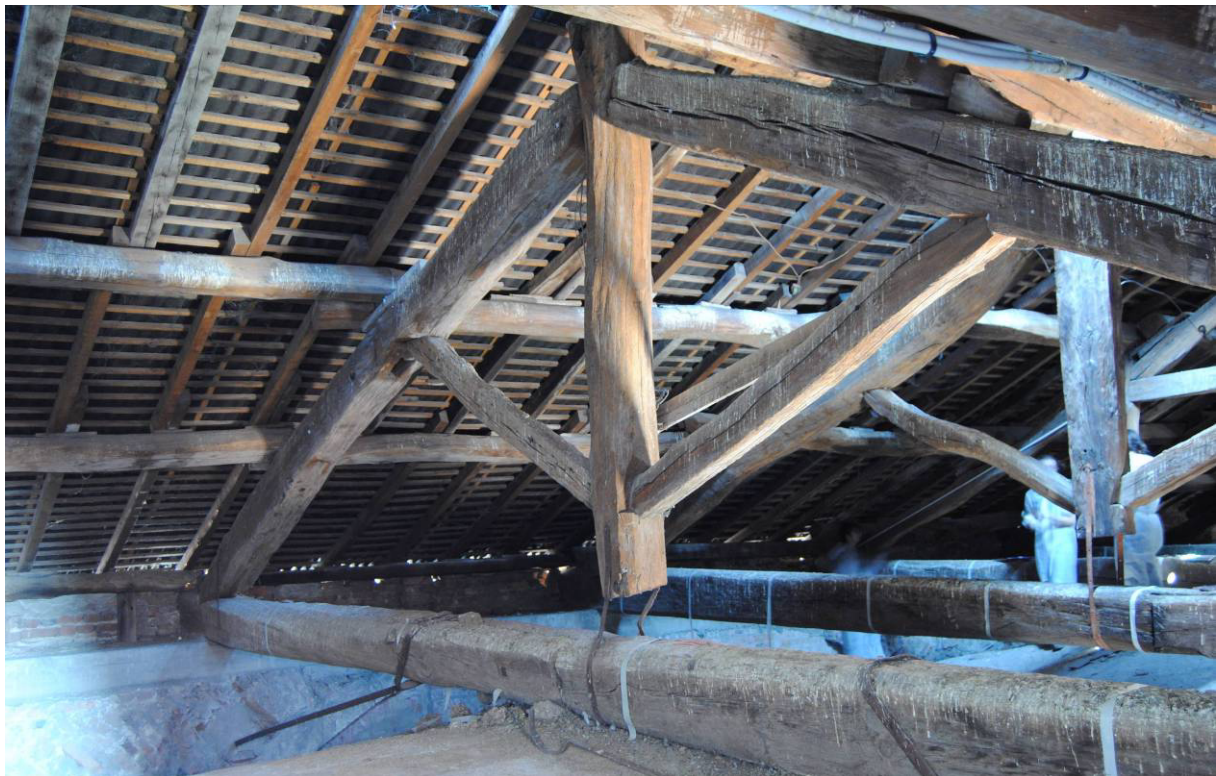
Figure 9: Truss number 1 (photograph by the author).

Both of the rafters of the truss number 1 show signs of a previous use: a mortise analogous to that present in truss number 3. The same type of mortise is present in a purlin placed next to the tiburium; many other purlins show signs of a precedent use, in particular some of them shows signs of a previous halved joint similar to that present in the top joint between the rafters of truss number 3. Therefore we can suppose that a higher number of trusses of the first category was previously present, and we can hypothesize that these constituted the structural system of the roof built together with the present vaults in the 15th century.

One of the trusses had to be built using the tie-beams of the pre-existing trusses as rafters; both of the new tie-beams had to be built assembling two beams and reinforcing the joint with iron bolts with nuts; the joints between tie-beams and rafters had to be reinforced with metal strapping and the king posts linked to the tie-beams with stirrup straps. This description matches perfectly to trusses number 1 and 2.

correspondent vault in the southern aisle was heavily repaired because they was severely damaged, it is likely that the metal rods made by Angelo De Paoli in 1864 are the one still present in truss number 1.

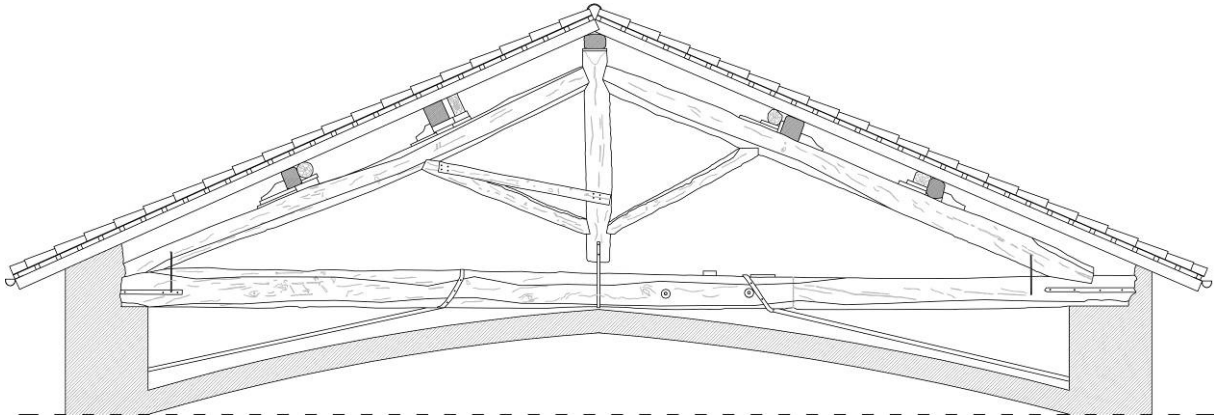
Figure 10: View of truss number 1 (survey by Giorgio Aivazopoulos, Stefania Bertagnolli, Federica Lana, Santo Occhiuzzi, Teresa Oddi and Antonella Semeraro, under the supervision of the author).

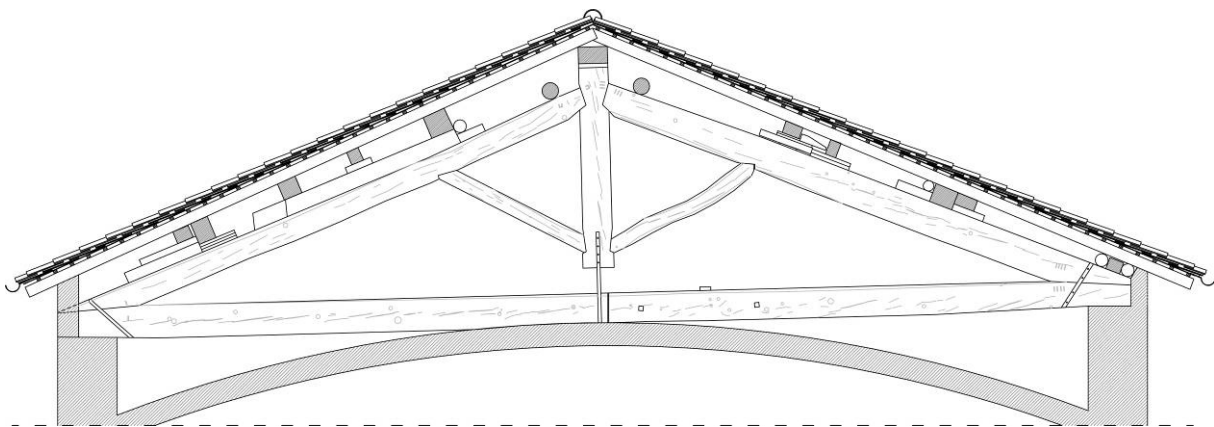
Figure 11: View of truss number 7 (survey by Francesco Ambrosini and Alessandro Cerri, under the supervision of the author).

In the parish archives there are no other documents about repair works to the roof up to the 1860s. The fact that the works of 1835 have been done as urgent and necessary repairs just like the ones of 1828 and by the same master mason leads to conjecture that trusses number 6 and 7 (very similar to trusses number 1 and 2) could have been built during 1828, but further clues should be sought to confirm this hypothesis.

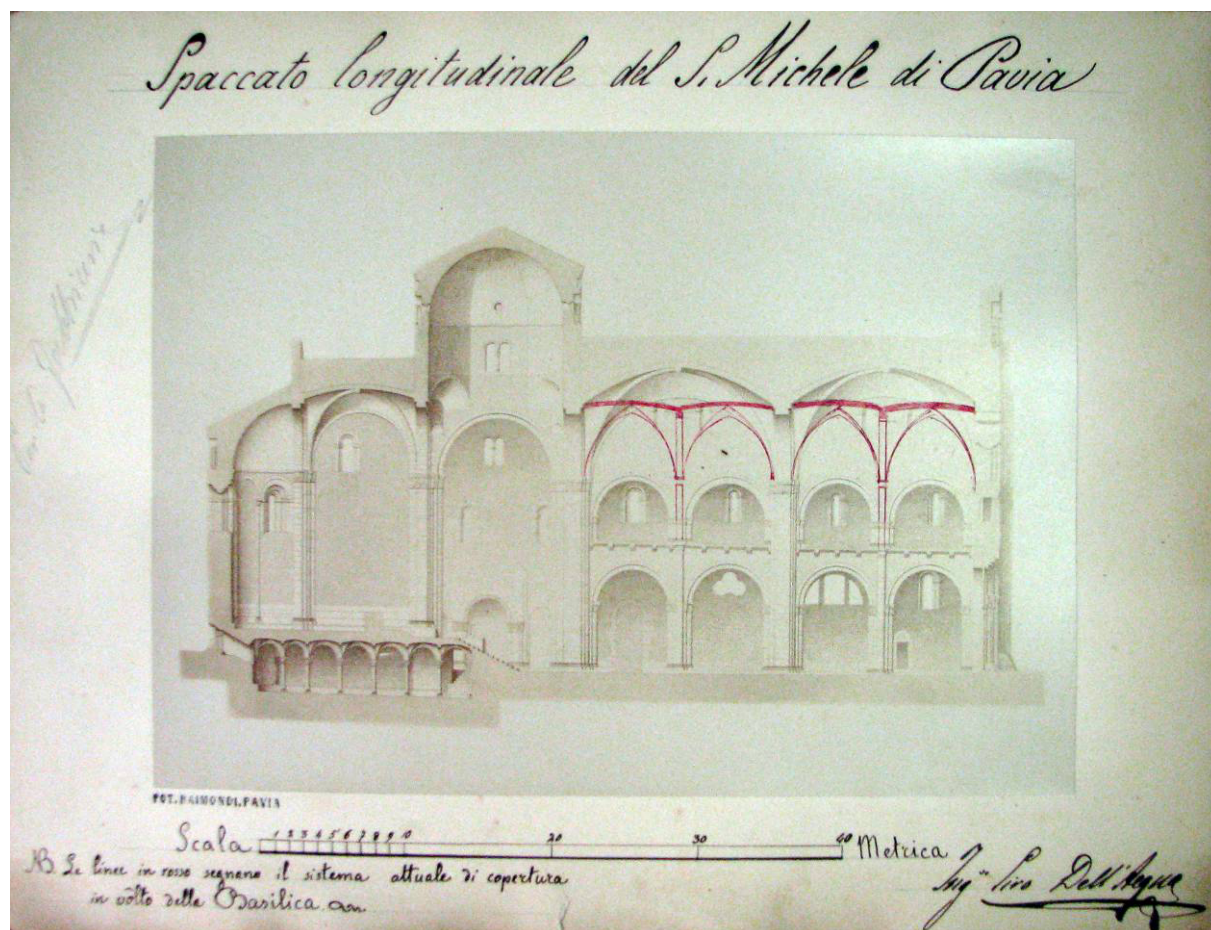
Figure 12: Plan by Siro Dell'Acqua for the demolition of existing vaults (in red) and building of new vaults [8].

In 1873 Siro Dell'Acqua wrote a project report in which he proposed the demolition of the existing vaults of the central nave and the construction of new vaults that were supposed to restore the form of the original ones [8]; in this report Siro Dell'Acqua states that this was his idea since 1866 when he published a paper about the history and restoration of the Basilica [9]. Siro Dell'Acqua's project involved the demolition of the trusses and their substitution with scissor trusses, thus he never planned a systematic work of refurbishment of the roof, but he only designed local interventions waiting to get approval and funding – which he never obtained – needed to implement his idea.
