Article

Integrated Low-Cost Approach for Measuring the State of Conservation of Agricultural Terraces in Tuscany, Italy

Citation: Cambi, M.; Giambastiani, Y.; Giannetti, F.; Nuti, E.; Dani, A.; Preti, F. Integrated Low-Cost Approach for Measuring the State of Conservation of Agricultural Terraces in Tuscany, Italy. *Water* **2021**, *13*, 113. <https://doi.org/10.3390/w13020113>

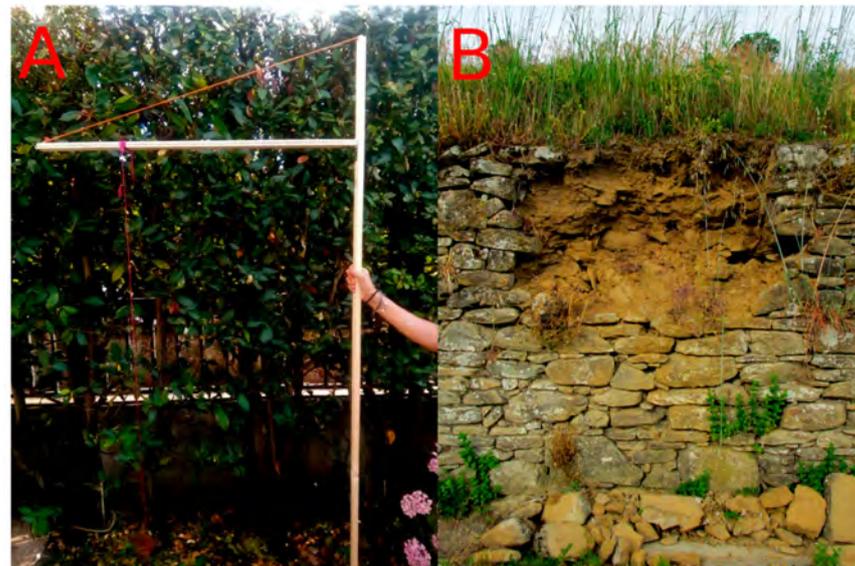
Figure 2. (A) Purpose-built instrument to measure deformation consisting of two graduated wooden strips and a plumb line to carry out horizontal measurements and allow the correct positioning of the instrument. (B) Example of dry-stone wall failure (Mugello area), damage scale 5.

The purpose-built instrument (Figure 2A) measures the orthogonal distance between the deformed portion and the original wall (Figure 3).

To validate the classification schemes introduced above, we first compared the measured deformations using our purpose-built instrument (Figure 2A) to the subjective damage scales (Table 1) assigned to the different dry walls for the Mugello area.

In the present study, we developed a descriptive, efficient damage scale classification scheme that can be used easily in the field. We could show that this subjective classification scheme was consistent with more objective deformation measurements to assess wall damage. Moreover, we designed a very simple and thus easy-to-replicate instrument consisting of graduated wooden rods and a plumb line to acquire objective measurements of deformation.

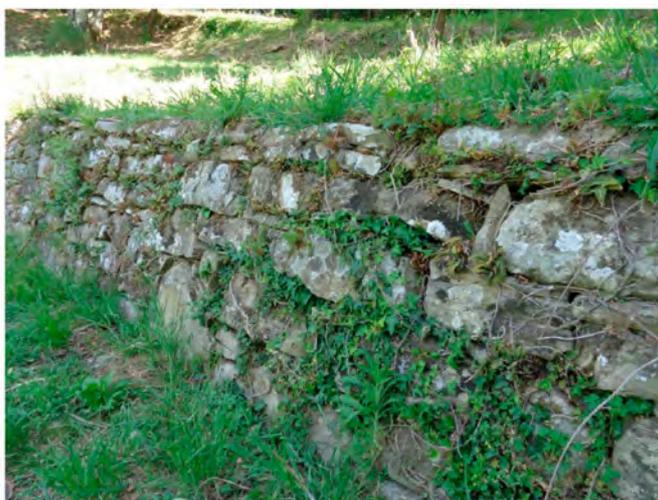
Figure A1. Damage class 1—Regular.

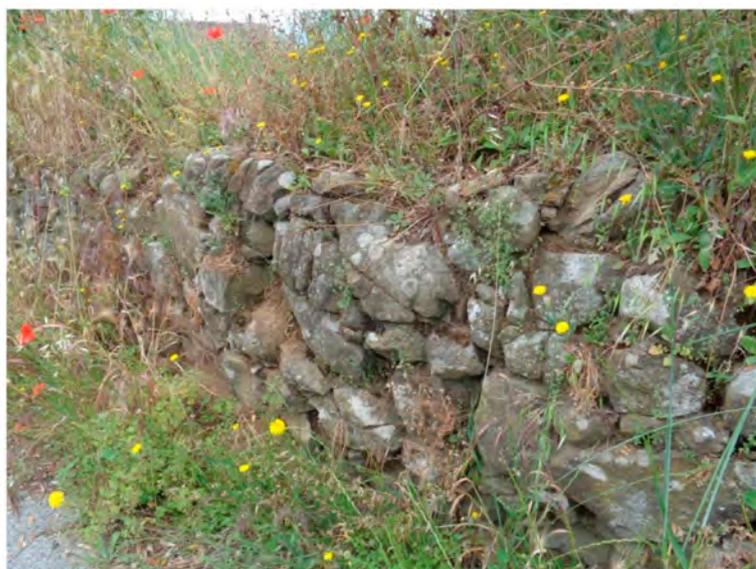
Figure A2. Damage class 2—Bulging in central and upper portion.

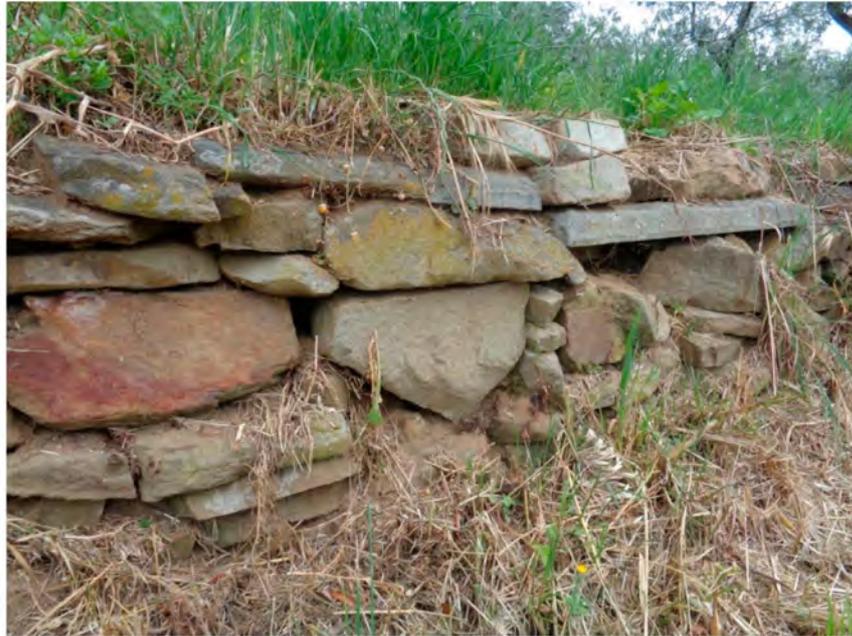
Figure A3. Damage class 3—Bulging in downside.

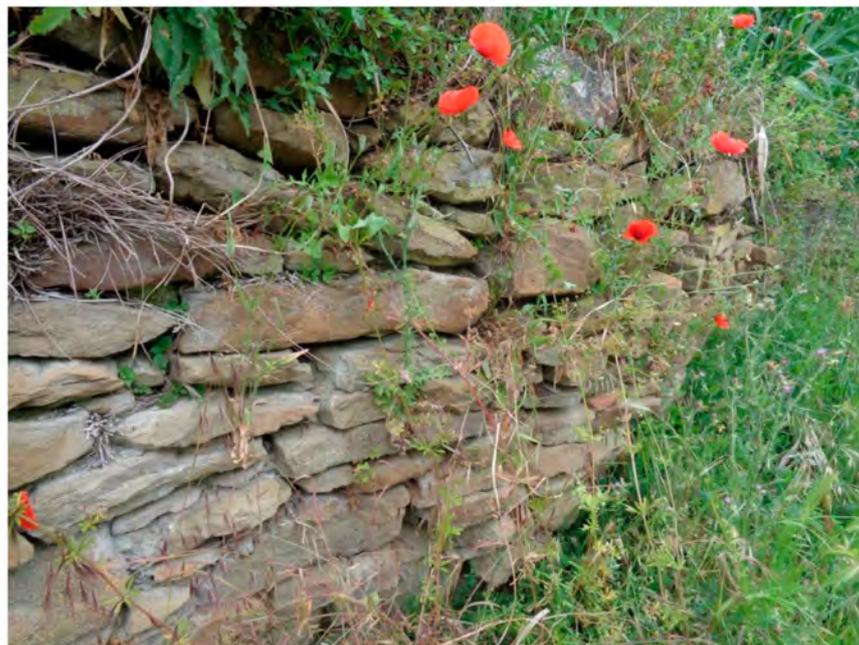
Figure A4. Damage class 4—Whole wall bulging, translation.

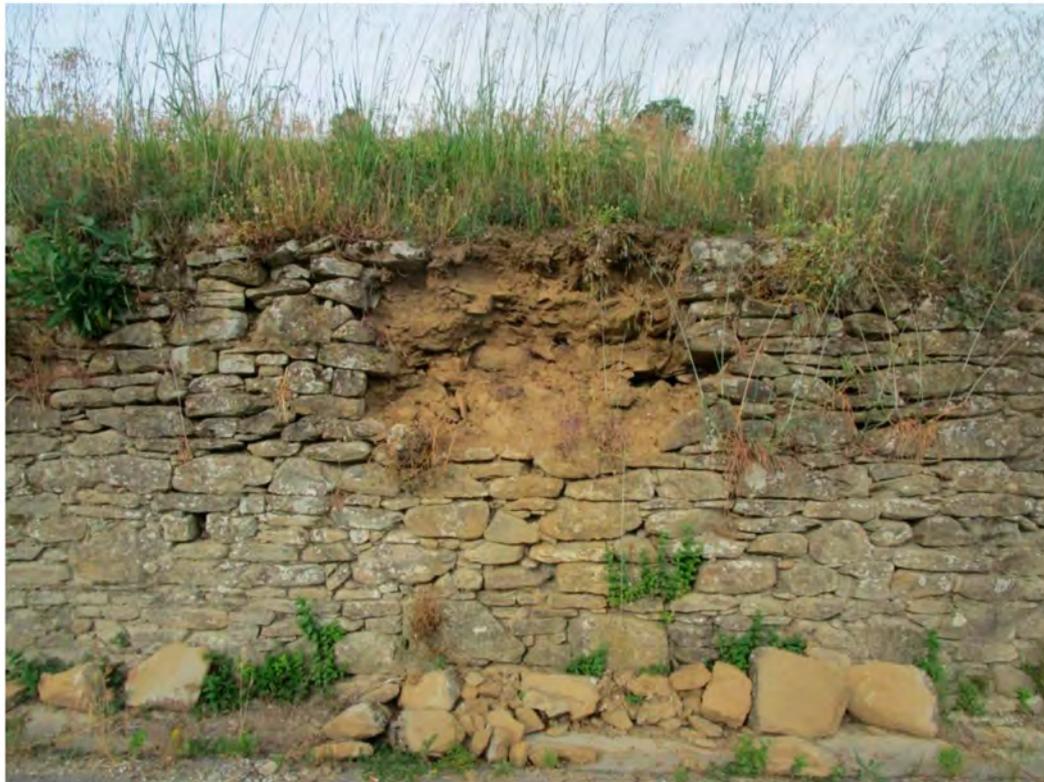
Figure A5. Damage class 5—Failure.

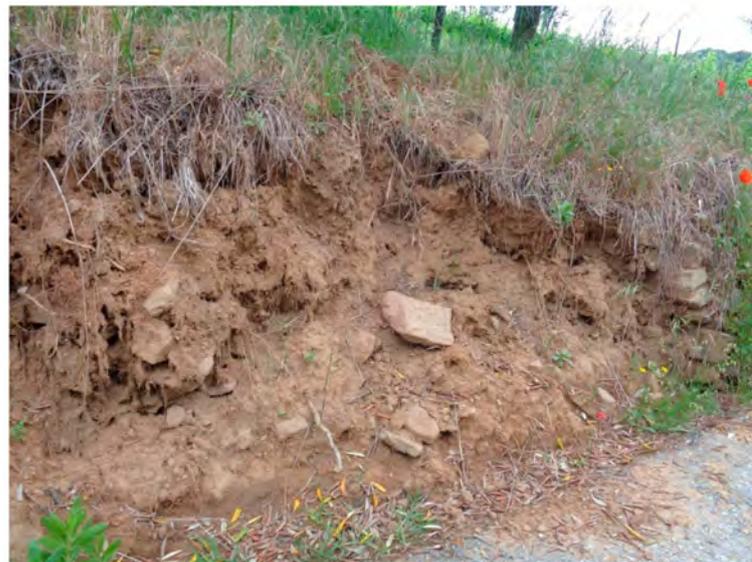
Figure A6. Damage class 6—Dry-stone wall missing.
