Uffizi Gallery monitoring for IAQ assessment

Abstract. In museums, poor indoor air quality combined with unsuitable thermal and hygrometric conditions can affect the visitors and staff well-being as well as cause the deterioration processes of the exhibit objects. In order to assess indoor air quality of the museum, a survey was carried out in some rooms of the Uffizi Gallery of Florence by the researchers of the Laboratory of Environmental Physics of the University of Florence. Indoor temperature, relative humidity, chemical and microbiological pollutants were sampled, and the results analyzed and discussed. To do that a general methodology of investigation and evaluation of the results was defined and applied to several rooms of the Gallery. The presence of critical pollutant concentration was underlined and proper investigations on the HVAC system were scheduled. In this paper the results regarding a representative room are shown and discussed.

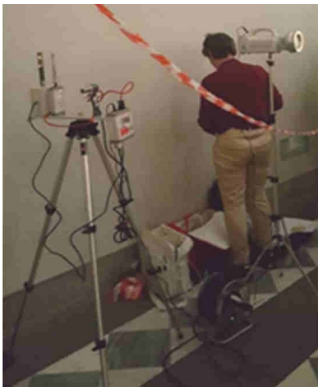
Fig. 8. Microclimatic station to sample dry and wet bulb temperature, air velocity, and CO₂ concentration (left). Surface air system impactor for active biological analysis - TBL and molds (right).

To sample environmental parameters (dry and wet bulb temperature, air velocity and CO₂ concentration), a microclimatic station with datalogger, positioned to a high of 1,6 m from floor, collecting samples every minute for 2 hours, was used with the following probes:

- psychrometer (accuracy $0,10^{\circ}\text{C} \div 0,13^{\circ}\text{C}$ with air temperature $0^{\circ}\text{C} \div 20^{\circ}\text{C}$; 2% (UR $15 \div 40\%$); 1% ($40 \div 70\%$); 0,5% ($70 \div 98\%$); measure range $t_{db}: 25 \div 150^{\circ}\text{C}$, $t_{wb}: 0 \div 60^{\circ}\text{C}$, RH: $0 \div 100\%$);
- anemometer (accuracy 0,05 m/s ($0 \div 0,5$ m/s); 0,1 m/s ($0,5 \div 1,5$ m/s); 4 % ($>1,5$ m/s) measure range $0 \div 20$ m/s);
- CO₂ probe (accuracy 3% measure range, measure range $0 \div 3000\text{ppm}$).

In Figure 8, the microclimatic station and the surface air system impactor for active biological analysis are presented.

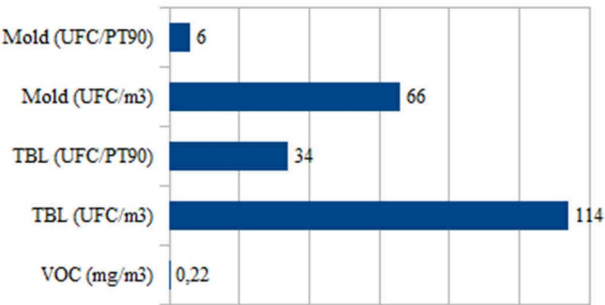
Fig. 10. Values for biological and chemical pollutants sampling in room 41 of the Uffizi Gallery.
Legend: TBL=Total Bacterial Load, VOC=Volatile Organic Compounds.

In Table 3, ranges of acceptable level for VOCs are reported. The values compared with the recommended limits shows acceptable concentrations of the pollutants. For VOCs concentration, European Standards suggest limit values for total VOCs; those can be used as reference values for museum IAQ assessment.

These guidelines suggest a total VOCs concentration range between 0,200 and 3 mg/m³ as acceptable level; moreover, any component can't exceed 50% of the value identifying its class. Some VOCs classes were not detected (halogen-aliphatic, halogen-aromatic, halogen-unsaturated, nitrogen-aromatic, oxygen-acid, ether, oxygen-acid, phenol, sulfur-mercaptan, sulfur-sulphide). For the other VOCs classes the cut-off value of the compound was set at 1% [17]; it represents the pollutant concentration in the compound that can be considered significantly present. The sum of the concentration values of the individual VOCs classes highlights the more present classes in the monitored rooms, such as the aldehydes and alcohols.

- aldehydes and alcohols are the most present VOCs classes; in addition to the pollutants associated with furnishings and cleaning products, the concentration of these pollutants can be also related to the presence of visitors;

- the monitored room can nevertheless be considered as a comfortable one as regards VOCs concentration in accordance with the European guidelines limit values;

- as regards biological pollution the following observations can be made: total bacterial load belongs to the “low” pollution level (<500 CFU/m³) and molds concentration belongs to the “low” pollution level (<100 CFU/m³). Nevertheless, sampled values point out that biological and chemical indicators of indoor air quality should be taken constantly under control;

- check the compositions of detergents and disinfectants for the presence of VOCs;
- check how to use sanitizers and disinfectants;
- check the composition of glues and paints used for any maintenance interventions in relation to the presence of VOCs;

- as for the biological pollution, sampling of specific pollutants must be carried out both in the air ducts and in the filters before and after the maintenance procedures;

- specific contaminants must be monitored to avoid deterioration effects on the exhibited artworks. As for the VOCs pollution a deep investigation of the more representative classes is suggested at least for 8 hours due to the collected complaints of the workers in the museum in accordance to the DL 81/2008 and ACGIH (American Conference of Governmental Industrial Hygienists) that define both threshold Limit Value - Time Weighted Average - and Threshold Limit Value - Short Term Exposure Limit - that can be taken as reference limits respectively for workers and visitors of the Uffizi Gallery.
