# Decay Process of Serpentinite: The Case of the San Giovanni Baptistery (Florence, Italy) Pavement

**Abstract:** Serpentinite is a low-grade metamorphic rock derived from the transformation of ultramafic rocks. Mainly because of its aesthetic characteristics it has been widely used as a building and ornamental stone. “Verde di Prato” is the most common local name used in Tuscany to refer to this type of rock, historically quarried in this area and used for many centuries in a large number of monuments of this region. In this paper, we report the results of a study carried out on the serpentinite from the pavement of the Florence baptistery, to properly characterize it from a physical point of view, describe the rock conservation state, and understand the phenomena responsible for its decay. The studied rock displays numerous forms of decay including fractures, loss of material, erosion, discolouration and efflorescence. X-ray diffractometer analyses of the efflorescence revealed the presence of numerous salts whose formation can be imputed to multiple, possibly concomitant, causes such as the high relative humidity and the variation of inside temperature, the presence of concrete

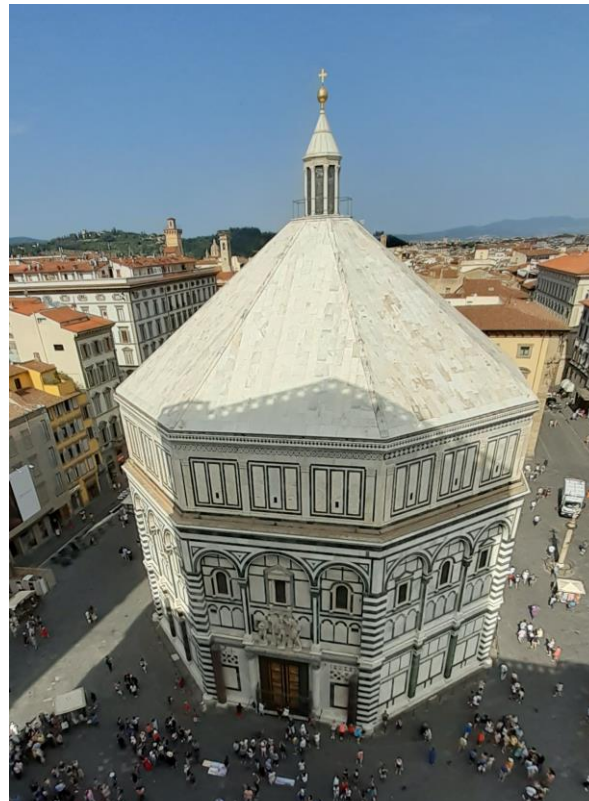
**Figure 1.** The Baptistery of San Giovanni as seen from the terrace of the Santa Maria del Fiore cathedral.

The baptistery of Florence (Figure 1) is part of the great monumental complex of Santa Maria del Fiore which comprehends the namesake cathedral, the baptistery, and the Giotto Bell Tower; it stands between Piazza del Duomo and Piazza di San Giovanni, in the historic centre of Florence which has been a UNESCO World Heritage Site since 1982. A special, almost magical, relationship exists between the baptistery and the Florentine people; it was intended for the liturgical function of baptism, a rite which large crowds attended, but following several authors e.g., [4] in the 10-11th centuries it acted also as Florence’s cathedral. Numerous personalities such as the poet Dante Alighieri and members of the Medici family were baptized in this baptistery. The age of the baptistery is still so debated and controversial that Toker [5] defined it as “among the most enigmatic buildings in Europe”; it is an early Christian or a medieval building? did the monument originate as a pagan temple or as a church? In the opinion of the architect Piero Degli Innocenti [6], who has spent a long time studying the matter, the present baptistery was built as a memorial to the defeat, in A.D. 406, of Radagaiso, a Gothic king who had invaded Roman Italy, by Stilicho, a military commander in the Roman army; later (1059), the building was consecrated to Christian worship by Pope Nicholas II [4,7].

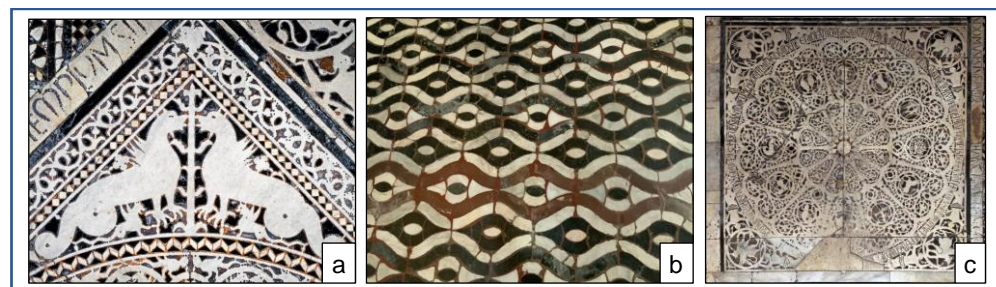
**Figure 3.** The pavement of the San Giovanni baptistery. (a) Detail showing fantastic animals facing one another (Archive of the Opera di Santa Maria del Fiore); (b) Detail of the three-colours geometric motif; (c) The zodiac showing in its centre the image of a flaming anthropomorphic Sun; the latter is surrounded by the signs of the constellations, inserted in a cosmic circle which in turn is inscribed in a square.

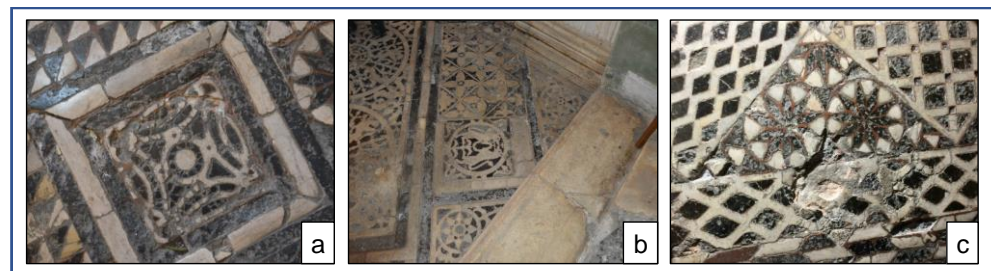
**Figure 4.** Fracture (a,b), loss of material (a–c), discolouration (b), differential erosion (a,c), lacunae (c).

The baptistery pavement, although numerous restorations, interventions and replacements of inlays have been made over the years, displays many forms of decay; the different stone inlays are characterised by discolourations, fractures, loss of material, differential erosion, lacunae (e.g., Figure 4).

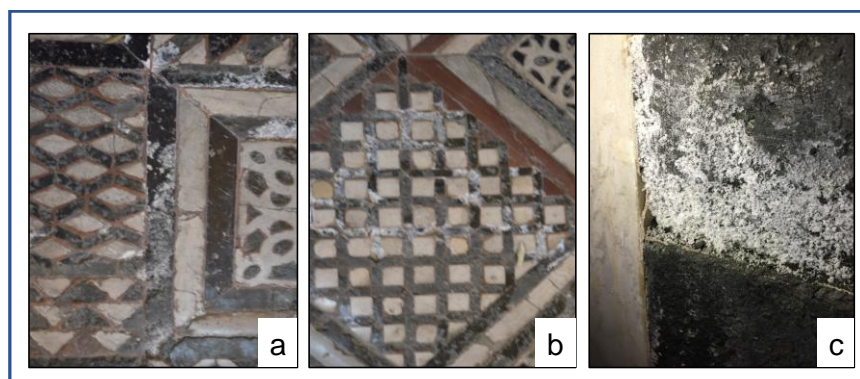
**Figure 5.** Details of the efflorescence on the serpentine floor (a,b) and wall (c).

Furthermore, on the serpentinite surface, white efflorescence is visible (Figure 5a,b) unlike on the marble and limestone. A careful observation of the entire pavement showed that this phenomenon is particularly evident in the SE sector. Consequently, our study was mainly aimed at the serpentinites of this area (Figure 2) located between the southern and eastern doors, close to the baptismal font; here the efflorescence is also abundant on the wall (Figure 5c).

Although used in indoor conditions, the studied serpentinites display numerous forms of decay; in particular, we studied the efflorescence, clearly visible on the green inlays (Figure 5); following several authors e.g., [22,23], this form of decay, which affects the integrity and durability of the materials and their aesthetics, is mainly caused by the infiltration of water through the building walls, and successive crystallisation of the carried dissolved ions. Salt crystallisation is considered one of the most destructive processes of stones as it is responsible not only for aesthetical problems but also for extensive decay when it occurs as subefflorescence [24]. This is particularly true in rocks as the studied serpentinites having relatively high porosity. The growth of salts causes stress inside the stone with a consequent additional form of decay. In the case of the studied serpentinites, we can hypothesize an important role of salts in determining the observed loss of material, discolouration, and fractures. However, as there are several factors responsible for the degradation of the pavement, it is very difficult to understand what the contribution is of each one.

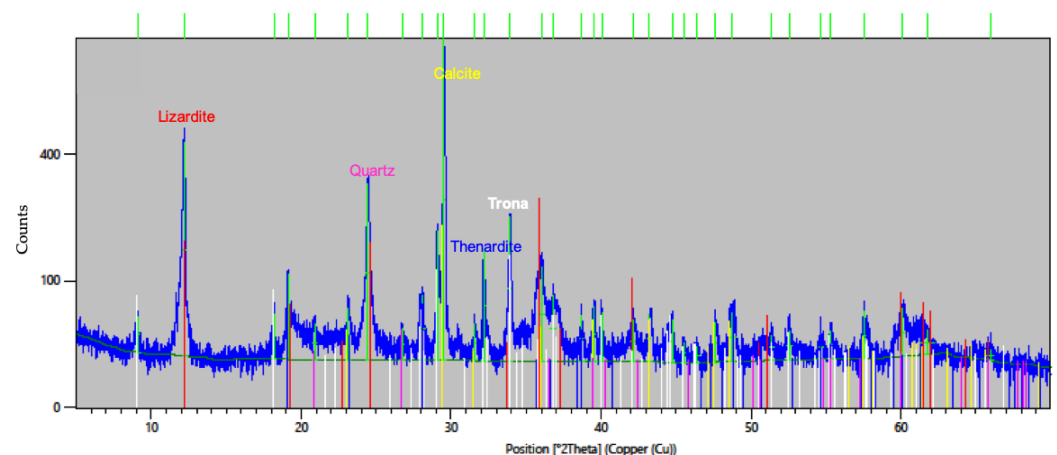
**Figure 6.** Representative X-ray diffraction pattern (sample EF 3). The different identified compounds are reported in correspondence with the main peaks.

The XRD (Table 1 and Figure 6) analyses of the efflorescence show the presence of salts such as trona [(Na<sub>3</sub>(CO<sub>3</sub>)(HCO<sub>3</sub>)<sub>2</sub>(H<sub>2</sub>O))] and/or thenardite (Na<sub>2</sub>SO<sub>4</sub>). The sample EF 6 contains a very small quantity of gypsum [(CaSO<sub>4</sub>·2(H<sub>2</sub>O))]. The XRD analyses also revealed the presence of lizardite, coming from the underlying serpentinite, calcite, quartz and feldspar coming from the mortar holding the green tiles together, and from the surrounding tiles. The efflorescence is not visible on the surface of the other rocks used on the floor; analyses were made also on powders scraped from the marble and limestone, but we found only calcite and gypsum on the marble, calcite, quartz, and gypsum on the red limestone. The EF 7 sample was collected from the SE serpentinite wall. In addition to trona, in this sample also niter (KNO<sub>3</sub>) and darapskite [Na<sub>3</sub>(NO<sub>3</sub>)(SO<sub>4</sub>)·H<sub>2</sub>O] were detected.

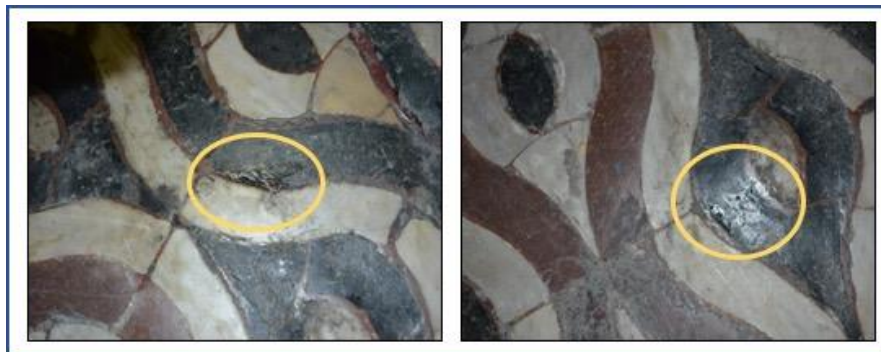
**Figure 7.** Detail of the baptistery pavement showing the water rising from the subsoil (yellow circles).

In the San Giovanni baptistery, the temperature often undergoes daily and seasonal changes, the relative humidity is always high (water rising from the subsoil is visible in some areas of the floor, see Figure 7), testifying to inappropriate conservative microclimate conditions.
