### **Experimental evaluation of in-plane shear behaviour of masonry walls retrofitted using conventional and innovative methods**

Experimental evaluation of in-plane shear behaviour of masonry walls retrofitted using conventional and innovative methods / A. Borri; M. Corradi; A. Vignoli. - In: MASONRY INTERNATIONAL. - ISSN 0950-2289. - STAMPA. - 21:(2008), pp. 29-42.

# Experimental Evaluation of In-plane Shear Behaviour of Masonry Walls Retrofitted Using Conventional and Innovative Methods

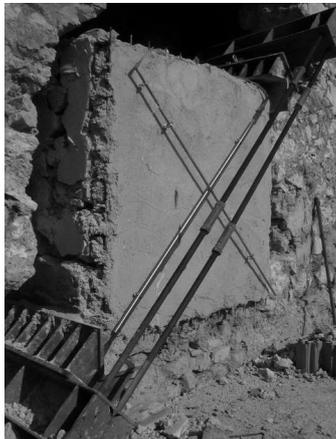
Figure 1 Concrete jacketing applied to a masonry panel

Strengthening by jacketing of rubble or cut, dimensioned stone masonry walls is an effective way to increase walls' shear resistance and lateral stiffness. Four masonry panels were reinforced with this method in order to compare the results with the other retrofitting methods applied to the same building and masonry wall. The concrete was applied by shotcreting and a total thickness of coating of 40-50mm was used (Figure 1). The coating was applied in two layers. After completing the first layer of shotcrete the steel (FeB 44K type) mesh (100 x 100mm, rebar diameter 6mm) was installed and then the second layer was applied. The steps for ferrocement reinforcement, applied to rubble or cut-stone masonry walls, were:

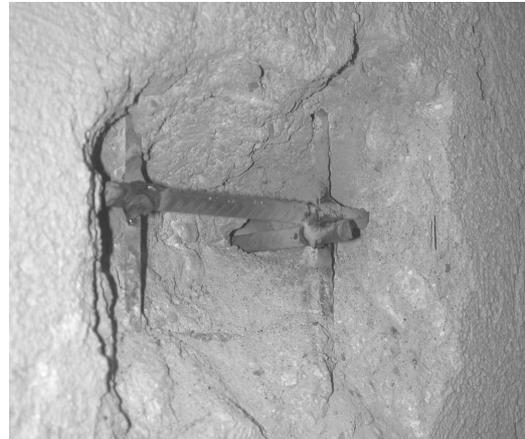
Figure 2 Detail of connection between anchor bars and ferro-cement

- removal of existing plaster;
- loose stones were first removed and then fixed with cement-based mortar.
- through holes are drilled for  $\phi 6\text{mm}$  rebars anchors  $9/\text{m}^2$  (Figure 2).

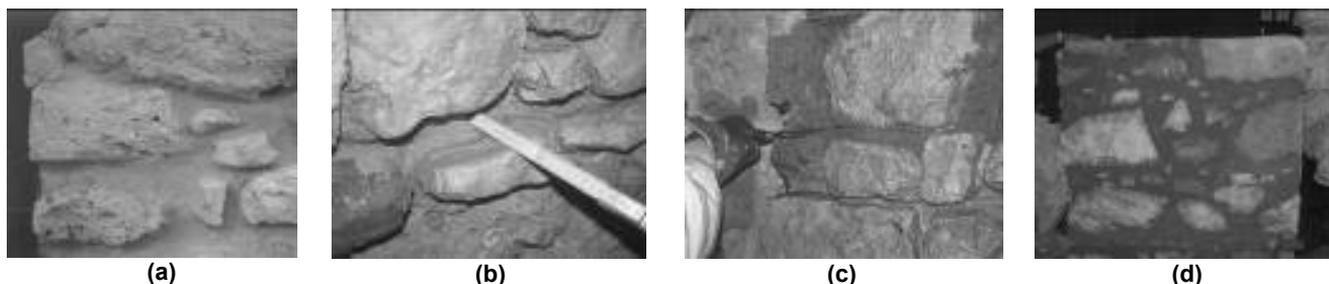
**Figure 3** (a) Joint after cleaning; (b) detail of the joint depth; (c) first layer of repointing; (d) after intervention

A complementary technique to the grouting is the deep repointing of mortar joints with an appropriate mortar. Deep repointing is a repair and preventive technique for double leaf masonry walls carried out on the two faces of the masonry. These tests are described in detail in [14]. The aim of this repair is to bond the stones of the external leaves, particularly in the case of badly bonded irregular stones and to obtain an external confinement of the wall in order to increase the masonry shear strength. The repointing can be carried out also in conjunction with grout injection. The choice of the mortar to be used for repointing is also difficult; in fact, to have good durability, this mortar must be compatible with the existing masonry from the physical, chemical and mechanical points of view. In the case of deep repointing, the mortar should be strong enough but not too stiff, and have good bond with the stones and with the existing mortar (Table 2).

In fact, the aims of the deep repointing are the following: (i) to replace the damaged mortar on the wall surface to a depth of 70-80mm in order to adequately bond in-plane the stones, (ii) to confine the wall externally as a complement to injection, (iii) to provide a better penetration of the grout while avoiding leakage to the exterior. When the repointing is successful, 70+70mm of the wall section (in the case of two leaf walls the thickness varies from 400 to 550mm) are well bond together and constitute good confinement for vertical loads. This technique can ensure a uniform distribution of the material in the external leaves. Injection is not always successful if grout cannot penetrate inside the masonry and connect the two leaves; in many cases transversal connectors, are needed instead. Regardless of this, injection is necessary and effective when diffused cracks are present.

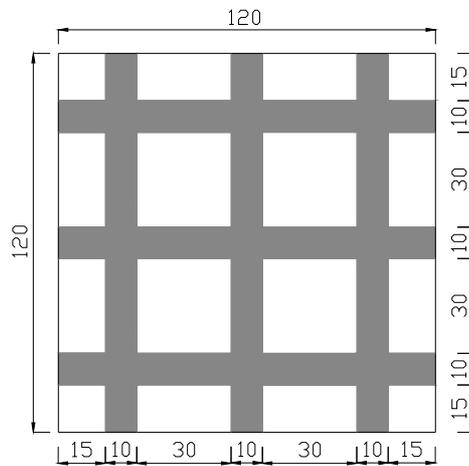
**Figure 4 FRP jacketing (FV type): fibre layout (dimensions in cm)**

The FRP laminates (FV type) involved in the experimental work consist in glass unidirectional fibres embedded in epoxy resin, according with the wet lay up technique. Strengthening with one sheet of GFRP was carried out on both sides of the panel, following the scheme presented in Figure 4.

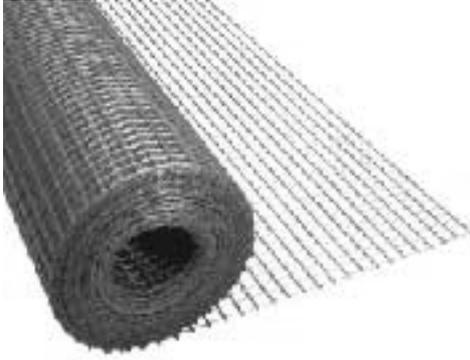
Figure 5 GFRP mesh (IG type)

The GFRP mesh (IG type) has a thickness of 0.67mm and has an opening of 10mm in longitudinal direction and 9mm in transversal direction (Figure 5). The main mechanical characteristics, declared by the manufacturer, are shown in Table 4. A coating made of hydraulic based mortar was used. The average compressive strength of the mortar was  $3.3\text{N}/\text{mm}^2$ . After the application was finished, each grid

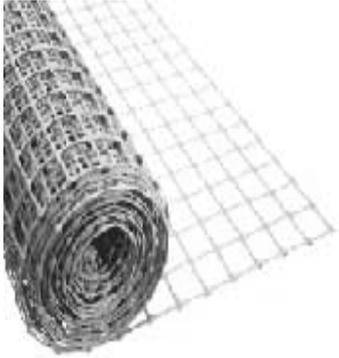
Figure 7 Polypropylene mesh

While extensive research was conducted for retrofitting of masonry structures using FRP, much less was reported for retrofitting of unreinforced masonry structures with polypropylene nets (Figure 7).

This research investigated the effectiveness of retrofitting on two sides of masonry panels. The mechanical characteristics of the polypropylene net with an approximate mesh size of  $30 \times 45\text{mm}$ , produced by Tenax, are given in Table 5. Through holes were drilled for  $\phi 12\text{mm}$  GFRP rebars anchors at  $5/\text{m}^2$ . Through anchors wrapped with GFRP sheets were fixed to the polypropylene reinforcement using epoxy-resins as shown in Figure 8. The same hydraulic mortar used for FRP jacketing (IG type) was applied. The coating was applied by shotcreting and a thickness of coating of 15-25mm was used (approximately 15mm for brick panels and 25mm for stone panels).

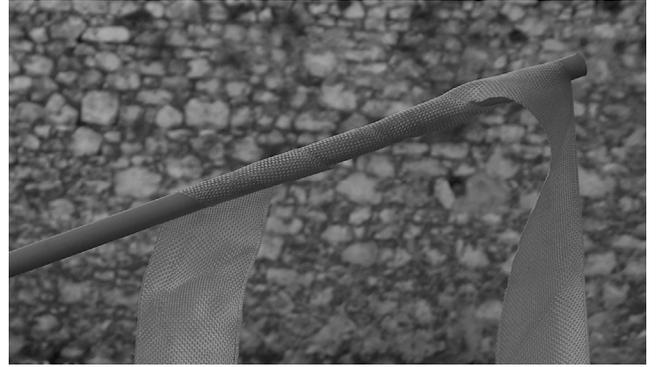
Figure 6 Connection between GFRP bar and sheet

For both uni-directional glass fibre and GFRP mesh reinforcement, through holes were drilled for  $\phi 12\text{mm}$  GFRP rebars anchors at  $5/\text{m}^2$ . Rebars were wrapped with GFRP sheets connected to the external reinforcement (Figure 6).

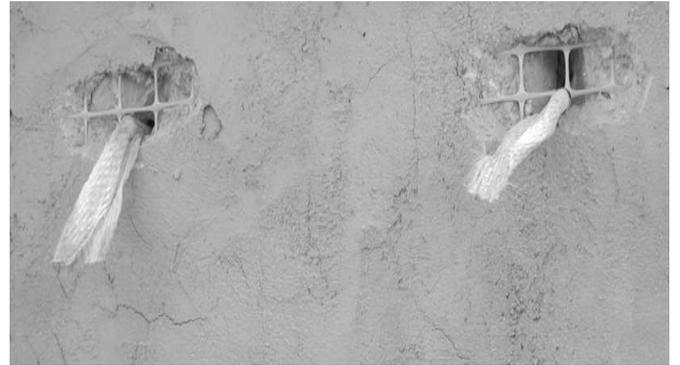
Figure 8 Connection between through anchors and polypropylene reinforcement: bars are wrapped with GFRP sheets and fixed to the polypropylene mesh using epoxy-resins

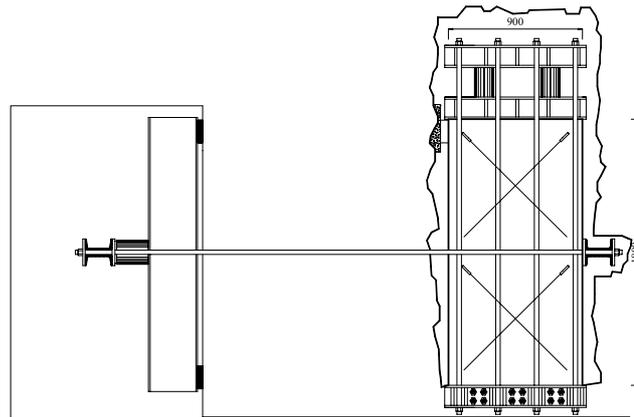
Figure 9 Shear compression test layout (dimensions in mm)

Shear-compression tests (Figure 9) were carried out on panels of 900 x 1800mm dimension with thickness variable from 240 to 700mm. During the test, the masonry was subjected to a vertical constant stress  $\sigma_0$  and simultaneously to an horizontal shear load  $T$  in the centre of the panel.

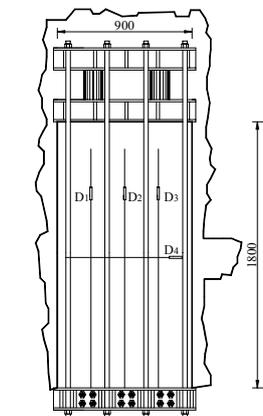
Figure 10 Compression test layout with position of the inductive transducers (dimensions in mm)

A compression test is usually carried out before the shear-compression test on the panels without reaching the failure, in order to determine first some masonry parameters such as the elastic modulus and the Poisson's ratio (Figure 10). For a more detailed description of the tests, see [12] and [15].

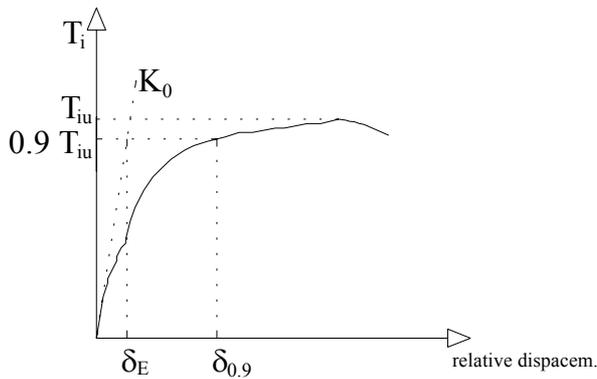
Figure 11  $\delta_E$  calculation procedure

where  $d$  and  $h$  are the thickness and height of masonry panel;  $E$  is the elastic modulus obtained from the compression test.  $\delta_E$  is the relative horizontal displacement between bottom and middle point of the panel assuming a linear elastic behaviour and it is calculated as indicated in Figure 11.

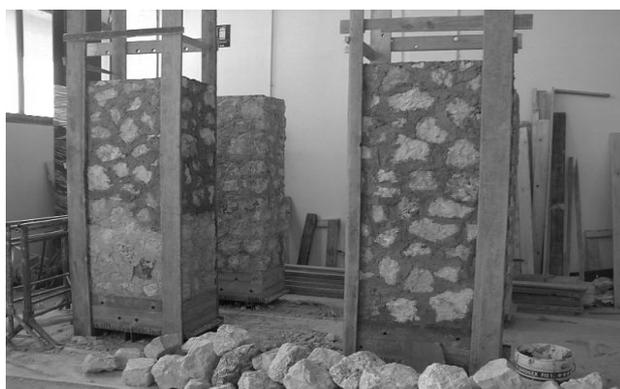
Figure 13 Panels built in the laboratory

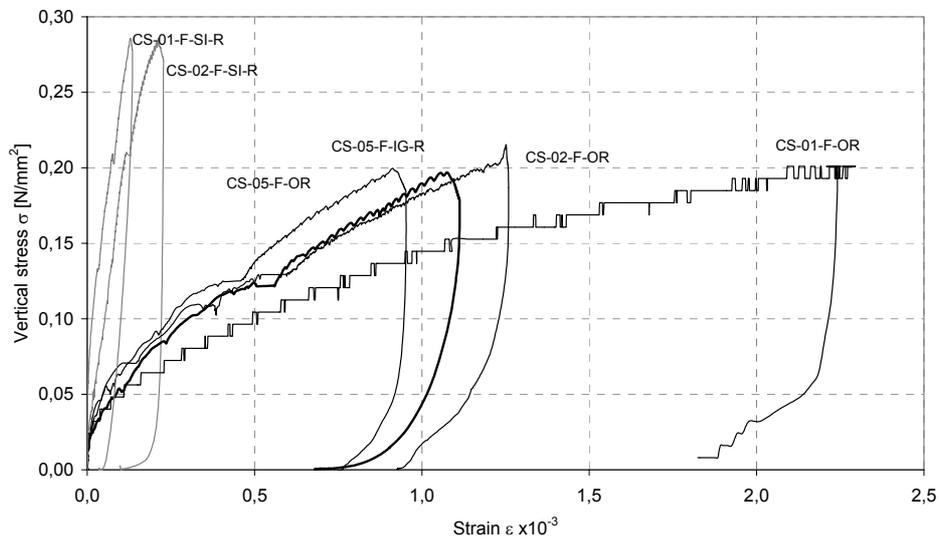
Figure 14 Compression tests: stress-strain plot for panels tested in-situ

Considering the notable variations in results typical of tests on masonry, the scattering of the Young modulus results obtained with the in-site experimental work is not very high. The average values of Young modulus  $E_1$  and  $E_{aver}$  are respectively 463 and 301N/mm<sup>2</sup>.

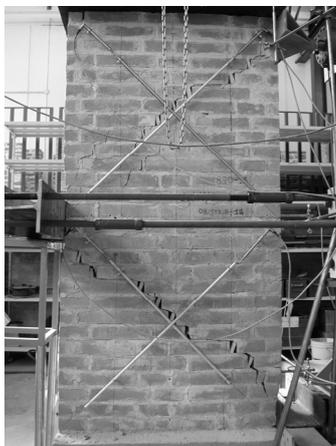
Figure 15 Unstrengthened brick panel: failure mechanism

Solid brick panels, although stepped shear friction cracks were observed, failed due to shear slide at the bed joints (Figure 15), with a characteristic shear strength  $\tau_k$  of  $0.188\text{N/mm}^2$  and a shear modulus  $G$  of  $207\text{N/mm}^2$ . The test results are compared in Table 7.

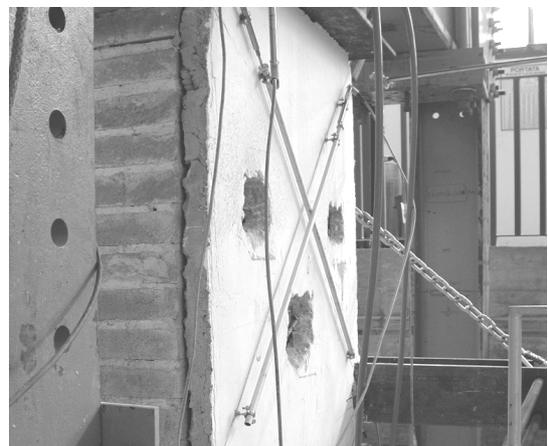
Figure 16 Ferro-cement: failure mechanism

and for repair, but it causes very high increases of shear stiffness ( $\tau_k = 0.205\text{N/mm}^2$ , +127%;  $G = 630\text{N/mm}^2$ , +472%). For tests TC-31-L-IT-P, TC-37-L-IT-R and TC-44-L-IT-R, no clear cracks were observed and the failure was caused by a debonding of concrete jacketing from masonry surface (Figure 16).

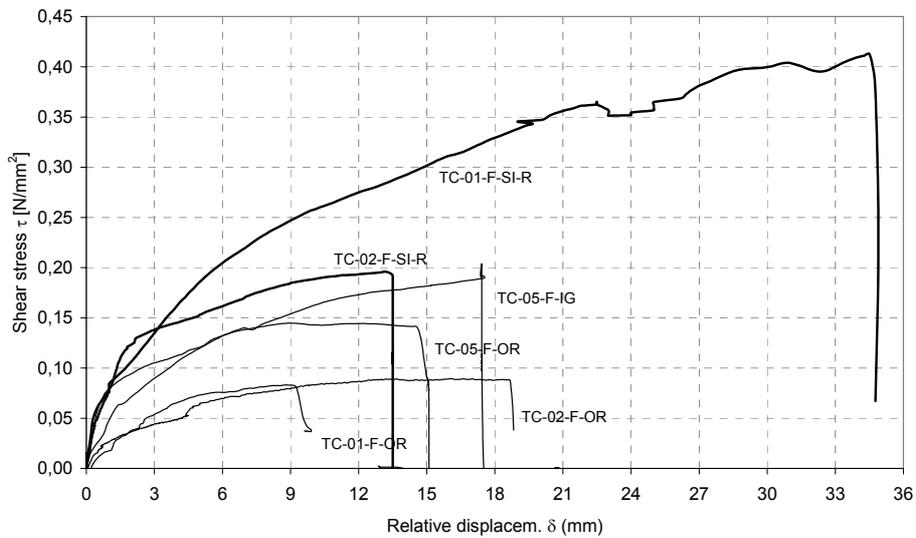
Figure 17 Shear-compression tests: stress-strain plot for panels tested in-site

The results obtained for the shear-compression tests carried out on panels repaired by means of injection and deep repointing showed significant high increases both in terms of shear strength  $\tau_k$  (+362%) and stiffness  $G$  (+362%) compared to the same un-strengthened panels. However, it must be pointed out that the presence of cracks (these cracks were caused by the initially tests on the same un-strengthened panels) facilitated the distribution of the injected grout within the panels. The results are shown in Table 7 and in Figure 17.

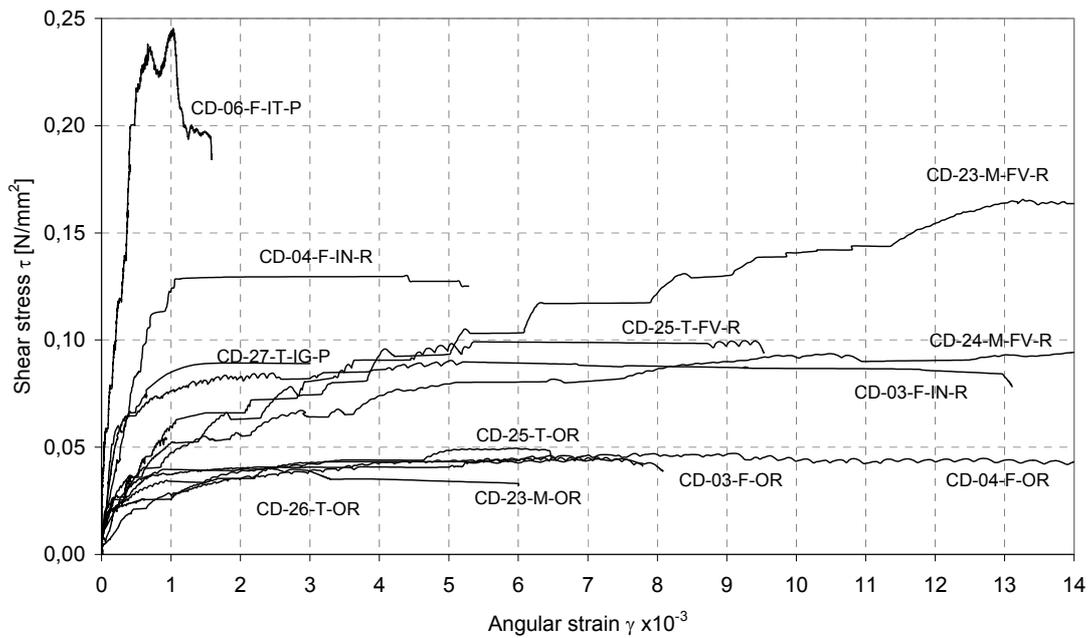
**Figure 18 Panels tested in-site: shear stress vs. angular strain**

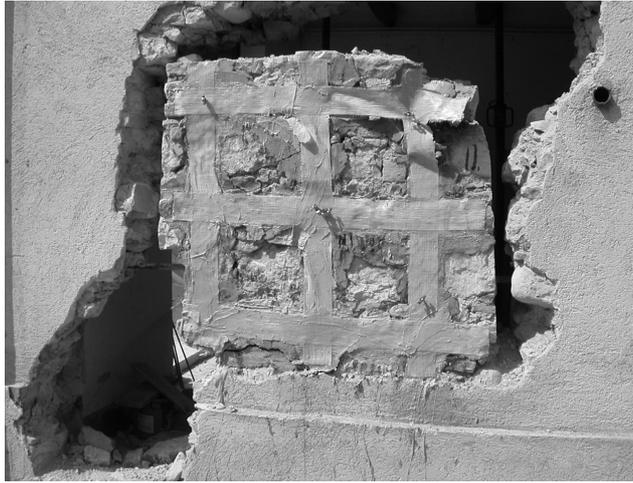
**Figure 19 A panel retrofitted with GFRP sheets**
