Old interventions and potential new treatments for Maya mural paintings in Tulum (Mexico)

KEYWORDS: Maya paintings, previous interventions, polymers, microemulsions

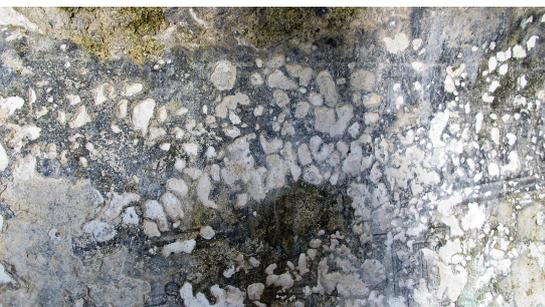
Figure 3
Alveolar decay

and decay effects, not all of which are yet fully understood. A very specific form of decay is occurring in Tulum, which is not found as extensively at surrounding sites. It has been described as alveolar decay or Liesegang patterns (Rodríguez-Navarro et al. 2002) and includes the preferential decay of areas of the lime-based plaster, following concentric shapes or lines, in which some lines seem to be case hardened, while the adjacent lines are decayed (Figure 3). In other areas around these losses, the plasters are extremely hard. Analyses and characterization of alveolar decay on mortars and renders are still underway.
