### **The Church of Meryem Ana in Göreme, Cappadocia, correct documentation for a meaningful heritage at risk**

The Church of Meryem Ana in Göreme, Cappadocia, correct documentation for a meaningful heritage at risk / Maria ANDALORO; Tatiana PIGNATALE; Giorgio VERDIANI. - ELETTRONICO. - 1:(2014), pp. 1-11. (Intervento presentato al convegno 18th International Conference on Cultural Heritage and New Technologies tenutosi a Vienna nel 11-13 Novembre 2013).

## The Church of Meryem Ana in Göreme, Cappadocia

### Correct documentation for a meaningful heritage at risk

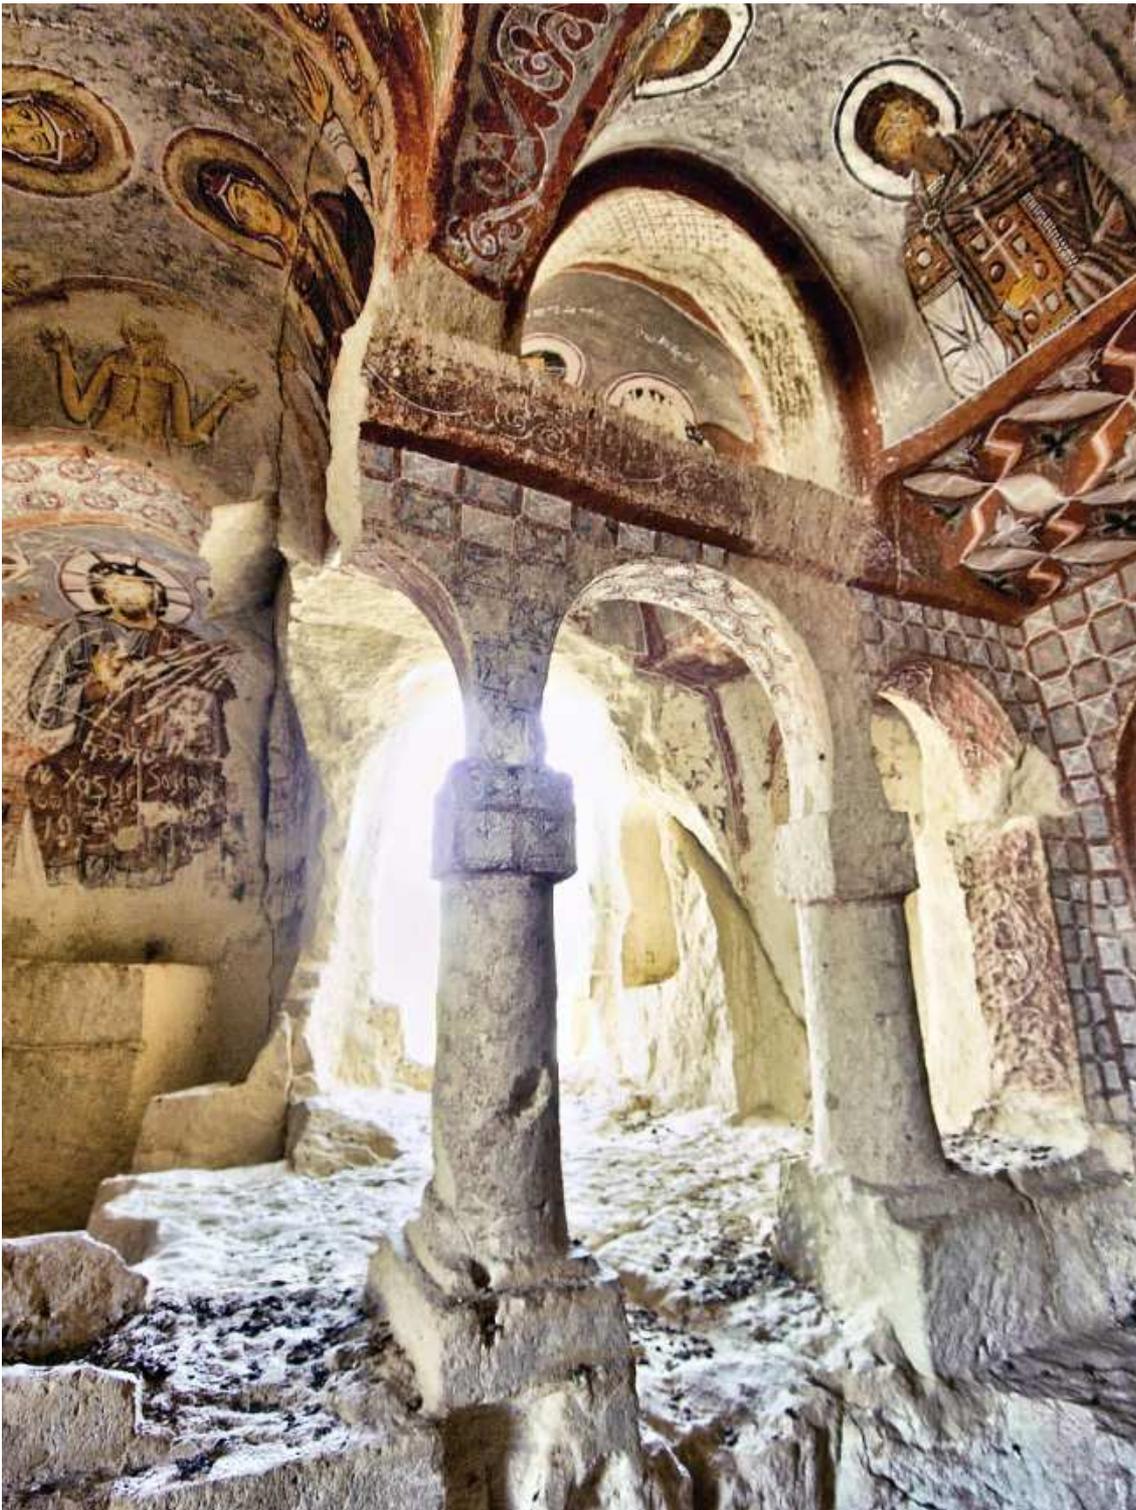
Fig. 1 – View of the inside of the church

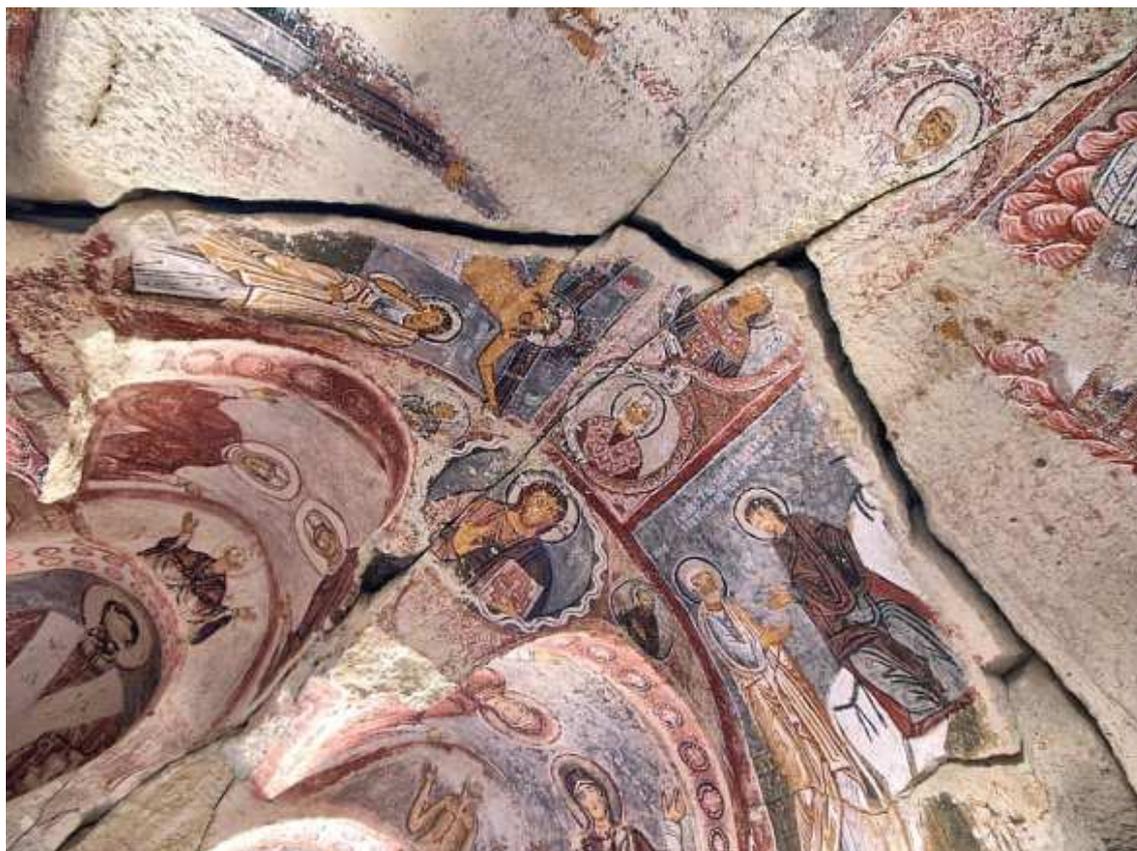
The Meryemana church, commonly defined as Göreme 33, is carved, together with a small monastic complex, in an emerging peak overlooking the valley of Kiliçlar – the Turkish name means the “valley of the swords”- from a 25 meters of high over the area where the valley becomes narrow. Here the fertile area rich of cultivations leaves the space to hard stones and high natural walls, where a feeble river has sculpted this valley. The path to reach the church is not easy, the only available passage crosses some rupestrian rooms with ruined fronts, where the visitor sometimes has to pass crawling on his knees because of the small size of the openings, and then reaches the plan space containing the entrance of the Church. Commonly the passage is not open to the public; a small gate closes one of the narrow openings leaving no possibility to continue the visit. The rooms giving the access to the church were separated by numerous rooms connected one another, and there are still the remains of a millstone door. Arrived at the entrance it is possible to notice that it is characterized by the typical horseshoe arch, which was once enriched with wall paintings. The paints are mainly dedicated to the narration of the life of St. Mary and all the biblical events connected to her figure. The architectural typology of the church is different from the other monuments of the area for the presence of a transverse nave blanket of two barrel vaults of different sizes, without support in between. The sequence of spaces shows clearly the complex development of the church across time, with some quite aggressive intervention, like the connection with the room of the tombs which has altered and destroyed a part of the original mural paints. The whole space is dimensioned in small proportions, but it has a very impressive effect on the visitor (fig. 1), the rich colours, the articulated shapes, the sequence of levels and a certain “sense of drama” capture the eyes and generate a strong sense of admiration. The bema is elevated on three steps, and it was originally separated through a carved iconostasis with six arches and five columns, but two columns get lost and so the large missing part creates an asymmetric perception of the church emphasizing the value of the remains. Besides this partially fallen and destroyed colonnade there are a cross-corridor and apses. Only two of the three original apses are preserved, the one on the South side is almost completely disappeared and a large opening toward the valley allows an impressive view toward the opposite peaks. Beneath the right part of the bema, there are other two main rooms excavated down the peak, they are structured one over the other, probably they were carved in different phases and were connected with wooden staircases which now is lost. For this reason the two lower rooms are accessible only “jumping” down, but they are not that tall and they can be easily accessed. The real risk is due to the fact that all the bema and its lower rooms are beyond the crack dividing the church in two parts, the whole crack develops all along the vaults and the vertical walls, and interests the pavement too (fig. 2). Only a

length of half a meter separates the two extremes of the crack on the floor. So any walk done on this side can be considered dangerous for the structure as well for a visitor.

Fig. 2 – The great crack passing all over the vaults

The digital survey is the right base to start projecting possible interventions on the church and its mural paintings. While visiting and surveying this church it was clear how all the traces of previous diagnostic tests (glass elements placed bridging the crack) were showing a progressive deterioration of this alteration, in fact none of the monitoring glass was in place any more, only the mortar used to position them was remained. A visual check was done looking at the Pasolini Medea's movie, it allowed to verify the crack growing, in the frames from the movie it appears smaller and not so accentuated, but it possible to observe it only in few frames. The main problem is the missing of quantitative documentation of this damage. So, in the second survey campaign, in September 2013, a great attention was dedicated to the outer parts of the peak, trying to put in evidence the consistence of the crack. But the gate closing the passage remained closed: the officer responsible of the museum area gave no authorization to access the church, considering it too much dangerous. A hard choice, but an evident signal about the desperate conditions of the church. The new survey was taken all along the peaks and all along the ridges as well as inside the passages and the caves around the church. This was done to have the maximum level of details from the stone system all around the church and its crack. The whole reconstruction phase did not give any meaningful difficulties, the high quality of the scans made all the details very readable and the alignment was completed in few days. When the new set of aligned pointclouds were ready, they have been composed and mounted with the previous survey. This second operation was rapid and gave no surprises, all the parts went into the "right place" with a very low error levels (a certain variation in the surveyed area was expected because of the changes in vegetation). The classic procedure of alignment, based on target recognition and geometrical confrontation between pointclouds proved to be a very well working solution even in this case. The final result was quite impressive, but not a complete survey yet. In fact the almost flat front of the peak, facing the valley, was an impossible surface to reach from the side where the church is, while the dense vegetation and the meaningful distance of the other side create the conditions to make impossible covering the whole stone surface. Only a further survey, operated from the opposite side of the valley, using a time of flight, long range laser scanner, will be able to make the coverage complete (this third survey is programmed for the September 2014).

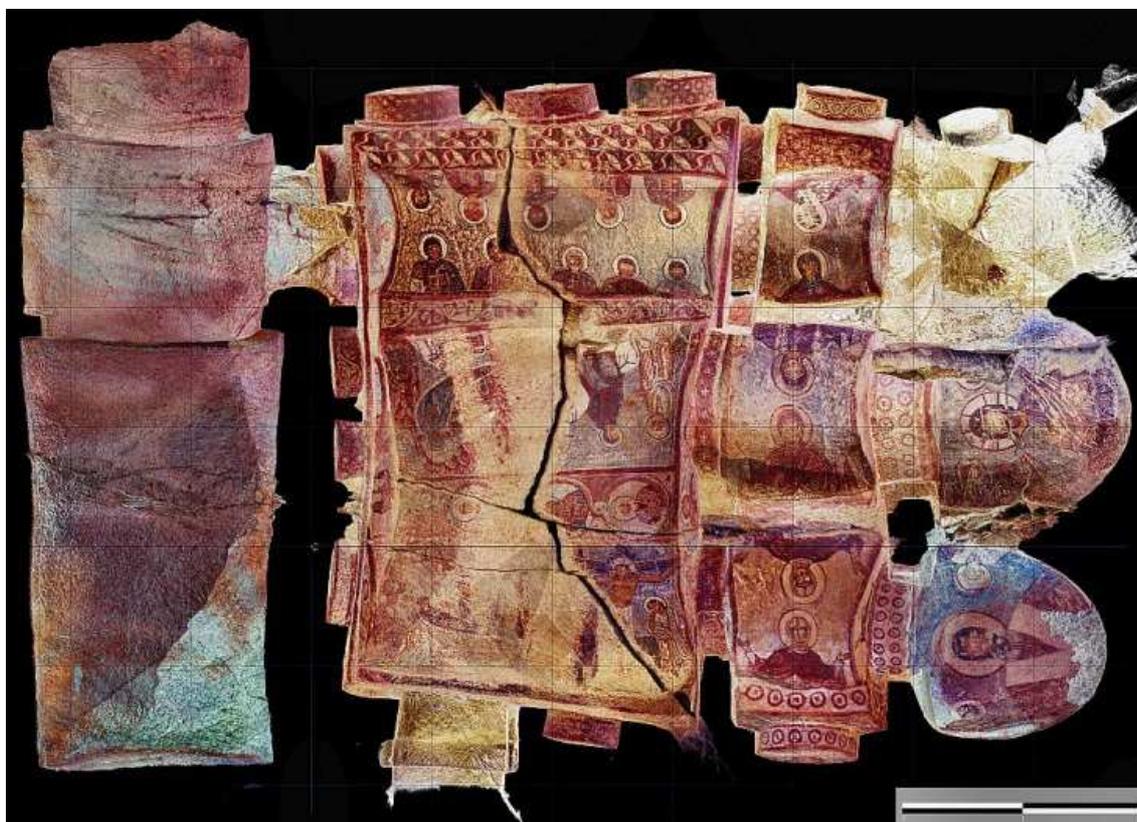
Fig. 3 – Horizontal section toward the vaults of the Meryemana Church (reference scale in meters)

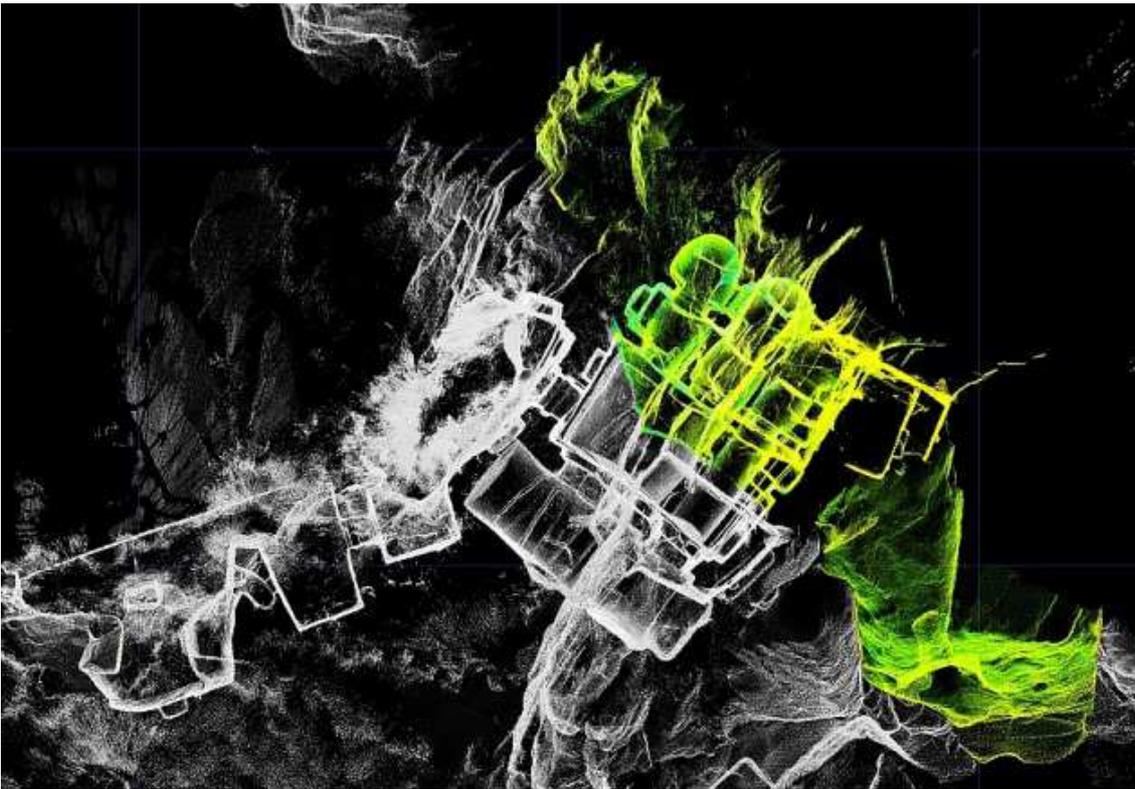
The actual dataset allows to read clearly the relationship between the carved rooms, the mass of the peak, the valley and the crack. The whole crack is clearly readable in the inside, and now, for the first time it is possible to read it with no doubts on the external surface of the peak. Even if it is impossible to scan all along the inside surface of the crack, the correspondence between the outer and inner signs allow to quantify and read the incoming collapse of the whole system. The mass of the moving part of the peak is easily defined, and show the repetition of the process that caused the "flat" face of the peak toward the valley. The volume is enormous, it comprehends a top part 17 meters high over the church and cross the whole peak, opening from the church to the sky. It is worth to say that this process is fully natural, it's in the part of the evolution of this stone, the carved rooms has probably speed up the erosion process of some parts, helping the felt of the connections corridor, but the church in itself is simply across the typical decay of this peak. It can be confirmed observing the "flat" front of the peak toward the valley, where it is possible to see an older fall,

leaving the surface exposed with no trace of rupestrian spaces, but the further phase of decay is now crossing the church and creating this impressive condition.

Fig. 4 – The part of the peak moving down affected by the crack: underlined, the global pointcloud model using green and yellow tones there is the falling volume (top view, grid size equal to 10 meters).

It is important to underline the fact that, during the survey campaign 2013, a more extended 3D laser scanner survey of all the external areas was done, allowing to complete most of the external surfaces of the whole peak and creating the conditions to better interpret the state of the crack menacing the church (fig. 4). The alignment of all the new 3D scans with the previous survey campaign was done using morphological references all around the area, the meaningful aspect of the stones and the overall short time between the two campaigns allowed a good result in the global alignment.

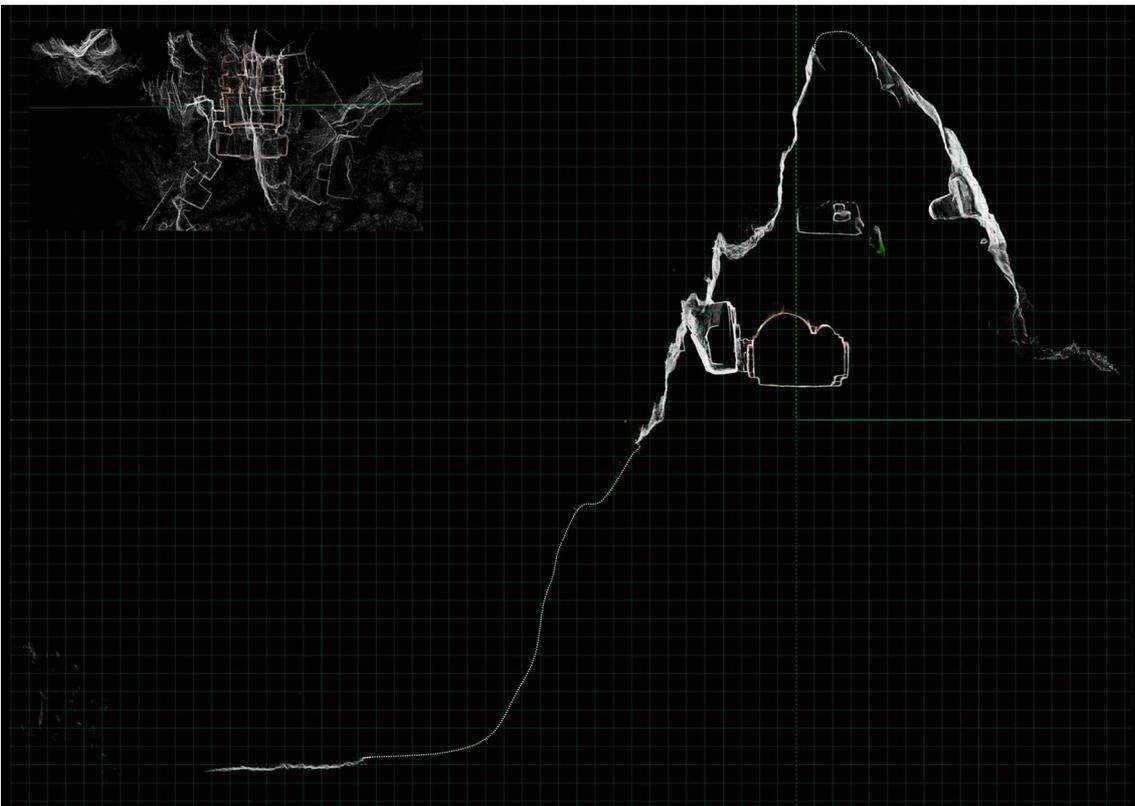
Fig. 5 – Vertical section across the church and across the valley (grid size equal to 1 meter).

The following passage was the production of a set of 2D representations starting from the extraction of high resolution bitmap from the orthographic view of the aligned pointclouds (fig. 5), these images, once scaled in the CAD software, were used as bases for classical drawings. Even if this processing is time consuming and creates useful but not impressive representation, it is important to remind that this kind of drawing is highly meaningful for real analysis and that the process of preparation and drawing in itself is a meaningful process of understanding and reading. This was done to create quickly a classic documentation of the whole settlement. When the whole set of pointclouds was optimized, it was then simplified and used as a base to create a surface model of this rupestrian architecture. Even if the 3D Laser Scanner has been used to take also the pictures in almost all the scans, to reach a better and more descriptive result it was preferred to remap the surfaces using high resolution images taken with professional Digital SLR cameras. Importing complete parts of the pointcloud in Raindrop Geomagic, it was possible to create very good quality surfaces and apply on them the images using the classical workflow offered by this software based on the definition of corresponding points between the image and the surface. The need to produce a lightweight 3D digital model for multimedia and dissemination purposes was faced using common procedures based on the extraction of a normal map from the high resolution model, applying the procedures of decimation and optimization on the same model and then using the normal map over the simplified model to create a virtual enhancement of the level of detail according to the original, not simplified surface.
