LOCAL DEFORMATION REACTIVITY OF PANEL PAINTINGS IN AN ENVIRONMENT WITH RANDOM MICROCLIMATE VARIATIONS: THE MALTESE MAESTRO ALBERTO'S *NATIVITY* CASE-STUDY

Paolo Dionisi-Vici[1], Michael Formosa[2], J Schiro[2], Luca Uzielli[3]*

[1]IVALSA-CNR, San Michele all'Adige – I
[2]Heritage Malta, Kalkara – MT
[3]DISTAF-UNIFI, Firenze – I

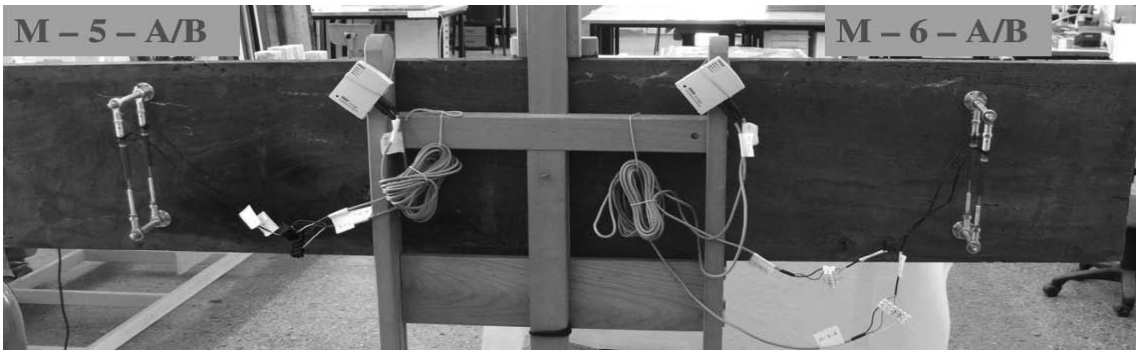
The painting has many painted layer's stability problems, indicated in red circles in the figure, probably depending on the reactivity of the wooden support to the microclimate variations.

Fig. 2: the two Deformometric Kits applied on the back of the painting, in correspondence to the damaged areas.

Due to the previously described simple mechanical structure of the painting, we considered interesting the analysis of the behaviour of the plank in different parts of its length, reasonably influenced by local irregularities of its physical structure. It was so decided to install two parallel systems placed in a similar way (almost the same distance between the transducers, according to the local structural differences) in different parts close to the more damaged areas (Fig. 1) along the length of the plank (Fig. 2).
