Restoration of a Sandstone Facade: From the Project to the Monitoring

RESTORATION OF A SANDSTONE FACADE: FROM THE PROJECT TO THE MONITORING

This work describes the restoration of a facade of an historical building, constructed from typical local sandstone, characterized by different subsequent decay phenomena and subjected in the past to a conservation treatment. The sandstone was characterized, the quarry of provenance was identified, and the causes of the different decay phenomena were investigated. Potential commercial products for the restoration were tested first in the laboratory, then in situ selected products were applied and the effectiveness of treatment was subsequently monitored. Analytical methodologies such as x-ray diffraction (XRD), observation of thin sections under polarized microscope (OM), Fourier transform infrared spectroscopy (FT-IR), micro-Raman spectroscopy, and water absorption tests were employed in the laboratory, while nondestructive tests, performed with portable instrumentation such as colorimeter and sponge contact, were carried out in situ.

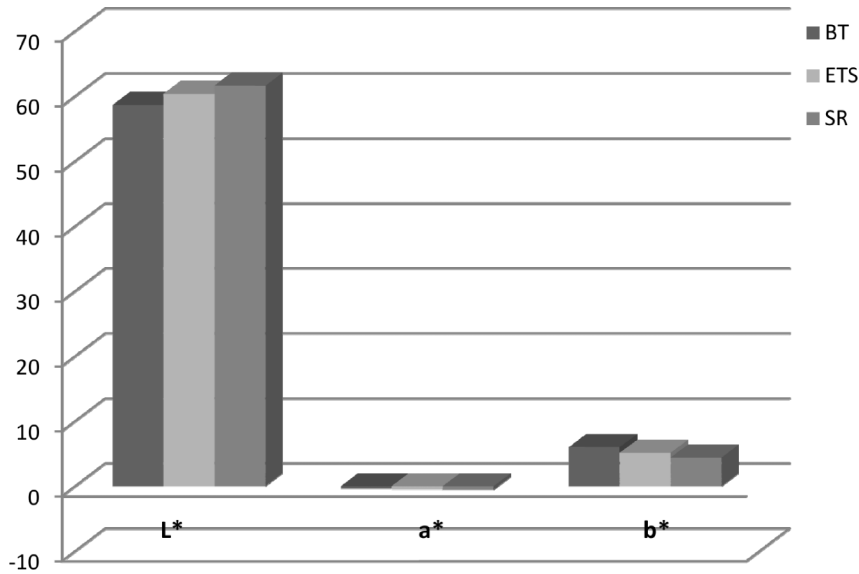
Figure 7. L*, a*, b* values of test samples before treatment and after treatment with ethyl silicates and siloxanic resin.

The change of color was tested after the application of the two treatments. In Figure 7, the values of L*, a* and b* are reported, before treatment (BF) and after treatments with ETS and SR. The ΔE values are, respectively, 1.92 after ETS treatment, and 1.46 after the SR treatment.
