# STABILITY ANALYSIS FOR THE ROCK BASEMENT OF THE CASTILLO DE LOS TRES REYES DEL MORRO, LA HABANA, CUBA

## Abstract

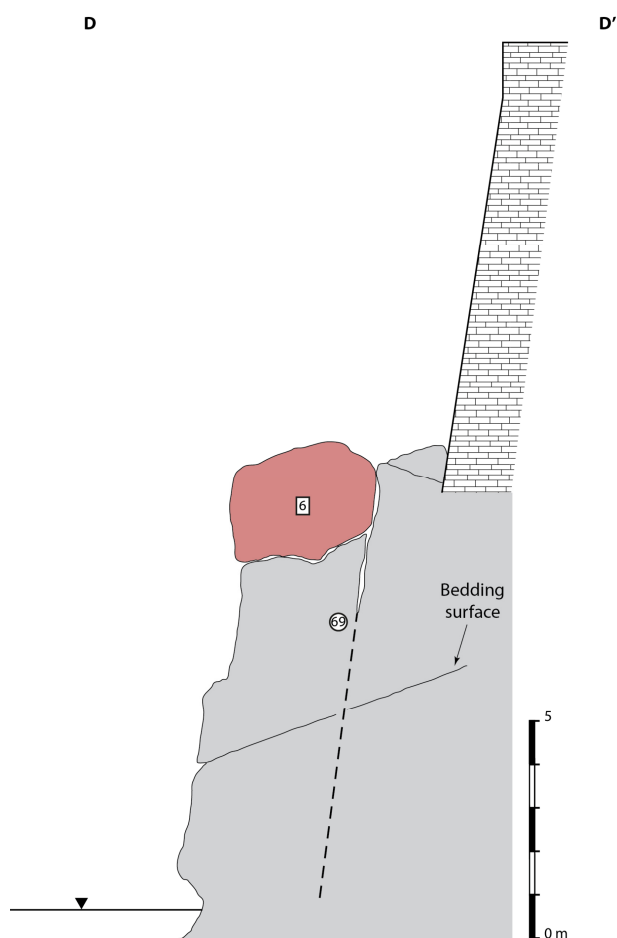
Figure 8– Section D-D' along the western margin of the promontory. Vertical and horizontal scales do not coincide, as the former is exaggerated. Modified after ENIA, 1989
