The restoration of San Paolo Church in Pisa: geotechnical aspects

Nunziante Squeglia,* Stefano Stacul,* Elena Diddi**

Summary

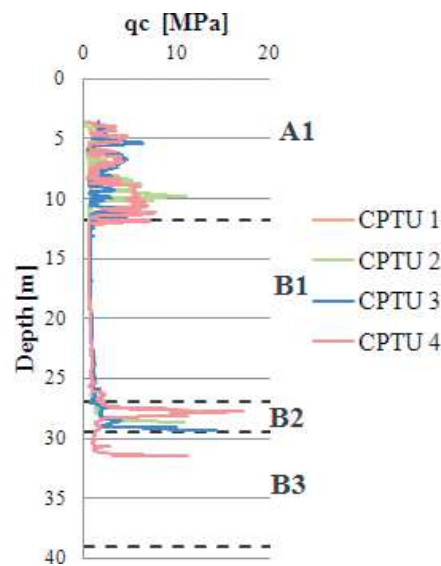
Soil profiles deduced by borehole and CPTUs revealed an essentially horizontal layering (Fig. 6). The sequence of strata is very similar to that of Leaning Tower subsoil [VIGGIANI and PEPE, 2005]; the same denomination of strata was therefore adopted (Fig. 7).

Fig. 6 – CPTU point resistance profiles.
Fig. 6 – Andamento con la profondità della resistenza alla punta.

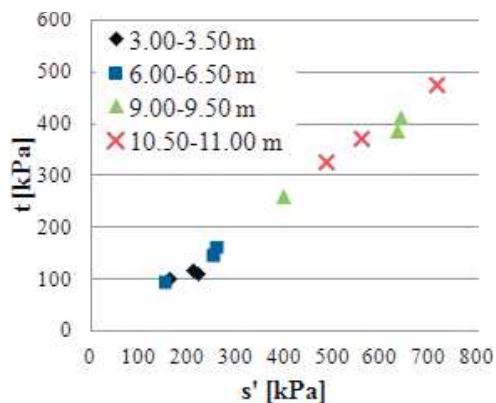
The soils that were found between the ground surface and a depth of 11.8 m are named Complex A. Below a shallow layer of made ground about 2.5 m thick, Complex A consists mainly of silty sand with a thickness of about 9 m. This layer features a very high value of friction angle (about 40 degrees (Fig. 8), as deduced by triaxial tests on undisturbed samples).

Fig. 8 – Failure stresses of A1 layer.
Fig. 8 – Stato tensionale in condizioni di rottura per lo strato A1.

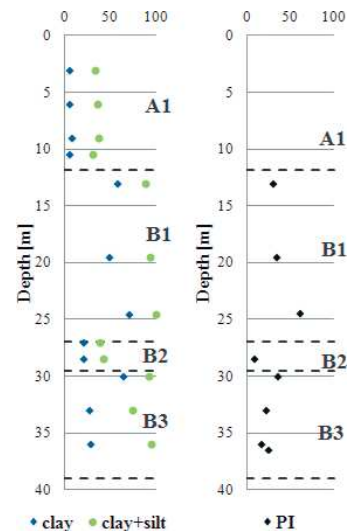
Fig. 9 – Grain size distribution and plasticity index profiles.
Fig. 9 – Andamento con la profondità della composizione granulometrica e dell'indice plastico.

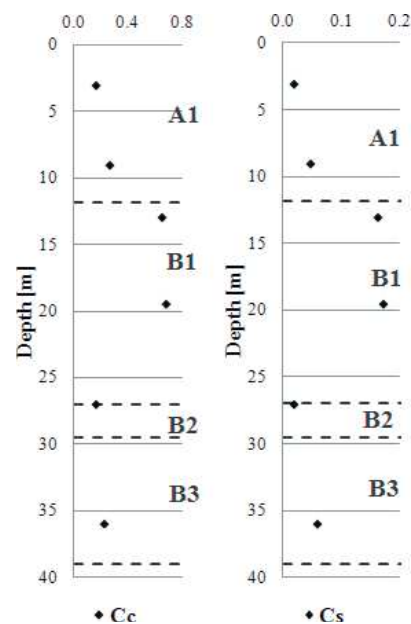
Fig. 10 – Compressibility parameters.
Fig. 10 – Andamento con la profondità dei parametri di compressibilità.

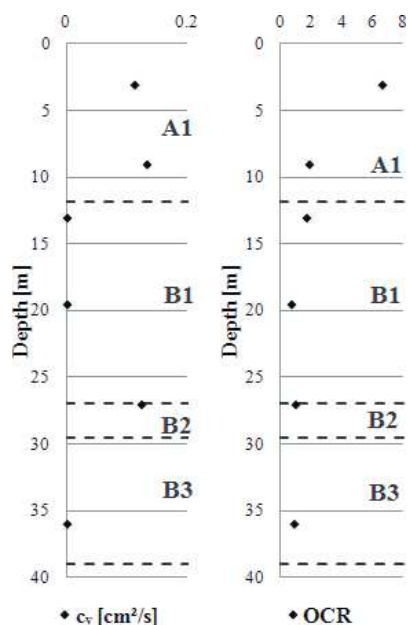
turn into three different layers. The shallower layer B1, between 11.8 m and 27 m depth, consists of a very compressible clay with silt, normally consolidated or slightly overconsolidated (OCR lower than 2, with an average value of 1.3). Layer B2 is a silty sand and layer B3 is a clayey silt with a PI lower than layer B1.

Fig. 11 – Consolidation coefficient and OCR profiles.
Fig. 11 – Andamento con la profondità del coefficiente di consolidazione e del OCR.

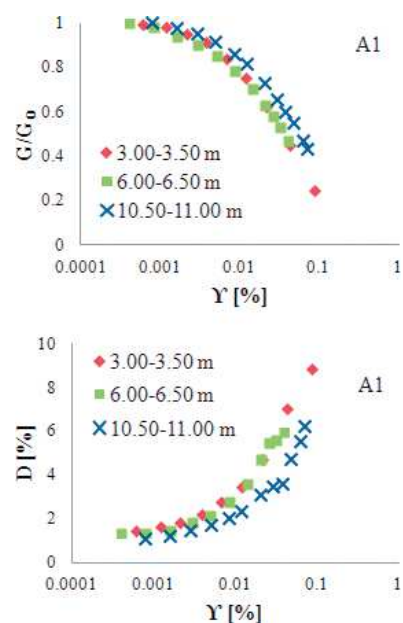
damping from the deformation. More homogeneous layers have been characterized by means of one test, whereas layer A1 needed three tests. The results of RC tests are reported in figure 13 and 14.

Fig. 13 – Modulus decay and damping for A1 layer.
Fig. 13 – Decadimento del modulo di rigidità tangenziale e smorzamento per lo strato A1.

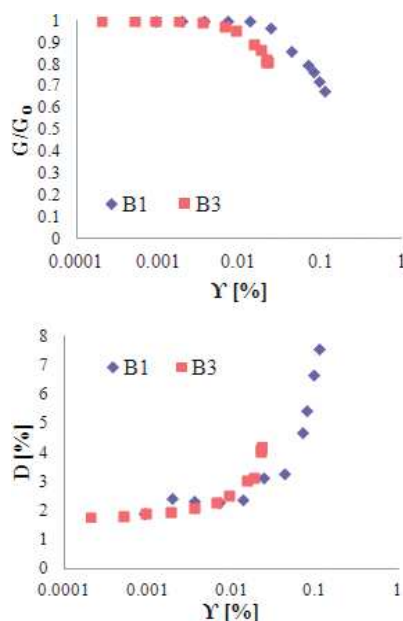
Fig. 14 – Modulus decay and damping for B1 and B3 layers.
Fig. 14 – Decadimento del modulo di rigidità tangenziale e smorzamento per gli strati B1 e B3.

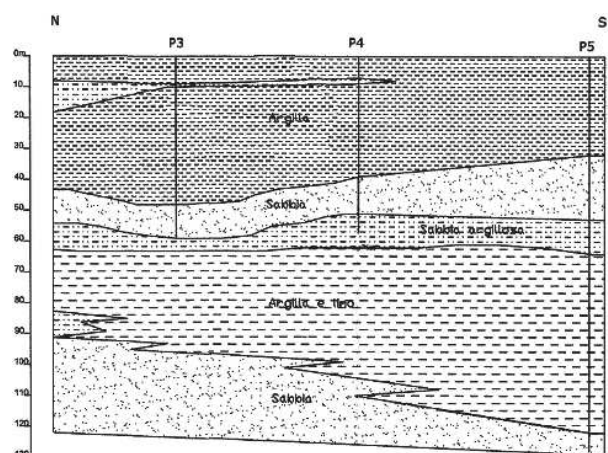
Fig. 22 – Recovered information about subsoil.

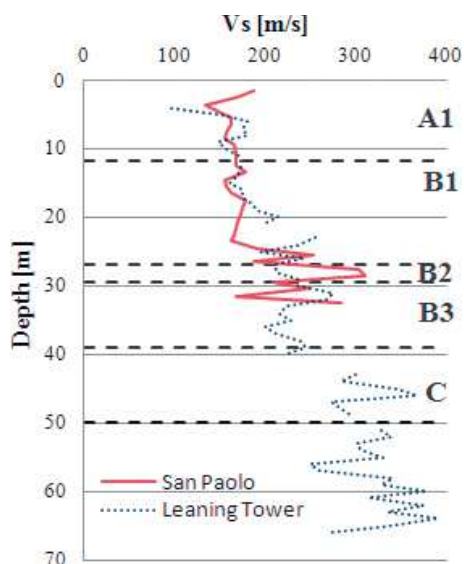
To define the dynamic properties of layer C, reference has been made to cross-hole measurement performed near the Leaning Tower. Figure 23 shows a comparison between Vs profile of Church site and Leaning Tower site, in which the satisfactory overlap of the two profiles is evident. About G/G₀ decay and dumping variation, the curves proposed by IDRISI [1990] have been used.

Fig. 23 – Comparison between V_s profile of Church site and Leaning Tower site.

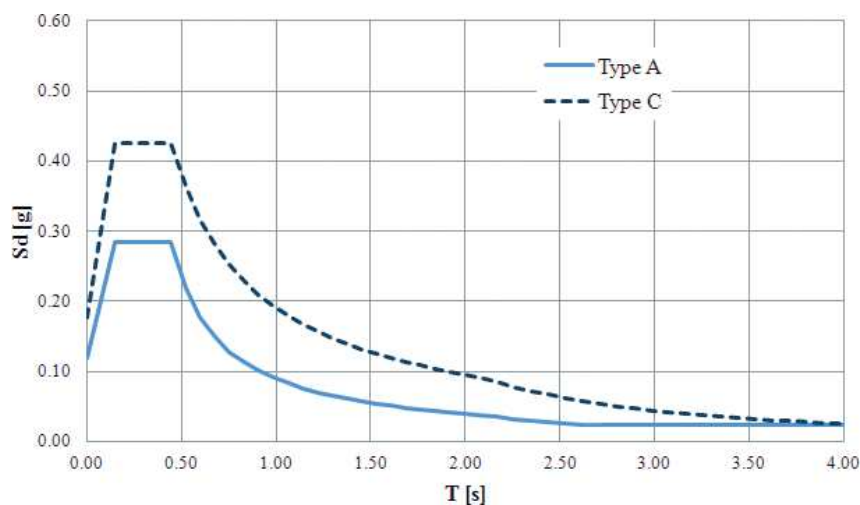
Fig. 24 – Response spectra as suggested by Italian Code for type C and type A soils.

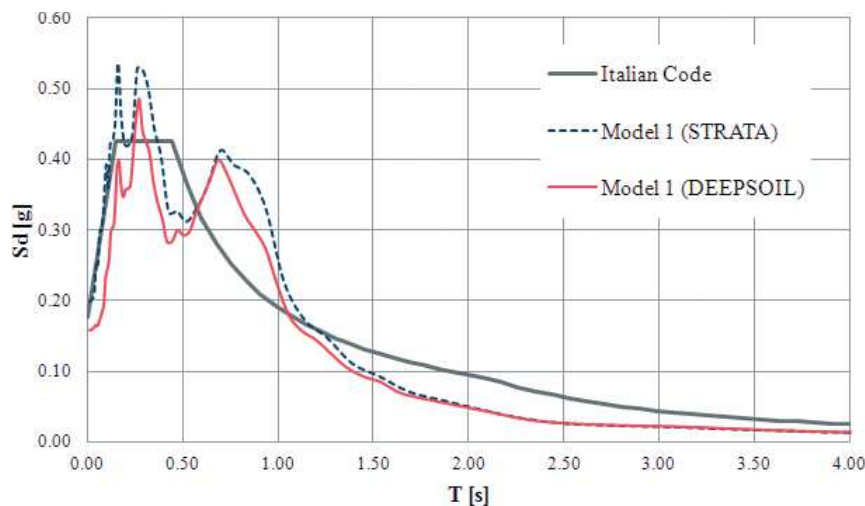
Figures 25 and 26 shows the results of a linear equivalent site effect analysis for both the subsoil models considered. For sake of comparison, the response spectrum provided by the Italian Code has been also reported in both figures. The similarity of results is quite evident, showing the substantial equivalence of the two software. The effect of the different soil model seems to consist in a more regular diagram below a period equal to 0.75 second and in a significant relative increase of amplitudes above the same limit.

Fig. 25 – Comparison between results of two software for Model 1.

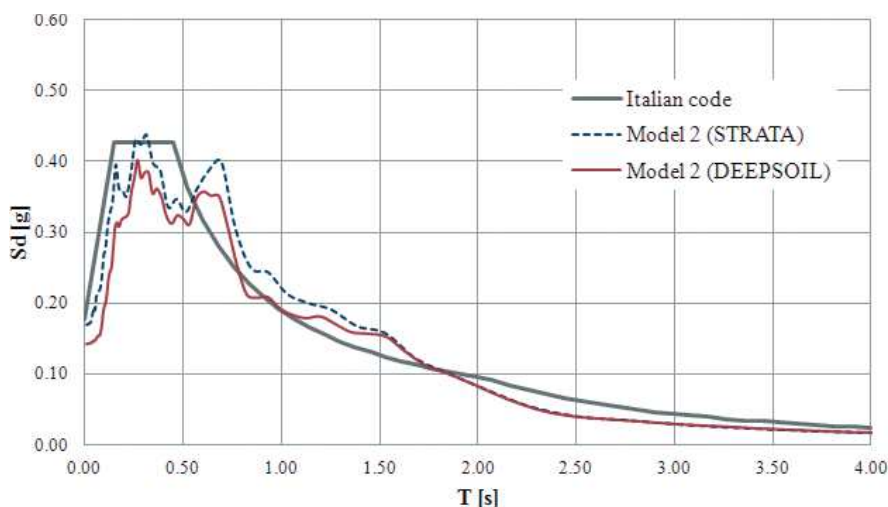
Fig. 26 – Comparison between results of two software for Model 2.
