Assessment of landslide-induced damage to structures: the Agnone landslide case study (southern Italy)

Keywords Landslides · Structurally complex formations · Damage classification · Buildings · Agnone

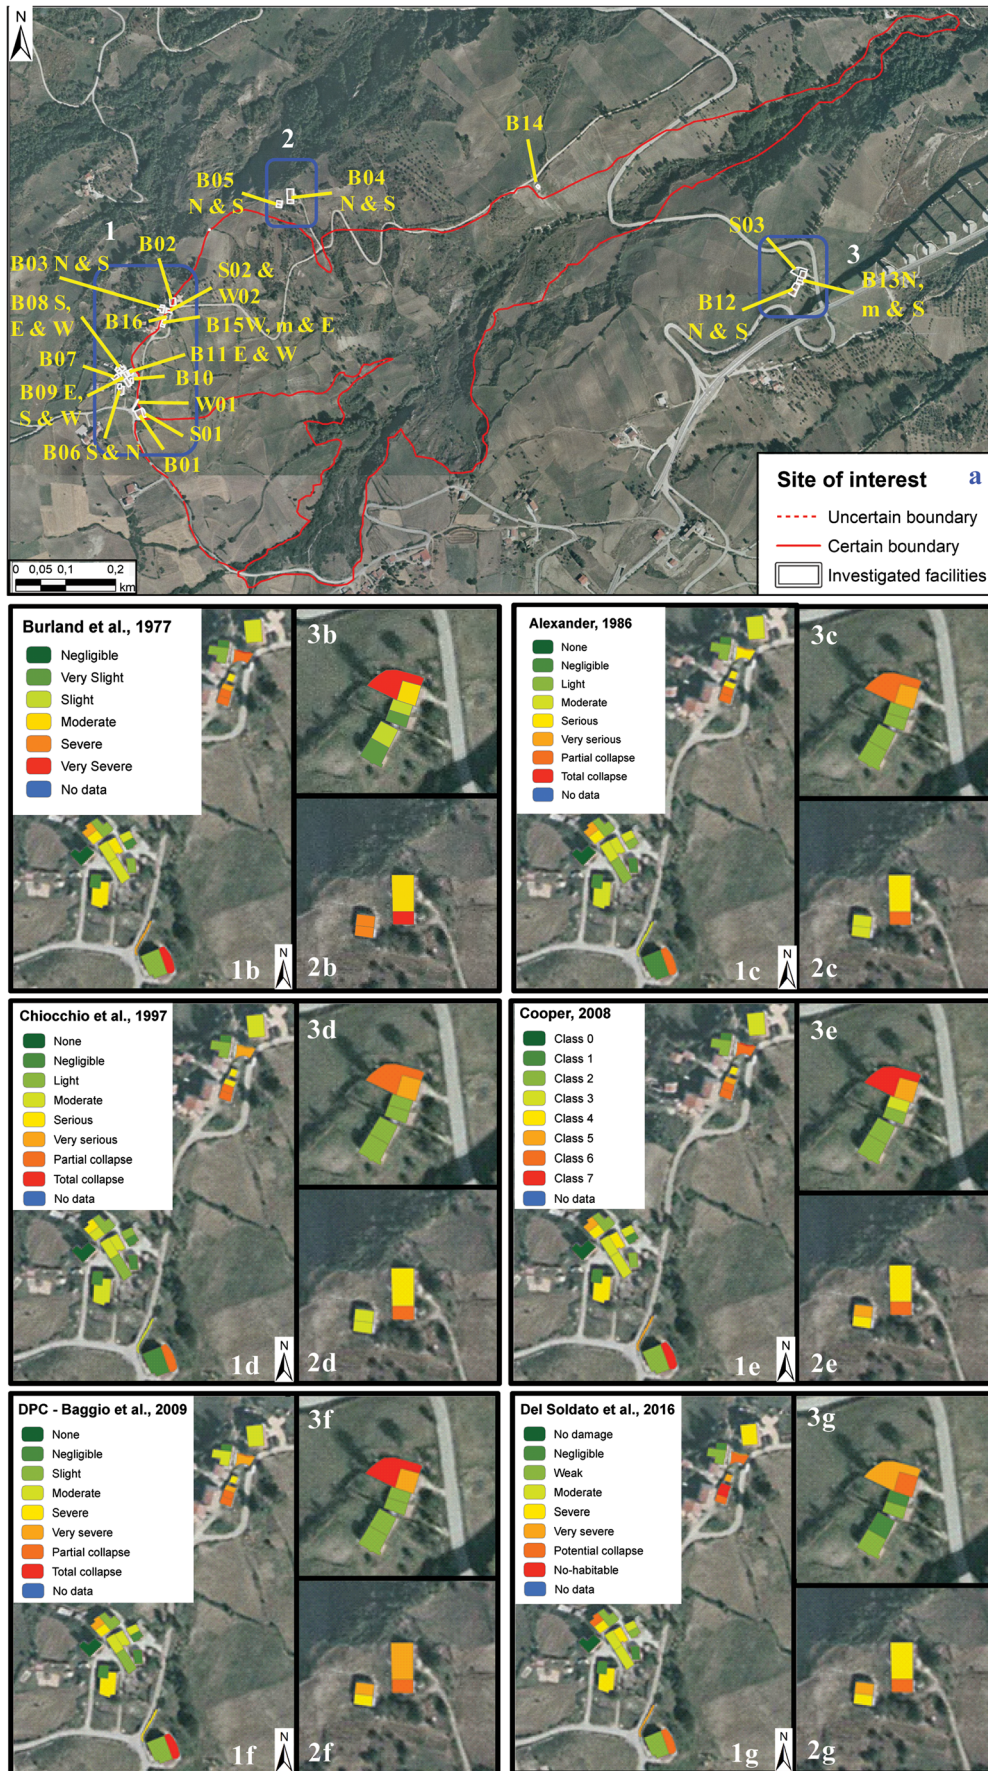
Following the classification of Burland (1977) (Fig. 11b), a large number of buildings (approximately 50%) present *Slight* and *Very severe* damage, as several abandoned structures are strongly affected by damage and have partially collapsed. Only two buildings have been assigned to the *Negligible* class, and four fall into the *Very slight* class. Negligible damage were observed in more recent structures, in a small house that was probably renovated in recent times and in buildings that were built further from the landslide than the others. The *Very slight* class includes a building located on the present-day crown of the landslide. This rank is due to the low level of damage present in its façades, although important damage could affect its foundation.

Alexander’s (1986) (Fig. 11c) classification measures crack apertures in centimeters instead of millimeters. This implies that the classification is less sensitive to damage, and most of the facilities are grouped into the *Light* and *Moderate* classes. Additionally, in this classification, “evacuation and rapid attention to ensure” is recommended for those facilities that exhibit *Moderate* damage. Concerning the buildings located on the crown of the landslide, this methodology classifies the damage as *Negligible*, despite the

The Chiocchio et al. (1997) (Fig. 11d) approach also measures cracks in walls using centimeters. However, this approach includes the construction distinction between masonry and reinforced concrete, in contrast to the previously mentioned methodologies. In this way, structures affected to a significant degree by rigid settlement, which were previously assigned to the low damage classes, are grouped with those affected by several cracks. A concentration of buildings is assigned to the *Light* and *Moderate* damage classes, and the authors suggest evacuation even for the *Moderate* category. Moreover, it is important to note that using this categorization, the building (B01) located on the probable present-day crown of the landslide has few, narrow visible cracks in its external façades, perhaps justifying the low damage classes assigned by the classification, despite an important rupture that affects the front concrete sidewalk. Six buildings, probably abandoned several years before the main event, are assigned to the highest categories of damage (i.e., *Partial collapse* and *Total collapse*), as in the Alexander (1986) approach.

In his approach, Cooper (2008) (Fig. 11e) introduces the description and categorization of landslide ground damage in addition to the classification of the damage recognizable on facilities and buildings. This classification uses millimeters to measure the opening of the cracks that appear on the elements of the investigated structures. In our case study, the classification assigns an important number of buildings to *Class 3*, compatible with the *Moderate* category of the other approaches. Comparing the proposed classification with the other areas, more facilities are sorted into the higher levels of damage. This is probably due to the method's higher

◀ **Fig. 11** a) Localization of the investigated buildings and facilities with their damage classifications according to b) Burland et al. (1977), c) Alexander (1986), d) Chiochio et al. (1997), e) Cooper (2008), f) DPC (Baggio et al. 2009), g) Del Soldato et al. (2017)

constructions are categorized in the low ranks of damage (*Negligible* and *Weak*), and a relevant number is characterized by important damage (*Moderate* and *Severe*). In the left flank of the landslide (i.e., area 2), the constructions are categorized with a high level of damage (*Severe* and *Very severe*) due to the important displacement caused by a double component of movement. The first displacement component affects the right side of the study area that is under the influence of the CL-PO landslide. The second component is due to an enlargement of the mass movement that affects the neighboring basin. The three sidewalks and the two investigated walls are all categorized into a high level of damage (*Severe* and *Very severe*) due to the open cracks and fractures that affect them and, in one case, the detachment of a portion of the sidewalk due to the regression of the landslide border. Only one edifice is featured by *No damage* due to its recent construction or renovation. Three structures are classified as *Total collapse*: two of them, both abandoned, are close to the crown, whereas the third is close to the left flank of the landslide.
