Ph.D. Thesis

**SEISMIC FRAGILITY ASSESSMENT OF
UNREINFORCED MASONRY CHURCHES IN
CENTRAL CHILE**

A dissertation presented by
Nuria Chiara PALAZZI

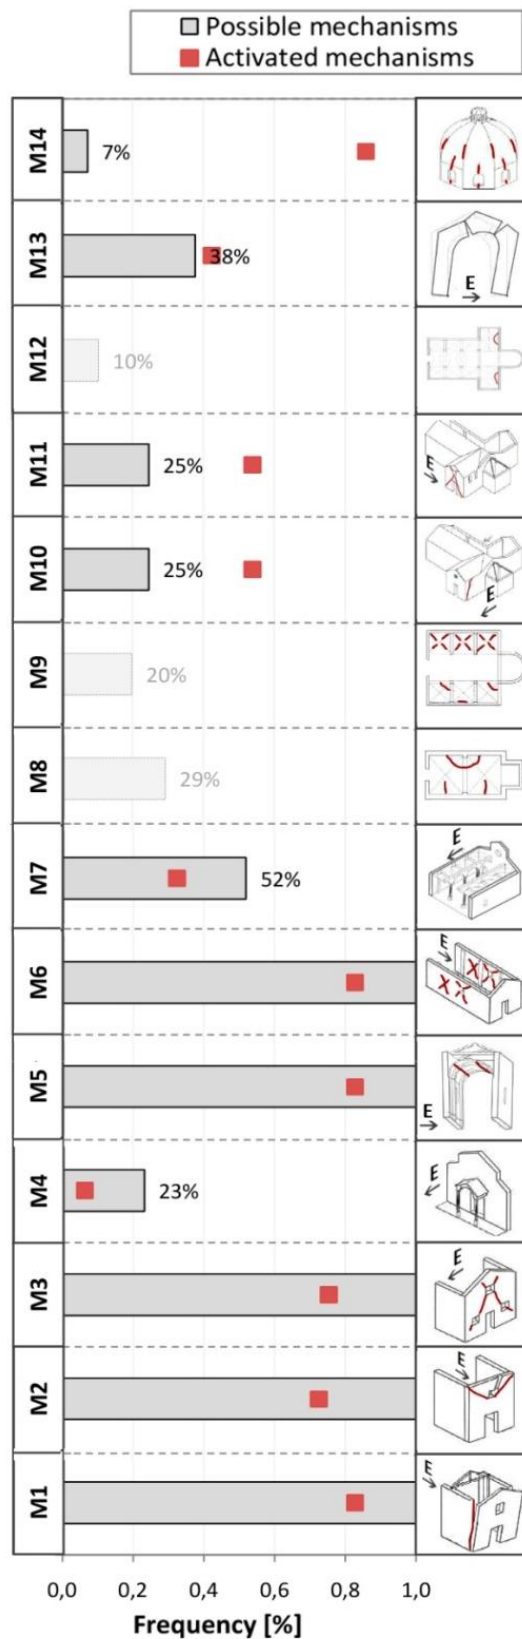
between the numbers of churches where the mechanisms were actually activated following the 2010 earthquake (effective mechanisms, EM), and the number of the possible mechanisms. The PM parameter highlights the specific features of Chilean URM churches with respect to the European religious buildings. Some mechanisms are absent, such as the damage involving the main nave (mechanism 8) and the side aisles (mechanism 9) vaults, due to the presence in churches of false vaults made of timber ribs clad in cane (present in about the 25% of the total stock) or *tijerales*. The mechanisms 1, 2 and 3, which analyze the in-plane and the out-of-plane behavior of the facade, and mechanisms 5 and 6, which respectively evaluate the transversal response of the central nave (and of the aisles, if present), and the in-plane response of the longitudinal walls, show that a systematic activation and the involved macro-elements, facade and central nave, are always present.

In all the bell towers, in-plane and out-of-plane damage was observed (mechanism 27 and 28), and the considered macro-element is present in almost all of the analyzed churches. The apse overturning causes frequent damage and through the interaction between the side walls and the roof structure (mechanism 16 and 19).

Figure 4.4 -(a) Percentage of possible collapse mechanisms (relative to the total sample) and the mechanisms activated after the 2010 earthquake (compared to the possible sample).

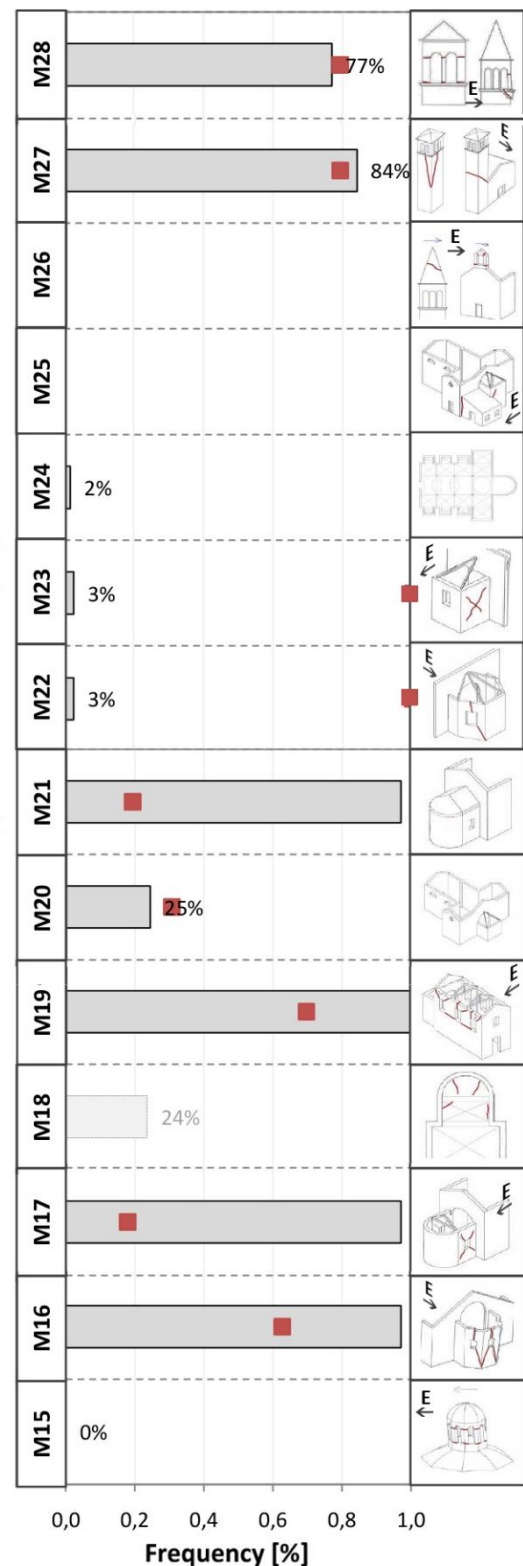
Figure 4.4 -(b) Percentage of possible collapse mechanisms (relative to the total sample) and the mechanisms activated after the 2010 earthquake (compared to the possible sample).

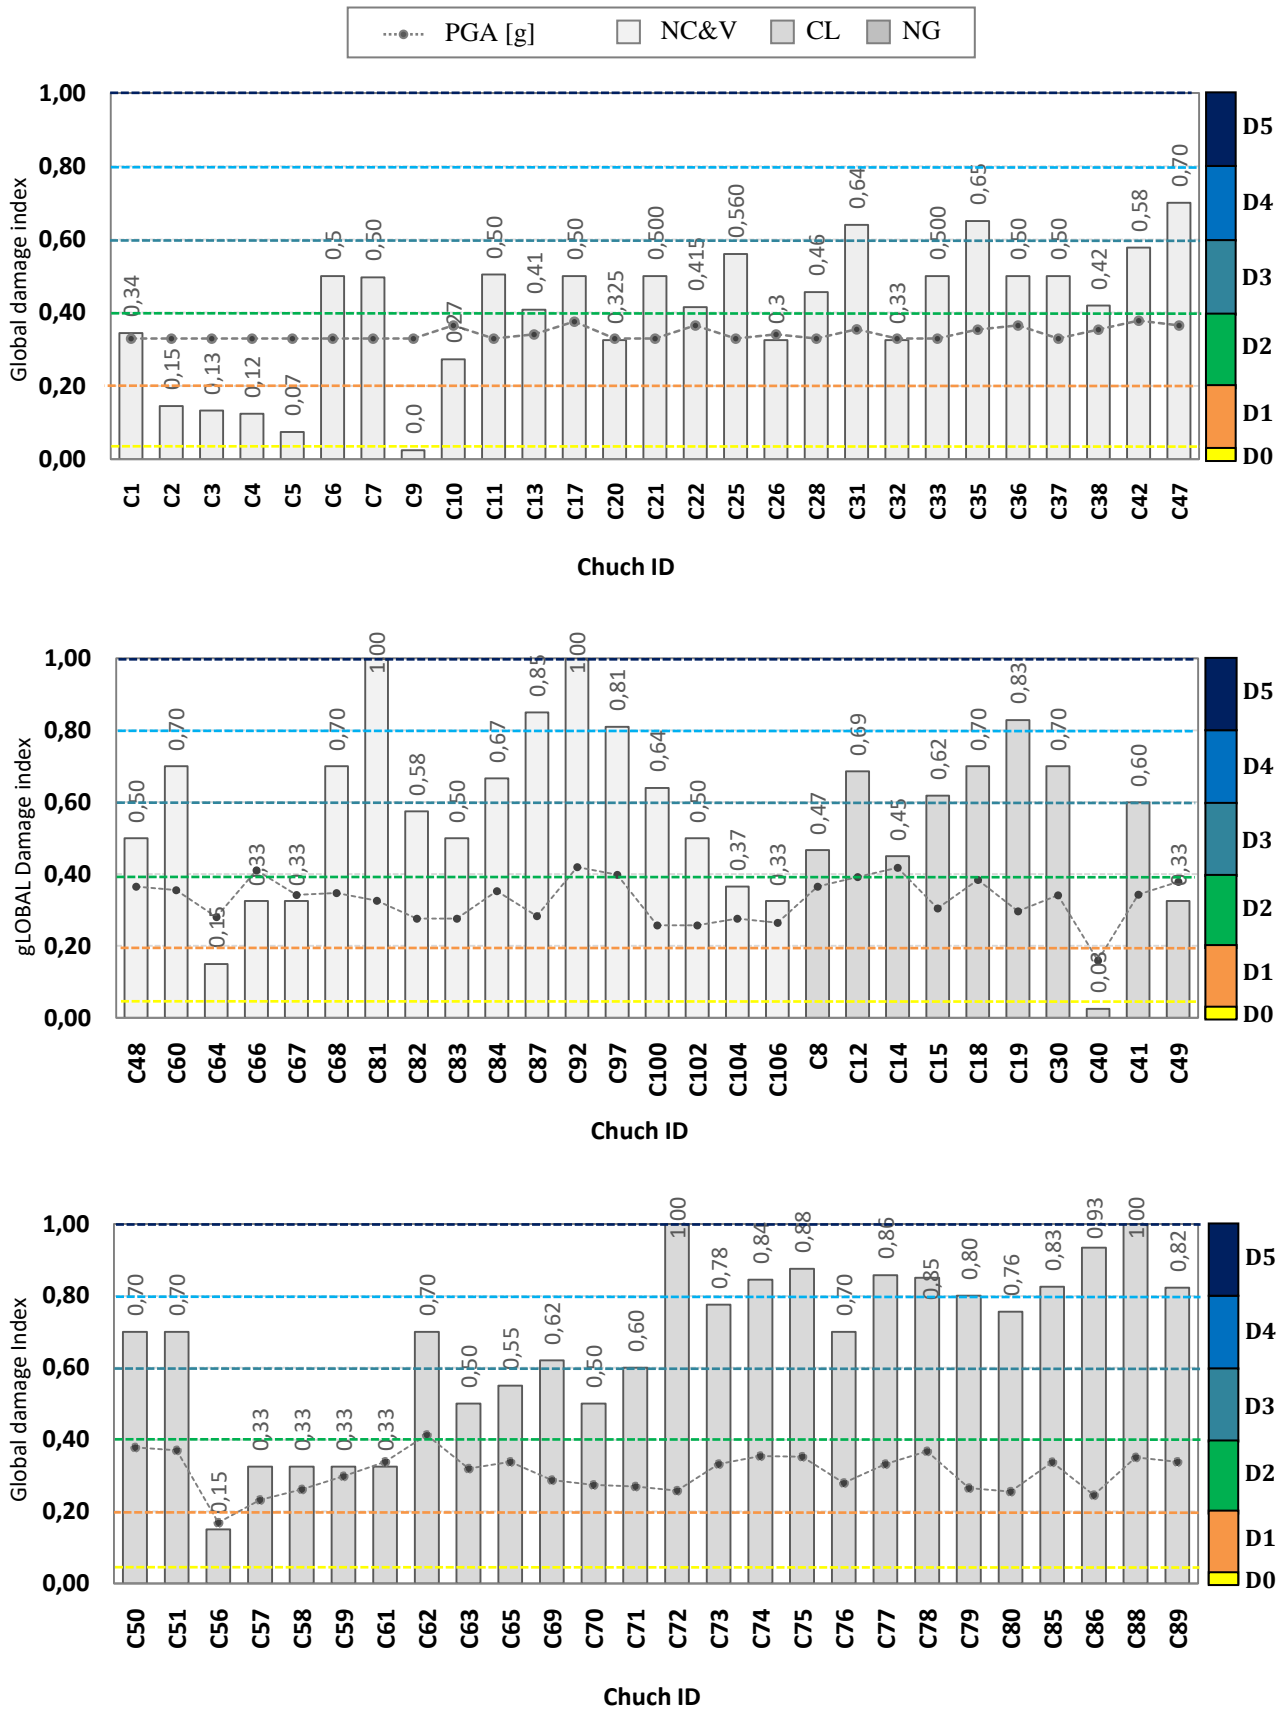
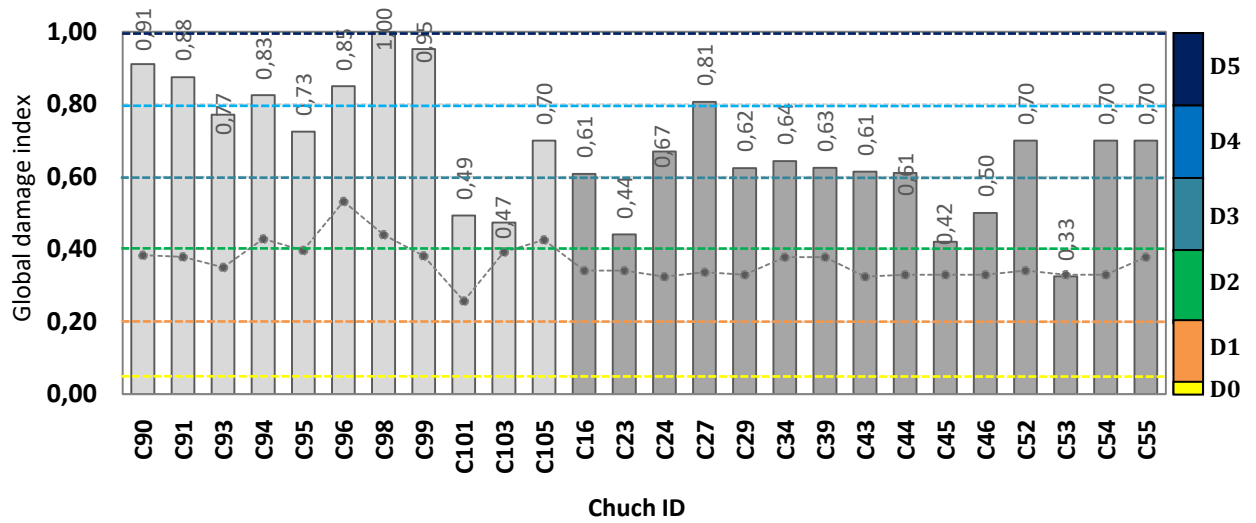
The results obtained by the damage index method, show better correlation in stone masonry churches (7 in totals) rather than brick and adobe structures. Indeed, during the Maule earthquake, CL and NG churches were the most damaged structures. Several of CL religious buildings, of which 57.4% were located in the both region 6th region (Libertador General Bernardo O'Higgins), underwent heavy structural damage. Extensive and deep cracks were observed activating local failure modes of different macro-elements, and in some case, total or near total collapse (66% of global damage levels in Colonial churches reached D_4 - D_5).

The NG buildings located in the city of Santiago at 325 kilometers from the epicenter exhibited activation of failures of numerous macro-elements and a prevalent damage level D_k in 66.6% of the cases. Compared to the previously analyzed buildings, the NC&V churches have shown a better structural response, with moderate structural and non-structural damage, 75% of the cases. The stone churches are focused on a more limited range of PGA (range between 0.25g to 0.3g).

Figure 4.7 - Damage levels according to Table 2 (Grunthal, 1998) and global damage index (Lagomarsino et al. 2004; Lagomarsino and Podestà, 2004b) for the 106 URM churches of Central Chile affected by the 2010 Maule earthquake.

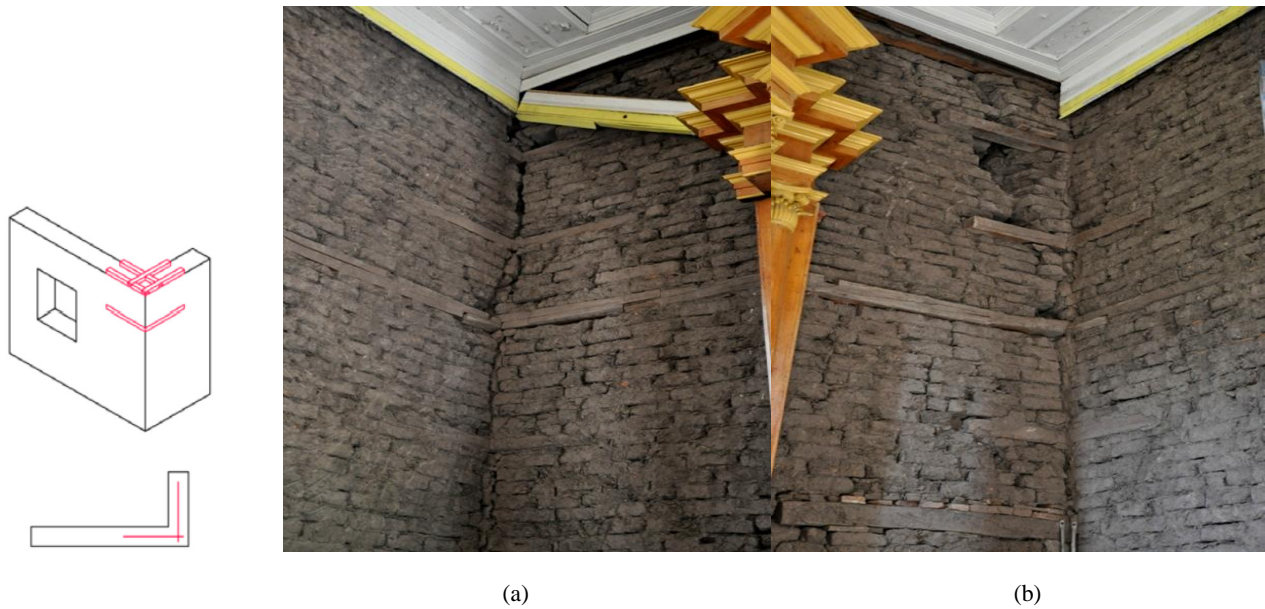
This traditional strengthening solution induces walls working together even when the bonds between perpendicular walls crack during an earthquake (Ortega et al., 2017), as can be seen in the 2010 post-earthquake photos of the rear wall of central nave (Fig.5.1.3 a-b).

Figure 5.1.3 – (a) (b) Corner keys between rear and lateral walls.

localized vertical crushing in the corner occurs due to the absence of masonry bonds (Fig.5.1.3). The fracture lines are in correspondence of longitudinal wall planes.

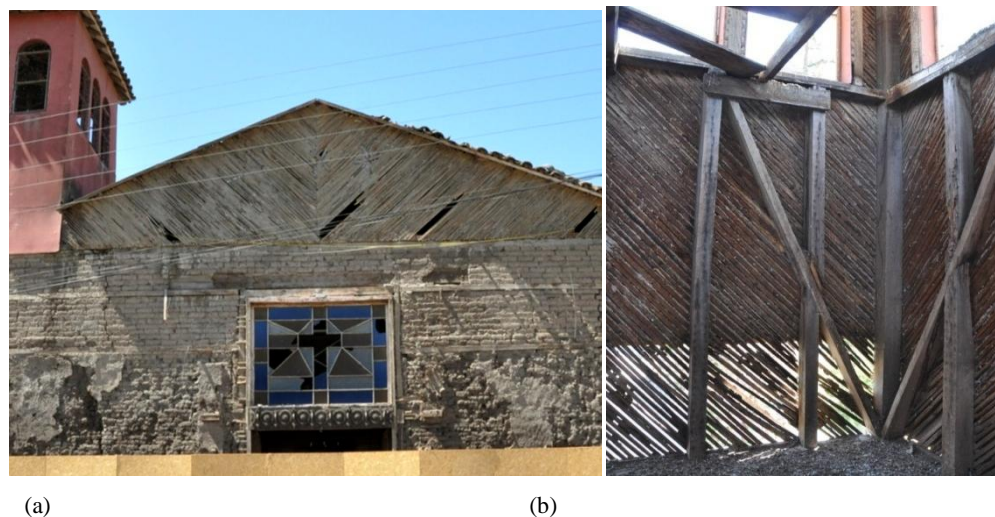
The upper part of façade (the gable) and bell tower are built by wooden portion wall well bound to the beam of roof (Fig. 5.1.4), and settled on a timber ring-beam. This traditional constructive system, already described in Chapter 2.3.1, constrains the structure and reduces the height of façade and bell tower macro-elements and their destabilizing moment.

Figure 5.1.4 - Wooden portion walls (tabique) of (a) façade gable and (b) bell tower.

The timber consolidation interventions of bell-tower cell and façade gable avoided local collapses and significant damage, guaranteeing ductility and allowing oscillation without loss of equilibrium. These traditional strengthening techniques showed high efficacy in avoiding complete loss and collapses after the several earthquakes that have hit the church.

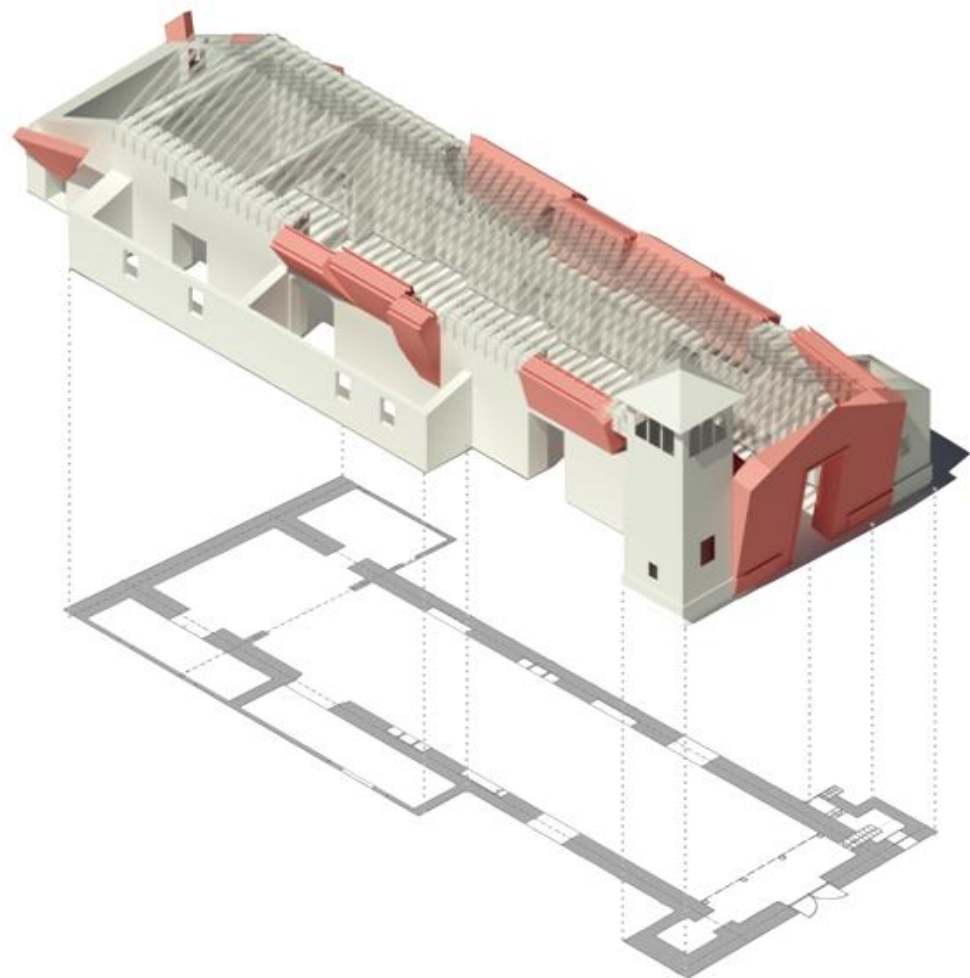
Firstly, the layout of the mechanisms that are most likely to be activated in the Parish has been defined for the current state and the identified mechanisms are shown in (Fig.5.1.11). The results of LKA (Kinematic multiplier α_0 , Participating Mass M^* , Mechanism Activation Acceleration a_0^* , the Demand Acceleration at ground and elevated levels) are shown in Table5.1.5.

Figure 5.1.11 – Identification of all local mechanisms in Malloa church.

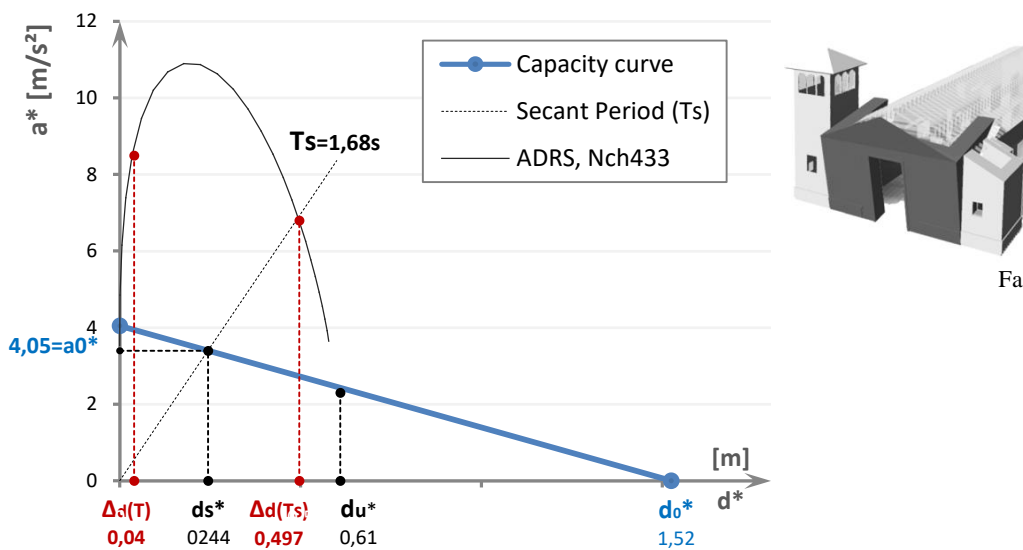
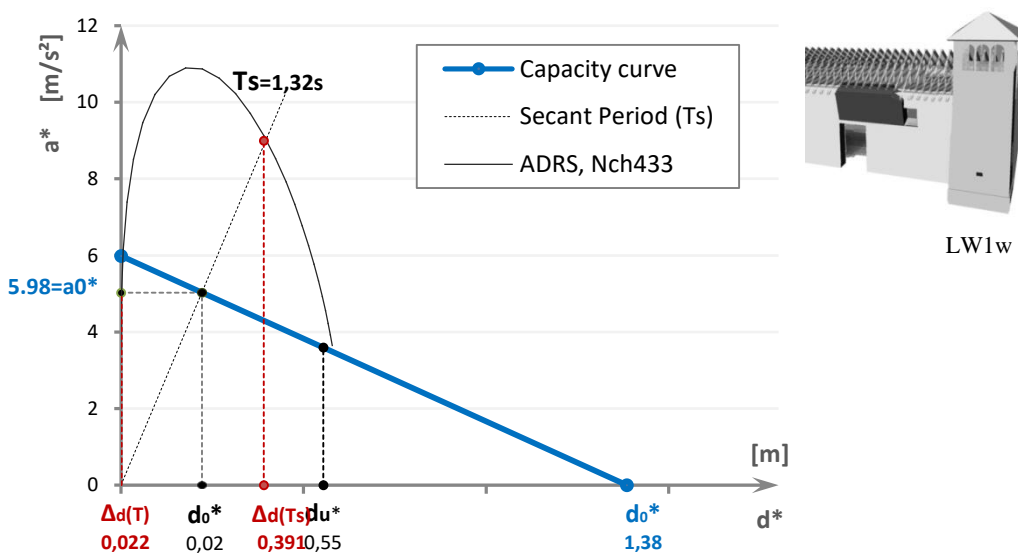
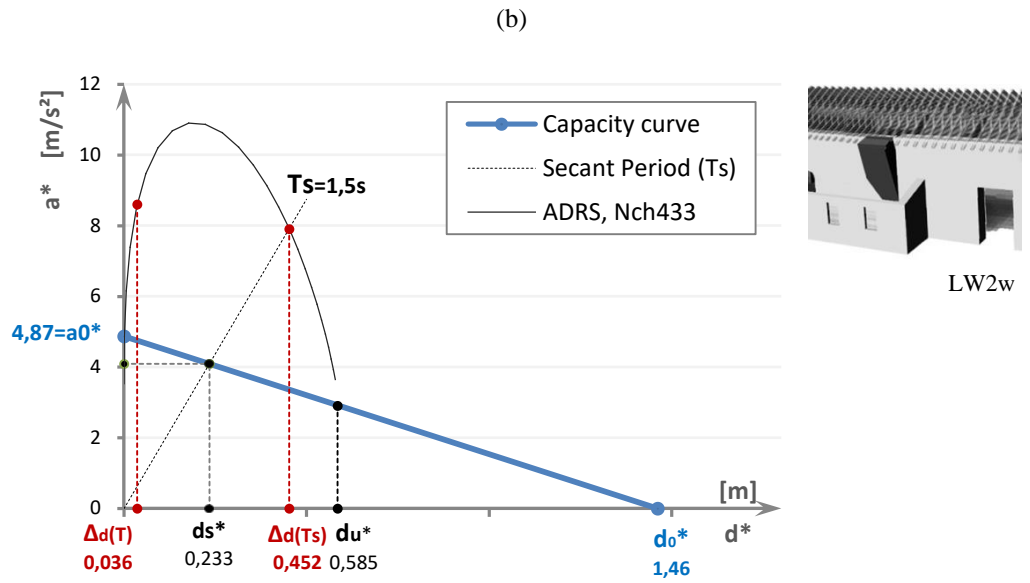
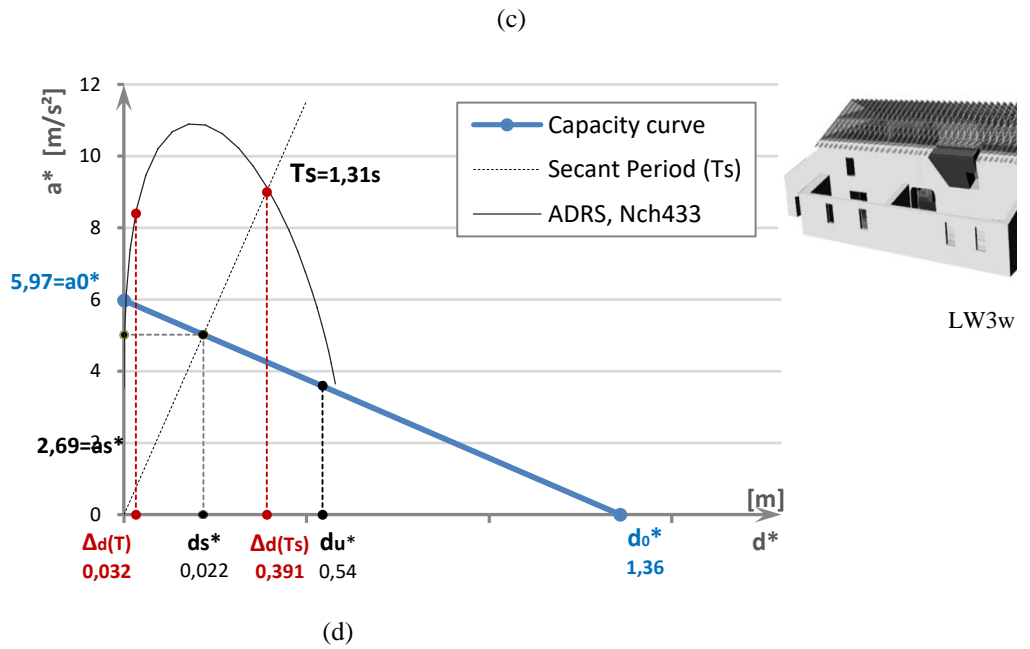
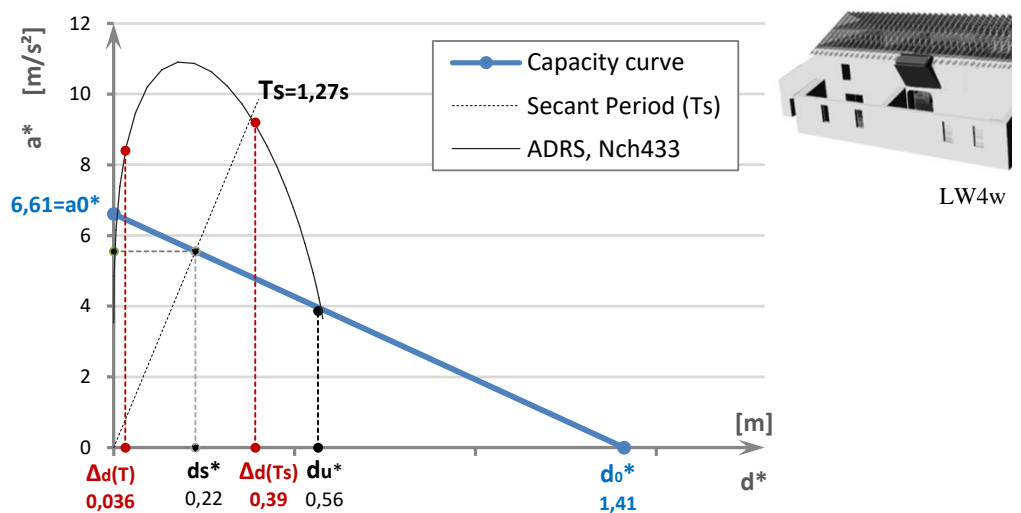
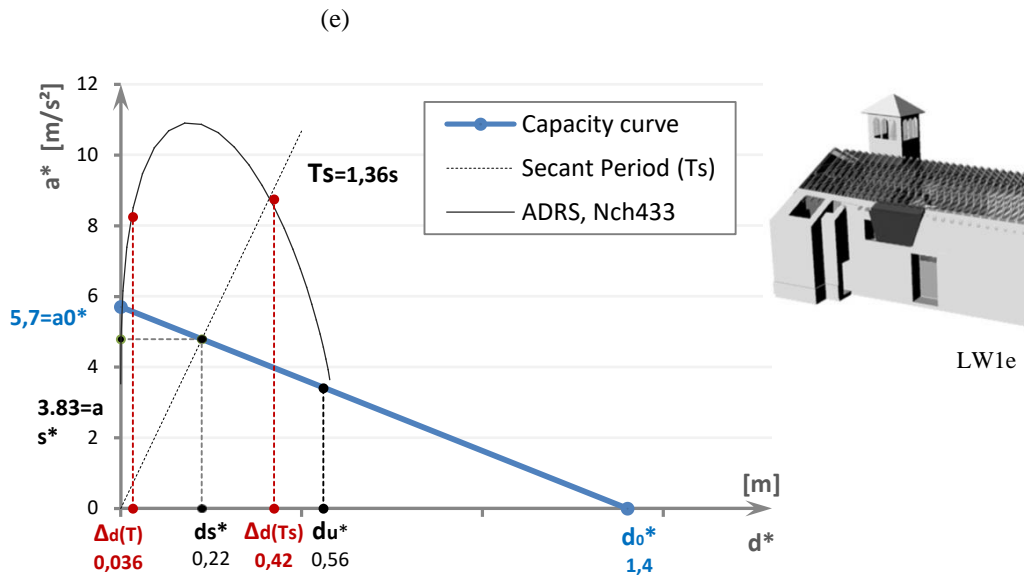
From the comparison between the displacement Capacity and Demand (equation 5.9) of each mechanisms analyzed, the checks are satisfied (Fig.5.1.15). The Capacity Spectrum highlights the great capacity in terms of displacement of the all squat macro-elements, far from collapse. The damage scenario is in concord with the crack pattern annotated during the surveying.

Figure 5.1.15 - Capacity and demand curves of incremental kinematic analysis: (a) main Façade; (b) west lateral wall macro-element1(c) west lateral wall macro-element2; (d) west lateral wall macro-element3; (e) west lateral wall macro-element4; (f) east lateral wall macro-element1; (g) east lateral wall macro-element2; (h) east lateral wall macro-element3; (i) east lateral wall macro-element4; and (l) east lateral wall macro-element; and Acceleration Displacement Response Spectrum (ADRS) according to Nch433Of.1996

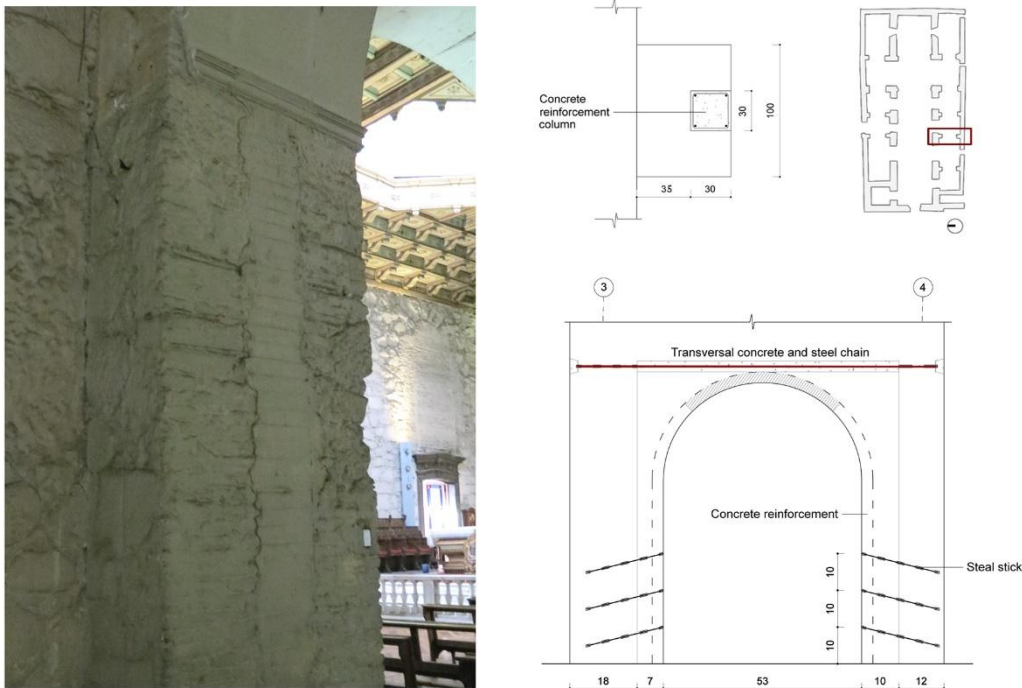
of brick in addition to the lateral aisles. The five arcades partitioning the lateral aisles brick masonries reinforce by and RC frame cast within intrados and an RC tie-rod at the top (Fig.5.2.2).

Figure 5.2.2 - Concrete reinforcements of arcs (Jorquera et al., 2016).

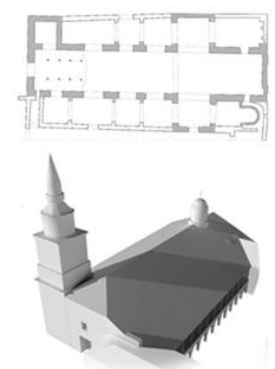
V. 1896-today

The most recent construction phase (1858-present day) saw a new brickwork chapel added to eastern wall behind the altar and the roof structure unified in 1895. The magnitude Mw 8.0 Algarrobo earthquake in 1985, with epicenter offshore and felt at 7.5 MMI in Santiago, caused extensive damage to the traverse arches of the lateral aisles of the church. These were reinforced (intervention designed by the engineer Santiago Arias (CMN 2010)) by inserting an RC frame (30x30 cm) and mixed RC-Steel tie-Rod system above the arches (Fig.5.2.3f). Due to the lack of intervention guidelines for historical masonry buildings, no principles of heritage conservation were followed during this intervention which was a common practice in most structural interventions done on historical monuments after the 1985 earthquake.

Significant damages were observed after the 2010 Maule earthquake Mw 8.8 (7.0 MMI in Santiago; Atkinson and Wald 2007) which included displacement of the arch intrados, deep cracks in the longitudinal stone walls and wall bulges at the spring level of the transverse arches. These crack patterns can still be observed. No significant deterioration of the 2010

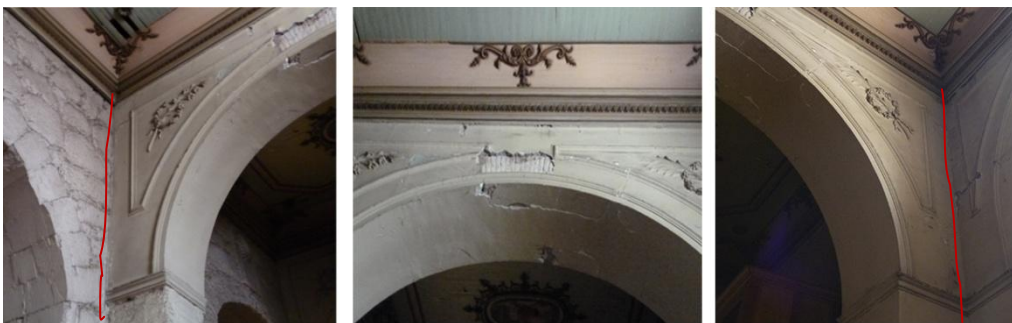
Figure 5.2.8—In-plane behavior of the transverse arcades

As they are vitally linked phenomena, longitudinal arcade walls' out-of-plane behavior and the transverse arcade wall's in-plane behavior were analyzed together. Diagonal cracks in the arches and top triangular adobe section exhibit the in-plane behavior for the transverse arcade. Crack patterns characteristic of masonry arcades affected by earthquake shaking documented in historic churches in the downtown of Santiago (the Metropolitan Cathedral, the Agustín Church, the Merced Church, etc.), are present in the San Francisco Church. This is documented in historical archives of repairs (Consejo de Monumentos Nacionales—CMN, 2010).

At present, the repairs undertaken in 1988, which installed a reinforced concrete frame and upper tie-rod (Fig.5.2.8) decreasing deformations while causing a profound change in the masonry arches' behavior, have caused adaptation in the behavior of the transverse arcade. Racks can be observed at and around the intrados to the arcades and in the piers, which resulted from discontinuities and disunity amongst the masonry and concrete. Deep cracks provide evidence of the insufficient bonding between the transverse brick masonry arcades and the stone longitudinal nave walls (Fig.5.2.8a). Significant bulges in the stone work corresponding to the transverse arch springs, likely linked with an RC tie-rod, define the longitudinal walls' unique out-of-plane behavior during seismic action. Unsettlingly, deep cracks and deformations in some arch piers of the nave are related to these bulges (Fig.5.2.8b). The pounding effect between the transverse and longitudinal walls is congruous with the

aforementioned phenomena, resulting from the disparate building techniques used in construction, repairs and renovations (i.e. brickwork and stonework) which cannot be easily bound together. Additionally, deep cracks due to earthquake shaking have formed in the arch intrados of the longitudinal walls pointing to their separation into two leaves (Fig.5.2.9c-d). The introduction of reinforced concrete chains in the top section of the transverse arcade walls played an essential role in the bulging phenomenon observed in the longitudinal walls (Fig. 5.2.9e). The effect of the tie-rods is twofold in that they increase resistance to overturning while changing the collapse modalities of the vertical arch mechanism linked to the bulging.

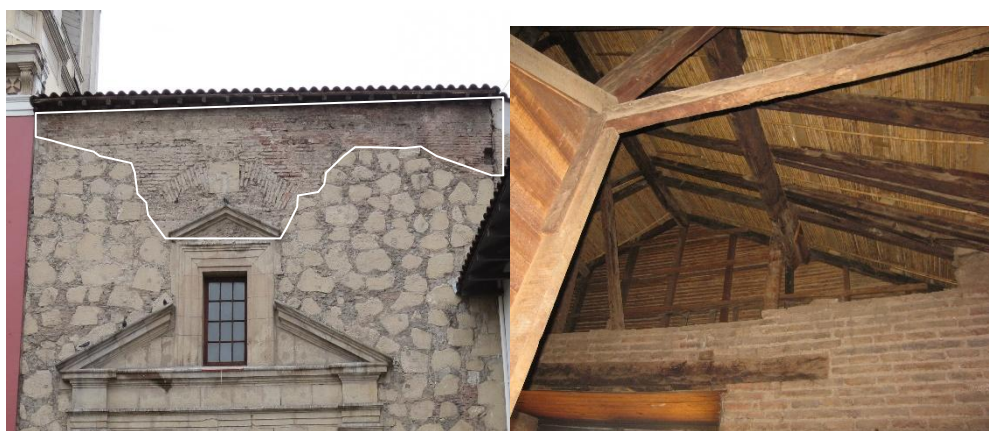
Figure 5.2.10 –Upper part of façade and presbytery wall.

In regard to the façade's out-of-plane behavior, a historical collapse is evident due to the presence of a brick reconstruction at its gable (Fig.5.2.10). The uneven thickness of the walls presents a risk of the apex wall overturning given the macro-element Length/Height ratio of 0.605 (D'Ayala and Speranza, 2003). Another vulnerability is inherent in the disjointedness amidst the main nave's orthogonal walls and the external orthogonal wall of the bell tower which is related to the unconventional bell tower producing inertia different than that of the main block. Regarding the rear wall of the presbytery's out-of-plane behavior, a collapse is

evidenced by the upper portion being reconstructed with wooden and brick elements (Fig.5.2.10). The subsequent aspects relate to these failure mechanisms: the notable distance between the walls; the walls' great slenderness ($\lambda c = 17.5$); the ratio between length of macro-element and height on ground $L/H = 0.88$ (D'Ayala and Speranza, 2003); the absence of a connection with the roof covering; and the existence of a wide gap. Vertical fractures, evidencing the north and south transepts' walls out-of-plane behavior, denote the constructive incongruousness between the top sections of the transept facades and the lower sections, which pertain to the initial center of the Latin cross (Section 5.2.2). A previous collapse is made apparent by the reconstruction brick wedged in the original stone walls.

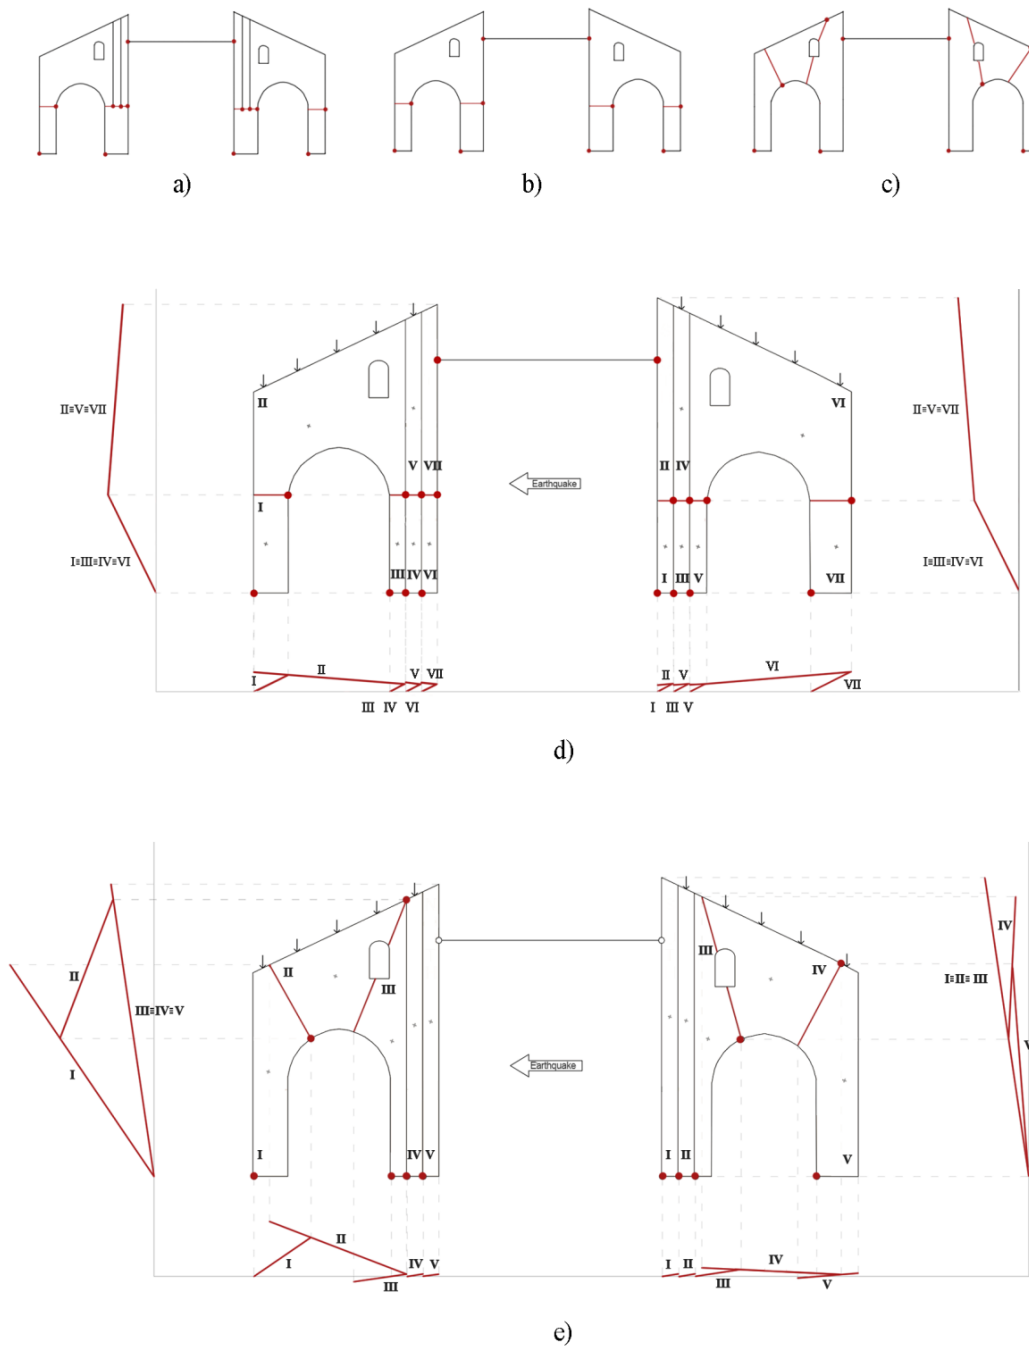
The response of the transversal arcade systems in the current state is analyzed through three mechanism scenarios, TA1, TA2, and TA3, based on visible crack patterns annotated during surveying activities (Fig.5.2.12). Different scenarios represent an increasing quality of the masonry of longitudinal walls (axis 2 and3; see Fig.5.2.1). Mechanism TA1 represents walls 2 and3 as a two-leaf masonry, thus by means of two blocks(Fig.5.1.12a), while mechanism TA2 assumes the same masonry quality for wall 2 and 3 but a complete effectiveness of the anchoring of the piers (Fig.5.1.12b).

Mechanism TA3 (Fig.5.1.12c) represents the longitudinal walls as a monolithic masonry with full effectiveness of the anchoring intervention on piers. The hypothesized direction of the action induces a counter- clockwise mono-lateral rotation of piers and a consequent clockwise rotation of upper blocks.

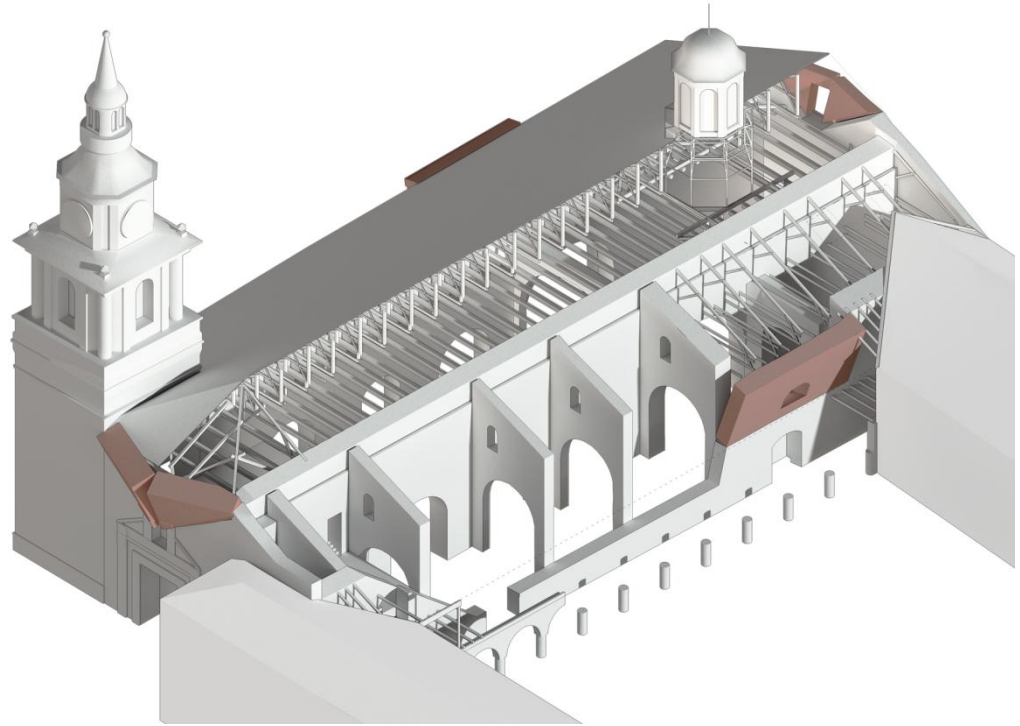
Figure 5.1.13 - Local mechanisms of collapse in current state (Stefanini, 2016).

Fig.5.1.13 shows the out-of-plane mechanisms identified for the current state. Mechanisms represent the overturning of gables of façade, and behind presbytery wall, i.e., MF and BP in Table5.2.4, whose cuneiform macro-blocks rock around two oblique cylindrical hinges, and the overturning of the north and south transept walls around cylindrical hinges placed 60 cm off the ground, NT and ST (Table5.2.4).

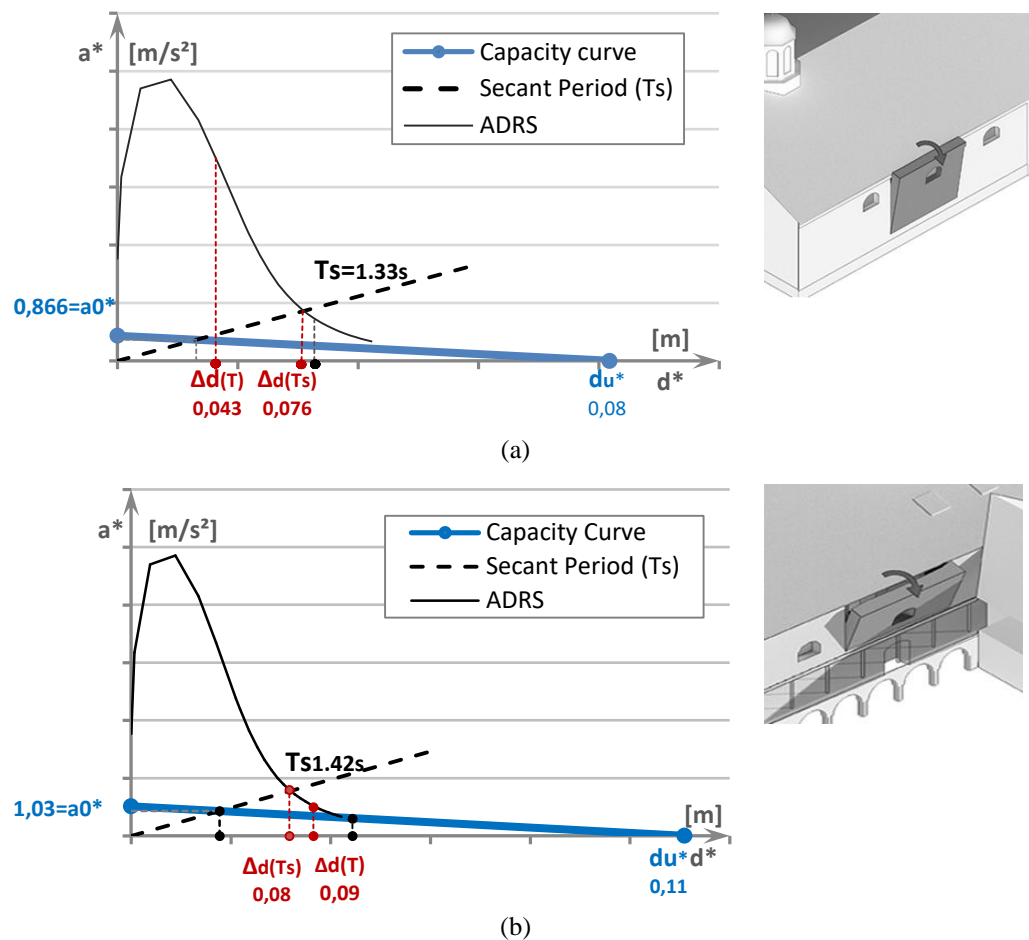
Figure 5.2.15 - Capacity and demand curves of incremental kinematic analysis: (a) north transept wall; and (b) south transept wall; and Acceleration Displacement Response Spectrum (ADRS) according to Nch2745Of.2013 (Palazzi et al., 2018c).

In order to enrich the understanding of the local response of the transept walls, considering the different nature of the mechanisms analyzed, further investigations have been carried out. In particular, the mechanisms regarding the transept walls are considered through incremental kinematic analysis (IKA). Incremental kinematic analysis (IKA) can be applied to evaluate the decrease of the kinematic multiplier α_0 due the increase of the displacement d_k of a control point

on varied geometrical configurations, repeatedly applying the principle of virtual works, assuming an increasing forcing action that cannot induce any transitory recovery of the block after the activation of motion (eq. 5.8 and 5.9). The displacement capacity curve obtained through IKA initiates with the value of acceleration necessary to activate the mechanism, a_0^* , and descends linearly, describing how the mechanism evolves until final failure, i.e., when the curve reaches nil value. Results of IKA can be used on properly damped response spectra but does not constitute an alternative to estimations offered by a nonlinear dynamic. Real out of plane mechanisms NT and ST are thus transformed into equivalent SDOF systems, whose capacity in displacement have to be compared with the related Acceleration Displacement Response Spectrum (ADRS) according to Nch2745Of.2013, as shown in Fig.5.2.15. From the comparison between the displacement Capacity and Demand (5.9) of both the transept walls, the tests are satisfied (Fig.5.2.15). Despite the activation of the mechanisms, both macro-elements (NT and ST) show a satisfactory capacity in displacement, which justifies the absence of the collapse.

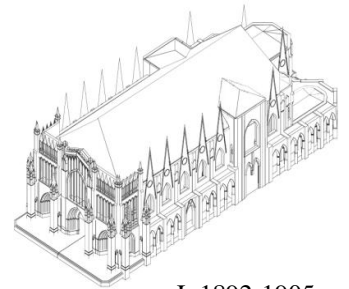
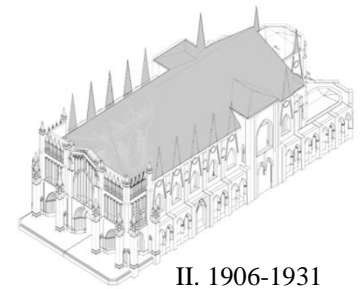
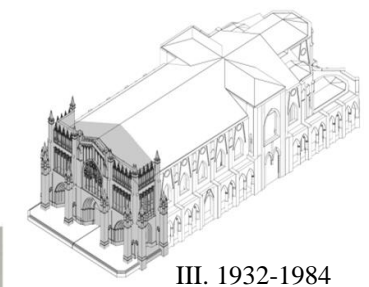
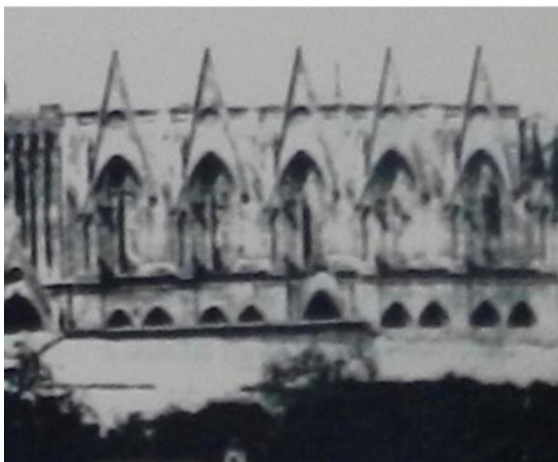
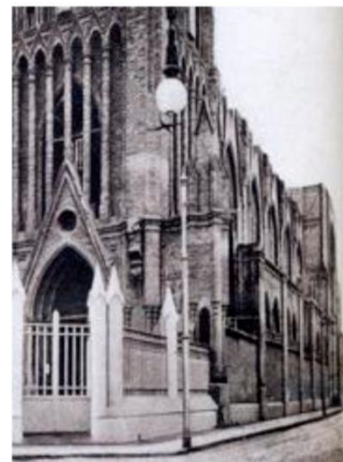
Figure 5.3.2 -Photo (a) original phase, and (b) uncertain date after 1906 (MOP)

- The Valparaíso 1906 earthquake (8.2 Mw), the first major seismic event that shook the church, completely destroyed the original roof structure, determined heavy damages in the flying buttresses, caused deep cracks in the key of windows arches of the west side aisle and of central apse. Consequently, the gables of the lateral walls and the damaged flying buttresses were demolished, the roof was replaced, and the transverse arches of the west aisle and the central apse were confined with metallic stripes, to tie the upper part of the west wall to the longitudinal arcades of the central nave (Correa, 2015).

- Following the Mendoza 1927 earthquake (7.1 Mw), the church suffered several structural, moderate and heavy, damages. The architects Smith Solar and Smith Miller modified the original façade (1928-1945), introducing a reinforced concrete ring-beam, slab and two gables on the lateral bays of the narthex (Fig.5.3.2).

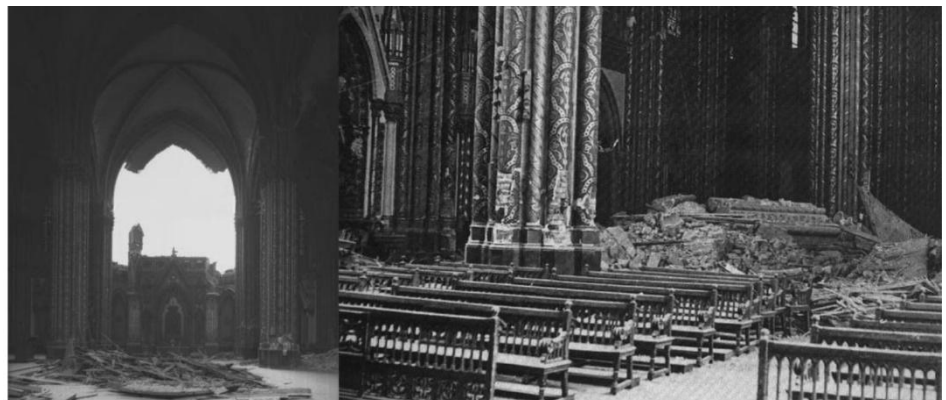
Following the 1985 seismic event, the upper part of the transept walls within two columns of the central nave arcades collapsed (Fig.5.3.3). The security measures started the same year and involved the reconstruction of the west and east transept walls with steel elements and gypsum structure, and the insertion of a ring-beam of reinforced concrete in the central apse. Two R.C. columns were erected, bound to the top of the lateral wall of west aisle. Since then, the church has remained inaccessible.

Figure 5.3.3 - Photo (a) west transept wall, and (b) two central nave columns, collapsed after the 1985 earthquake (Ministry of Public Works).

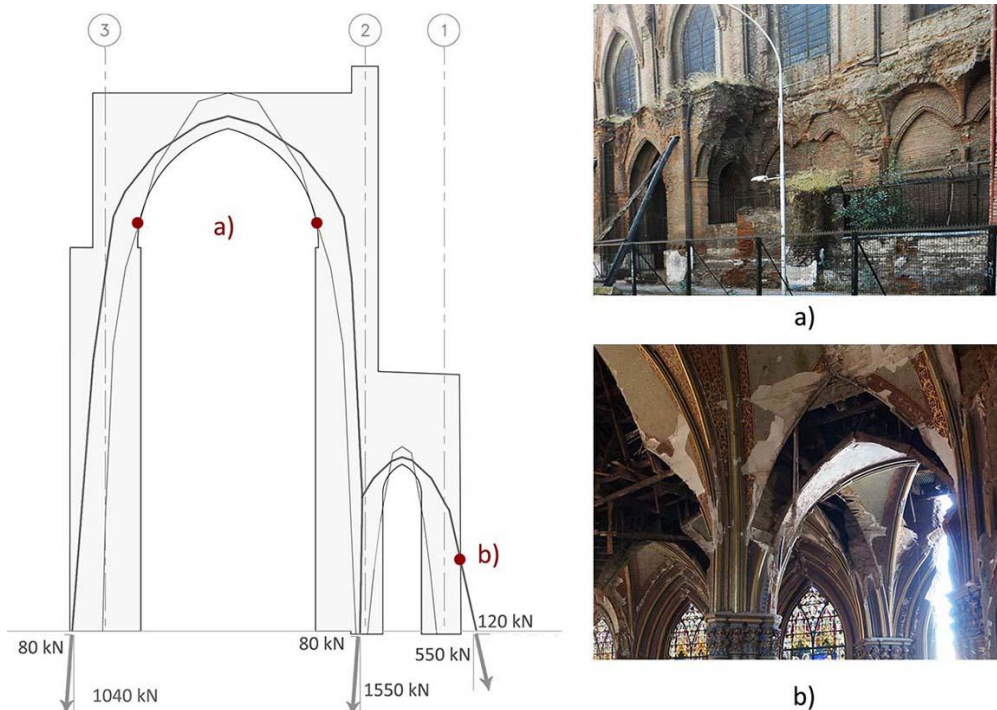
Figure 5.3.13. Thrusts line of wall portion in interception of longitudinal walls 3, 2 and 1, and transverse arcade D.

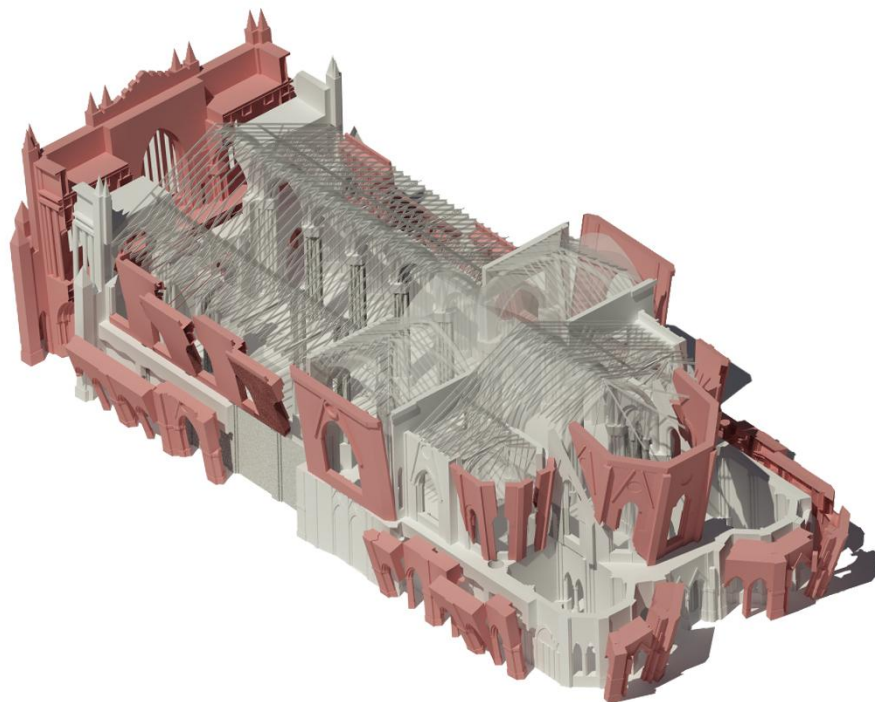
Figure 5.3.15 - Identification of local mechanisms of collapse in the current state of Basilica.

- (ii) All out-of-plane failures detected at the present state are identified in (Fig.5.3.15). The mechanisms represent the simple overturning of the rigid sub-blocks that made up the west side aisle, SAw1-2; the central, west and east lateral apses, APc, APe-w1, APe-w2, APe-w3, around cylinder hinge placed 8.5m off the ground at the level of the external gallery roof. The macro-blocks, that composed the outer walls of the gallery, EAw-e1 and EAw-e2, rock around cylinder hinge placed at ground level.

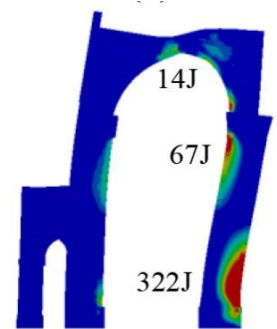
The 3D nonlinear ANSYS model by (Rendel et al., 2014) confirms the identified position of hinges (Fig.5.3.19), where cracking due to tensile stresses occurred. In particular, the SAw3 configuration is characterized by equivalent accumulated plastic strain energy at base of column is equal to 351J, at top of 88J, and in the intrados of the arch crown to 13J.

Figure 5.3.19 – Equivalent accumulated plastic strain for arch (Values correspond to the total plastic strain energy [Joules] at the base and top of the column and the arch).
