Ph.D. Thesis

**SEISMIC FRAGILITY ASSESSMENT OF
UNREINFORCED MASONRY CHURCHES IN
CENTRAL CHILE**

A dissertation presented by
Nuria Chiara PALAZZI

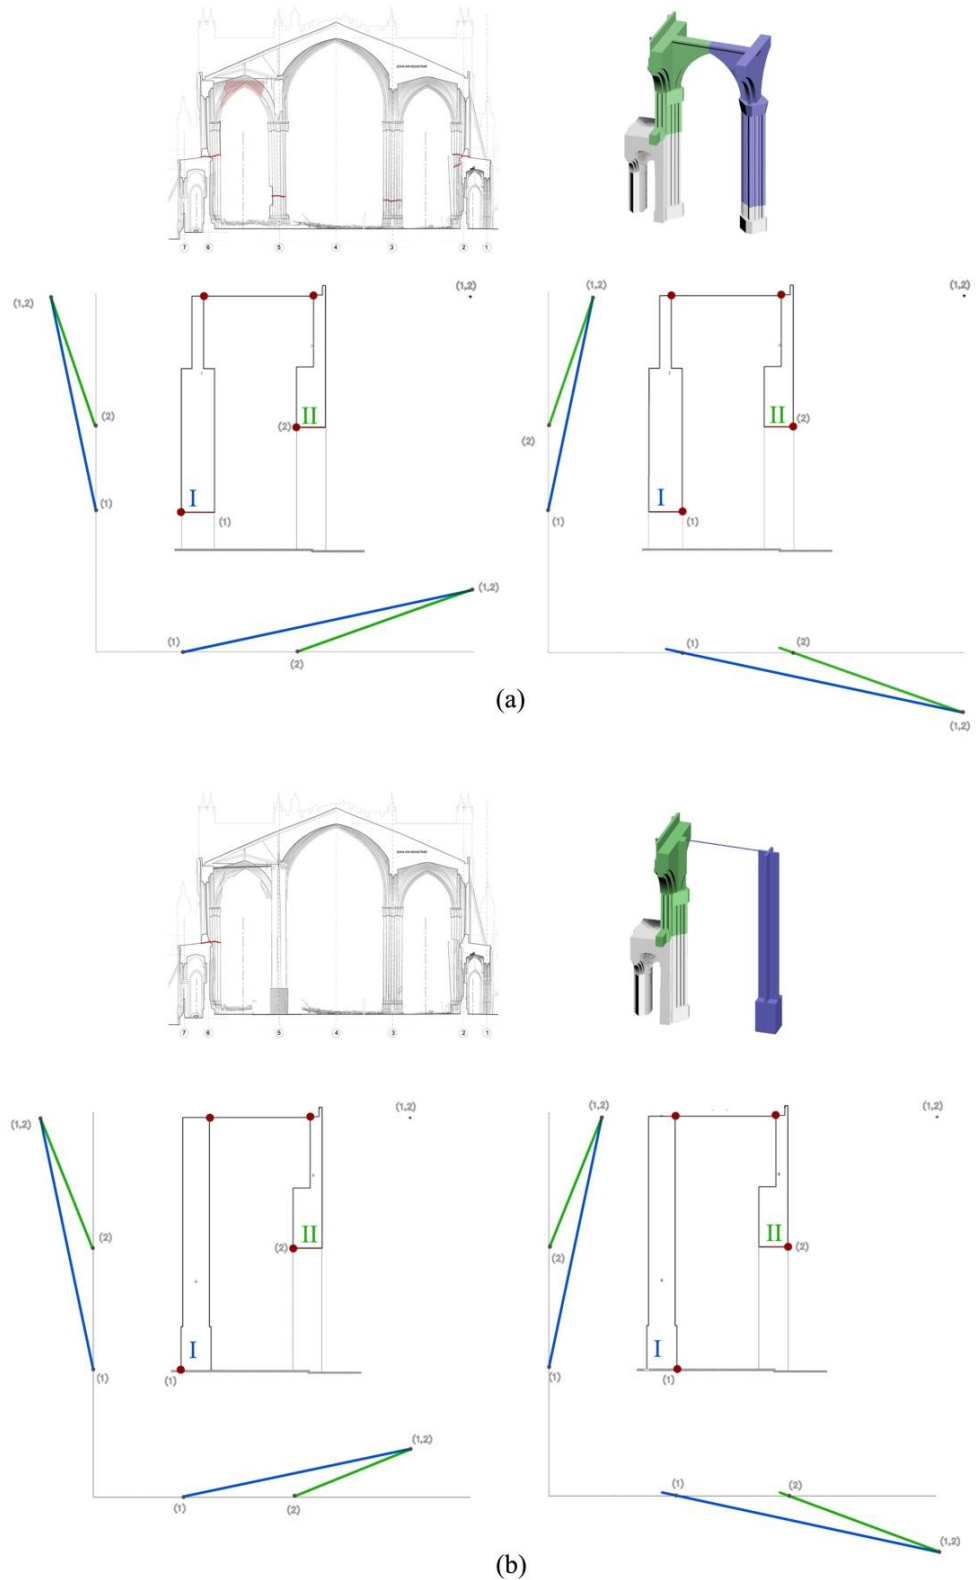
- (i) Concerning the in-plane behavior, the activation of four-hinge collapse mechanisms has been detected in all the transverse arcades of the side aisles (Fig.5.3.11). As predicted by the theoretical models (Romano&Ochsendorf, 2009; Misseri&Rovero, 2017), this failure depends fundamentally on the thickness of arch (defined by the ratio of the thickness compared to the pointed radius, t/R_{point} , and the ratio of the eccentricity compared to the circular radius, e/R_{circ}) and on the angle of embrace (α). In fact, the transverse arcades of the Basilica present a

Figure 5.3.17 – In-plane mechanism of the transverse arcade of the side aisles: (a) SAw-e (original configuration) west and east side aisles; and (b) SAw3-4 (current state) west side aisle.

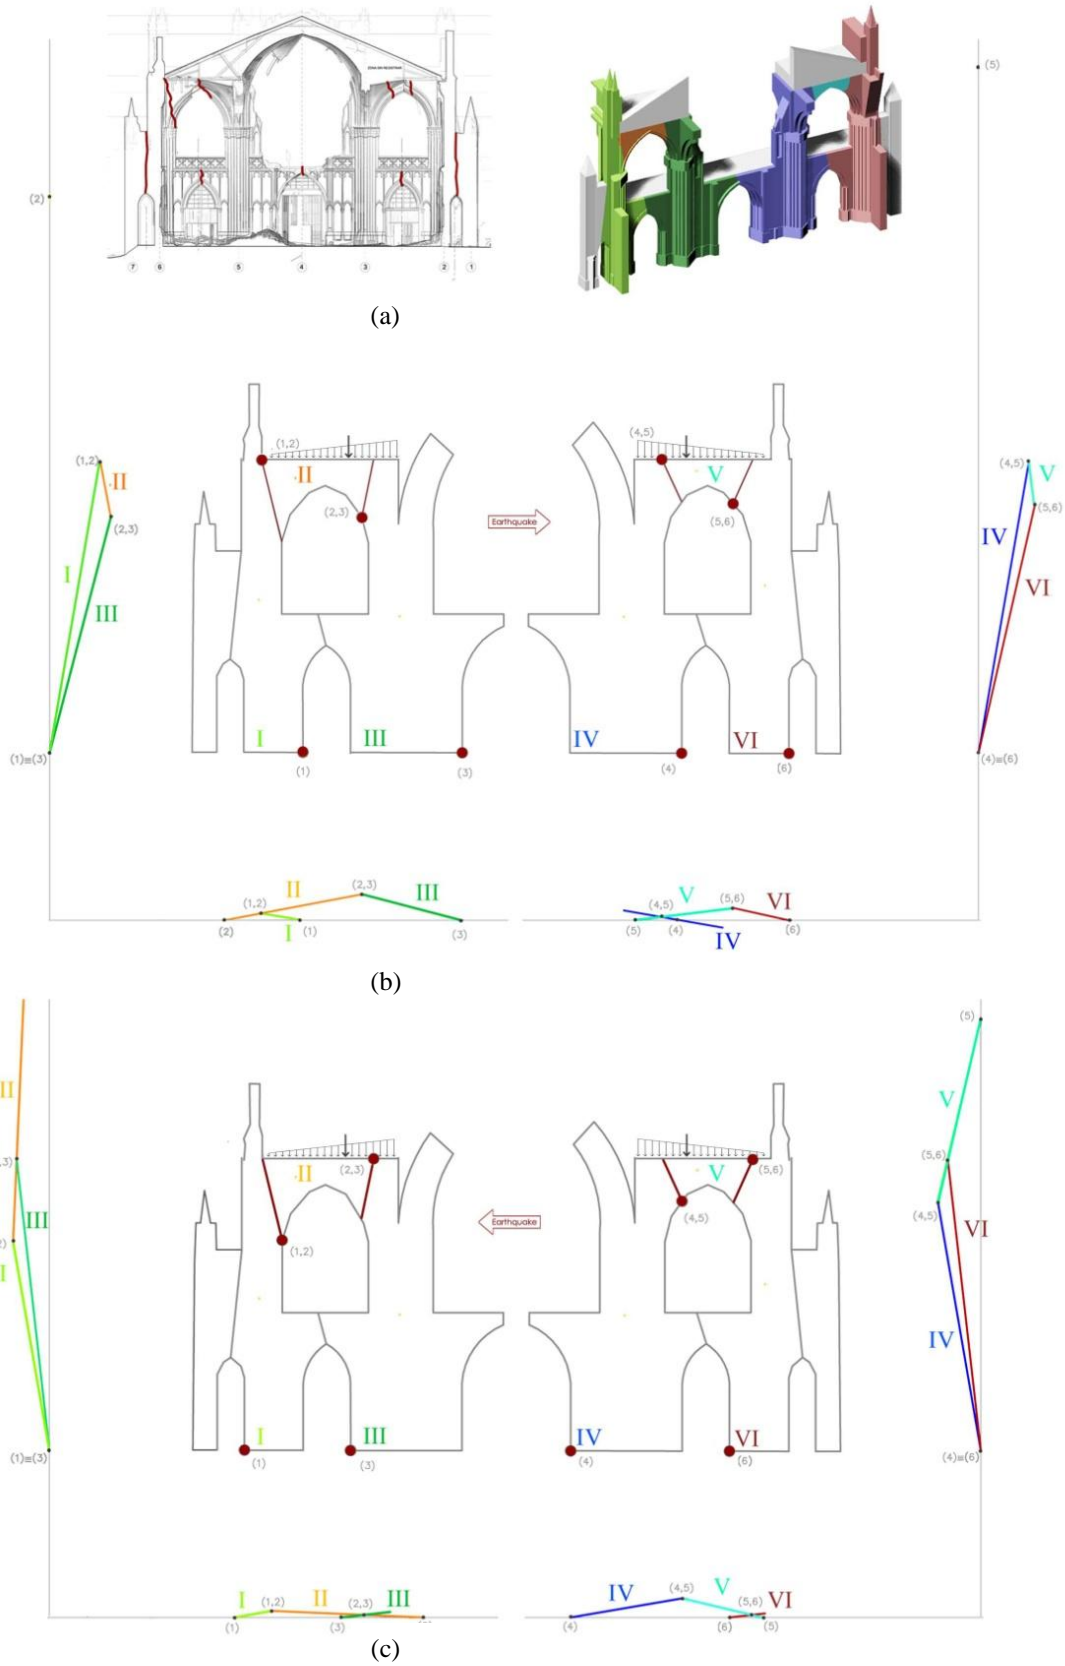
In relation to the in-plane behavior of the transverse arcade-walls of the narthex, dangerous disconnections occurred in the arches system during past seismic shake, both in the 1985 and 2010 earthquakes. If on one hand, the RC slab

Figure 5.3.18– In-plane mechanism of the transverse arcade of the Narthex at the current state.

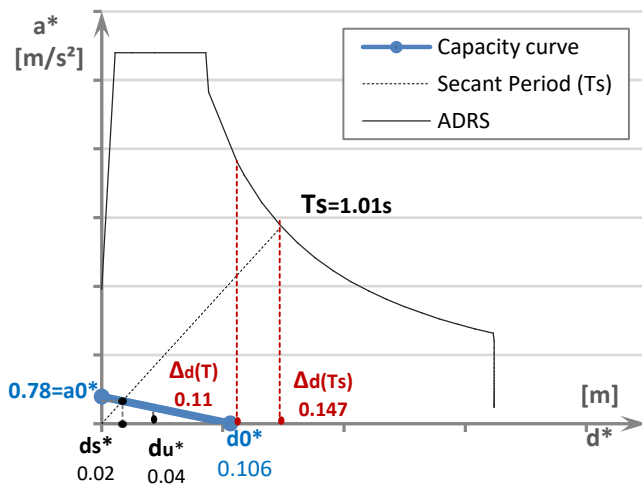
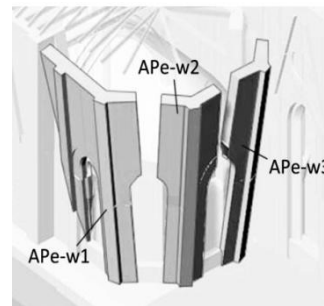
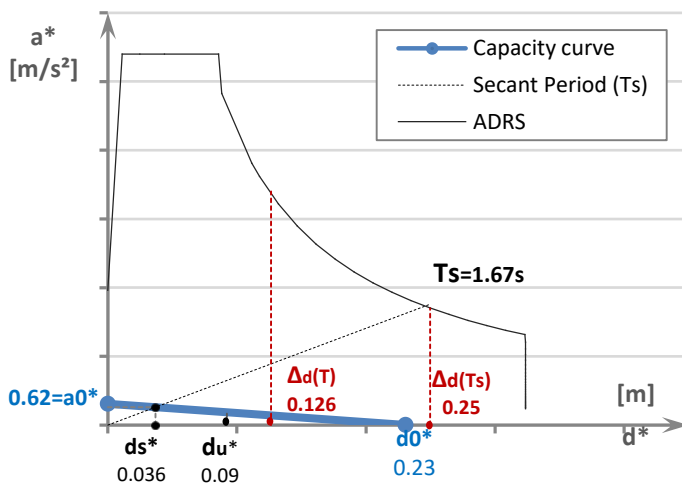
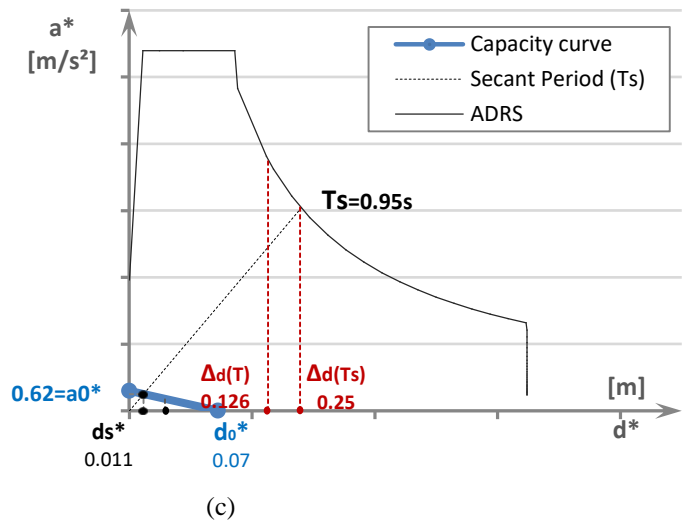
From the comparison between the displacement Capacity and Demand, eq. (5.9), of each mechanisms analyzed, the checks no are satisfied (Fig. 5.3.19, 20 and 21). The Capacity Spectrum highlights the limit condition in terms of displacement of the all macro-elements, coming to collapse. The damage scenario is in concord with the crack pattern annotated during the surveying.

Figure 5.3.19- Capacity and demand curves of incremental kinematic analysis of the three sub-portions of the lateral apses: (a) Ape-w1 (b) Ape-w2 and (c) Ape-w3; and Acceleration Displacement Response Spectrum (ADRS) according to Nch2745Of.2013.

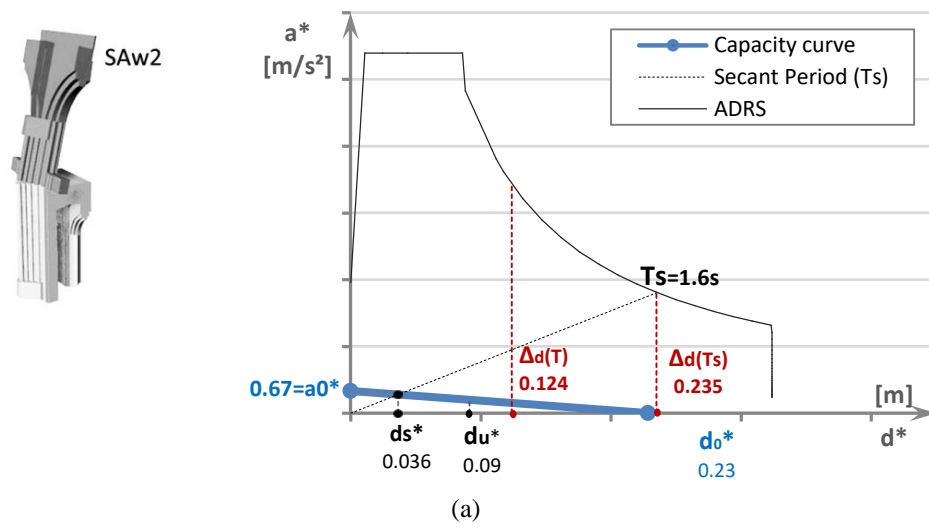
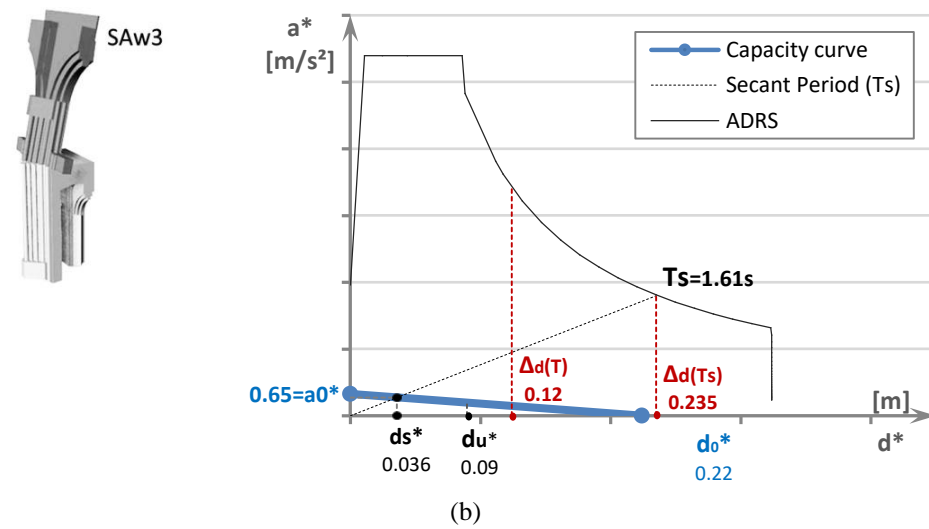
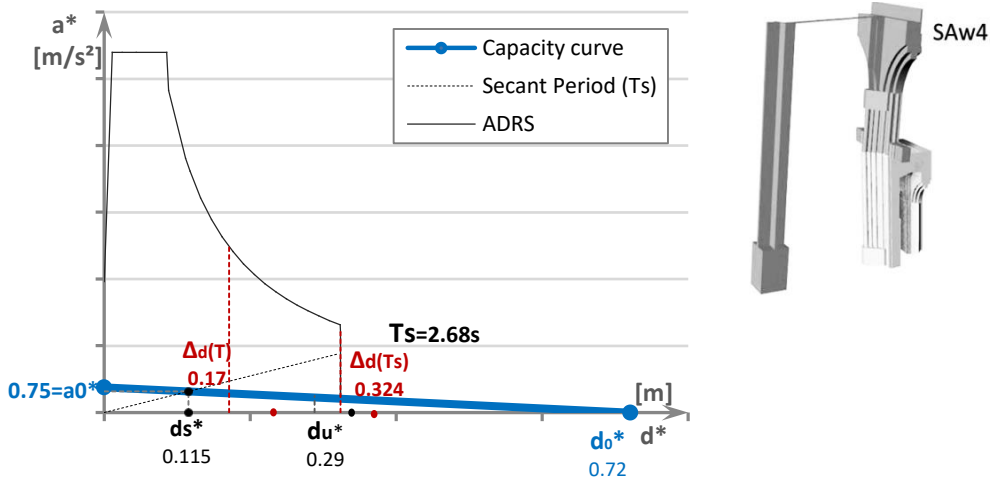
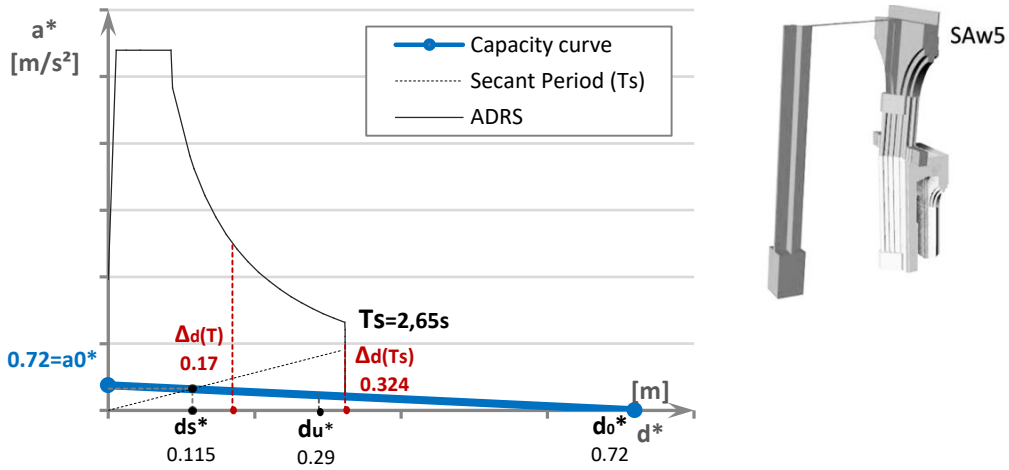
Figure 5.3.20 - Capacity and demand curves of incremental kinematic analysis, four sub-portions of the west side aisle wall: (a) SAw1 (b) SAw 2, (c) SAw 3, and (d) Saw4; and Acceleration Displacement Response Spectrum (ADRS) according to Nch2745Of.2013.

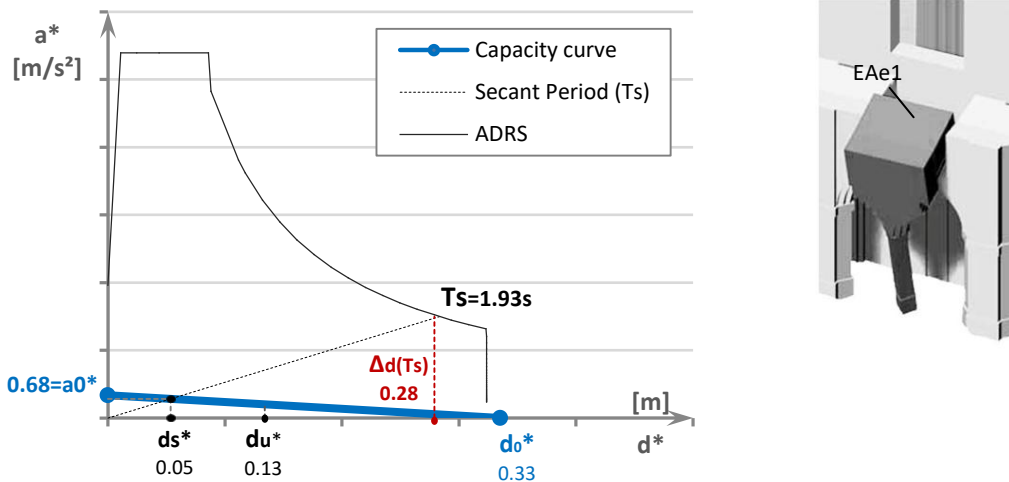
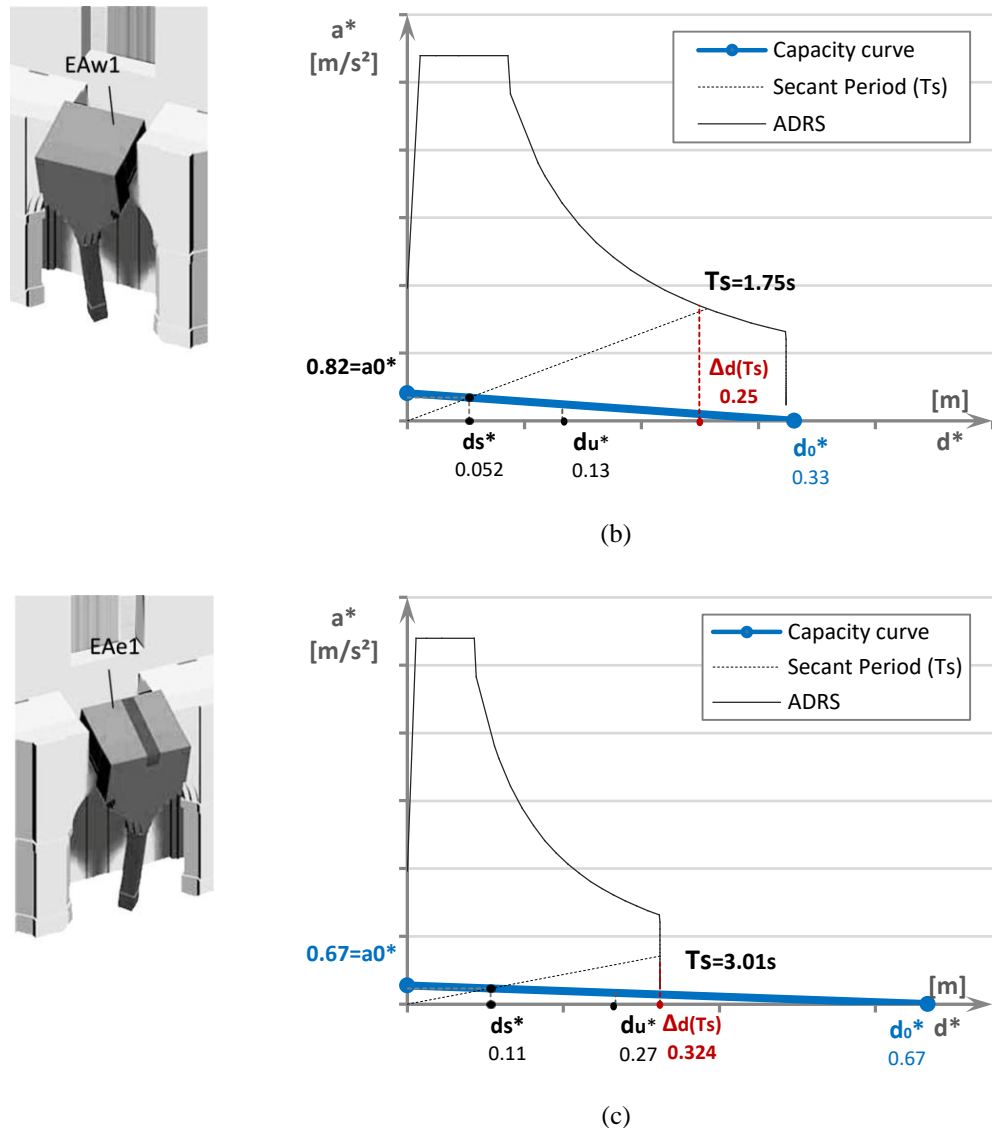
Figure 5.3.21- Capacity and demand curves of incremental kinematic analysis, three sub-portions of the west and east external gallery: (a) EAe-w2, (b) EAw 1, and (c) EAe1; and Acceleration Displacement Response Spectrum (ADRS) according to Nch2745Of2013.

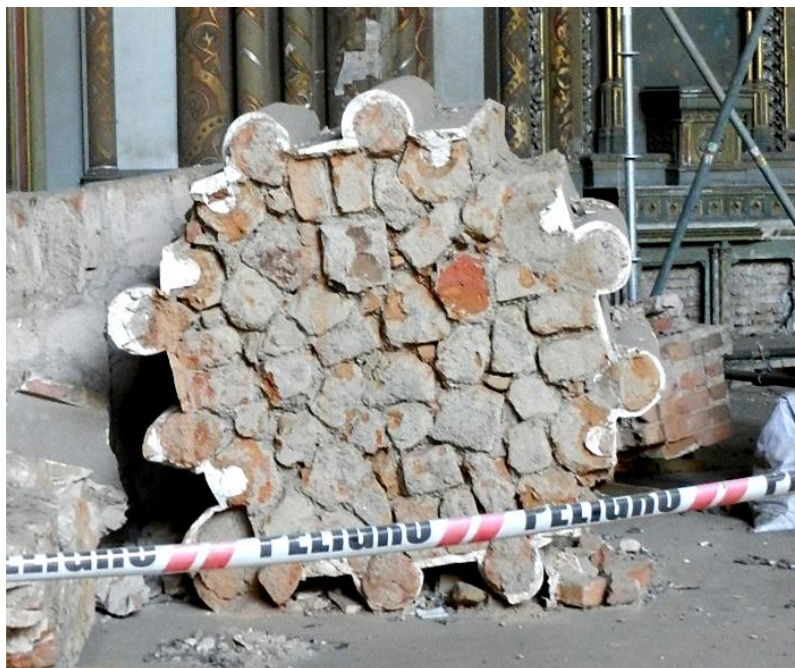
Figure 6.15 – Column section of Basilica del Salvador

With the aim of improving the cohesion and coherence of the Basilica's masonry columns (Fig.6.15), Chapter 5.3, grout injections are proposed. Mineralogical and petrographic studies of column mortar sample (M4, Chapter 5.3.2) were carried out to define the grout injection features. The results of the analysis showed that the M4 sample consists of a particularly lean mixture (binder/aggregate 1/3-1/4), comprised of volcanic fragments (Andesine ((Na,Ca)(Si,Al)4O8)), feldspars ((Al,B,Si)4O8), and *cocciopesto*. The aggregate has a bimodal granulometry (prevalent 600-800 μ m, 1,5-3 secondary) with granules of a basically rounded shape, which indicates a fluvial origin. Composition is predominantly of volcanic rock

fragments compared to single granules. Thus, inorganic binders such as hydraulic-lime or ternary grouts are suggested for GI intervention.

After the study of mortar grout composition, the GI procedure comprises: choice of injection points (2-3 injection points/m²), plaster removal, drilling of 40mm diameter spaced on a 400mm grid, sealing and repointing of the mortar joints, assessment of the injection pressure, and GI with fluid lime-based grout through a ultra-fine aggregate and low salt content.

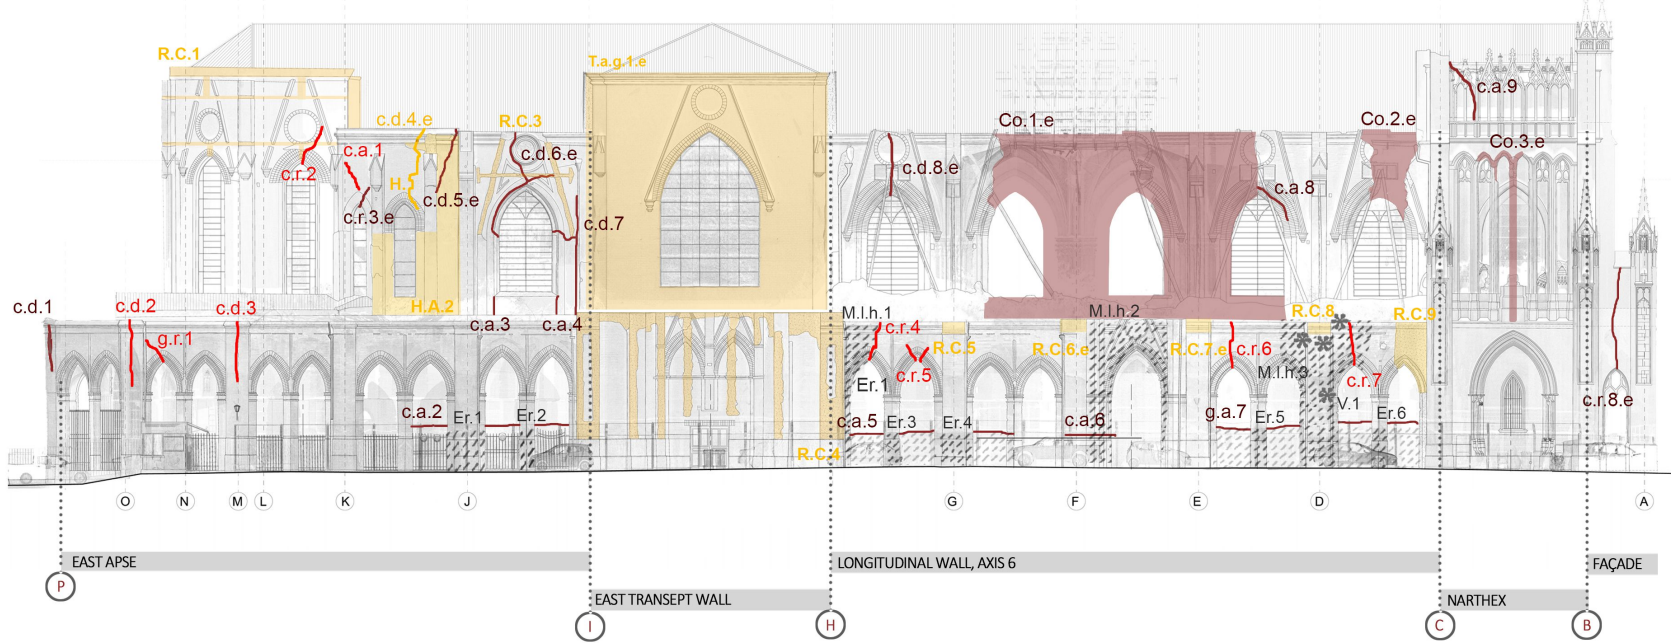
EAST ELEVATION, AXIS 2

D.b.i Detachment of beam or metal tie
~~—~~ Detachment of beam or tie-rod and loss of operability or, and / or severe deformation of a key
P.H. Crack pattern after 2010 Maule earthquake
