# An Innovative Method Based on In Situ Deformometric Monitoring to Support Decisions for the Structural Restoration of a Historic Panel Painting

**Abstract:** This paper describes an innovative method developed by the authors to support basic decisions concerning the structural restoration of a large historical panel painting which had been damaged by inappropriate attachment to a wall and ongoing exposure to severe changes in environmental humidity. The *Lapidazione di Santo Stefano* is a large panel (2.78 × 3.92 m<sup>2</sup>) painted by Giorgio Vasari in 1571 and has been housed since then in the Church of Santo Stefano dei Cavalieri in Pisa (Italy). Its wooden support is made of large horizontal planks glued together along their edges and stiffened by vertical, dovetailed crossbeams. The panel was tightly fastened to a church wall with several rigid bolts; due to the moisture cycling produced by rainwater leakage and a subsequent “compression set”, it had developed severe tension stresses perpendicular to the grain, resulting in cracks affecting both the wood and the paint layers. To decide how to carry out the structural restoration of the panel, it was necessary to know whe

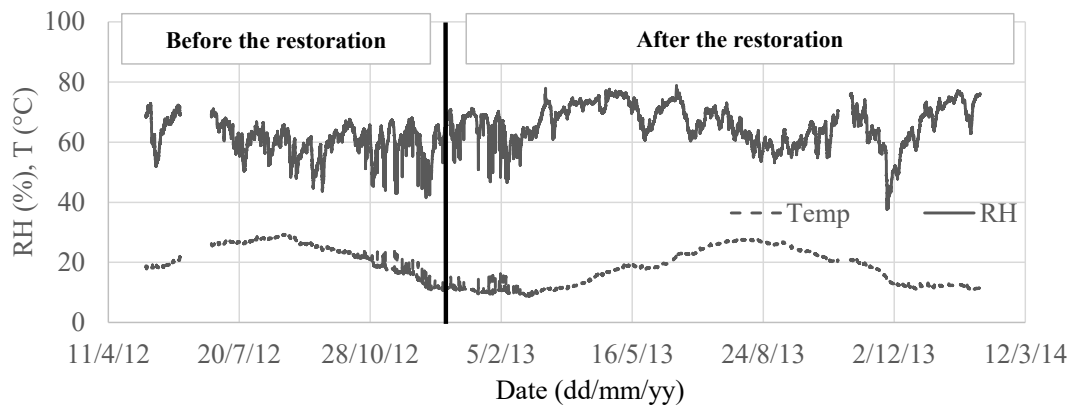
**Figure 5.** The graph shows the climatic conditions the panel painting underwent before and after the restoration. Note. Due to the unforeseen exhaustion of some batteries, data are missing for approximately the month of June.
