The Historic Timber Roof of "Giordano's Warehouse" in Vallombrosa: Design, Story and Collapse

Marco Togni *, **Luca Uzielli***, **Nicola Venturi ***, **Alberto Bronzi ****

DISTAF – Department of Forest Environmental Sciences and Technologies, Firenze *, CFS – *Corpo Forestale dello Stato*, Firenze **

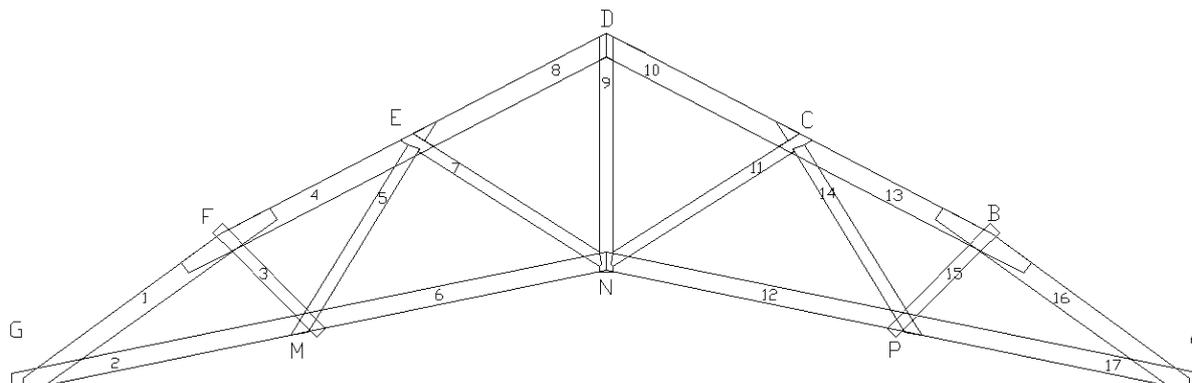
Figure 2. The truss with the labels of the joints and the timber members, as proposed by Giordano.

The data shows the critical nodes could be the central ones, "D" and "N", due to the highest number of timber members which were concurrent, and the high number of nails and T irons, for the high load to be transferred.

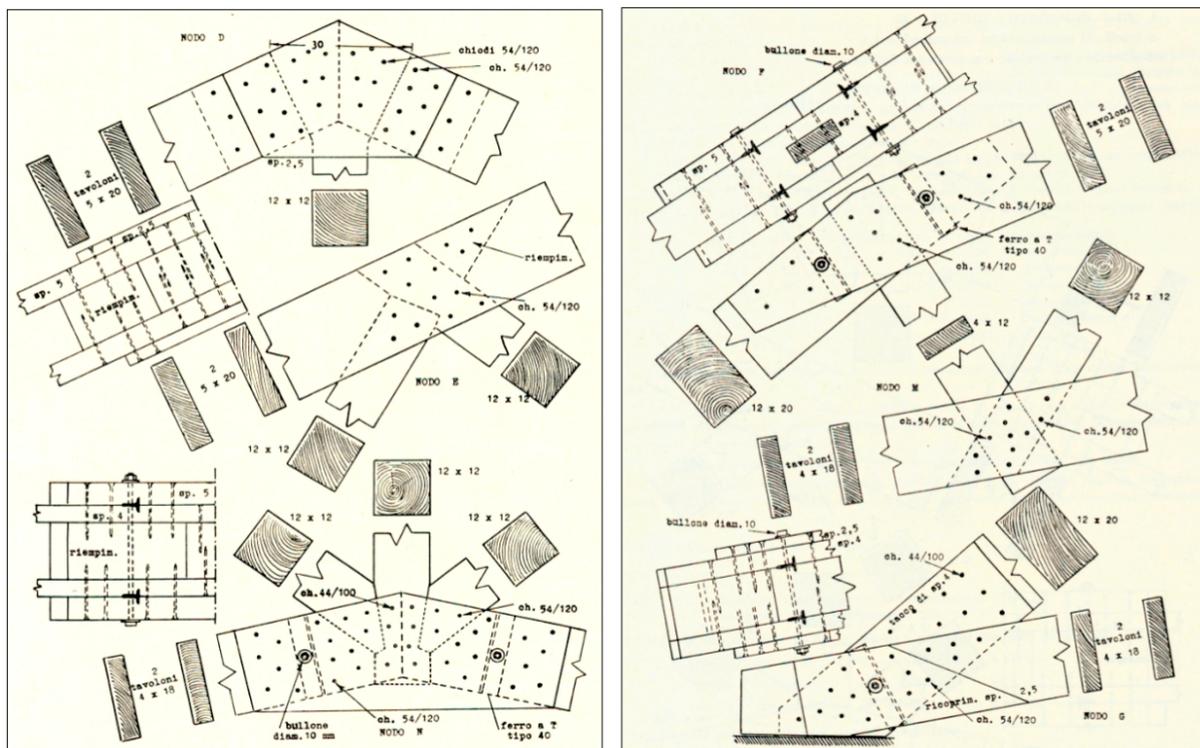
Figure 3. Original illustrations of the composition of nodes [Giordano, 1964, pp. 417-418].

The connections were joined with simple nails, 100 e 120mm long. To simplify assembly, Prof. Giordano prepared a rigid template for each joint, in which the holes necessary to place the nails in the correct number and position were punched.
