Seismic Behavior Assessment of a Brazilian Heritage Construction

Seismic behavior assessment of a Brazilian heritage construction

ABSTRACT. Preservation of historical constructions, and passing it on to future generations, is a major issue in modern societies. Earthquakes are one of the major causes of damages to heritage buildings across the world. The city of Sobral (Ceará State, Brazil) keeps in its historic center a large number of heritage buildings and, since 2008, an intense seismic activity has been observed. This study aims to contribute to the preservation of the Sobral heritage constructions against seismic loads through the assessment of the seismic behavior of one representative building: the Nossa Senhora das Dores Church, a 19th century historical construction. First, a 3D finite element (FE) model was built and tuned according to the results of dynamic tests performed under environmental loads. Next, the FE model was employed to assess the seismic behavior of the church by performing linear time-history analyses employing two real earthquakes. The results showed big displacements and high stresses in many parts of the church, allowing to identify the most critical

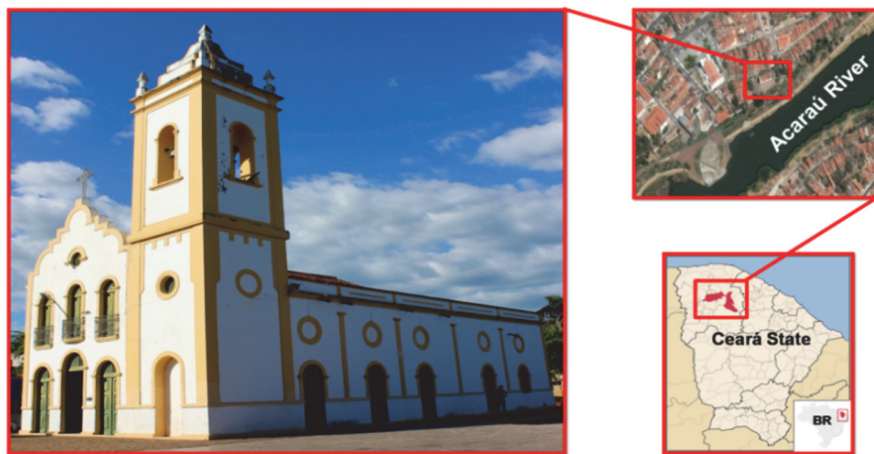
Figure 4: View of the Nossa Senhora das Dores Church with its location in Sobral City and location of Sobral city in Ceará State.

The Nossa Senhora das Dores Church (Fig. 4) is one of the most important historical buildings of the Sobral historic center, near the Acaraú River. Sobral is a city 345 years old, that keeps one of the largest and most important historic city centers of Brazil, with over around 1,200 properties registered by National Historic and Artistic Heritage Institute (IPHAN). This structure was chosen as case study being representative of the studies that should be performed on the Brazilian heritage constructions.
