Seismic Behavior Assessment of a Brazilian Heritage Construction

Seismic behavior assessment of a Brazilian heritage construction

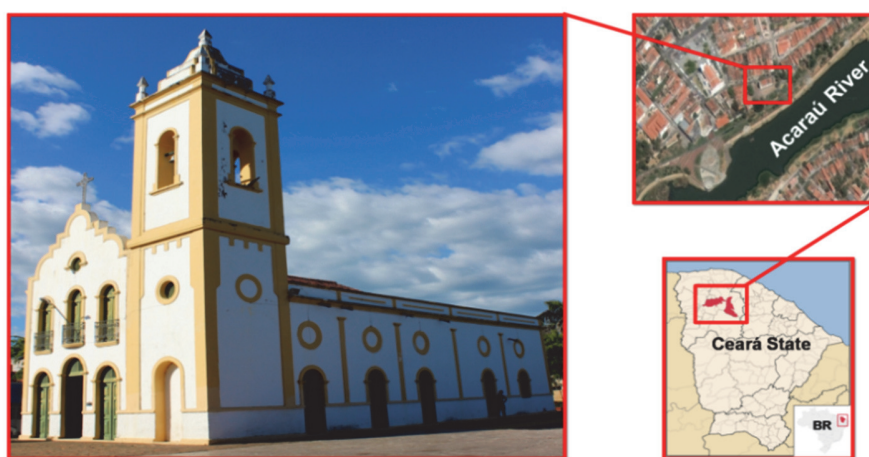
Figure 4: View of the Nossa Senhora das Dores Church with its location in Sobral City and location of Sobral city in Ceará State.

The Nossa Senhora das Dores Church (Fig. 4) is one of the most important historical buildings of the Sobral historic center, near the Acaraú River. Sobral is a city 345 years old, that keeps one of the largest and most important historic city centers of Brazil, with over around 1,200 properties registered by National Historic and Artistic Heritage Institute (IPHAN). This structure was chosen as case study being representative of the studies that should be performed on the Brazilian heritage constructions.

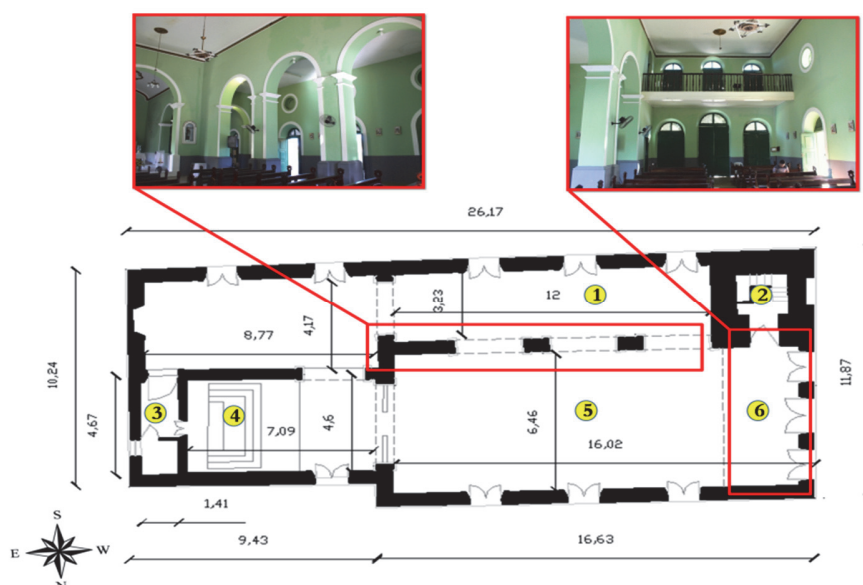
Figure 5: Schematic view of geometry of the Nossa Senhora das Dores Church, where (1) is the Lateral nave, (2) is the Lateral Tower, (3) is the office, (4) is the Altar-Mor, (5) is the Central Nave and (6) is the Coro-Alto.

The church dates back from the beginning of the 19th century and was built in a place where there was a small niche in the old Rio street, near the Acaraú River [27]. This church is very close to the Igreja da Sé of Sobral, and next to the urbanization of the near left of the Acaraú River. Its structure is composed of clay bricks masonry, and the church was built using local constructive techniques. The church's geometry, shown in Fig. 5, is almost regular with a length of about 26.2 m and a width of about 11.9 m; there is a lateral tower 20.50 m high. The structure is divided in a Central Nave (about 6.5 m × 16.0 m) and in a Lateral Nave (about 3.2 m × 12.0 m), separated by two columns and three arches. The Coro-Alto, the Altar-Mor and an office are located at the end of the building (Fig. 5).
