Seismic Behavior Assessment of a Brazilian Heritage Construction

Seismic behavior assessment of a Brazilian heritage construction

ABSTRACT. Preservation of historical constructions, and passing it on to future generations, is a major issue in modern societies. Earthquakes are one of the major causes of damages to heritage buildings across the world. The city of Sobral (Ceará State, Brazil) keeps in its historic center a large number of heritage buildings and, since 2008, an intense seismic activity has been observed. This study aims to contribute to the preservation of the Sobral heritage constructions against seismic loads through the assessment of the seismic behavior of one representative building: the Nossa Senhora das Dores Church, a 19th century historical construction. First, a 3D finite element (FE) model was built and tuned according to the results of dynamic tests performed under environmental loads. Next, the FE model was employed to assess the seismic behavior of the church by performing linear time-history analyses employing two real earthquakes. The results showed big displacements and high stresses in many parts of the church, allowing to identify the most critical

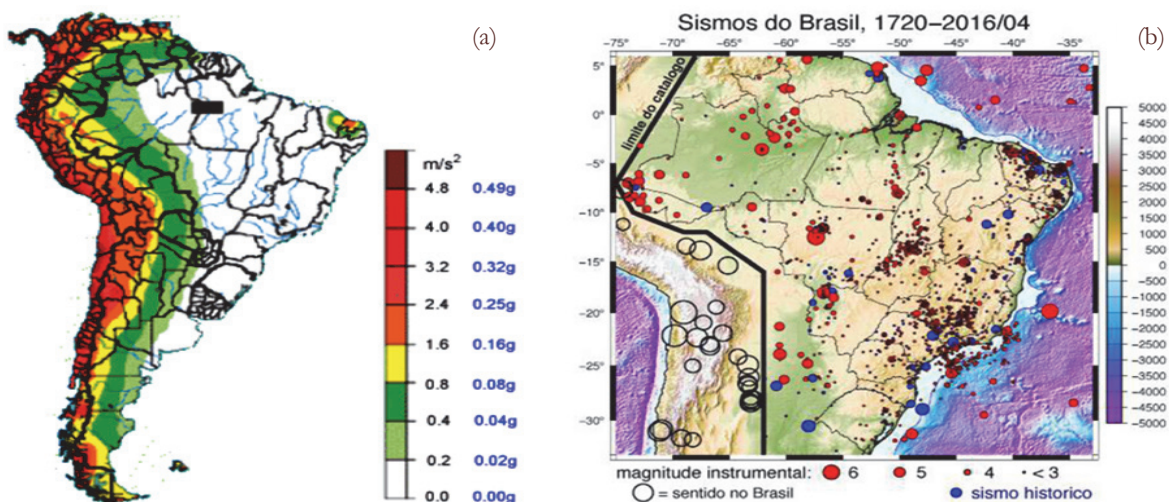
Figure 1: Brazilian seismicity: (a) map of the seismicity of South America [24] and (b) Brazilian Seismic Catalog [19].

A map of the South America seismic hazard, produced by United States Geological Survey (USGS), is shown in Fig. 1.(a): Peak Ground Accelerations (PGA) are reported both in m/s^2 and as a fraction of g (the acceleration due to gravity) with a 10% probability of being exceeded in 50 years [24]. This figure shows that there is a large part of Brazil where there is not seismic activity or it is practically null (white area), however, in the northeast region of the country is possible to observe a small area seismically active, more precisely, the area between the states of Ceará, Rio Grande do Norte and Paraíba, that have considerable values of PGA, ranging between 0.02 g and 0.25 g . Fig. 1.(b) shows the Brazilian seismic catalog which, according to [19] indicates all the earthquakes already cataloged in the country from 1720 to 2016. The map includes ancient and recent earthquakes, and only superficial earthquakes are shown (i.e. depth < 50 km). The blue circles are epicentres of historical earthquakes with magnitude estimated from the macrosismic effects. The red circles are epicentres of earthquakes recorded by seismographic stations. The empty circles - in the Andes - are epicentres of earthquakes in which the seismic waves have caused the oscillation of tall buildings in some Brazilian cities. Fig. 1 confirms that the northern part of the Ceará State, where the city of Sobral is located, has been affected by an intense seismic activity.

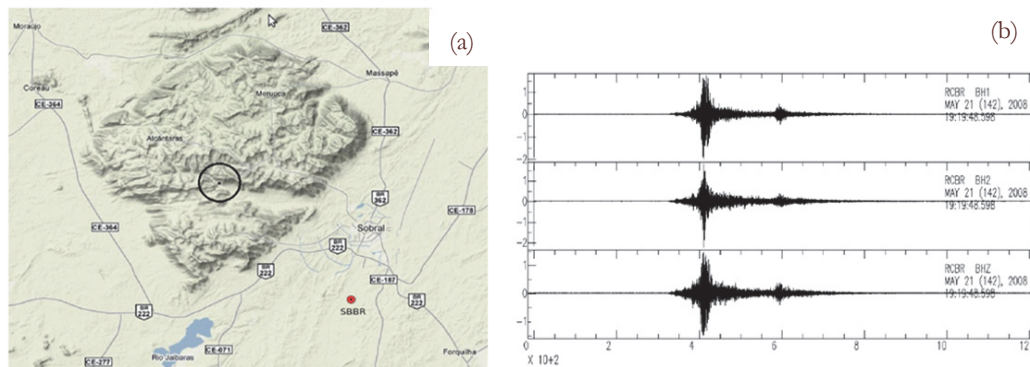
Figure 2: (a) geographical position of the earthquake of magnitude 4.2 m_b registered in 05/21/2008 (black circle) and (b) Seismogram of the event, where BH1 represents the component E-W, BH2 represents the component N-S and BHZ represents the vertical component (adapted from [25]).

mically active area, where in 1980 an earthquake of magnitude of 5.2 m_b was registered in the Pacajús city. The seismic activity in the northeast region of Ceará State, more precisely, in the Sobral region, is very old and it is the second most important in the Brazilian northeast, being preceded only by the region of the edge of the Bacia Potiguar, that includes a large part of the State of Rio Grande do Norte and the eastern part of the Ceará State. Since 2008 an intense seismic activity in the Sobral region has been observed, where several earthquakes have occurred and the big of these was occurred on 05/21/2008, of 4.2 m_b magnitude. The geographical position of the event and the seismogram recorded by the Riachuelo station (RCBR), located at Riachuelo-RN at approximately 572 km away from Sobral city, are shown in Fig. 2. These events have caused damage in some buildings.

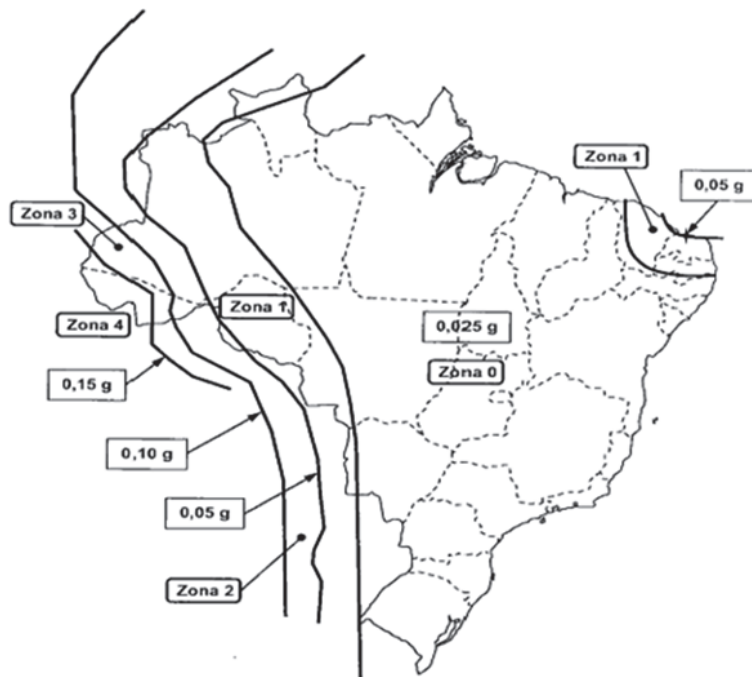
Figure 3: Seismic zones of Brazil [20].

fine the five Brazilian seismic zones presented in Fig. 3, with reference to the values of the ground accelerations for each zone as: Zone 0 – $a_g < 0.025 g$; Zone 1 – $0.025 g < a_g \leq 0.05 g$; Zone 2 – $0.05 g < a_g \leq 0.10 g$; Zone 3 – $0.10 g < a_g < 0.15 g$; and Zone 4 – $a_g > 0.15 g$.

Analyzing the seismic zones shown in Fig. 3, it is possible to observe that a large part of Brazil is covered by Zone 0, that causes a maximum ground acceleration of $0.025 g$, that is, the soil moves at a maximum speed of about 0.245 m/s^2 . However, in some North-Eastern states, such as Ceará, Rio Grande do Norte and Paraíba, most of their territories are located in Zone 1, that has the maximum ground acceleration of $0.05 g$ that corresponds to 0.490 m/s^2 .

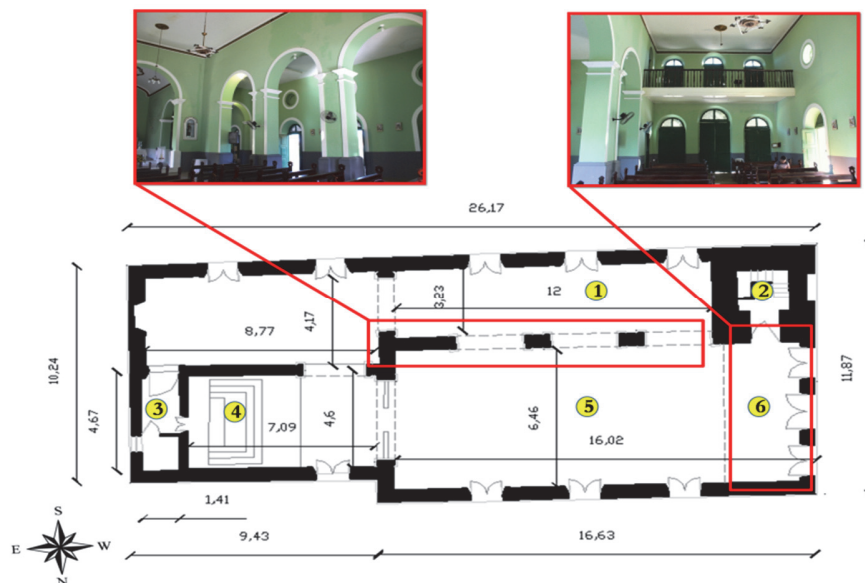
Figure 5: Schematic view of geometry of the Nossa Senhora das Dores Church, where (1) is the Lateral nave, (2) is the Lateral Tower, (3) is the office, (4) is the Altar-Mor, (5) is the Central Nave and (6) is the Coro-Alto.

The church dates back from the beginning of the 19th century and was built in a place where there was a small niche in the old Rio street, near the Acaraú River [27]. This church is very close to the Igreja da Sé of Sobral, and next to the urbanization of the near left of the Acaraú River. Its structure is composed of clay bricks masonry, and the church was built using local constructive techniques. The church's geometry, shown in Fig. 5, is almost regular with a length of about 26.2 m and a width of about 11.9 m; there is a lateral tower 20.50 m high. The structure is divided in a Central Nave (about 6.5 m × 16.0 m) and in a Lateral Nave (about 3.2 m × 12.0 m), separated by two columns and three arches. The Coro-Alto, the Altar-Mor and an office are located at the end of the building (Fig. 5).

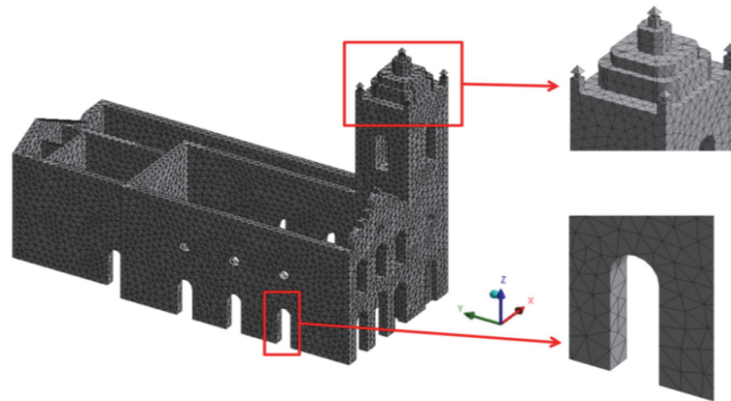
Figure 6: View of the 3D finite element numerical model of the Nossa Senhora das Dores Church.

Based on a geometric survey, provided by IPHAN-CE, and on the geometric characteristics observed by visual inspection, a 3D numerical model of the Nossa Senhora das Dores Church was built (Fig. 6). To build the 3D FE model some simplifications were done, aimed to reduce possible discontinuities in the finite element mesh. The architectural details of the main façade, the reinforced-concrete (RC) stair, the roofs and the Coro-Alto were not included in the model, but their respective loads and masses were applied on the corresponding walls.

The FE model was built with the commercial code ANSYS; SOLID187 tetrahedral elements with quadratic displacement behavior were employed (the finite element is defined by 10 nodes having three degrees of freedom at each node). A mesh-size of about 500 mm was adopted and the final FE model, shown in Fig. 6, was built with 53,889 elements and 93,380 nodes.

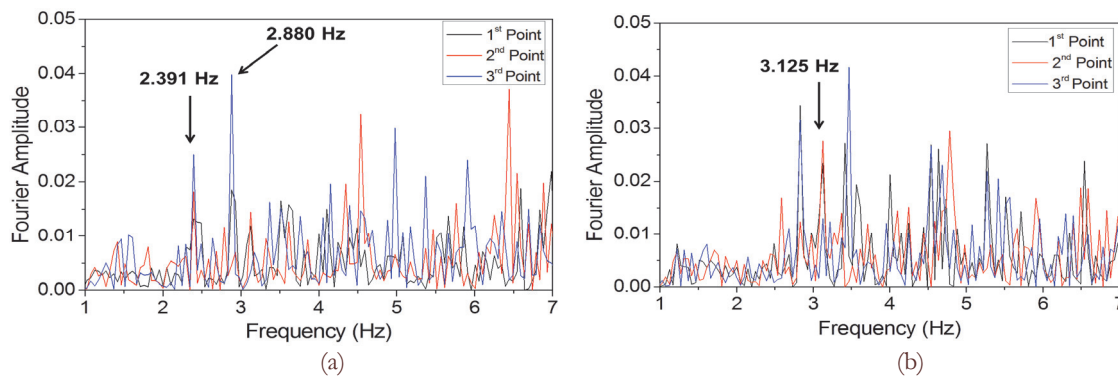
Figure 7: Fourier spectrum in (a) X direction and (b) in Y for the three points tested.

The numerical model of the Nossa Senhora das Dores Church was subsequently calibrated based on the experimental results obtained by performing environmental vibration tests (EVT). From the EVT, three testing positions were recorded and the Fourier Spectrum on the two principal directions of the Church was calculated. The obtained results are shown in Fig. 7.(a) for the X direction (the transversal one) and in Fig. 7.(b) for the Y direction (the longitudinal one). Analyzing the two spectra, it can be inferred that the first 3 natural frequencies of the church are included in the range between 2.00 Hz and 3.50 Hz. Analyzing the frequencies with the highest amplitude with respect to each main direction of the church, the first fundamental frequency resulted 2.391 Hz in the X direction, the second was 2.880 Hz also in the X direction since the amplitude of the first two peaks in the X direction is greater than in Y direction. The third natural frequency was obtained in the Y direction, with the third peak of the spectrum in Fig. 7.(b), and was characterized as 3.125 Hz because in this direction its amplitude is greater than the third peak of spectrum in Fig. 7.(a).

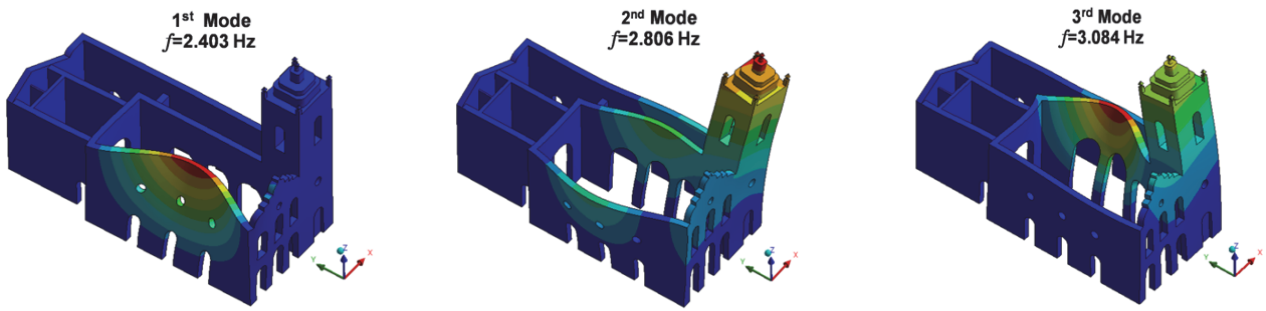
Figure 8: First three modal shapes of the Nossa Senhora das Dores Church.

The elastic parameters of the FE model were hence calibrated in order to fit the natural frequencies obtained by the EVT, assuming as starting values the ones estimated in accordance with the Italian recommendation [31]. The specific weight and the masses have been keeping constant, and the Young's Modulus has been iteratively updated (within the range from 1.50 GPa to 1.75 GPa) in order to fit the experimental values. The first three natural frequencies were assumed sufficient for the calibration. It is worth noting that, after calibrating the Young's Modulus in order to reproduce the first numerical natural frequency, a good adherence between experimental and numerical results was also obtained for the second and third frequency, denoting that the numerical model reproduces correctly stiffness and masses of the church. The final identified Young's Modulus was equal to 1.70 GPa. With this fitting, based only on the first frequency, the results and the errors associated with each frequency are shown in Tab. 3, while the first three numerical modal shapes are shown in Fig. 8.

Analyzing the numerical modal shapes of the church (Fig. 8), it is possible to observe that the first mode shape involves the translation in the weakest transversal direction (X direction) of the wall of the North lateral façade, with significant out-of-plane deformation (out-of-plane mode of the longitudinal wall). The second and third modal shapes are still local modes, involving out-of-plane deformation of the façade, of the lateral walls and the central arches and the lateral tower. The distribution of the mode shapes demonstrates that the church displays low transversal and torsional stiffness, with significant out-of-plane deformations of the elements. This demonstrates that the dynamic response of the Church is strongly affected by the local behavior of elementary macro-elements. It is possible to observe that the participating masses of each mode of vibration are affected by high dispersion: the distribution of the first 100 vibration modes (in the longitudinal and transversal direction) is reported in Figure 9.(a).

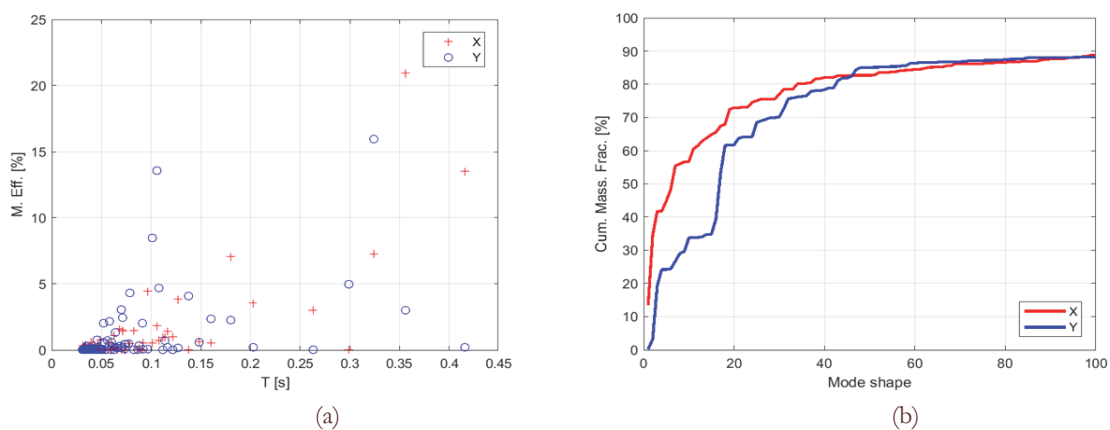
Figure 9: (a) Modal participating mass ratios vs. main periods and (b) cumulative modal mass ratio (CMF).

The modal participating mass ratios (ME) is plotted as a function of the corresponding period (T), and it is possible to observe that almost all vibration modes have modal participating mass ratio less than 10-15%. As the participating mass ratio

of each vibration mode is small, it is necessary to take into account about the first 100 modes to describe the dynamic behavior of the Church: the cumulative modal mass ratio is reported in Figure 9.(b).

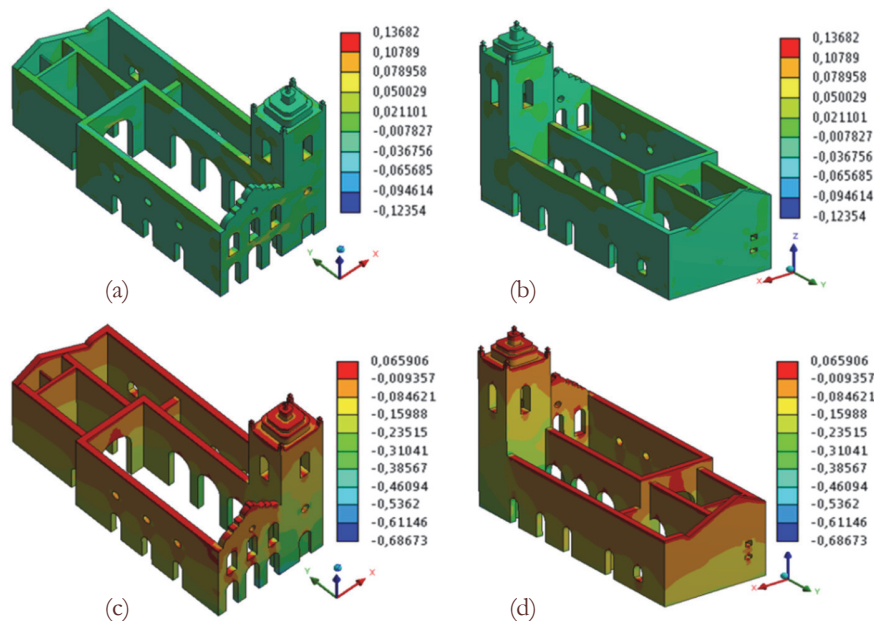
Figure 10: Results from the static analysis of the Nossa Senhora das Dores Church: (a) and (b) maximum principal; (c) and (d) vertical stress. Unit in MPa.

The identified numerical model has been preliminarily employed to perform a static analysis under dead and live loads. The stress maps are shown in Fig. 10, where both the maximum principal stress (Figs. 10.(a) and 10.(b)) and the vertical stresses (Figs. 10.(c) and 10.(d)) are reported. The maximum tensile stress is about 0.14 MPa and was found in many regions of the structure such as: in the center of the arch facing the altar; in the openings of the Lateral Façade west; in the openings of the Lateral Tower and the connection between the central arches and the Lateral Tower. This value is lower than the maximum admissible value assumed for the tensile strength (0.16 MPa).

Positive values of normal stress can be mainly identified in the surrounding opened regions, like the arches in the doors and the windows. In the main façades, positive values of normal stress indicated the existence of tensile stresses especially between the top of the arches of the doors and the bottom of the windows, while negative values of normal stress are related to compression. However, 0.69 MPa was the maximum value of the compressive stress, while the maximum value of

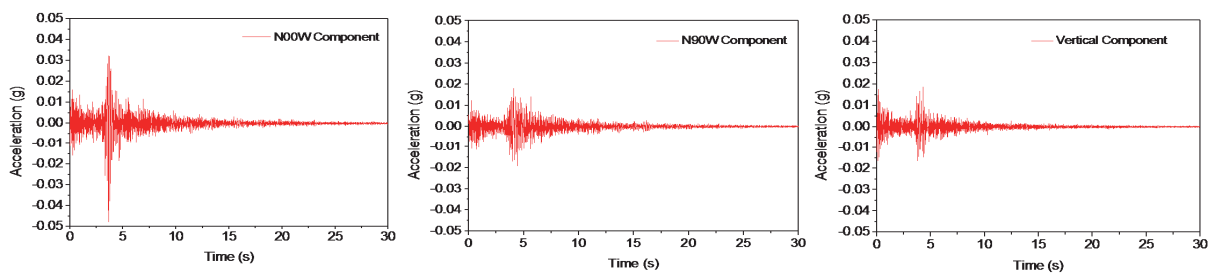
Figure 11: Accelerograms of the Earthquake 1- *San Juan de los Llanos*.

To analyze the seismic behavior of the church, linear time-history analyses of the structure were performed. Due to the absence of natural records of Brazilian earthquakes, records of real earthquakes occurred in other countries were used. The church was subjected to two earthquakes of different magnitudes with time-length of 30 s each one. As Earthquake 1, obtained by [49], the three components of the accelerogram of the *San Juan de los Llanos* earthquake (Fig. 11) occurred on 06/15/2014, 36 km from Ometepe, Guerrero, Mexico, of magnitude 4.1 with peak ground acceleration of 0.048 g on the component N00W was used. This earthquake was selected because its peak ground acceleration is very close to the value of the soil acceleration of the Sobral city which, according to the seismic zoning of [20], is located in Zone 1 with a maximum acceleration of 0.05 g . In addition, the magnitude of this earthquake is consistent with the seismic hazard of Sobral city, because the biggest earthquake recorded in this region had a magnitude of 4.2 m_b .

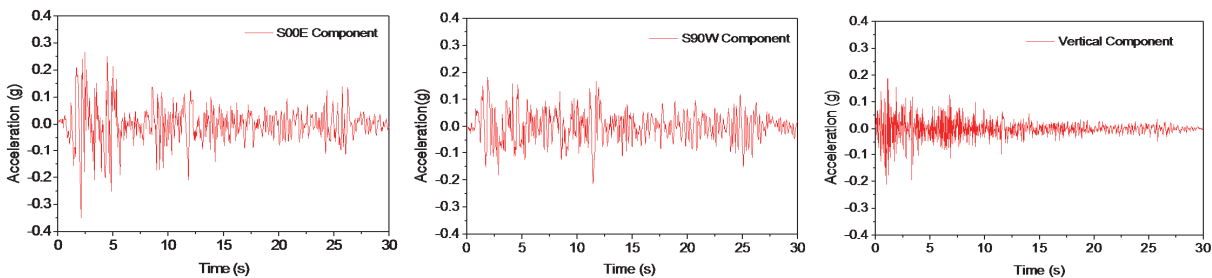
Figure 12: Accelerograms of the Earthquake 2- *El Centro*.

As Earthquake 2, the three components of the *El Centro* earthquake (Fig. 12; [50]), registered in El Centro, California, USA, at 05/18/1940, with a magnitude of 6.9 M_w and peak ground acceleration of 0.348 g on the S00E component was adopted. It was used because it is one of the most emblematic earthquakes, and also because in Brazil an earthquake of similar magnitude, according to [19], was occurred at 1955 in Porto dos Gauchos, State of Mato Grosso and had 6.2 m_b .

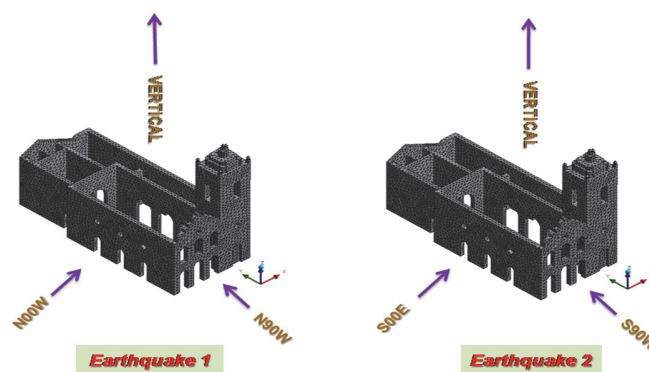
Figure 13: Applying of the three accelerograms of each earthquake on the 3D numerical model.

The three accelerograms of each earthquake were applied at the base of the FE model through the transient analysis by modal superposition in ANSYS. The three accelerograms were simultaneously and orthogonally applied in the three axes of the numerical model, as shown in Fig. 12. For each analysis, an integration interval of 0.02 s and with 30 s length was adopted, thus, the total of points of integration was 1,500.

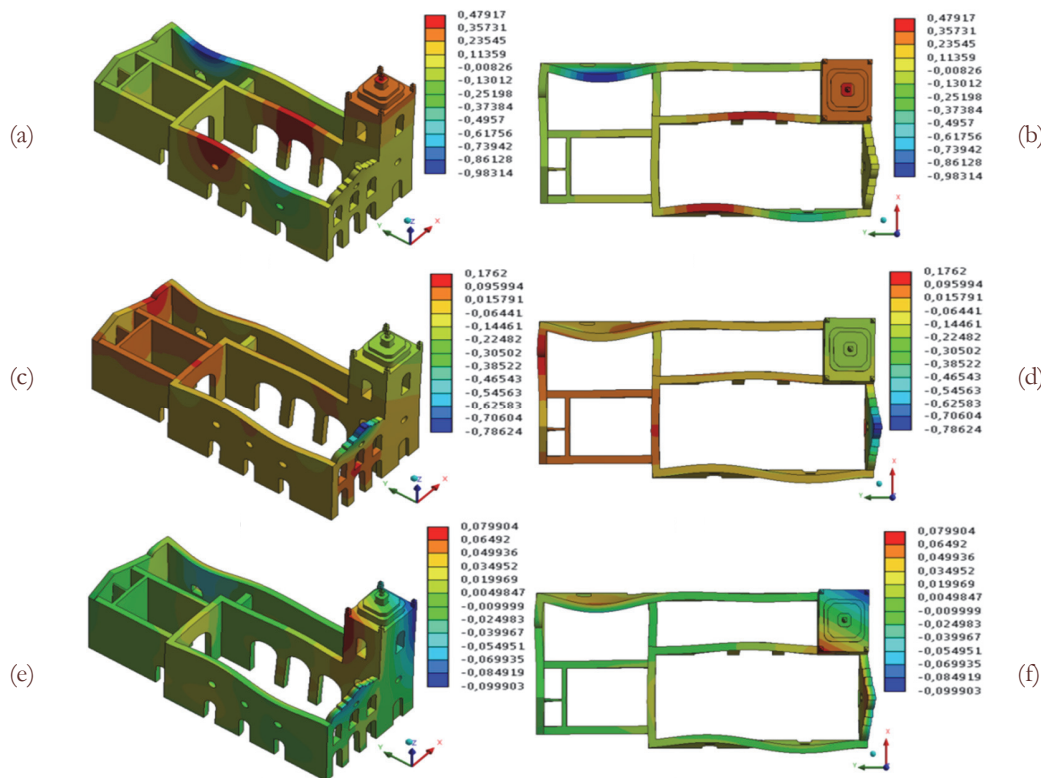
Figure 14: Directional displacements after Earthquake 1: (a) and (b) in direction X; (c) and (d) in direction Y; (e) and (f) in direction Z. Unit in mm.

In Fig. 14 the displacements that occurred in the structure over the three axes (X, Y and Z) after Earthquake 1 are shown. Figs. 14.(a) and 14.(b) show the displacements in the X direction. In this direction the biggest displacement, about 0.5 mm, is observed in three regions, namely: i) the wall of the north lateral façade; ii) part of the region of the central arches that separate the two naves and iii) at the top of the lateral tower. However, the biggest displacement in the X direction is found over the negative X direction and was recorded in a region of the wall of the south lateral façade (with a value of about 0.98 mm). The displacements along the Y direction are shown in Fig. 14.(c) and 14.(d). The maximum, in the positive direction, about 0.18 mm, is recorded in: i) the center of the wall of the west main façade, ii) the top of the wall of east façade and iii) the top of the main arch that is located in front of the altar-Mor. The biggest displacement over the negative Y direction, about 0.79 mm, was observed at the top of the west main façade. The vertical displacements are represented in Figs. 14.(e) and 14.(f). Vertical displacements are very low; the maximum displacement is 0.08 mm and occurs in the rear diagonal of the lateral tower. The biggest displacement over the negative Z direction is observed at the diagonal of the lateral tower along of the west main façade and its value is equal to 0.10 mm.

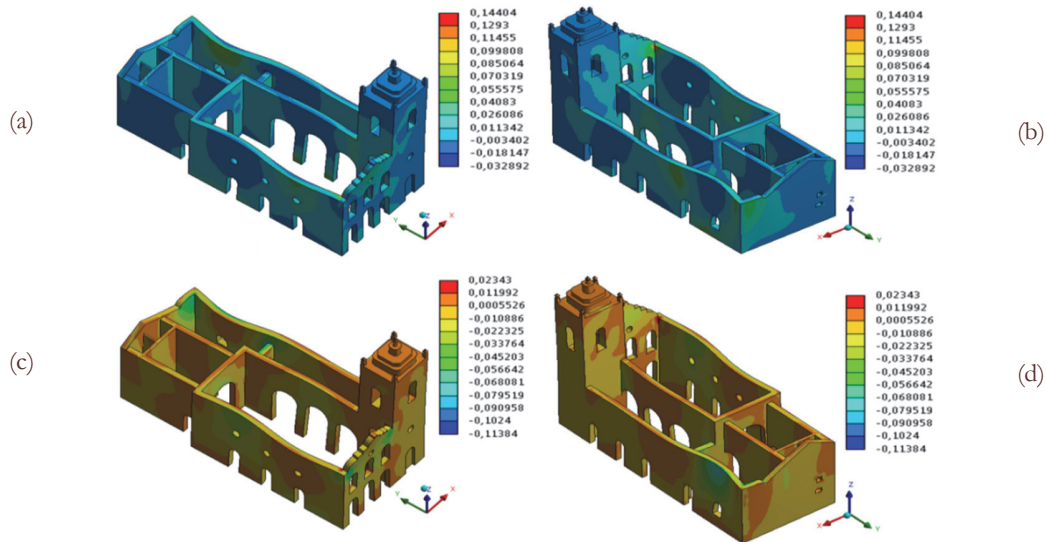
Figure 15: Principal stress after Earthquake 1: (a) and (b) maximum principal stress; (c) and (d) minimum principal stress. Unit in MPa.

The maximum and minimum principal stresses are reported in Fig. 15. Analyzing Fig. 15.(a) and 15.(b), it can be observed that the maximum tensile stress is located in correspondence of the connection between the west main façade and the north lateral façade (about 0.15 MPa). This traction is due to the displacement of the west main façade out of the XZ plane. In some interior regions of the wall of the south lateral façade, tensile stresses of approximately 0.08 MPa are also

found. In the walls of the north lateral façade and the wall of the east façade it can be observed traction zones of 0.07 MPa. The minimum principal stresses (negative values indicates as usual compression stress) are represented in Fig. 15.(c) and 15. (d). Values of about 0.11 MPa can be identified in correspondence of the connection of the wall of the south lateral façade with the wall of a smaller arc located in the rear of the lateral nave. This value is lower than the one obtained with the static analysis (whose value was about 0.69 MPa). These compressive stresses are lower than the assumed compressive strength of the clay brick. However, in other regions of the structure compression stresses were observed, namely: i) the wall of the main west façade and the wall of the north lateral façade, approximately 0.06 MPa; ii) some regions of the wall of north lateral façade, where the stress is between 0.10 MPa to 0.03 MPa.

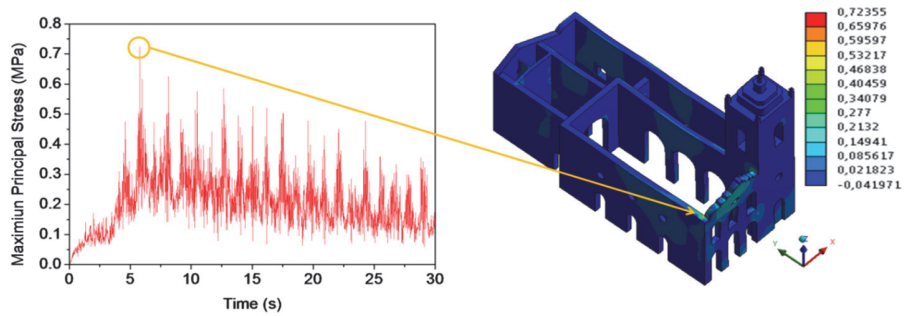
Figure 16: Peak of the maximum principal stress during Earthquake 1. Unit in MPa.

A peak of tensile stress (Fig. 16) equal to 0.72 MPa at $t=5.78$ s was observed in correspondence of the connection between the wall of the north lateral façade with the wall of the west main façade. The peak of tensile stress is due to the motion of the upper part of the wall of the west main façade out of the XZ plane. This value is higher than the assumed tensile strength, and it highlights a vulnerability of the pediment of the church (its overturning).

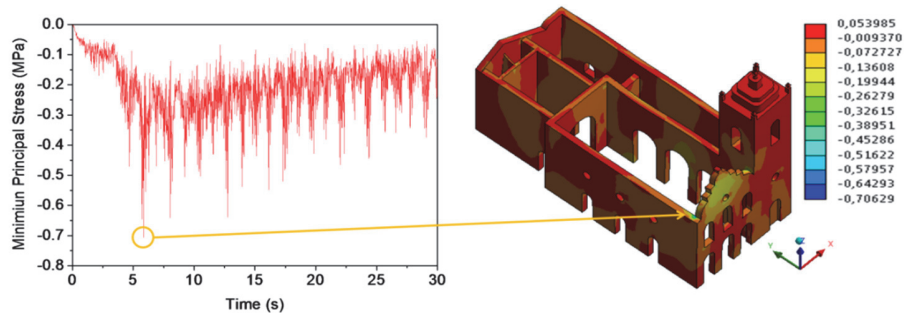
Figure 17: Peak of minimum principal stress during Earthquake 1. Unit in MPa.

Concerning the minimum principal stress, a peak of compression (Fig. 17) was also observed. In this case, this peak was evidenced at $t=5.92$ s and had a value of 0.71 MPa. A similar value was also found in the connection between the wall of the north lateral façade with the wall of the west main façade. This value is lower than the assumed compression strength (3.20 MPa), but is interesting since it confirms a vulnerability of the church: the overturning of the main façade during the Earthquake 1.

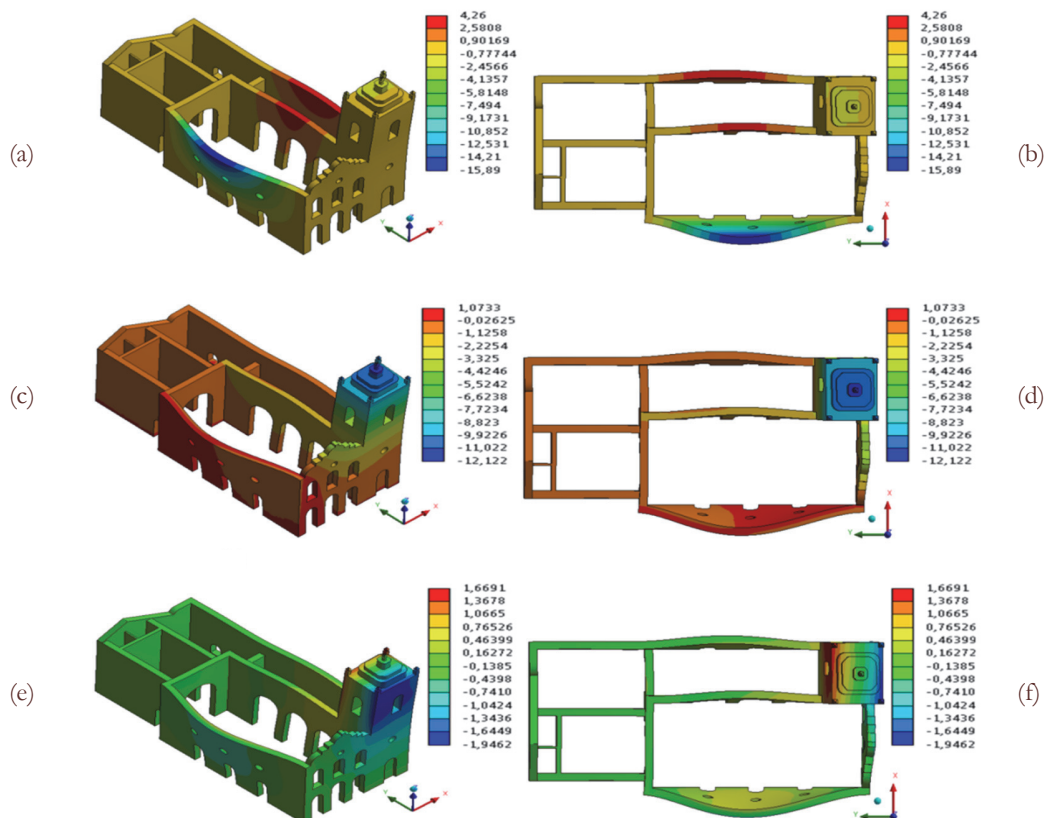
Figure 18: Directional displacements after Earthquake 2: (a) and (b) direction X; (c) and (d) direction Y; (e) and (f) direction Z. Unit in mm.

The displacements obtained using the Earthquake 2 are shown in Fig. 18; the maximum displacements in the X direction, Figs. 18.(a) and 18.(b), are about 4.30 mm and are located at the top of the central region of the wall of the south lateral façade (and also in correspondence of the wall of the central arches that separates the two naves). The biggest displacement, however, occurs in the wall of the north lateral façade along the negative X direction and has a value of about 15.90 mm. The displacements in the Y direction are shown in Fig. 18.(c) and 18.(d). It can be observed that the biggest value along the positive Y direction (the longitudinal one) is equal to 1.10 mm and is recorded on the wall of the north lateral façade and on the wall of the west main façade. The biggest displacement occurs in the negative Y direction, is located at the top of the lateral tower and corresponding to about 12.10 mm. In the region of the central arcs, displacements of approximately 2.2 mm in negative Y direction are also evidenced.

With respect to the vertical displacements, represented in Fig. 18.(e) and 18.(f), the back side of the lateral tower near the top, presents displacements of about 1.70 mm in the positive Z direction. The front side of the lateral tower also presents displacement of 1.95 mm, in module, along the negative Z direction. In addition, the wall of the region of the central arches connected to the side tower exhibits displacement of approximately 1.10 mm in the positive Z direction. As a general comment, analyzing the displacements exhibited by the church during the earthquake, it is possible to observe the absence of a box-behavior: the church behaves as a combination of independent macro-elements with first and second mode potential failures.

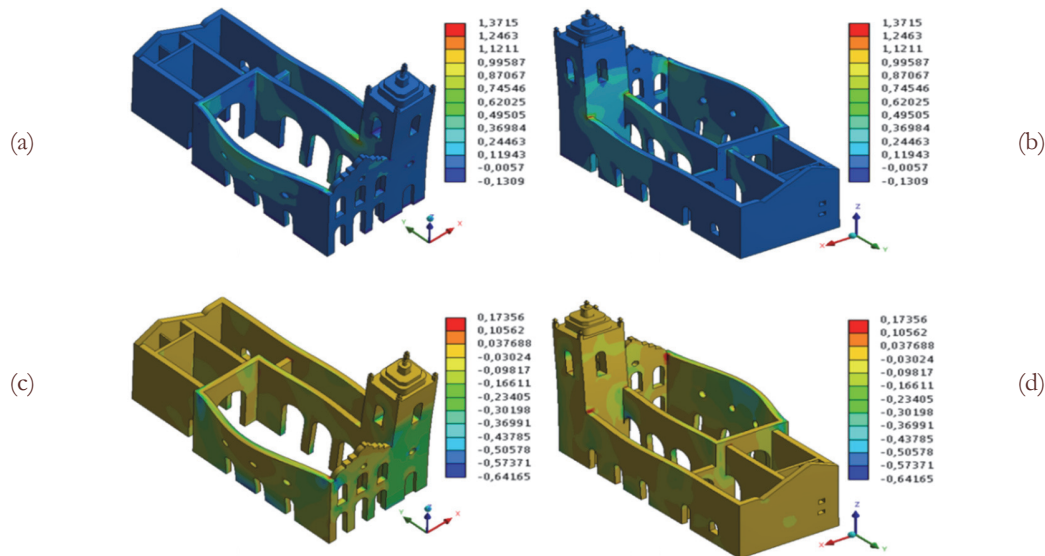
Figure 19: Principal stress after Earthquake 2: (a) and (b) maximum principal stress; (c) and (d) minimum principal stress. Unit in MPa.

The principal stresses are shown in Fig. 19. The maximum tensile stress, reported in Fig. 19.(a) and 19.(b), reached the value of 1.37 MPa, in correspondence of the connections of the lateral tower with the wall of the south lateral façade and the wall of the central arches. A similar value was found in correspondence of the connection of the wall of the north lateral façade with the wall of the main façade. These values are higher than the assumed tensile strength and denote potential collapse (and/or possible pounding) of this connection. A region of the wall of the north lateral façade with traction of about 0.74 MPa is also observed. The walls of the central arches and the wall of the south lateral façade reached a tensile stress of about 0.244 MPa, that indicate potential cracks. The minimum principal stresses (compressive stress) are reported in Fig. 19.(c) and 19.(d). The higher value of about 0.65 MPa, occurs in many regions of the structure, namely: i) in the upper left corner of the west main façade, just above of the door opening; ii) in the first arc in contact to the lateral tower; iii) in the inferior central region, situated at the base of the door aperture and iv) in the upper left corner of the north lateral façade. In the front side of the lateral tower, the same west main façade, compressive stress ranging from 0.03 MPa to 0.51 MPa were observed.

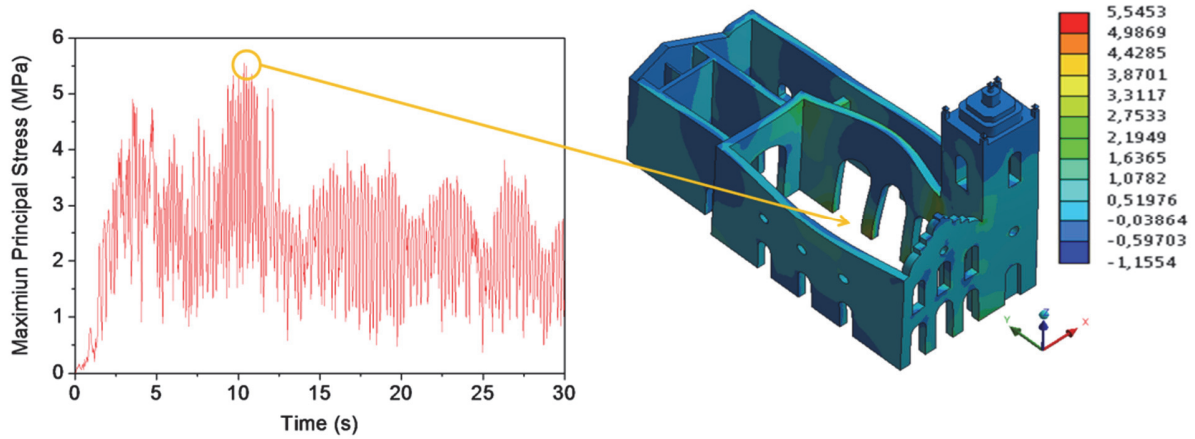
Figure 20: Peak of maximum principal stress during the Earthquake 2. Unit in MPa.

During the Earthquake 2, a maximum principal stress peak was observed as reported in Fig. 20. The peak is a tensile stress of about 5.54 MPa at $t=10.34$ s and is obtained at the base section of a column of the central wall of the structure. The high value denotes a potential collapse the column due to overturning. Other critical zones can be identified, namely: i) the region of connection of the wall of the central arches with the wall of the triumphal arch in front of the altar (which is subjected to a tensile stress of about 2.19 MPa); ii) the region of connection of the wall of central arches with the lateral tower, just above the first arch (with a peak of tensile stress of about 3.30 MPa); iii) the region of connection of the wall of the west main façade with the lateral tower (with a tensile stress of about 1.64 MPa); iv) the upper region of the central arches and the inferior region of the smaller arc, located at the end of the smaller nave (about 2.19 MPa and 3.30 MPa, respectively). In all these regions cracks and/or local collapses are potentially expected during the seismic loading.

The time-history of the minimum principal stress is reported in Fig. 21. It is possible to observe a peak of stress of about 5.66 MPa at $t = 10.66$ s at the base of the column of the central arch. This region is the same that presented a peak of traction (see Fig. 20), and this result is a confirmation of the potential overturning of this central wall during the earthquake. Other regions present high compressive stresses, namely: i) the upper part of the first arc in contact with the lateral tower (a compression of about 3.94 MPa is recorded); ii) the region of connection between the upper part of the wall of the central arches with the wall of the arch in front of the altar and iii) the internal wall of the south lateral façade in

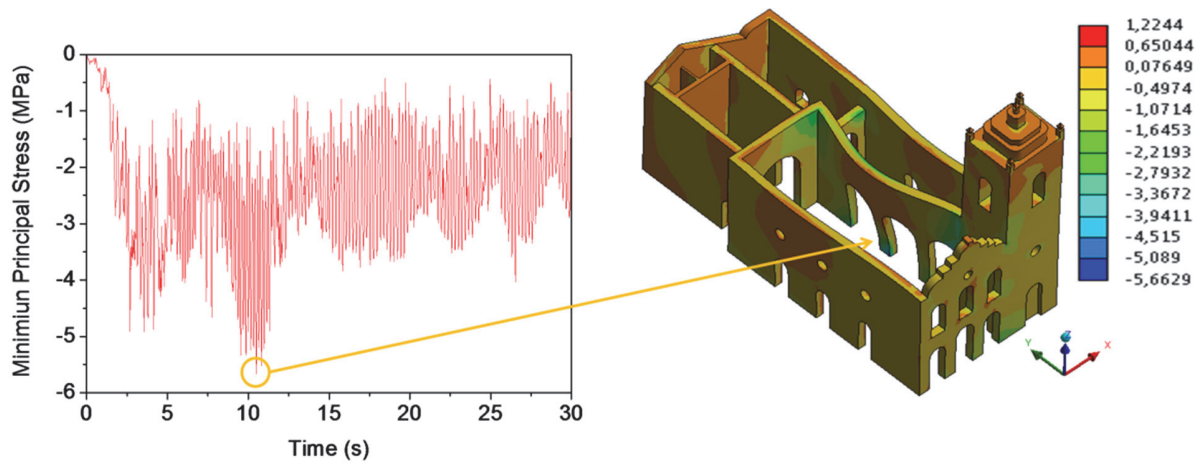
Figure 21: Peak of minimum principal stress during the Earthquake 2. Unit in MPa.

Both the maximum principal stress peak (5.54 MPa at $t=10.34$ s) and the minimum principal stress peak (5.67 MPa at $t=10.66$ s) over the structure were not close to the peak ground acceleration of the Earthquake 2 accelerograms (the S00E component was 0.348 g at $t=2.12$ s, the Vertical component was 0.21 g at $t=0.98$ s; however the S90W component was 0.214 g at $t=11.44$ s).

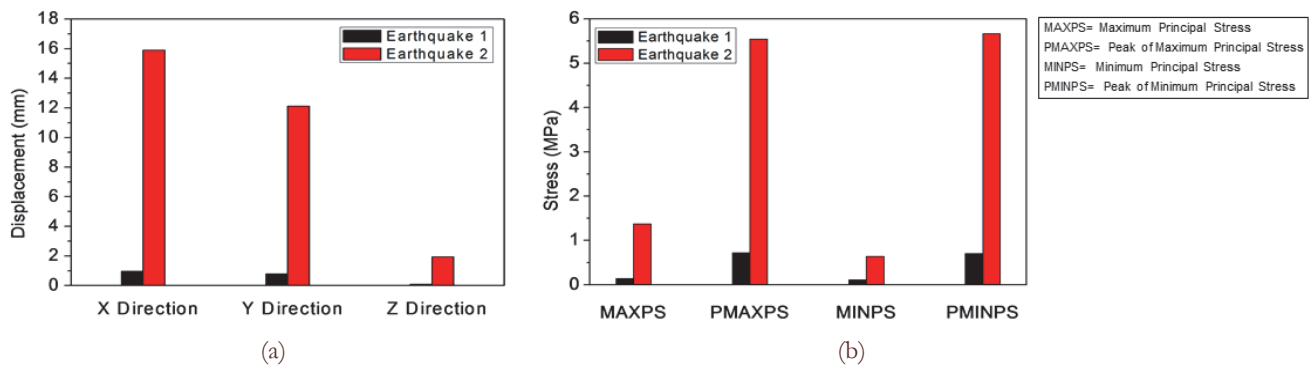
Figure 22: Comparison between (a) the directional displacements and (b) the principal stresses obtained in the seismic analyzes.

During the application of Earthquake 1 and Earthquake 2 to the Nossa Senhora das Dores Church, directional displacements in the X, Y and Z directions and principal stresses are obtained, as well as the peaks of stress during the 30 s of seismic loading. Because the two earthquakes have different magnitude, different frequency content, different peak ground acceleration and because the peaks are also different between the three components of each earthquake, the results obtained in the two analyzes show significant differences. In Fig. 22.(a) the maximum value of the directional displacements obtained in the two analyzes is reported while Fig. 22.(b) reports and compares the maximum and minimum principal stresses obtained during the two time-histories. The Earthquake 2, as expected, was the one that caused greater displacements and higher stresses. It can be interesting, anyway, to observe that in both cases the biggest displacements over the time-histories are obtained in the X direction (the transversal one), thus confirming the potential overturning of the main nave of the church.
