Effect of spherical dents on microstructure evolution and rolling contact fatigue of wheel/rail materials

X.J. Zhao^{1,2}, J.Guo¹, Q.Y. Liu¹, E. Butini², L. Marini², E. Meli², A. Rindi², W.J. Wang^{1,*}

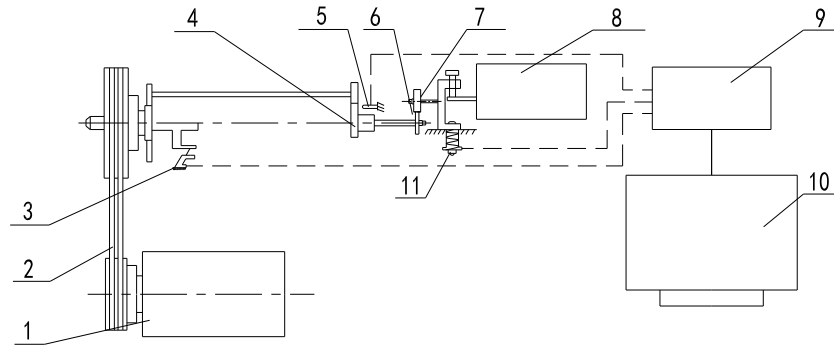
Fig.1

Fig.1: Schematic diagram of the machine.

1. DC motor; 2. Drive belt; 3. Torque sensor; 4. Drive shaft gears; 5. Photosensor; 6. Lower roller; 7. Upper roller; 8. Driven shaft gears; 9. Controller; 10. Computer; 11. Load sensor

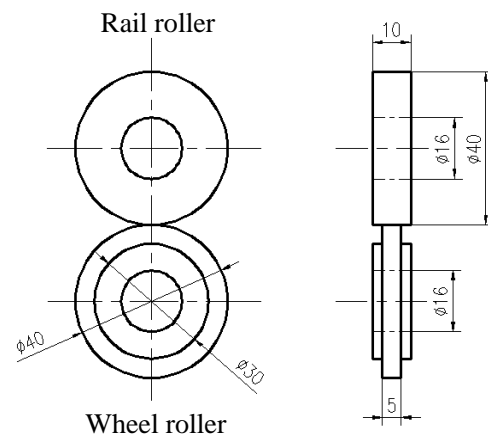
Fig. 2

Fig.2 Scheme size of the wheel and rail rollers.

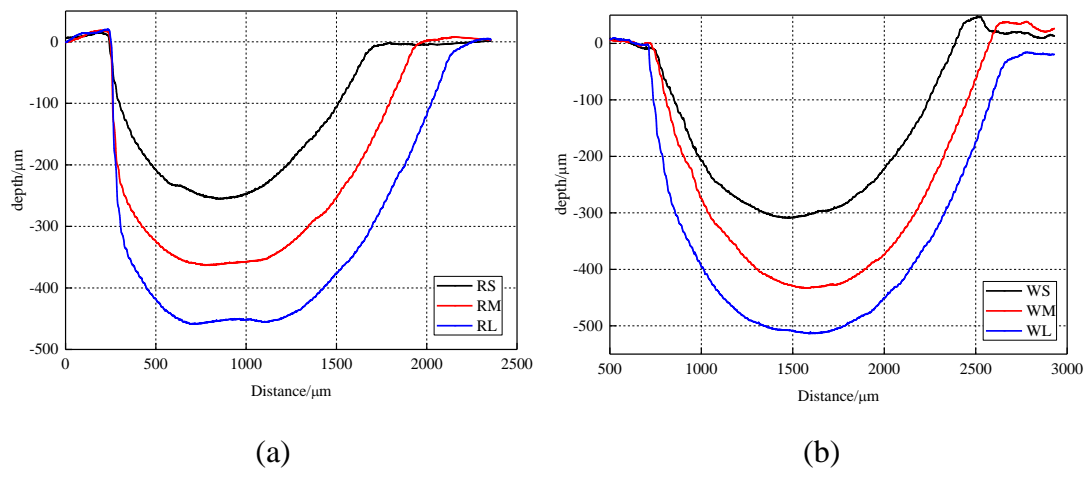
Fig.3

Fig.3: Scheme of dents on wheel/rail simple before testing, (a) rail; (b) wheel.

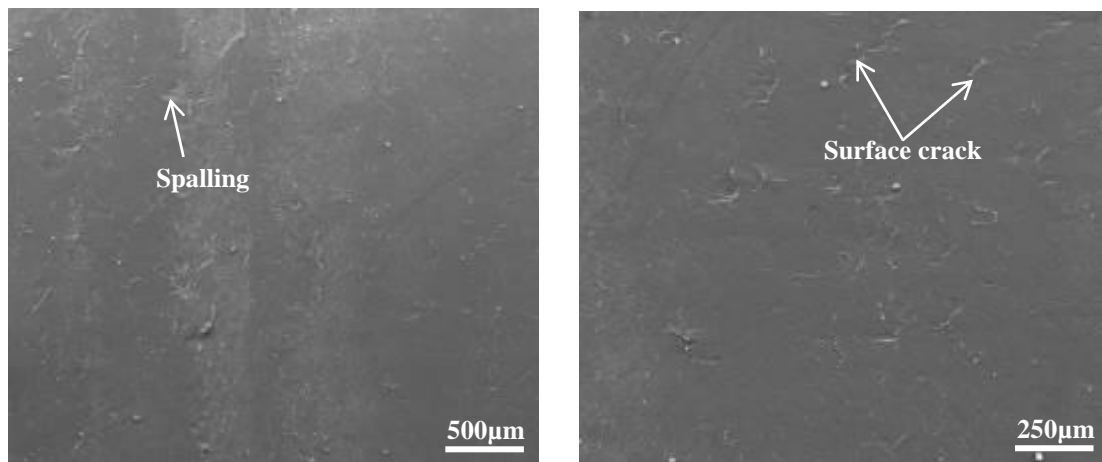
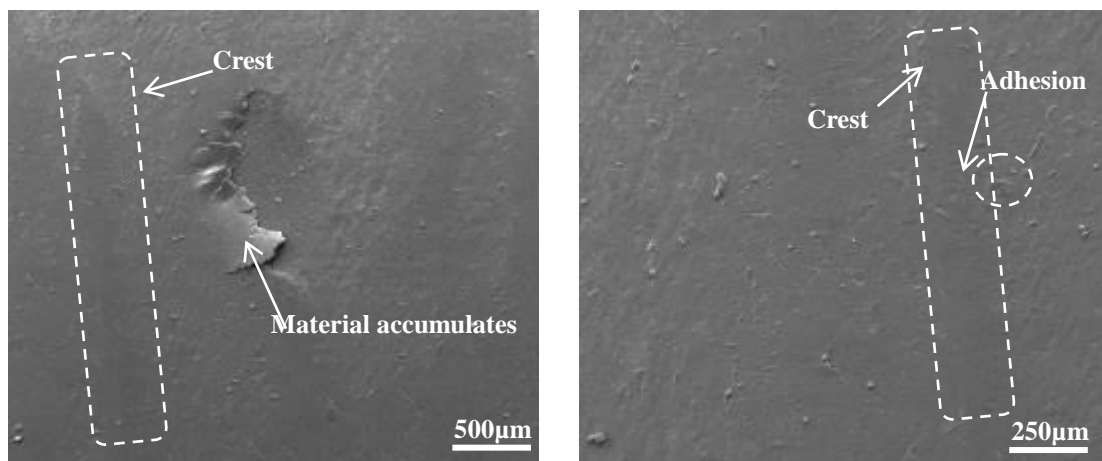
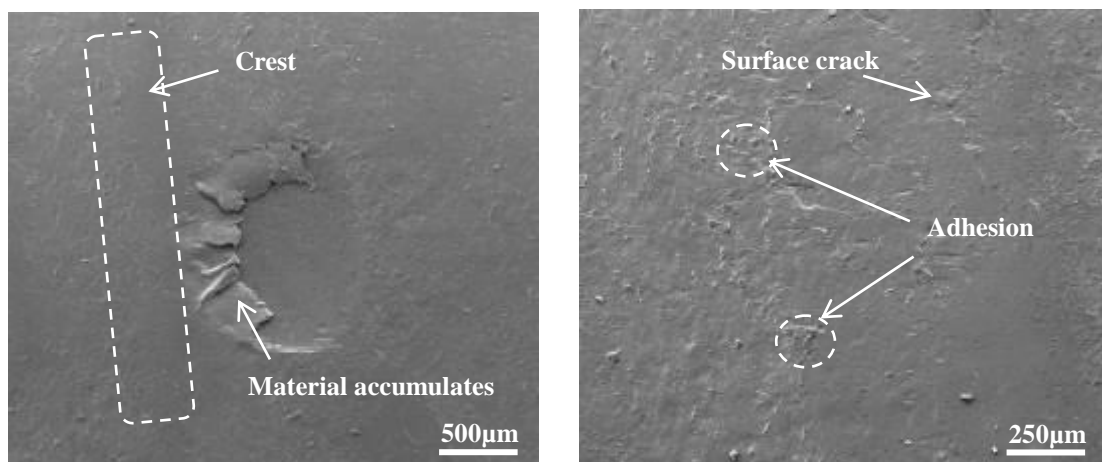
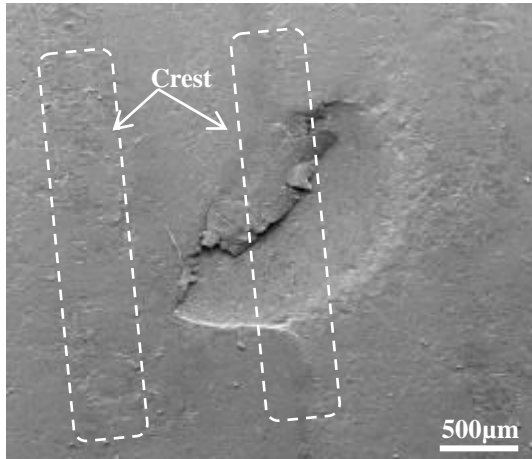
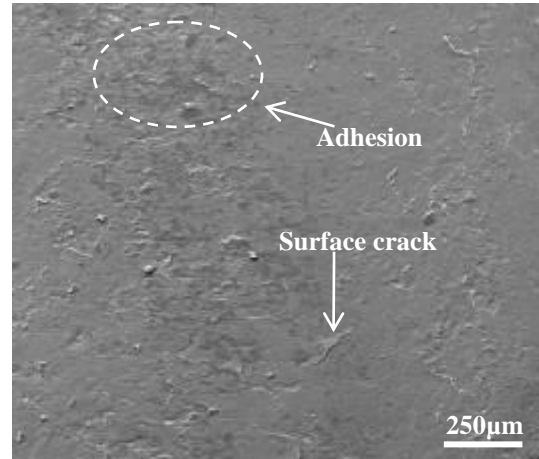
Fig.4

Fig.4: SEM micrographs of surface damage of rail rollers, (a) RN; (b) RS; (c) RM; (d) RL.

SEM micrographs of surface damage on rail rollers are shown in Fig.4. It is obvious that the material accumulates on one side of the dents. Compared to the rail roller without dents,

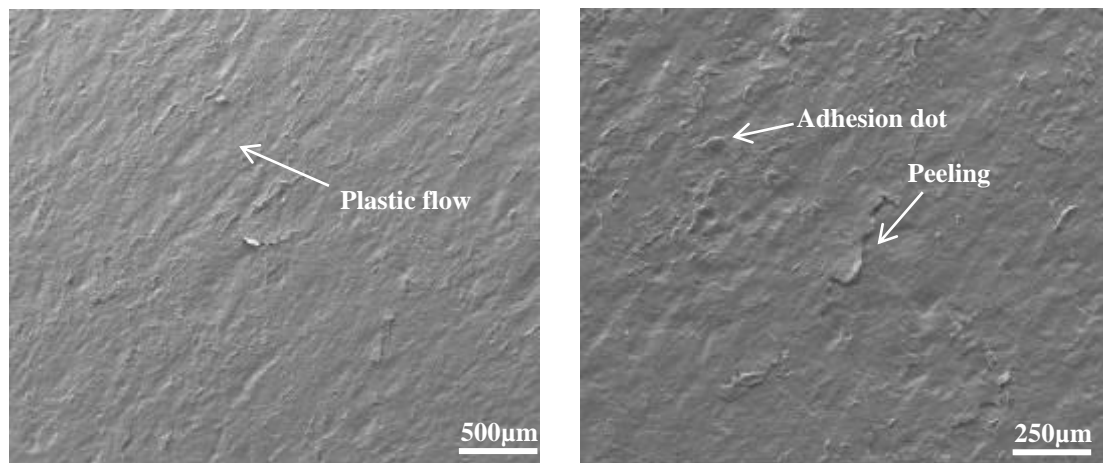
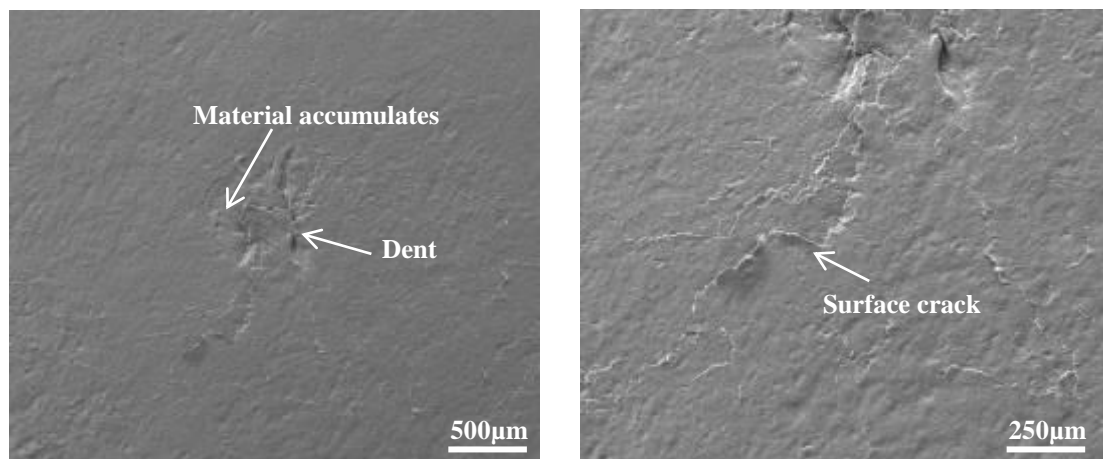
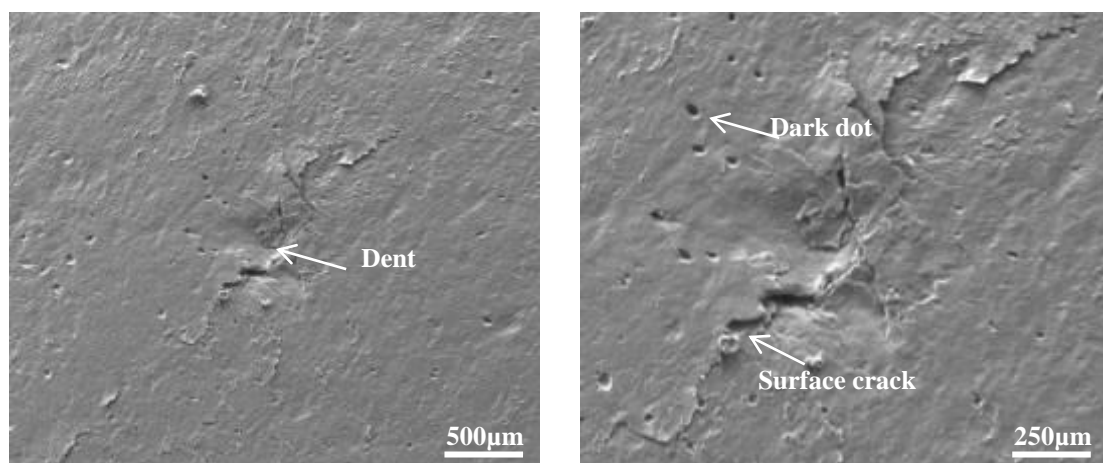
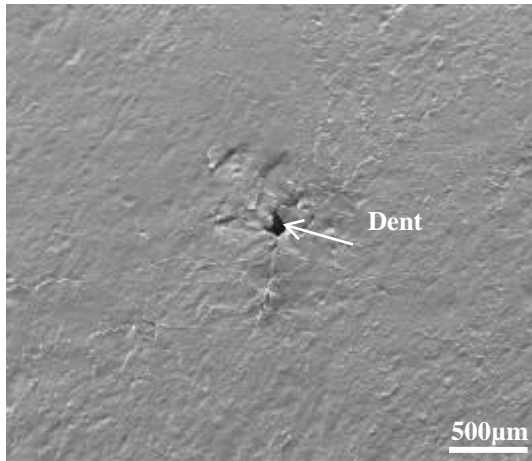
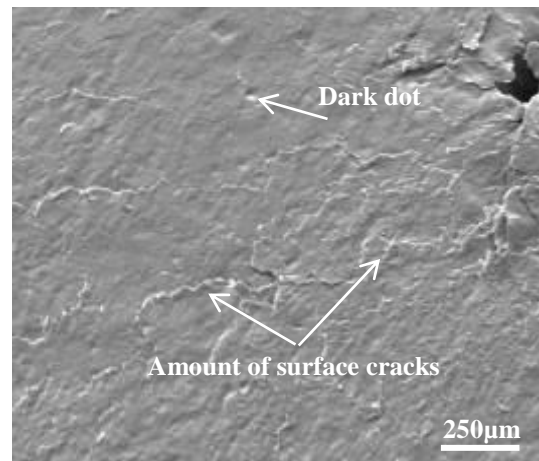
Fig.5

Fig.5: SEM micrographs of surface damage of wheel rollers, (a) WN; (b) WS; (c) WM; (d) WL.

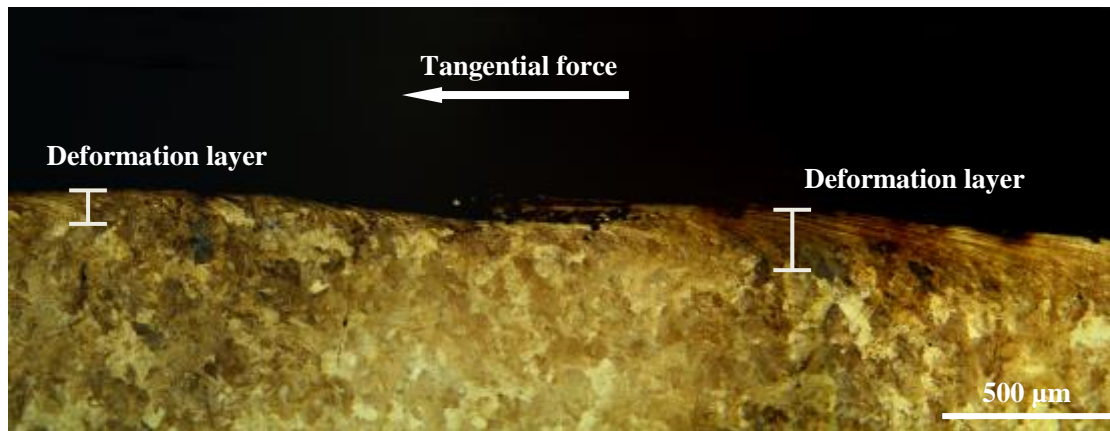
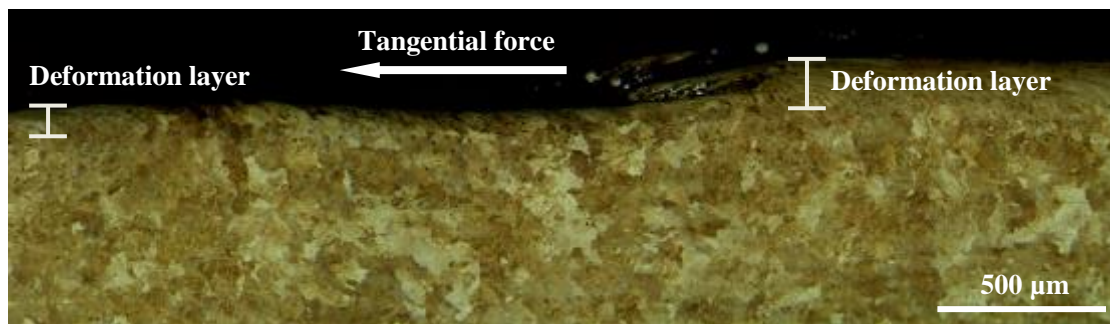
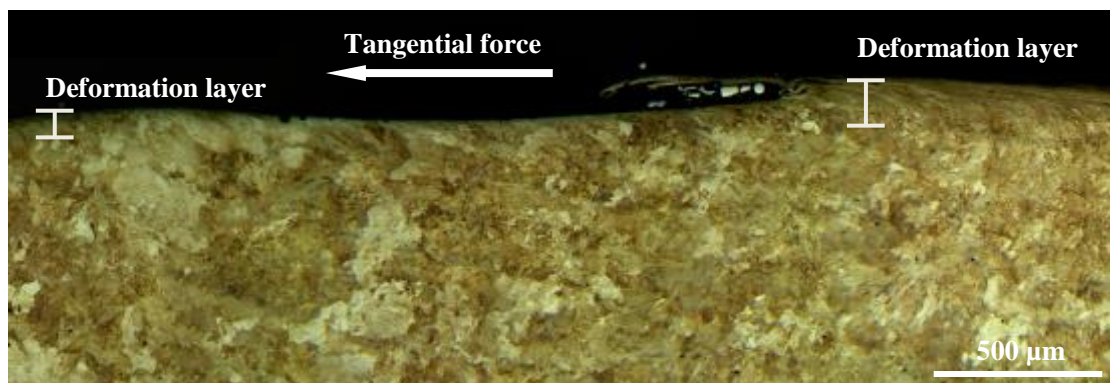
Fig.6

Fig.6: OM micrographs of plastic deformation of rail rollers, (a) RS; (b) RM; (c) RL.

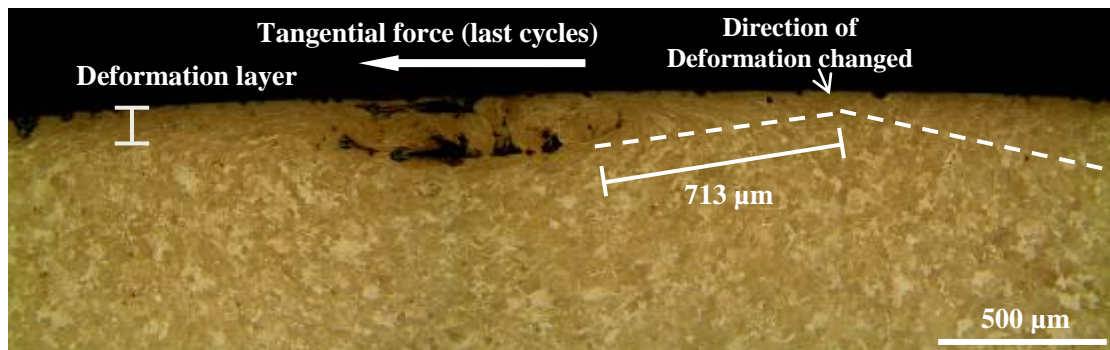
Fig.7

Fig.7: OM micrographs of plastic deformation of wheel rollers, (a) WS; (b) WM; (c) WL.

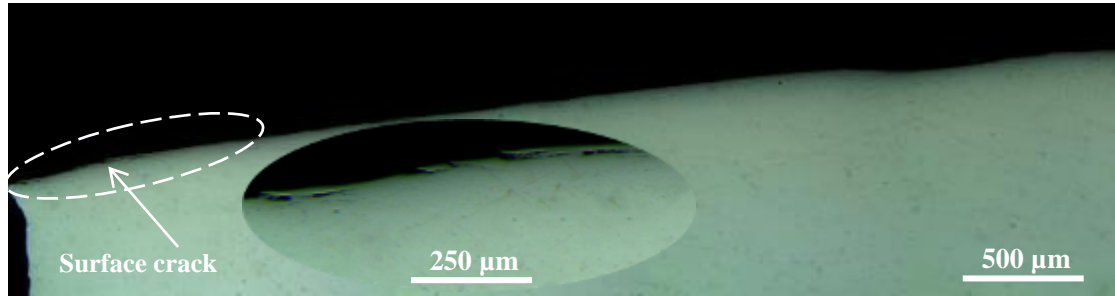
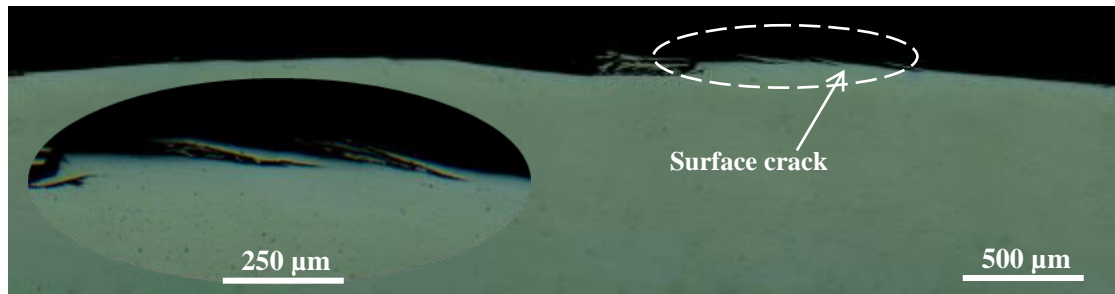
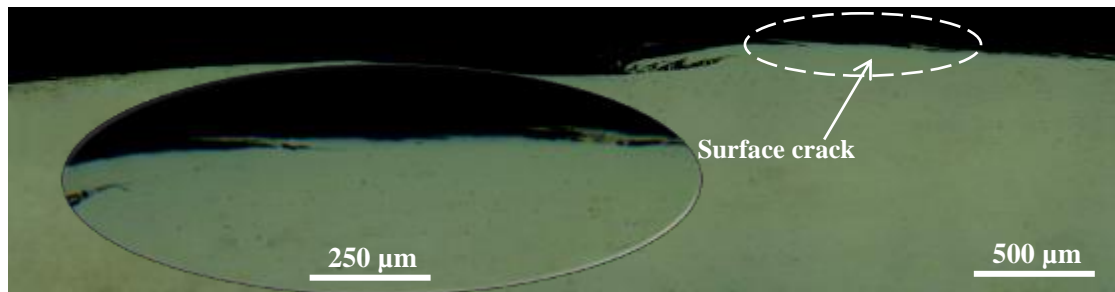
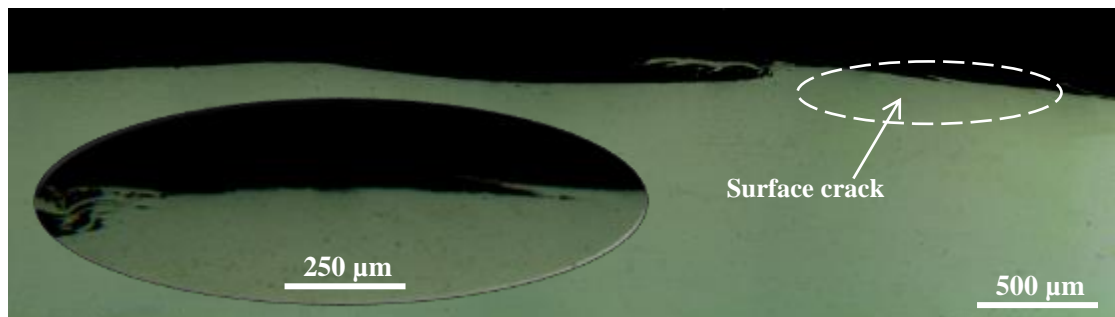
Fig.8

Fig.8: OM micrographs of fatigue cracks on the section of rail rollers, (a) RN; (b) RS; (c) RM; (d) RL.

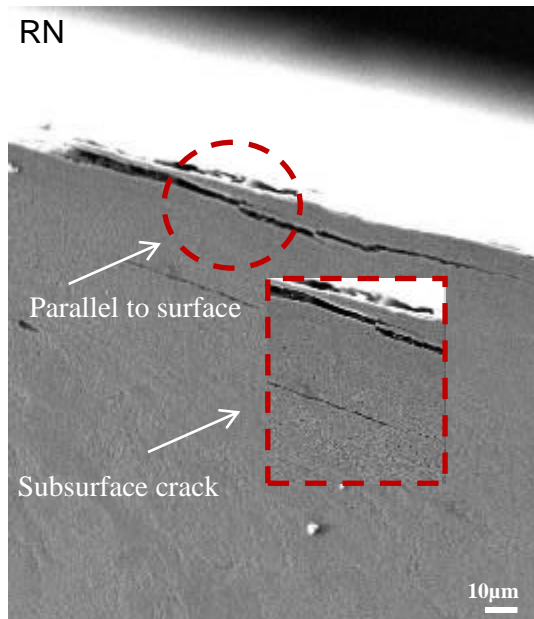
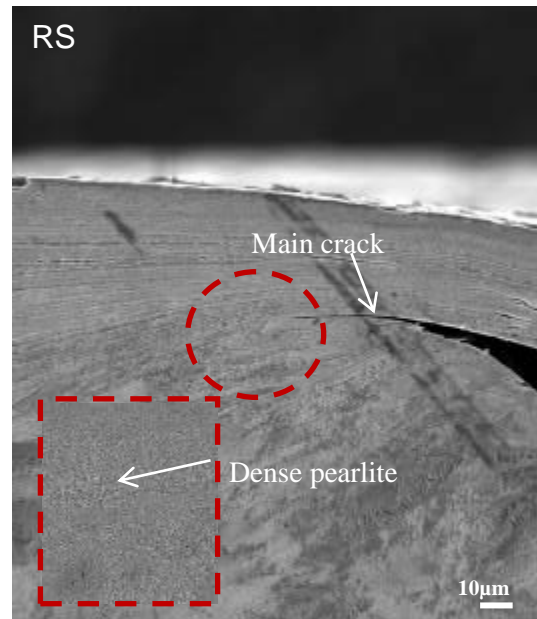
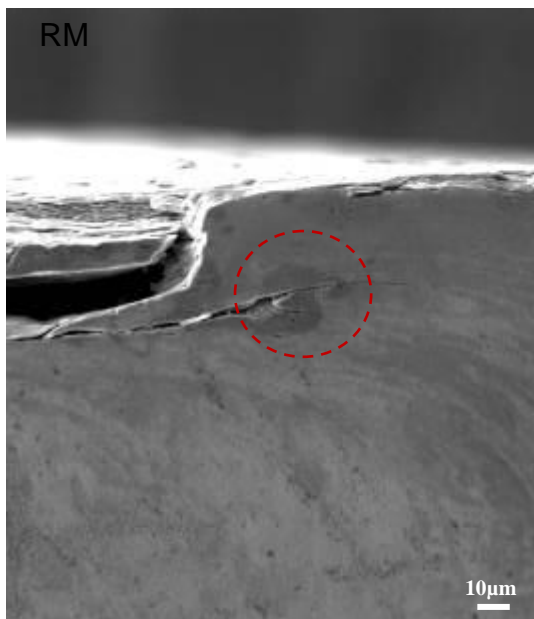
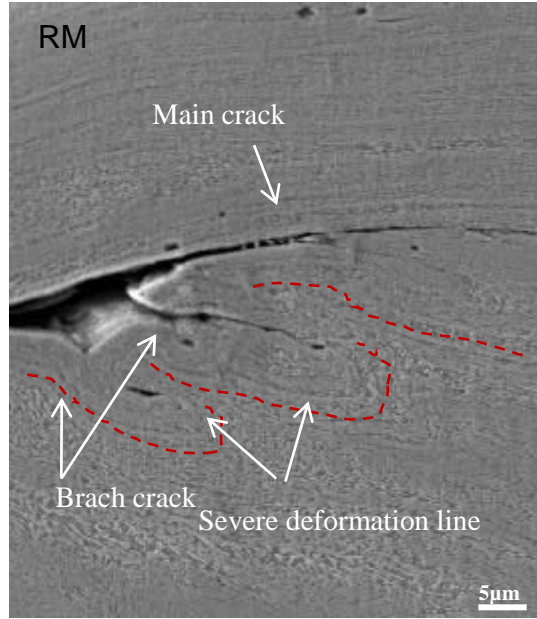
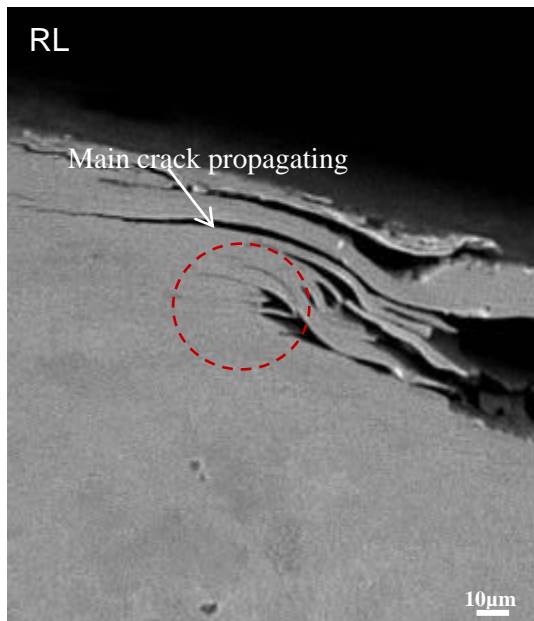
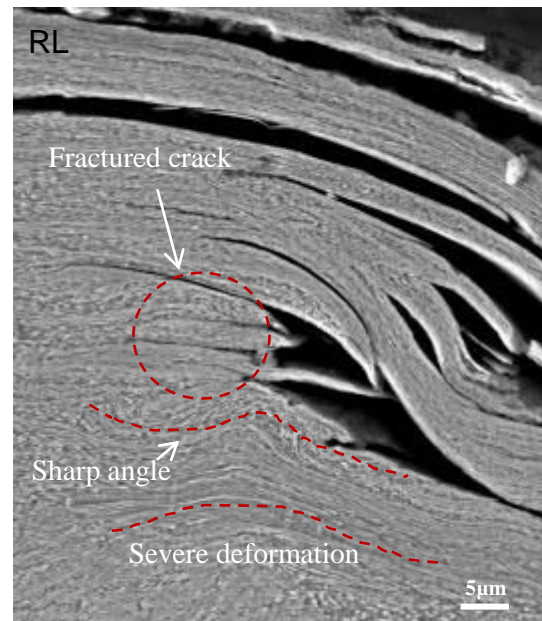
Fig.9

Fig.9: SEM micrographs of fatigue cracks on the section of rail rollers, (a) RN; (b) RS; (c) RM; (d) RL

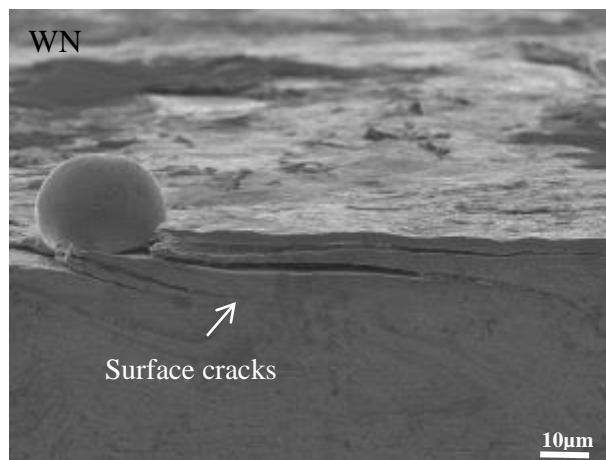
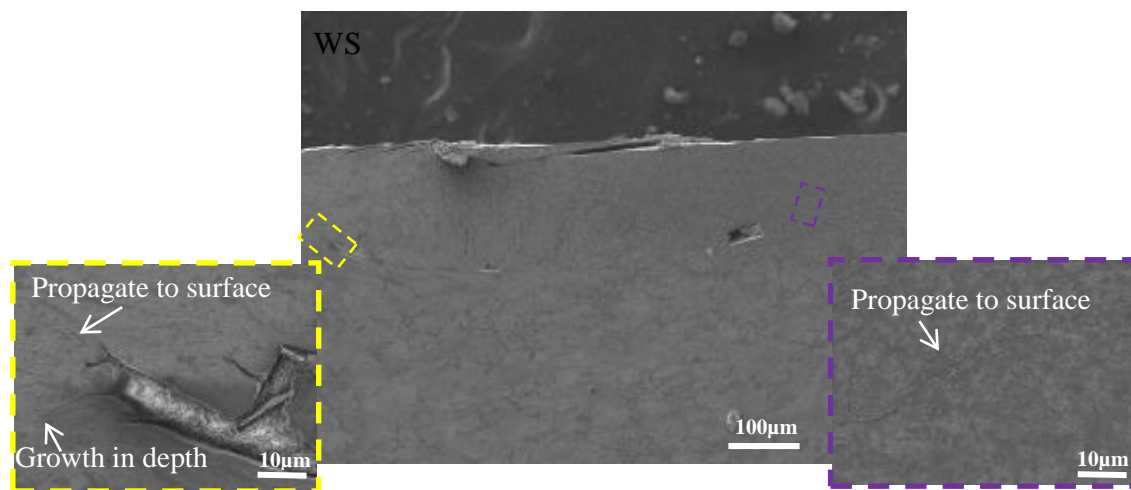
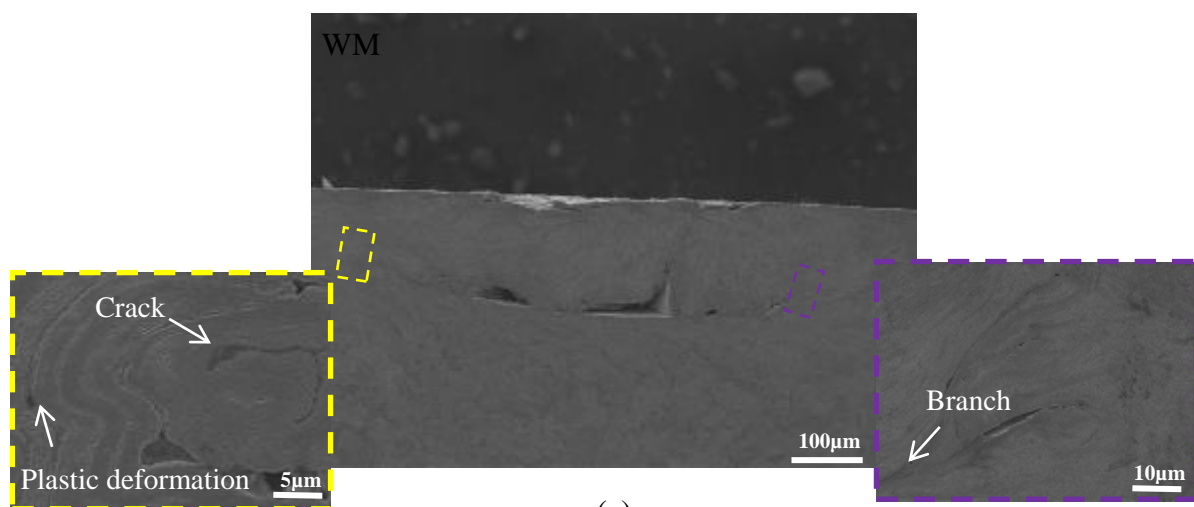
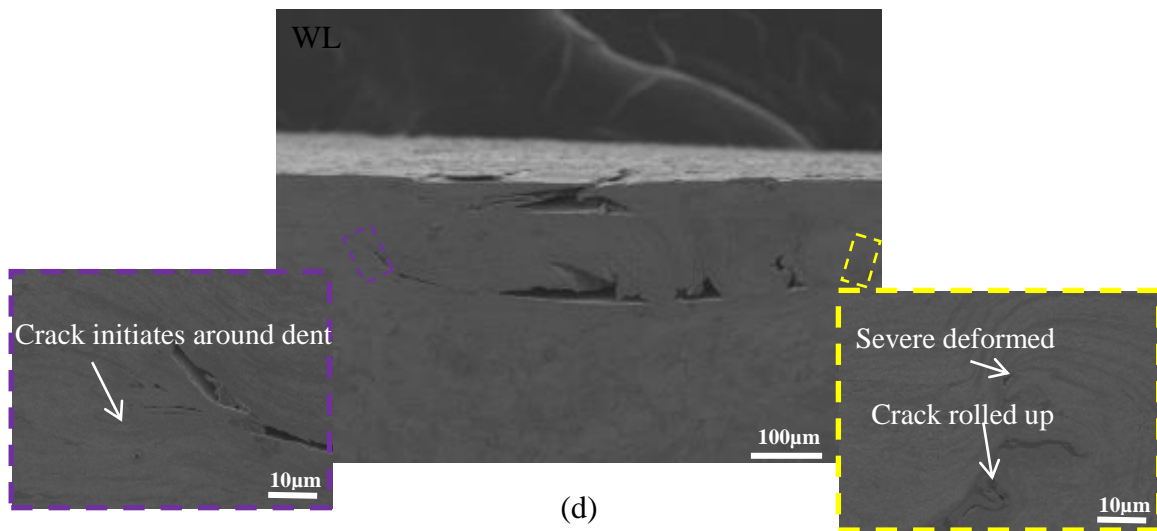
Fig.10

Fig.10: SEM micrographs of fatigue cracks on the section of wheel rollers, (a) WN; (b) WS; (c) WM; (d) WL

Because of the inversion of tangential force on wheel roller, the “front area” in the previous period turns into “rear area” in the current period. As it is mentioned above, the rear area of the dent has a higher wear rate. In the primary cycles, the material accumulates in the front area of dent (Fig.15a). Subsequently, the plastic deformation is easily worn and forms a new plastic deformation layer with single flow direction as the “front area” changes into “rear area”. As a result, a fiber texture with small misorientation emerges in the rear of dent. As a previous paper mentions [26], tiny cracks tend to propagate in the area with small misorientation (Fig.15b). The other side of dent experiences the transformation from “rear area” into “front area”. Due to low wear rate in “front area”, the microstructure is affected by two plastic deformation lines with different flow directions. The previous plastic deformation is rolled up (Fig.6), the continuous fiber texture is destroyed (Fig.12b) and the microstructure is mainly anisotropic, which slows down the crack growth. This way, the crack in rear area of dent on wheel roller is longer than that in the front area (Fig.10).

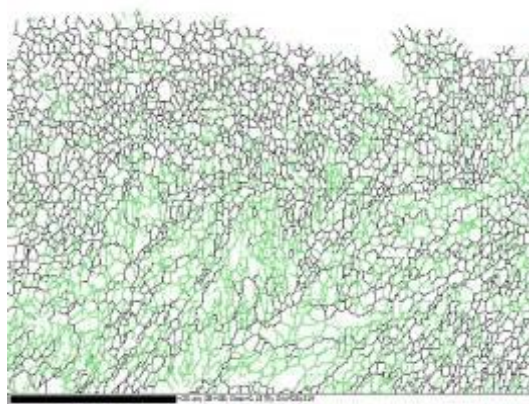
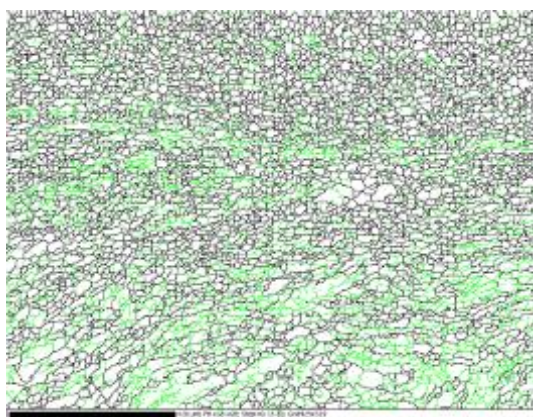
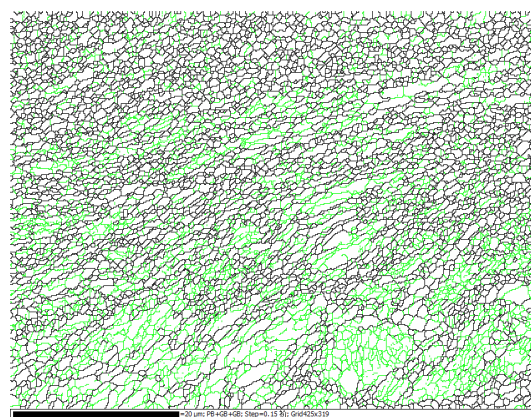
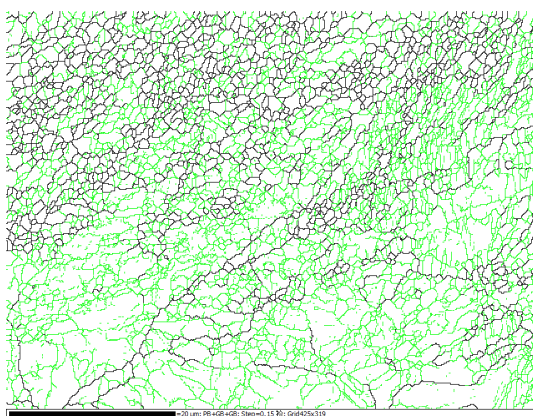
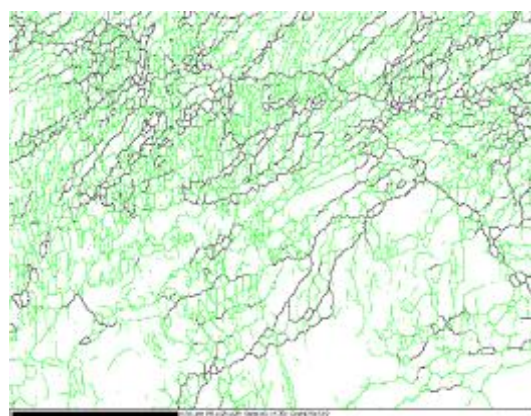
Fig.11: EBSD micrographs of grain boundary on wheel/rail rollers, (a) WN; (b) WM (in the front of dent); (c) WM (in the rear of dent); (d) RM (in the front of dent); (e) RM (in the rear of dent)

The EBSD method is focused on the deformed grains on wheel and rail rollers with dent. Therefore, the test areas are selected at about 50 μm below the surface. Fig.11 reveals the distinct differences of grain angle between rail and wheel rollers. The black line sketches the grains boundary with large angle (more than 15 degree) while the green line stands for the grains boundary with small angle (from 2 up to 15 degree). It is obvious from Fig.11a that grains with large angle gather near the surface and become less frequent inside the body. However, the grains with large angle boundary dominate on defected wheel roller as Figs.11b-c show. On the contrary, the situation changes on the defected rail roller, especially in the rear of the dent. In this case, the majority of grains are characterized by small boundary angle. It can be attribute to the fact that the slight deformation in the rear area assures less energy to disorder the grains.

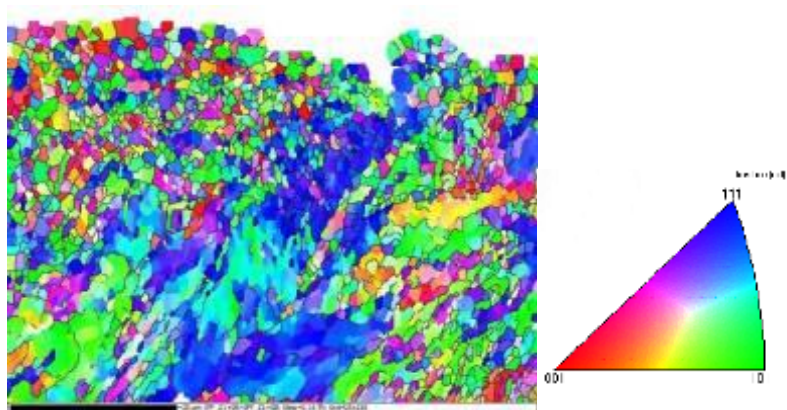
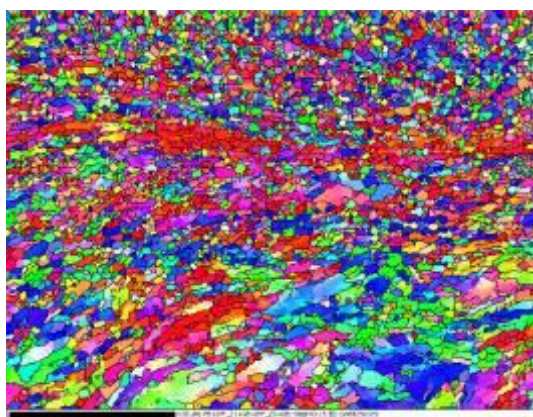
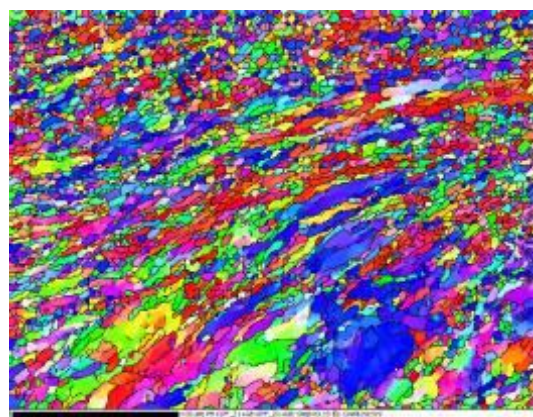
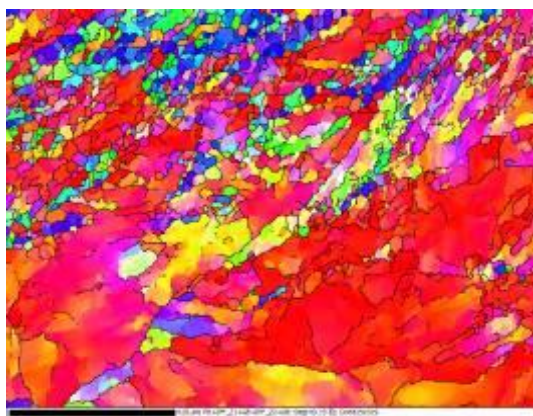
Fig.12

Fig.12: Inverse pole figure (IPF) of wheel/rail rollers, (a) WN; (b) WM (in the front of dent); (c) WM (in the rear of dent); (d) RM (in the front of dent); (e) RM (in the rear of dent)

The inversed pole figure (IPF) shows the crystal orientation of each grain on rail and wheel rollers. The similar color presents a same orientation trend for grains. The gains orientation in wheel roller shows a clear anisotropy phenomenon (Fig.12b). Only a few fiber textures with small misorientation can be found in the rear of dent (Fig.12c). Conversely, the grains in rail roller share an almost similar crystal orientation, especially in rear of dent (Fig.12e).

Adhesion describes the tangential force resulting at the wheel–rail contact [23]. In ~~these~~ experiments, the slippage is set as 0.91%, which provides a relatively high adhesion coefficient between the rail/wheel surface [24]. This way, the tangential force acting on the contact area is large enough to drastically change the microstructure of ~~grains~~ and cause severe plastic deformation. Severe plastic deformation of the wheel/rail materials caused by the heavy and cyclic contact loading is known to have a great influence on RCF crack initiation [25]. The wear rate and material ratcheting are coupled factors which determine the depth of plastic deformation. Fig.14a shows material movement in front and rear areas on defected rail roller. In the edge of the front area, the tangential force compels the material sliding and forms an accumulation layer. As a result, the plastic deformation fills up the dent on one side. On the other hand, in the rear area, the tangential force can be divided into two components acting on the edge of dent. Since the edge of dent is not parallel to the surface, one of the force component rapidly removes material at the edge of dent and leaves a slope there. The second force component acts on this slope again and then the material is removed layer by layer. Therefore, the depth of plastic deformation in the front area is larger than that in the rear area as Fig. 6 presents. Due to such an unbalanced deformation distribution, the yield strain in the front area is more than 2 times the strain in the rear area. It can be inferred from Figs.12 and 13 that a high strain area is usually associated with large misorientation, and

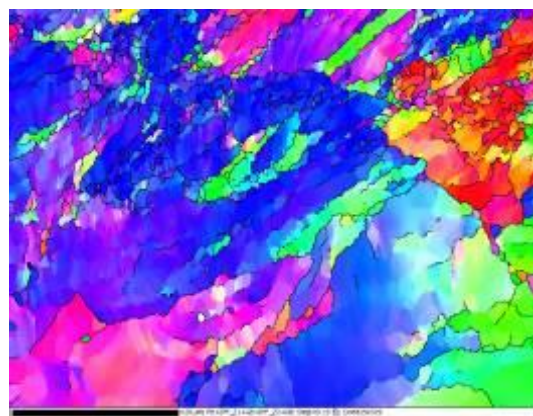
Fig.13

Fig.13: Strain contouring of wheel/rail rollers, (a) WN; (b) WM (in the front of dent); (c) WM (in the rear of dent); (d) RM (in the front of dent); (e) RM (in the rear of dent)

The strain distribution on wheel and rail roller after testing is shown in Fig.13. On WN rollers, the high strain areas are concentrated near the surface at the maximum value of 9.55. When a dent appears on wheel roller, the strain increases immediately up to 16.55. On the contrary, the strain on rail roller shows an extremely low value at 5.85 and it decreases rapidly

rear area of the dent on rail roller (there is a few quantity of large angle grain boundary and it even decreases rapidly in depth). Therefore, the strain in defected rail roller achieves an extremely low value and drops sharply towards the inside of the body. As EBSD data indicate, the strain in defected wheel roller is approximately 3-6 times that in defected rail roller (Fig.13). The previous papers pointed out that highly strained grain can act as a crack propagation path [27, 28]. As a result, the cracks in defected rail roller are small and hard to propagate in depth, while the crack in defected wheel roller is long and grows in various directions.
