### **An experimental investigation on mass failures occurring in a riverbank composed of sandy gravel**

## An experimental investigation on mass failures occurring in a riverbank composed of sandy gravel

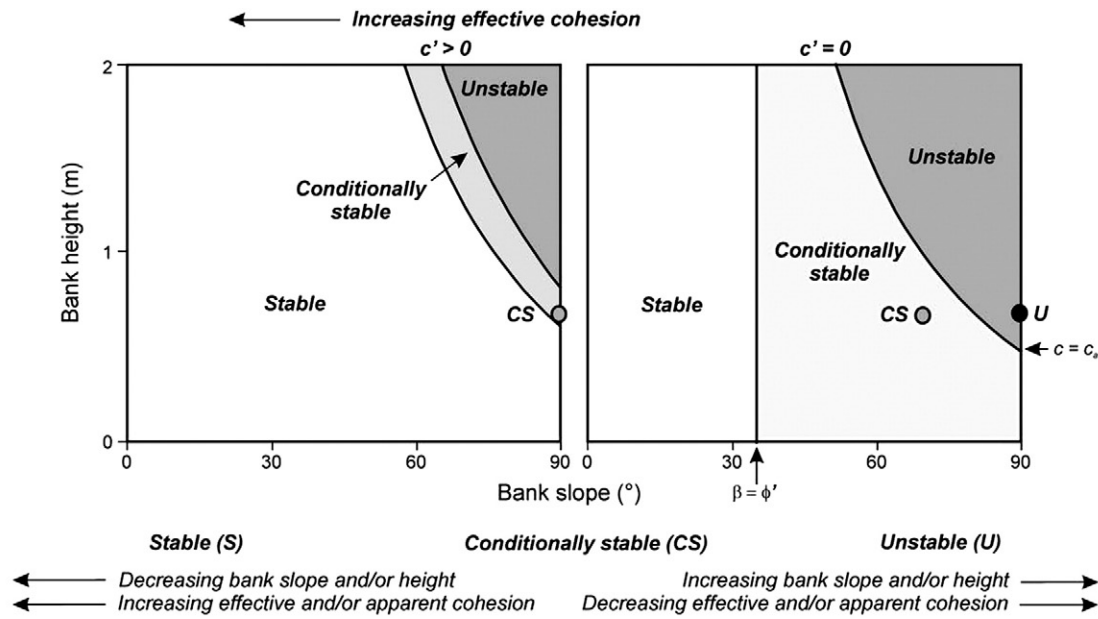
Fig. 9. Conceptual sketch of the evolution of bank profiles, depending on initial conditions.

Although uncertainty occurs in the shear strength parameters, the stability charts allow for a better interpretation of the results for each experiment and for comparing the three experiments (Fig. 8D). A general conceptual sketch of the evolution of bank profiles, interpreted by using this concept, is reported in Fig. 9.

The bank trajectories shown in the conceptual sketch of Fig. 9 illustrate the occurrence of different dominant processes, starting from different initial bank conditions (I), although some common points can be recognised. The second phase of instability (II) is
