An experimental investigation on mass failures occurring in a riverbank composed of sandy gravel

L. Nardi, M. Rinaldi ^{*}, L. Solari

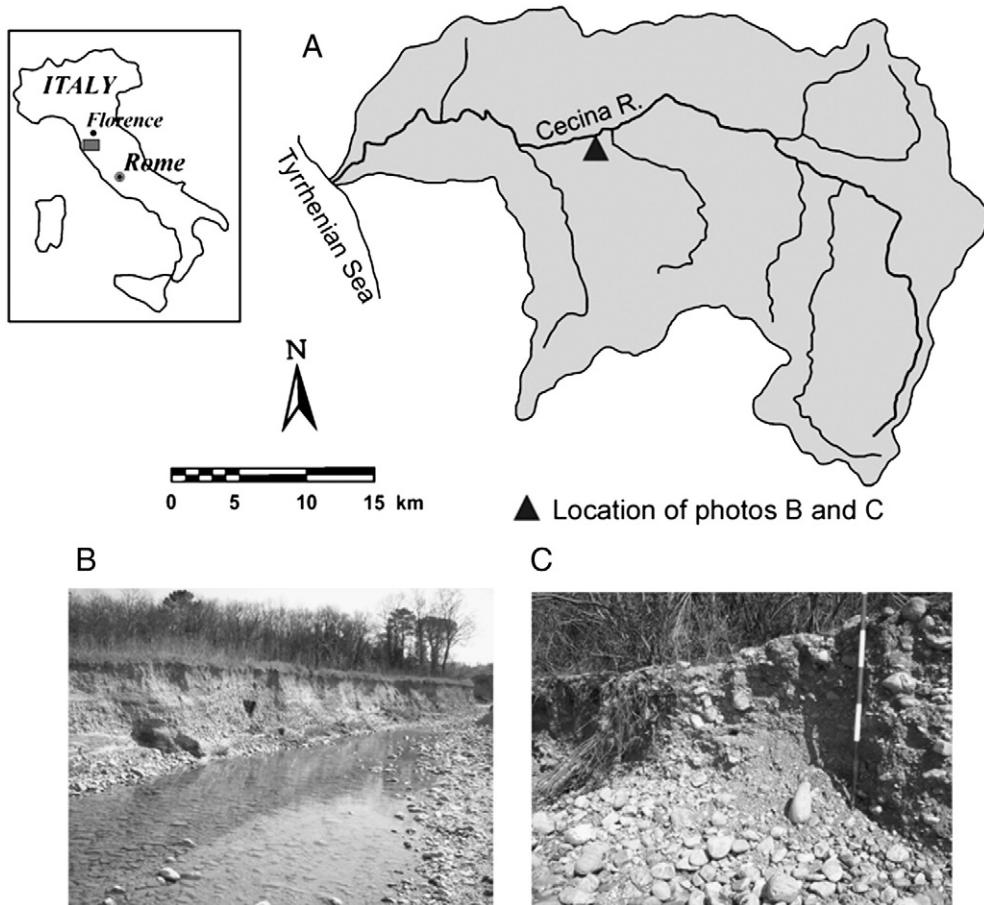
Fig. 1. Location of the Cecina River. A: Cecina basin; B: eroding composite riverbank of the Cecina River; C: detail of a coarse-grained bank with evidence of mass failure.

The characteristics of the bank model were defined based on a series of observations and grain-size analyses carried out on basal layers of composite riverbanks along the Cecina River (Tuscany, Central Italy) (Fig. 1). The selection of the Cecina River as a reference field study case is motivated by various reasons, including: (1) the presence of actively eroding composite banks (Fig. 1B), consisting of a basal layer of packed and slightly cemented gravel, with generally a wedge of loose gravel and cobble located at the bank toe, and an upper fine-grained (predominantly sandy silt) cohesive portion of the bank; (2) existing research activities on riverbank processes along this river (see Rinaldi et al., 2008; Luppi et al., 2009). The bank reconstructed in the laboratory was not intended to scale an entire bank profile of the Cecina River, but rather to mimic a single layer of the basal portion, to investigate the basic processes occurring on this part of the bank. The grain-size distribution of the basal gravel layer along Cecina riverbanks is quite variable, and we

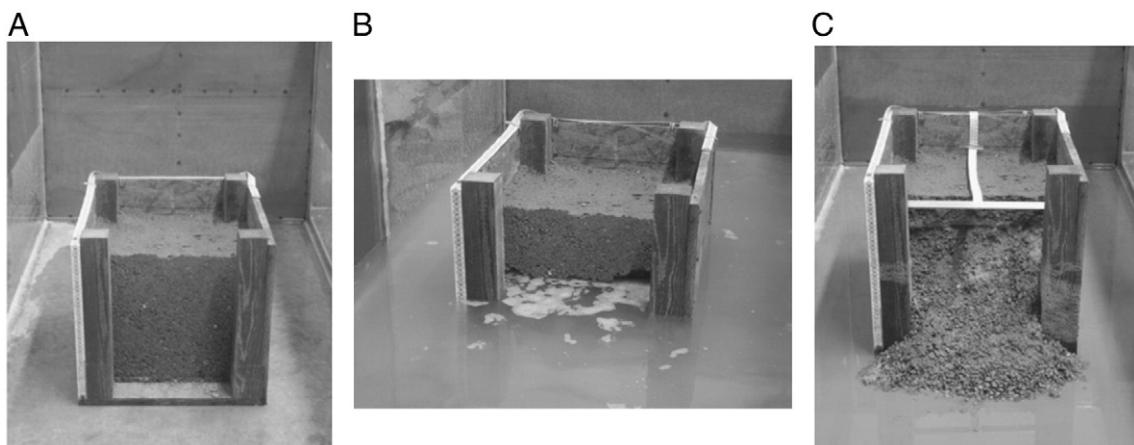
Fig. 2. Initial tests. A: Beginning of test 4; B: rising phase of test 4; C: conclusion of test 4.

We started with a series of experiments carried out in small boxes to test the responses, in terms of processes and stability, of different sediment mixtures, hydrographs, and bank geometries (Fig. 2). For example, in this phase we tested which possible sediment mixture (relative percentage of sand) appeared to be more suitable to reproduce the desired mass failures, avoiding excessive stability or instability. The boxes were constructed of wood, with a rectangular base of 45 × 50 cm and a height of 40 cm, and a frontal wooden panel with an assigned slope angle which was removed at the start of the test. During the tests, the boxes were placed in the tank, and subject to given hydrographs, with a peak water stage of 25 cm, and a total duration of 1 h and 40 min. A summary of the initial tests carried out is reported in Table 1. The results of these tests were used in the later analyses for classification of different failure mechanisms and observations on instability conditions, as some mechanisms were more frequently observed in these tests than during the main experiments.

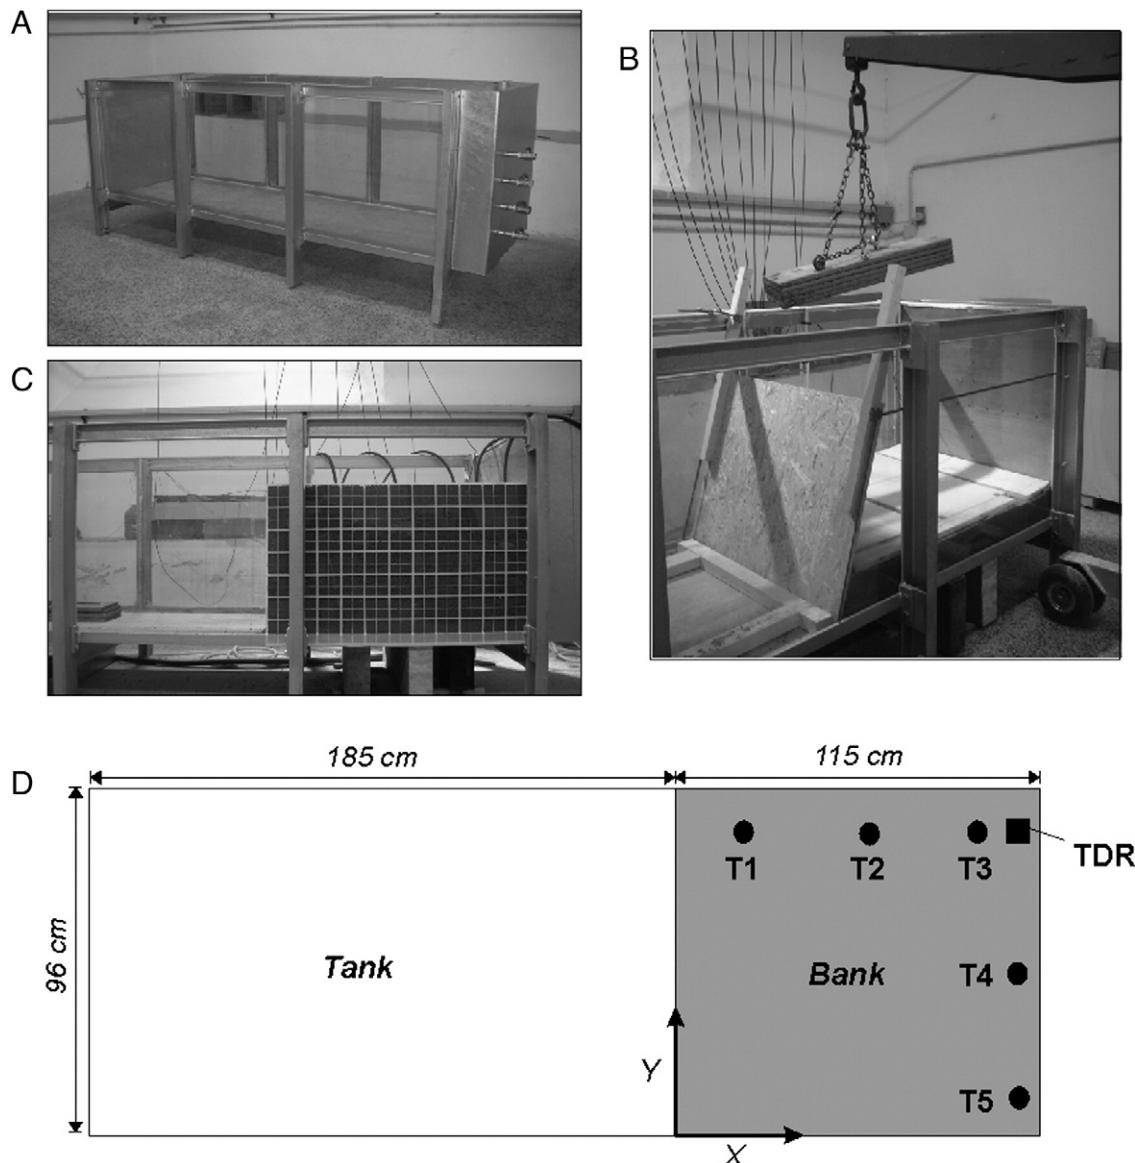
Fig. 3. Experimental setup. A: tank; B: loads made by steel plates and setup of the wooden panel during the construction of the bank physical model; C: bank model for EXP3; D: configuration of monitoring instruments (for positions and depths of each of the instruments see Table 2).

For the main experiments, a tank was specifically designed and built (Fig. 3A). The tank is 1 m wide, 3 m long, and 1 m high, having a steel structure, a zinc plated bottom, and glass walls to allow for observations and video monitoring during the experiments. The front side is constructed of a zinc plated door to allow for the construction of the bank inside the tank. A smaller reservoir is included on the back of the tank to maintain a given water head during the experiments, with a porous plate separating the reservoir from the main body of the tank ("lysimeter" modality, according to the experimental setup developed by Fox et al., 2006).

10 cm layers, until a given bank height was obtained. A distributed load (made by steel plates: see Fig. 3B) was applied to the top of each layer, with a weight decreasing from the bottom to the top of the bank model. Each layer was left under the assigned load for about 20 h to allow for a sufficient consolidation. Measurements of changes in the thickness of each layer before and after consolidation were carried out. We also considered the option of a dynamic compaction by using a mechanical earth compactor, but this was excluded for the following reasons: (1) to avoid damages to the tank; (2) to avoid the formation of interstitial over-pressure; and (3) because static compaction better reproduce the conditions that normally occur in nature from lithostatic loads.

During construction of the bank and compaction, a wooden panel was positioned to assign a given slope angle to the bank (see Fig. 3B). The panel was removed immediately before the start of each experiment. For EXP1, a basal failure occurred immediately after the panel removal (see Section 3 for details). This unforeseen collapse could be in part explained by limited compaction of the material along the slope boundary, as in that portion of the bank the application of the load was more difficult, and the portion of sediment directly in

contact with the panel was not really subject to vertical overloads. Consequently, the assigned bank slope angle was changed to 90° for EXP2 and EXP3 (Fig. 3C). A failure, however, also occurred at the beginning of EXP2, which did not occur in EXP3, presumably because of the presence of cement in the sediment mixture (reasons for the occurrence of an initial failure for EXP1 and EXP2 are discussed later).

Planimetric and vertical positions of tensiometers and TDR during the three main experiments. X and Y: planimetric coordinates (see Fig. 3); Z: elevation above the bottom of the bank.

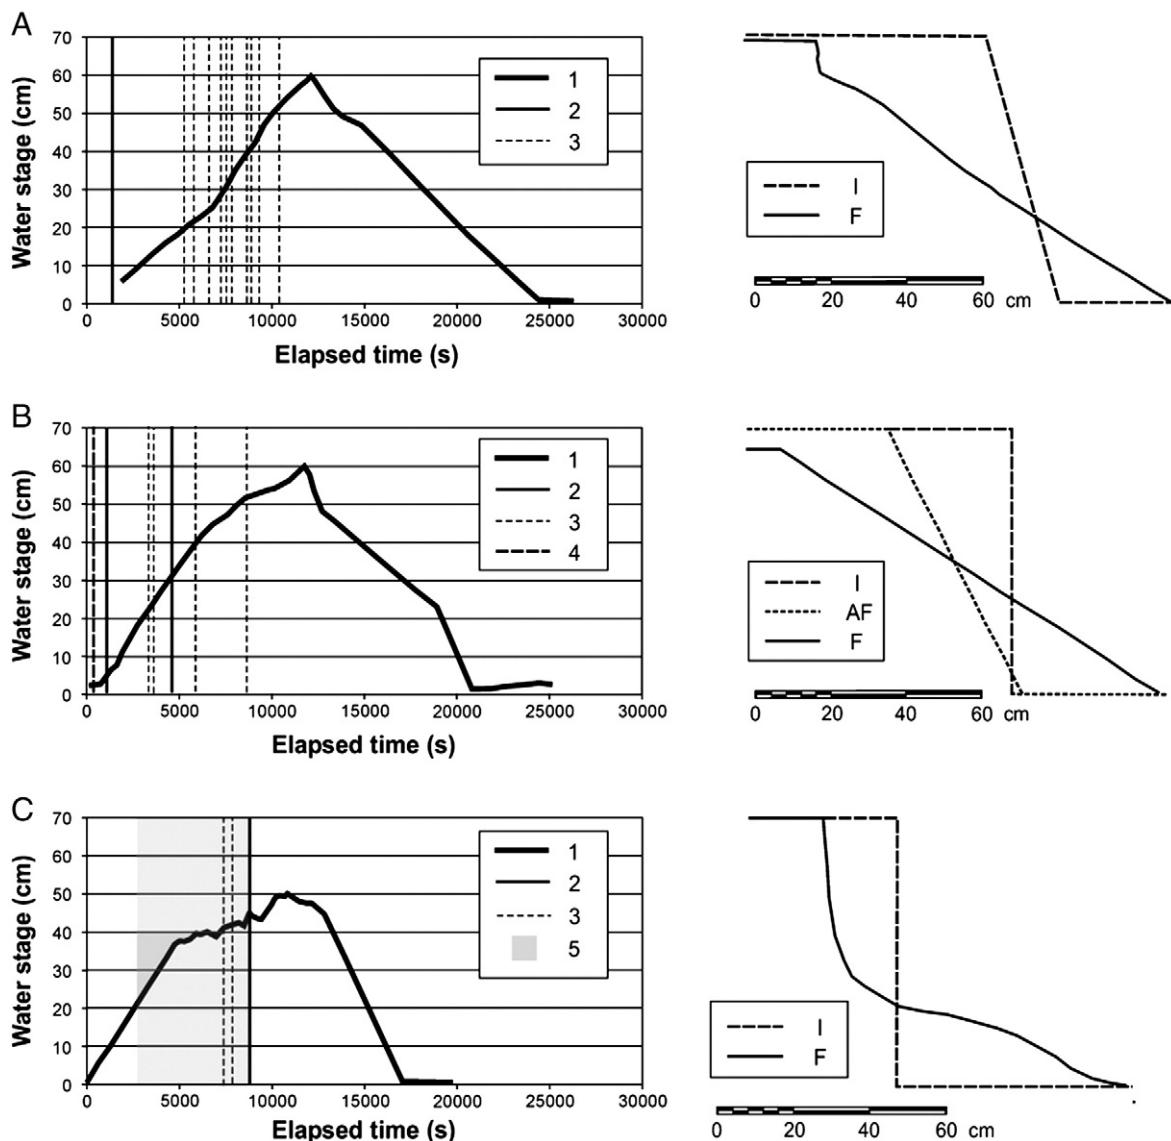
Fig. 4. Summary of hydrographs, failures and profile evolution during EXP1 (A), EXP2 (B), and EXP3 (C): hydrograph and failures (on the left), and changes in bank profile (on the right). 1: Hydrograph; 2: large failures; 3: small failures; 4: initial failure immediately after the panel removal; 5: progressive erosion because of loss of matric suction; I: initial profile; F: final profile; AF (in EXP2): new profile after immediate failure.

experiments (Fig. 4), and with a shape similar to that observed in a series of monitored flow events occurred on the Cecina River (see Luppi et al., 2009).

Regarding the main experiments, the occurrence of mass failures at the scale of each hydrograph, and resulting modifications from the initial to the final bank profile, are reported in Fig. 4. In this figure, mass failures indicated as being large are those involving a significant

portion of the bank height and approximately the entire width, whereas small failures are those which occurred on localised portions of the bank profile and/or width. It is possible to observe that all the mass failures occurred during the rising phase of the hydrographs. In the case of the EXP1 and EXP2 the mass failures were distributed along the entire rising part of the hydrograph. In the case of EXP3, as effect of cementation and increased shear strength, the failures occurred exclusively in proximity of the peak of the hydrograph.

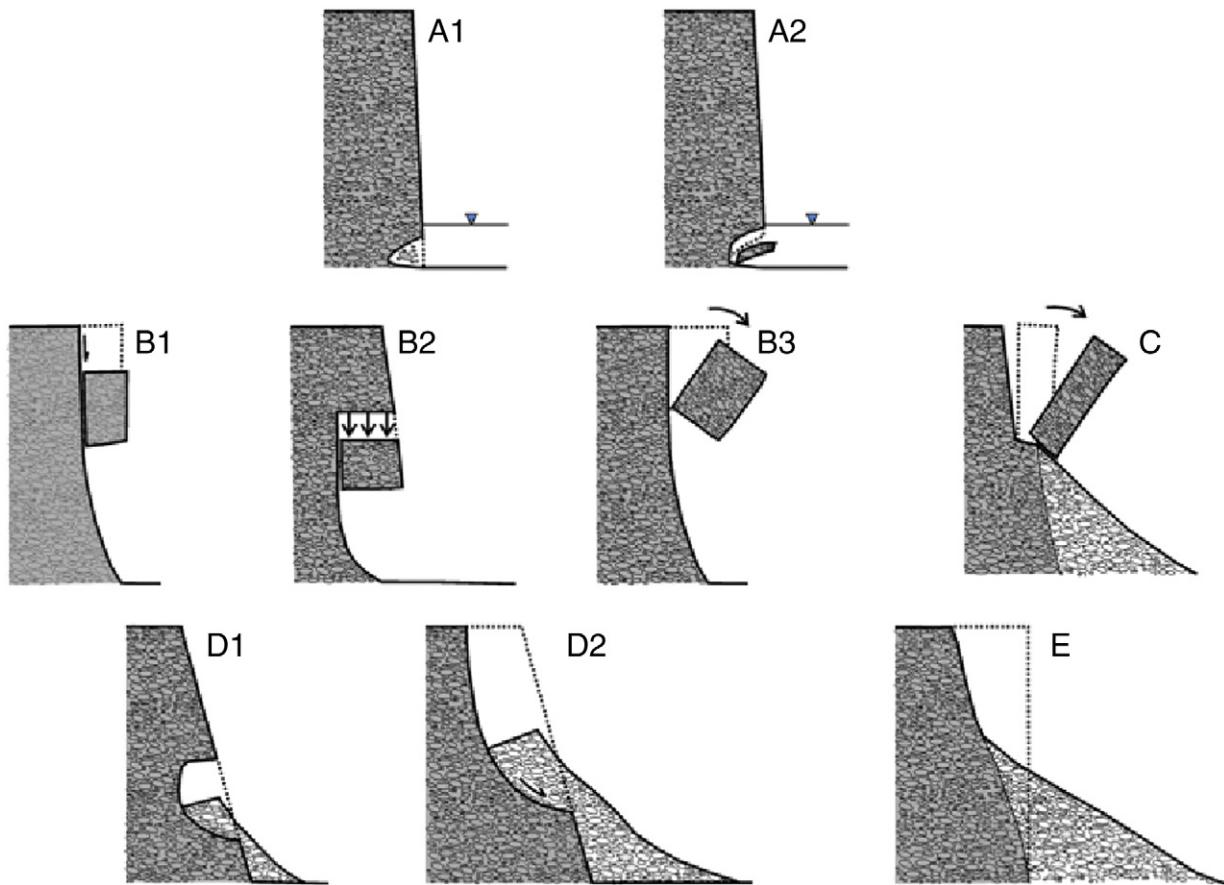
Fig. 5. Types of erosion processes. A: erosion (A1) and failure (A2) because of loss of matric suction; B: cantilever failures (B1: shear failure; B2: tensile failure; B3: beam failure); C: slab failure; D: slides (D1: alcove-type failure; D2: rotational slide); E: dry granular flow.

- 1) Erosion and failures because of loss of matric suction. This process is related to a loosening of the weak links between particles as soon as the pores are saturated by water and the resulting increased weight of aggregates or small blocks from sediment saturation (see also the discussion). The erosion process initially produces a scour at the bank toe (Fig. 5, case A1), followed by small-scale mass failures, resulting in the collapse of the upper small block or aggregate of particles by tensile failure (Fig. 5, case A2).

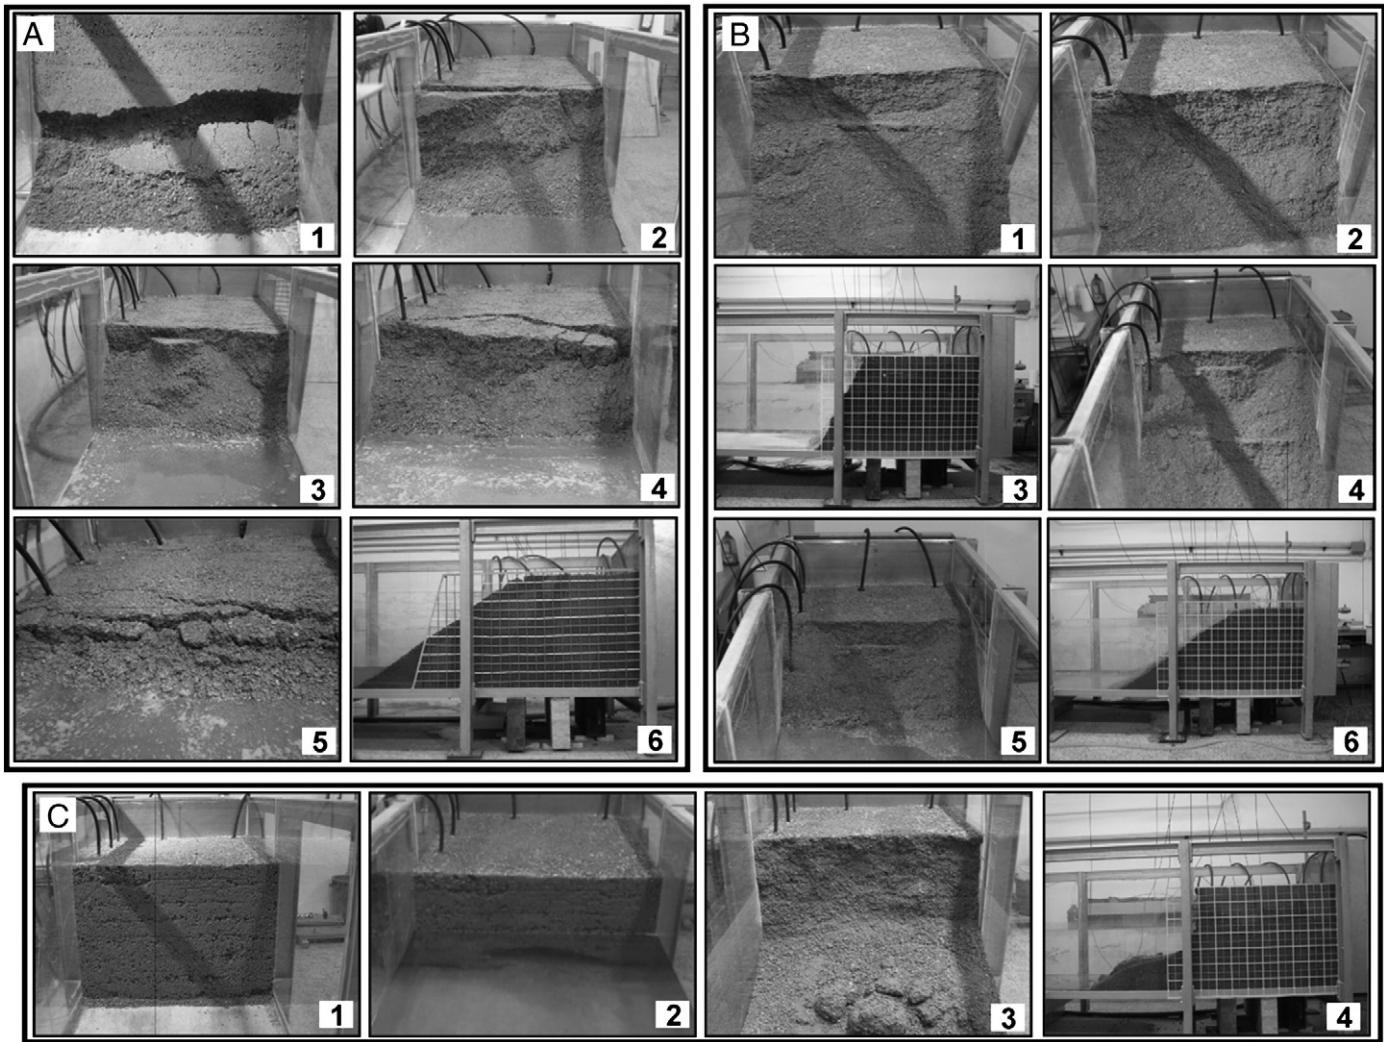
Fig. 6. Photos of bank profile evolution during some of the experiments. A: EXP1; B: EXP2; C: EXP3 (for the numbered photos see description in the text).

EXP2. The initial bank slope was set at 90°, but immediately after the removal of the wooden panel, (1) a failure across the whole bank

occurred, classified as a granular flow in loose cohesionless material, creating a nearly plane surface. (2, 3) The failed material was removed from the bank toe, and the bank was shaped according to an angle of about 67° to continue the experiment. After 7 min and 20 s, a large rotational failure occurred involving the upper and middle portion of the whole bank. This can be better described as a flow slide, as multiple and temporary concave failure surfaces were observed. After this event, only other small failures occurred during the ascending phase of the hydrograph, until (4) the profile became a nearly planar surface with a slope of about 35°, corresponding approximately to the angle of repose for this sediment. Similarly to EXP1, the bank profile did not change during the descending phase of the hydrograph.

EXP3. The bank material in this last experiment included a small quantity of cement. Consequently, the bank showed a response different from previous experiments. (1) The initial bank was set at 90° and remained stable after the removal of the wooden panel. (2) After about 40 min, a scour because of loss of matric suction started to manifest along most of the basal area of the bank, but was more evident on the right and central part. This process started at the interface of different sub-layers of 10 cm built during the compaction procedure. The scour progressively continued to extend laterally and within the bank as time progressed. A first manifestation of failure involved a small block on the left margin located 10 cm below the water stage. This failure rapidly progressed upward as a tensile cantilever failure. (3) After 145 min and 54 s from the beginning, a rapid succession of further tensile failures occurred in various portions, until the cantilevered bank was completely up to the water stage. About 5 s later (elapsed time 146 min), a rapid succession of three cantilever failures occurred (the smaller was a tensile failure, the two larger were beam failures), recreating a nearly vertical bank face. (4) This became the final bank configuration, because

no failures occurred during the descending phase of the hydrograph, with a basal wedge of failed material at a slope angle of about 20° and some of the failed blocks still recognisable, and an approximately vertical face of about 40 cm.

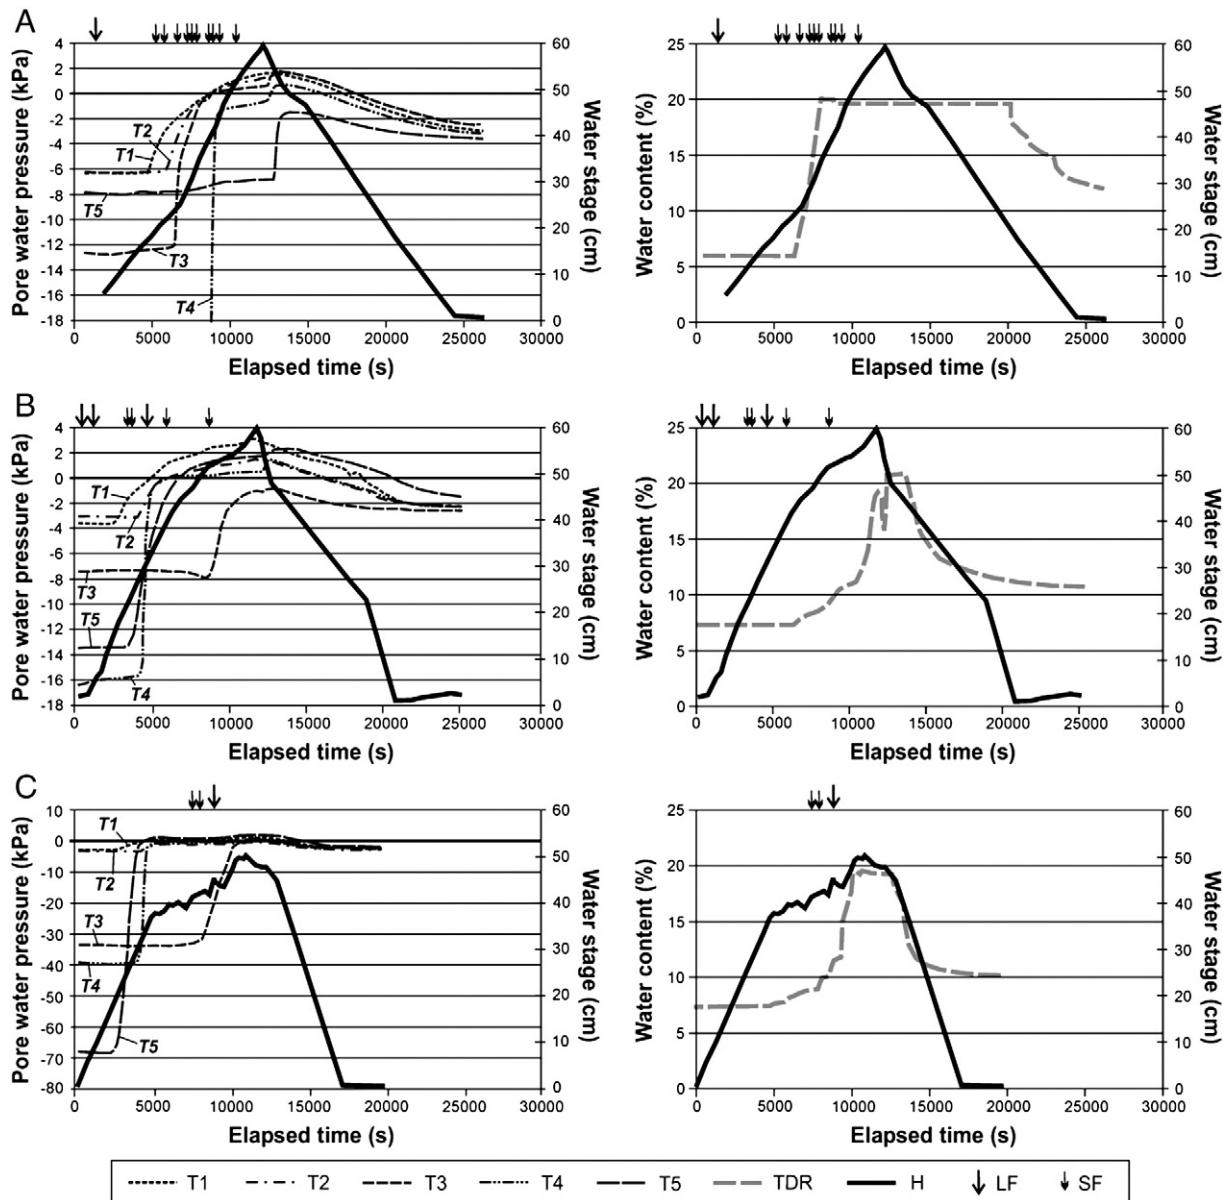
Fig. 7. Trends of measured parameters and summary of failures during EXP1 (A), EXP2 (B), and EXP3 (C): hydrograph, failures, pore water pressures (on the left), and water content (on the right). T1, T2, T3, T4, T5: pore water pressure measured by the tensiometers; TDR: water content measured by the TDR; H: hydrograph; LF: large failures; SF: small failures.

EXP2. As mentioned before, for this experiment a slightly different configuration of the sensors was used (see Table 2): the trends of pore water pressures were, therefore, different from EXP1. Fig. 7B shows that T1 was the first tensiometer to reach saturation when the water stage was 32 cm, followed by T2 and T4, for water stages from 38 to 40 cm. T5 was located in a lower position than T4 and, at the beginning of the test, measured a pressure higher than T4. T5 reached saturation later, however, when the water stage was 43.5 cm. This happened because the reaction of T5 was slower than T4. T3 did not reach saturation because it was located in the back of the bank at 52 cm from the bottom, whereas the valve behind the lysimeter was open at 34 cm. TDR indicates that saturation at around 45 cm from the bottom of the bank, corresponding to the height of the sensor, occurred when the water stage was 51.4 cm. The water content of saturated material for this test was 20.9%.

EXP3. For this experiment the same configuration of the sensors as in EXP2 was used. As well as the previous tests, the initial values recorded by the tensiometers are very different (Fig. 7C): T5 measured the lowest value, followed respectively by T4 and T3. This could result from the proximity of these three tensiometers to the porous plate of the lysimeter which dries the material around it. As the water stage increased, between 28.5 and 35 cm, all the tensiometers except T3 started to react. Because of its highest position, T3 started to measure increasing values of pore water pressure when water stage was 41.8 cm, but did not reach saturation. During this experiment, the peak of the hydrograph could not exceed 50.3 cm. The TDR measured water content of the saturated material equal to 19.6% when the water stage was 49.9 cm.

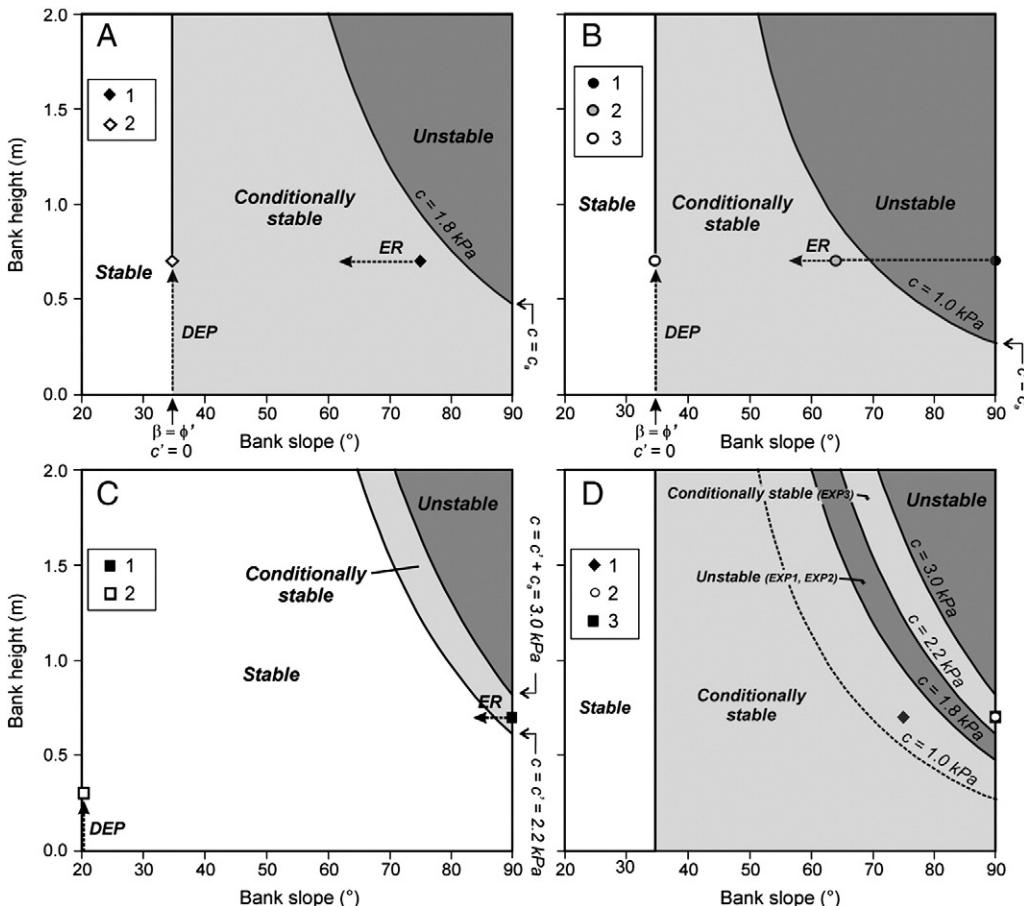
Fig. 8. Stability charts. A: EXP1. 1: Initial bank geometry (packed bank); 2: final bank geometry (loose bank). B: EXP2. 1: Initial bank geometry (packed bank); 2: new bank geometry (after initial failure); 3: final bank geometry (loose bank). C: EXP3. 1: Initial bank geometry (slightly cemented bank); 2: final bank geometry (loose bank). D: summary of all experiments. 1: Initial bank geometry of EXP1; 2: initial bank geometry of EXP2; 3: initial bank geometry of EXP3. ER: trajectory of eroding (packed) bank; DEP: trajectory of depositing (loose) basal bank.

In detail, a series of stability charts (bank height versus slope) were created for each experiment (Fig. 8), following the approach used in Rinaldi and Casagli (1999). This entails plotting curves obtained from geotechnical limit equilibrium analysis by using the slope stability charts proposed by Hoek and Bray (1981) for circular failures with a tension crack at a critical depth. This mechanism is considered here as representative of the overall bank instability, rather than associated to specific observed failures (although in two experiments, failures with a component of sliding along a rotational surface were actually observed).

For each experiment an upper curve associated with limit equilibrium for the initial conditions was obtained by using these parameters (Fig. 8). This curve represents the upper bound of stability when the total cohesion is maximum (beginning of the experiment).

Then limit equilibrium conditions were estimated in case of a complete loss of apparent cohesion. For EXP1 and EXP2 (Fig. 8A and B), being $c' = 0$, when $c_a = 0$ and assuming that positive pore pressures have not yet developed, the bank stability does not depend on the bank height, but the bank slope coincides with the friction angle. This is represented by a vertical line with abscissa equal to $\phi' = 35^\circ$, that can be identified as a lower bound corresponding to an ultimate stable angle of the sediment mixture when the total cohesion is equal to zero. For EXP3 ($c' > 0$), the condition associated with $c_a = 0$ is represented by a second curve, on the left of the upper bound (Fig. 8C).

Although uncertainty occurs in the shear strength parameters, the stability charts allow for a better interpretation of the results for each experiment and for comparing the three experiments (Fig. 8D). A general conceptual sketch of the evolution of bank profiles, interpreted by using this concept, is reported in Fig. 9.

EXP1. The initial bank geometry is in the region of conditionally stable conditions (Fig. 8A), that means that it should remain stable until the apparent cohesion would decrease. Actually, as observed before, the bank is subject to an initial failure. This is not predicted by the stability chart for a series of reasons, including: (1) it is not a rotational failure involving the whole bank, but occurs on the lower portion of the bank; (2) this failure can be associated to the sudden stress release because of removal of the panel, and to the poor compaction of the sediment in that zone from the non-verticality of the bank. The initial failure in turn generates additional stress release on the upper portion and induces a series of cantilever failures. Subsequent failures are associated with increasing pore water pressures (during this phase the upper bound moves towards the left with decreasing apparent cohesion, decreasing the region of conditional stability). The packed eroding bank moves towards the left of the chart (progressively decreasing the slope), whereas a new bank of loose sediment is progressively deposited at a slope approximately equal to the angle of repose.

EXP2. In this case the bank starts from unstable conditions (Fig. 8B). This results from the increase in bank slope and lower initial apparent cohesion. An overall failure immediately occurs after the panel removal. After remodelling the bank, a new failure affects the entire bank, so the profile moves rapidly towards left in the chart (decreasing bank slope), whereas a loose bank is generated at the angle of repose.

EXP3. In this case, it is evident how the presence of a small percentage of cement changes the stability chart, with a much wider region of stable conditions, and a very narrow region of conditionally stable conditions. Nevertheless, the bank is again in the conditionally stable region (Fig. 8C). It has been verified that the bank remains in this region even considering the uncertainty of the effective cohesion, e.g. varying c' in the range 1.81 ± 2.42 kPa. A change in stability conditions can result from a decrease of apparent cohesion and/or to some modification of the bank geometry by other factors. The bank remains stable until erosion because of the loss of matric suction, occurring with positive pore water pressures (submerged conditions), starts to manifest on the bank toe. At the end, after the occurrence of cantilever failures, the bank geometry of the cohesive portion moves to a slightly lower bank slope, whereas a new wedge of loose material is formed at the bank toe, but with a height significantly lower than the previous experiments.

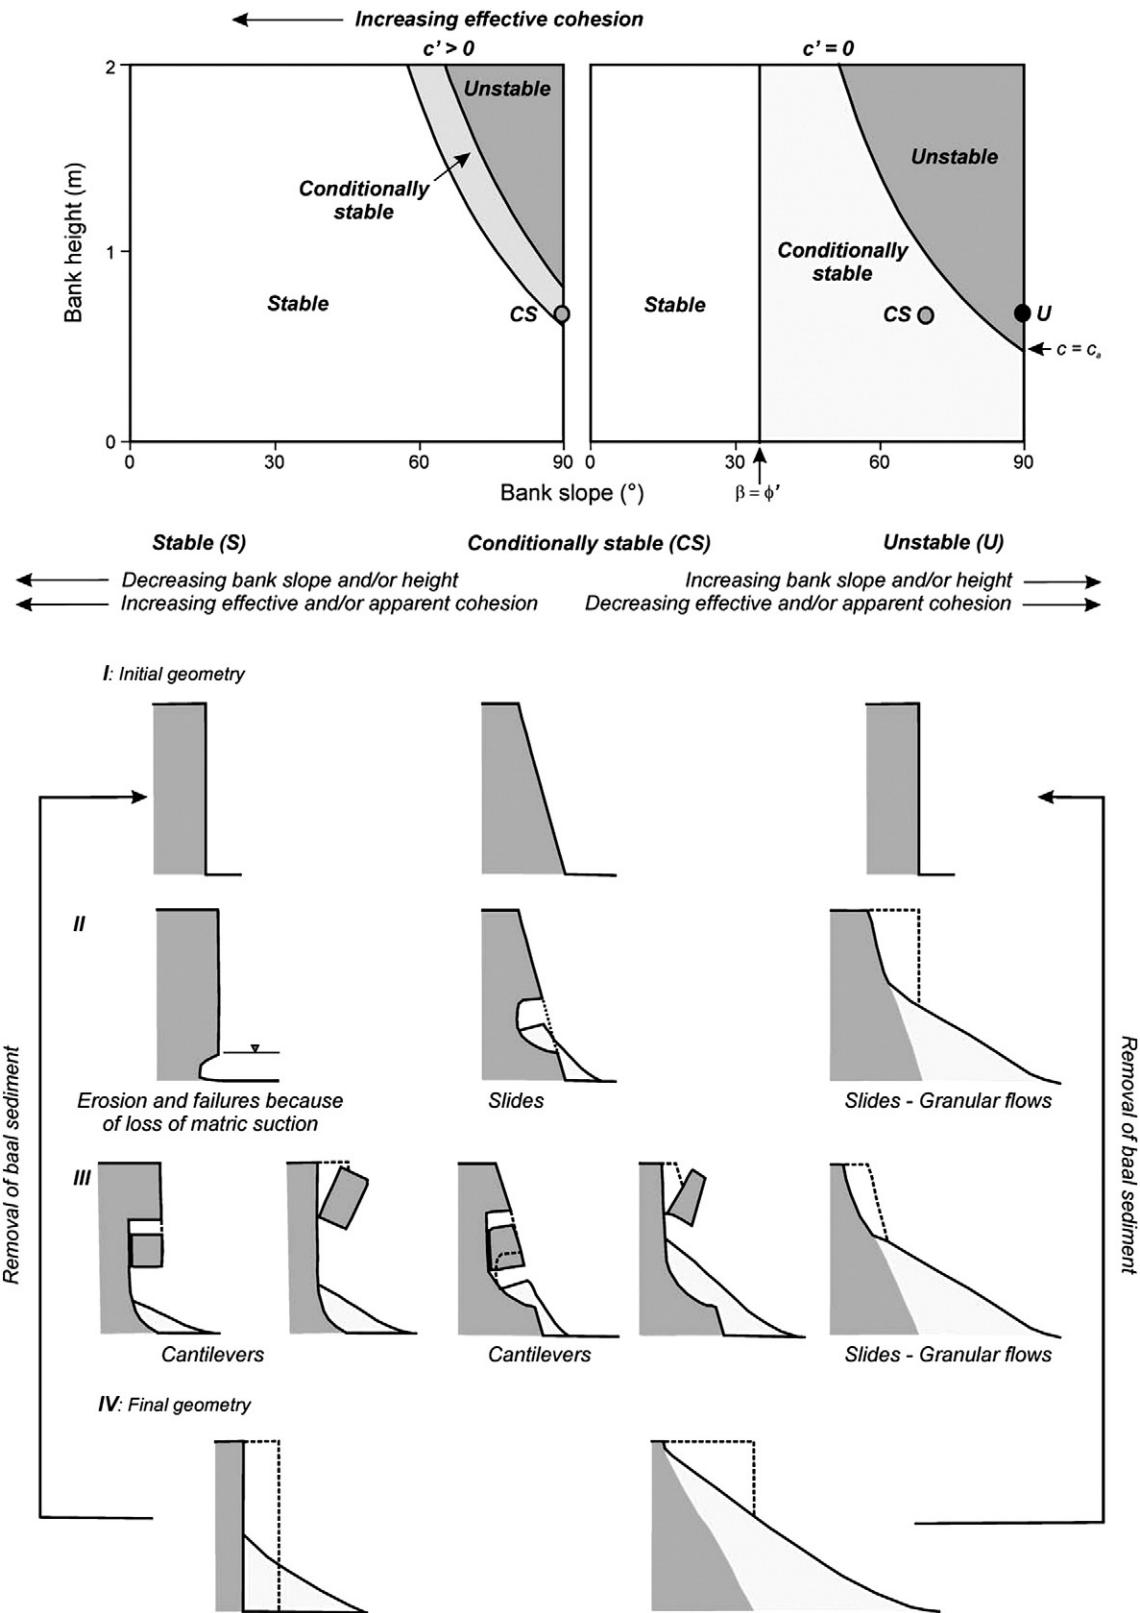
Fig. 9. Conceptual sketch of the evolution of bank profiles, depending on initial conditions.

The bank trajectories shown in the conceptual sketch of Fig. 9 illustrate the occurrence of different dominant processes, starting from different initial bank conditions (I), although some common points can be recognised. The second phase of instability (II) is
