# Study on the Influence of Sand Erosion Process on the Wear and Damage of Heat-Treated U75V Rail Steel

*Usually, rail materials are exactly affected by the erosion of windblown sand in the desert environment. For this reason, the influence of impact angle, particle velocity, and particle size on the erosion wear behavior of the U75V heat-treated rail steel, a material frequently employed in Chinese railways, were studied in this work. The results showed that, with increasing impact angle, the erosion rate increased between 15 deg and 45 deg, decreased between 45 deg and 75 deg, and then increased again between 75 deg and 90 deg. The highest erosion rate occurred at about 45 deg. When the particle velocity increased, the erosion rate increased approximately in a quadratic way. As the sand particle size increased, the erosion rate presented a decreasing trend. During the initial stage of erosion, shear craters, indentation craters, and ploughing craters were the main surface damage features. The shear craters predominated at the impact angle of 45 deg whereas the indentation craters predominated at 90 deg. During the steady-state of erosion, the rail damage was mainly composed of c

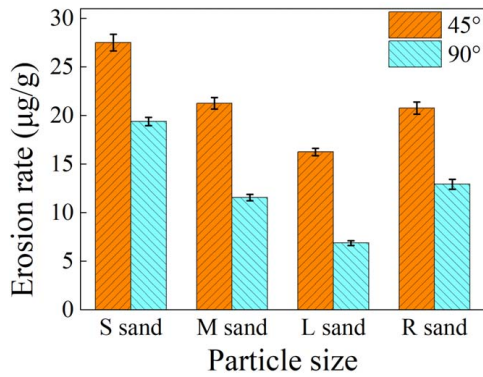
**Fig. 9 Correlation between erosion rate and particle size at the impact angles of 45 deg and 90 deg (particle velocity of 20 m/s)**

**3.1.3 Effect of Particle Size on Erosion Rate.** Figure 9 shows the erosion rates with different sizes of sand particles at the impact angles of 45 deg and 90 deg (particle velocity of 20 m/s). The erosion rate decreased with increasing particle size. Additionally, the erosion rate of the R sand was similar to that of the M sand. The trend of the erosion rate with particle size was consistent with that in Ref. [27]. A possible explanation is that the number of the sand particles decreases if the particle size increases (for the same mass of sand); thus, the number of the impacts on the same spot of the rail surface decreases with increasing particle size,

Figure 9 also shows that the erosion rate at 45 deg was always greater than that at 90 deg as expected. This was mainly because the shear stress and normal stress were simultaneously produced on the specimen surface at low impact angles whereas the normal stress was mainly produced at high impact angles [35]. Another reason for this trend was that the probability of rebounding particles and fragments colliding with incoming particles at low impact angles is lower than that at high impact angles. Such collisions could lead to a loss of kinetic energy and change direction of the incoming particles [36], affecting the capability of material removal. The erosion rates with S sand, M sand, and L sand at 45 deg were 42%, 84%, and 136% larger than those at 90 deg, respectively. It showed that the difference in erosion rate between 45 deg and 90 deg increased with increasing particle size. The results also revealed that the erosion rate at 45 deg was less sensitive to the particle size than that at 90 deg.

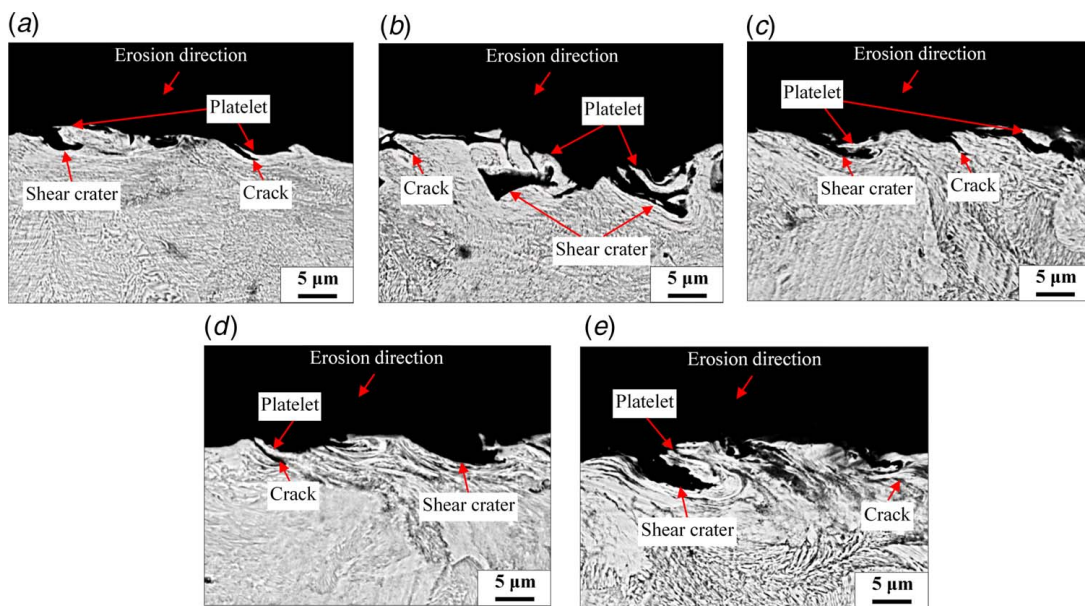
**Fig. 15** SEM photographs of the damaged cross sections during the steady-state with different sand particle sizes and particle velocities at 45-deg impact angle: (a) R sand, 20 m/s, (b) R sand, 34 m/s, (c) S sand, 20 m/s, (d) M sand, 20 m/s, and (e) L sand, 20 m/s

**3.3 Subsurface Damage During the Steady-State.** Figure 15 shows the SEM photographs of the cross sections of the damaged rail during the steady-state at the impact angle of 45 deg. It is clear that shear craters, platelets, and cracks were formed on the cross sections produced by different particle velocities and different particle sizes. Shear craters were adjacent to each other along the rail specimen surface and their shapes were quite similar. It is evident that the material near the specimen surface, especially at the bottom of the shear craters, exhibited plastic flow, where the pearlite interlamellar spacing was much smaller than that of the matrix material. Platelets had significant differences in size and shape, and most of the platelets were generated above the end (right side) of the shear craters. Cracks mainly occurred at the bottom of the shear craters, and their orientations were roughly parallel to those of the plastic flows. Figures 15(a) and 15(b) show the subsurface damages caused by R sand with particle velocities of 20 m/s and 34 m/s, respectively. The dimensions of shear craters and the size of platelets significantly increased with increasing particle velocity. On the other hand, Figs. 15(c)–15(e) shows the subsurface damages due to S sand, M sand, and L sand, respectively, with a particle velocity of 20 m/s. The dimensions of shear crater appeared to increase with increasing particle size.
