Effect of spherical dents on microstructure evolution and rolling contact fatigue of wheel/rail materials

X.J. Zhao^{1,2}, J.Guo¹, Q.Y. Liu¹, E. Butini², L. Marini², E. Meli², A. Rindi², W.J. Wang^{1,*}

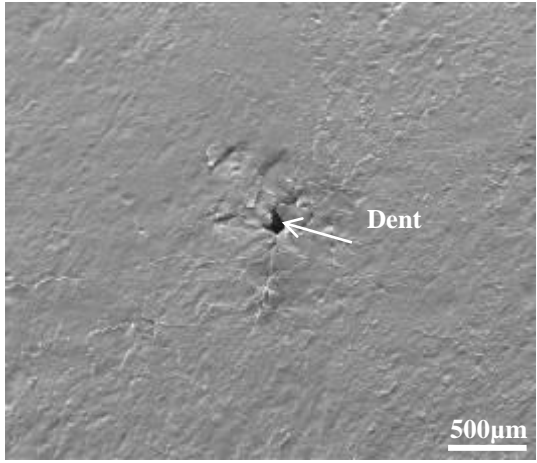
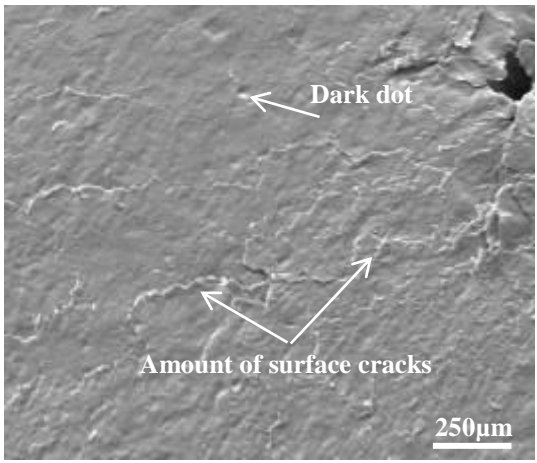
Fig.5

Fig.5: SEM micrographs of surface damage of wheel rollers, (a) WN; (b) WS; (c) WM; (d) WL.
