Effect of spherical dents on microstructure evolution and rolling contact fatigue of wheel/rail materials

Effect of spherical dents on microstructure evolution and rolling contact fatigue of wheel/rail materials / E. Butini, L. Marini, E. Meli, A. Rindi. - In: TRIBOLOGY INTERNATIONAL. - ISSN 0301-679X. - ELETTRONICO. - 127:(2018), pp. 520-532.

Keywords: Wheel/rail materials; Spherical dents; RCF; Microstructure evolution

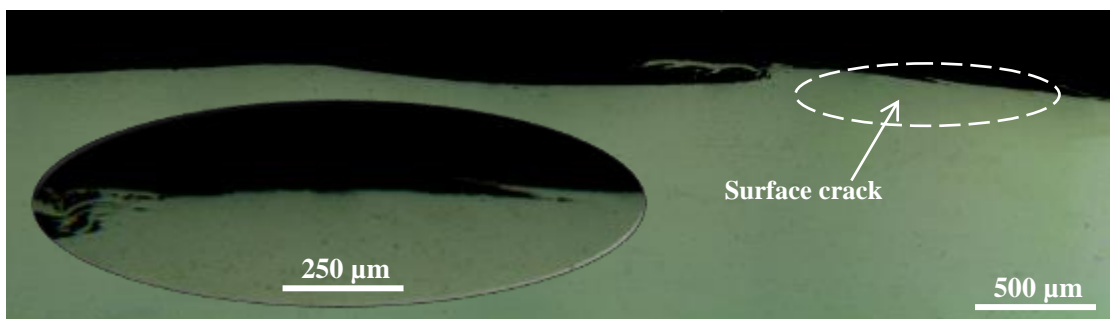
Fig.8

Fig.8: OM micrographs of fatigue cracks on the section of rail rollers, (a) RN; (b) RS; (c) RM; (d) RL.
