# Timber Strengthening Systems operated on the Vasari's Ceiling in Palazzo Vecchio

Timber Strengthening Systems operated on the Vasari's Ceiling in Palazzo Vecchio / P.P.Derinaldis; G. Tampone; G. Tempesta. - STAMPA. - (2006), pp. 421-428. (Intervento presentato al convegno Structural Analysis of Historical Constructions. Possibilities of numerical and experimental techniques tenutosi a New Delhi).

## Timber Strengthening Systems operated on the Vasari's Ceiling in Palazzo Vecchio

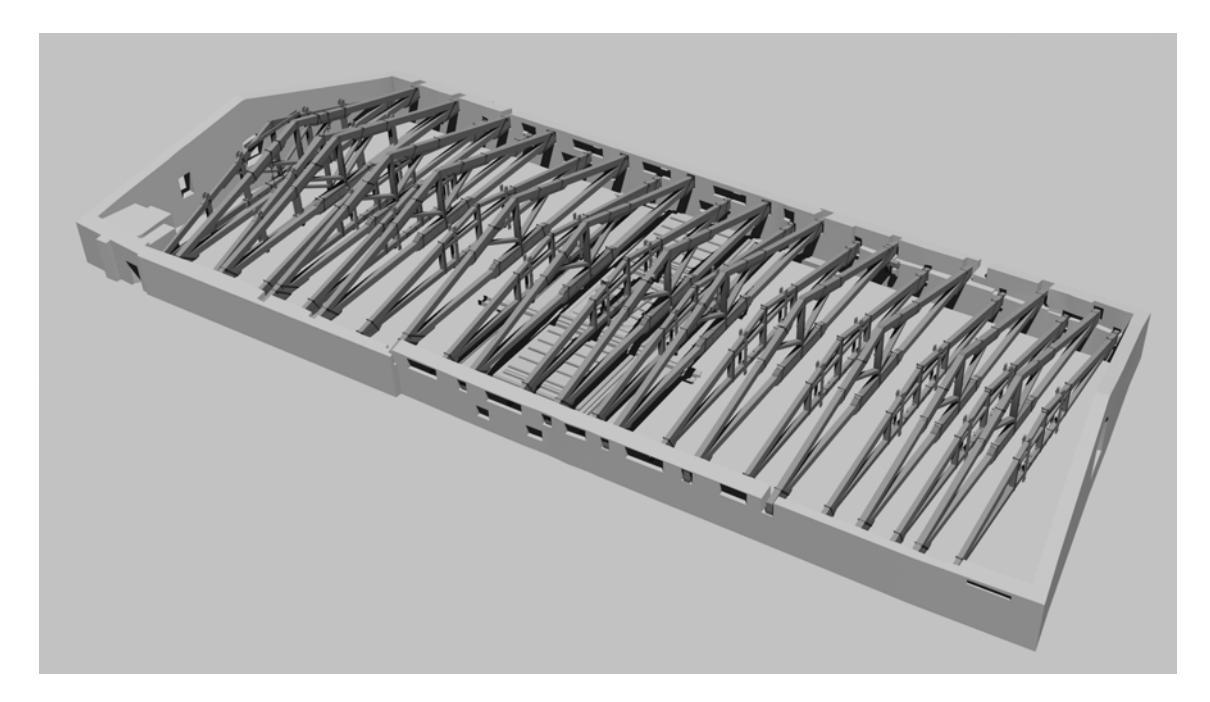
Figure 1: "Salone dei 500". Perspective view of the garret.

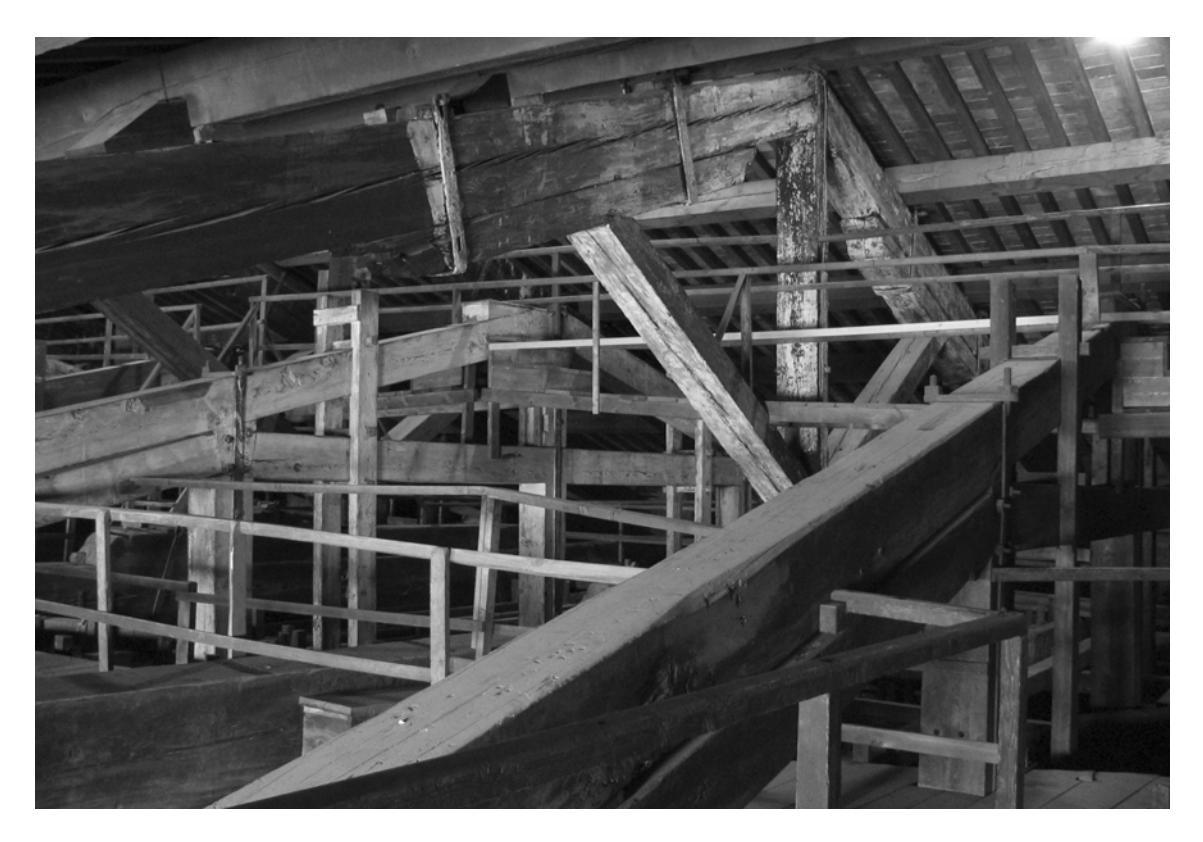
Figure 2: Panoramic view of the "Salone dei 500" garret, in the middle the vasarian trusses.

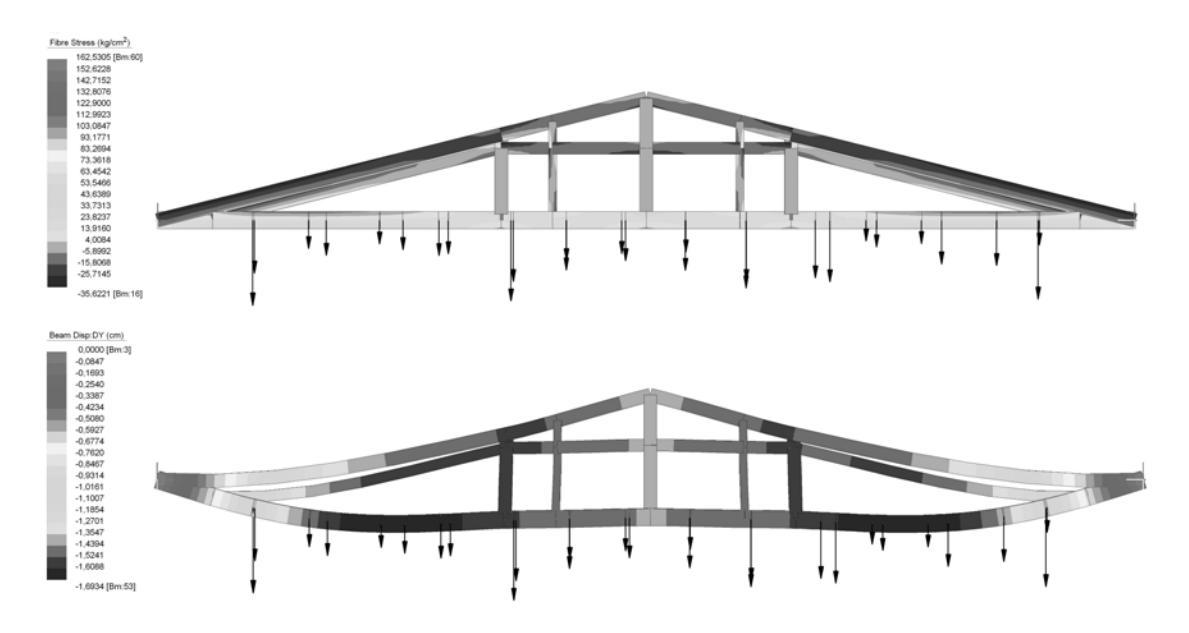
Figure 3: Numerical model of the 7<sup>th</sup> Graldi's truss. The painted ceiling is suspended from this truss. Structural unit subjected to statical loads. Stresses (up). Vertical displacements (down).

The structural analysis for the Giraldi's trusses shows that the stresses in the wood vary in a very narrow range and the values are small (see Table 4). A deformation curve of the rafter different from that of the under rafter and a tendency of these members to share have been observed.

43.5	0.072	80		
Table 3: Trusses sustaining the false celing.				
Maximun overload (5 <sup>th</sup> wooden truss)		Minimun overload (1 <sup>th</sup> wooden truss)		
kN		kN		
82		29		
Table 4: Domenico Giraldi's 7 <sup>th</sup> truss positioned in 1854.				
With internal fixed joints		With internal joints like hinges		
Stress	Displacement max (y)	Stress	Displacement max (y)	
N/cm <sup>2</sup>	cm	N/cm <sup>2</sup>	cm	
1593.88 (metallic elements) -349.33	-1.7	1650.18 (metallic elements) -480.45	-2.5

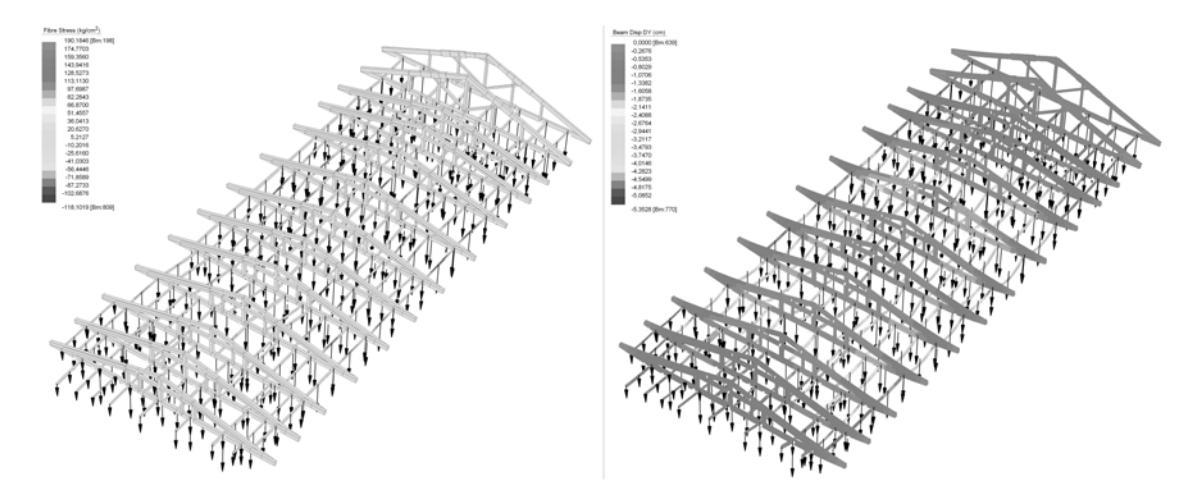
Figure 4: Numerical model of the trusses which sustain the false celing and of the interposed joists. Structural system subjected to statical loads. Stresses (right). Vertical displacements (left).

In the complete structural model, defined by the parallel collection of wooden trusses, a system of the wooden joists has been considered arranged among the singles structural units. Both the self weigth load of the ceiling and the loads trasmitted by the metallic and timber suspension devices have been applied directly to the wooden joists.

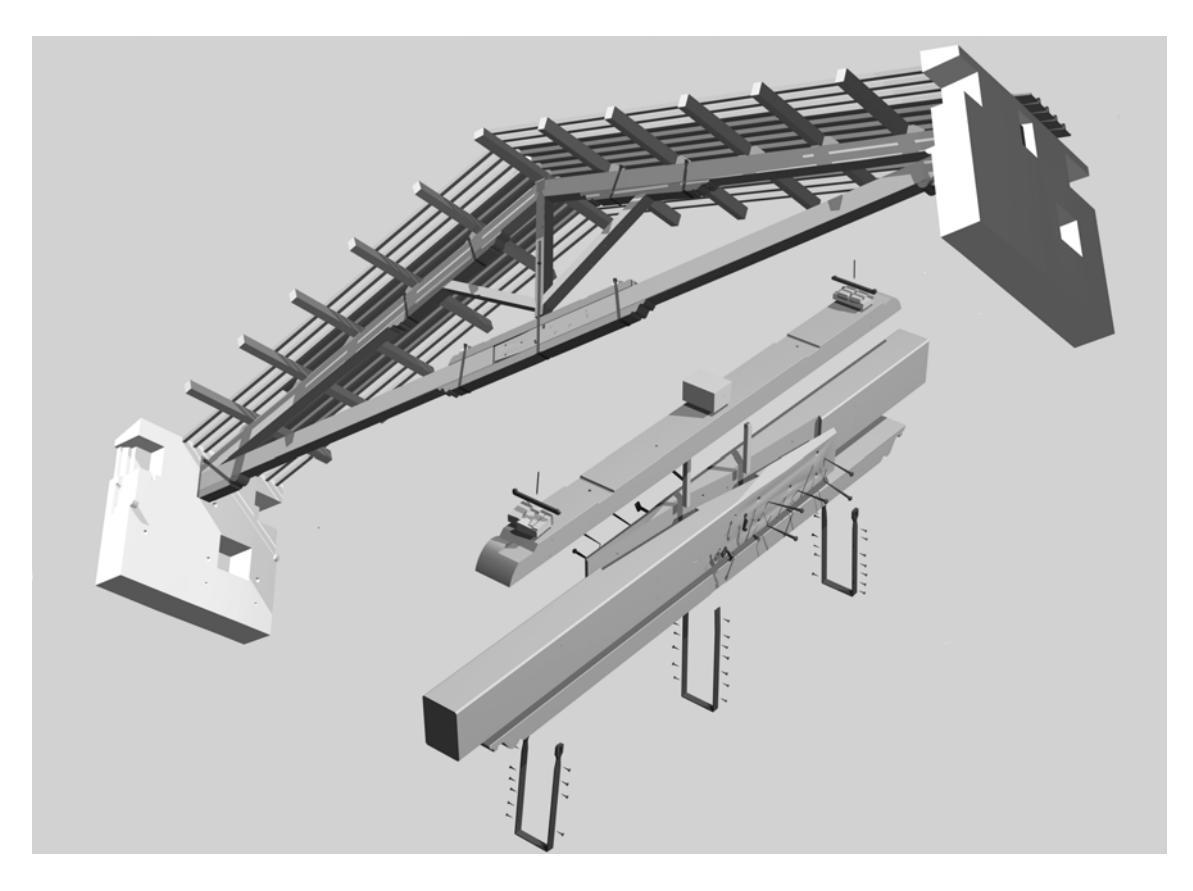
Figure 5: The vasarian truss; exploded view of the chord.

The chords are made, in account of the length, 24 m average, of two elements connected in the middle by a seal joint (a simplified "Jupiter's arrow joint") the contact surfaces of which are resting in vertical planes, also inclusive of a superior and a slightly longer inferior element. These, acting as brackets, are intended to stiffen the connection and to make it suitable to resist also to bending moment: this is generated by the not negligible self weight of the chord and by the weight of the false ceiling. The central connection is completed with nails and bolts of various type set untidily (a sign of multiple interventions) which stop any mutual motion and do not allow adjustment; very sophisticated the bolts, which are to be attributed to the Vasari's time. Besides the four pieces are tightened by two end iron ties. These have no wedges (today) but a single upper horizontal connector and they can be tightened to the woods only inserting wooden thicknesses.
