Static Testing of a Bridge Using an Interferometric Radar: The Case Study of "Ponte degli Alpini," Belluno, Italy

The bridge under test is named "Ponte degli Alpini," located in Belluno, Italy. Large reinforcement works were implemented in order to make the bridge compliant with the most recent antiseismic law. The works finished in 2009, the year after a load test was planned before to open the bridge to heavy traffic (over 3.5 tons).

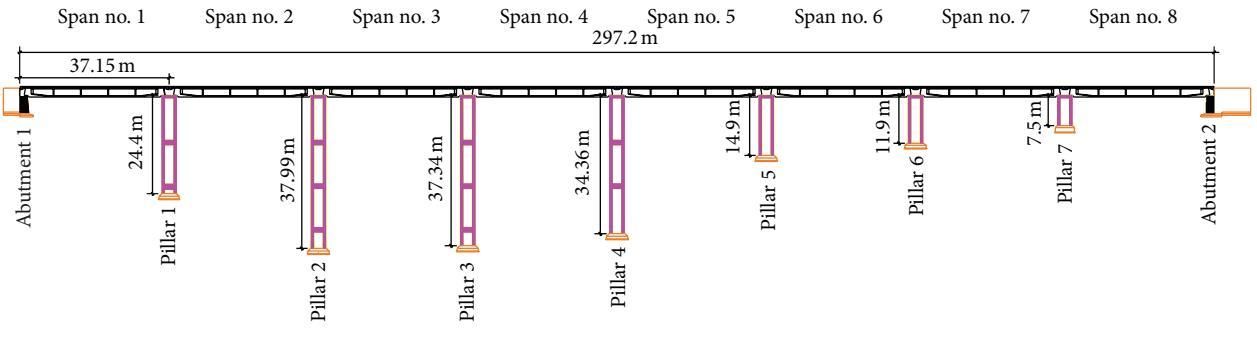
The "Ponte degli Alpini" is an 8-span bridge, 297 m long. Each span has 4 longitudinal reinforced concrete beams, 37 m long, and a slab. The beams are supported by concrete piers (see Figure 1).

FIGURE 1: Scheme of "Ponte degli Alpini."

For testing one of the lateral span (labelled with no. 8 in Figure 1), the radar has been used in only-range modality (see Figure 3). It means that it is able to discriminate the target points only for their different distances from the radar head.

For testing the central spam (labelled with no. 4 in Figure 1), the radar has been used in cross-range modality. It means that the radar head has been moved during each single measurement on a mechanical linear guide (as shown in Figure 12), in order to acquire a bidimensional image of the

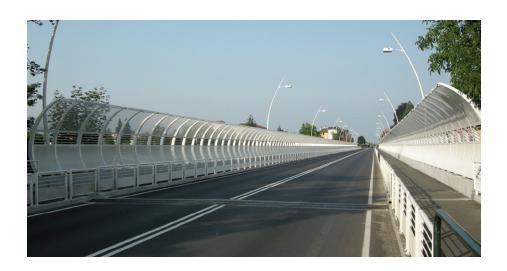
The bridge is 13.40 m large, with a central roadway 9 m large with two sidewalks 2.2 m large as shown in the picture of Figure 2.

FIGURE 2: Deck of "Ponte degli Alpini."

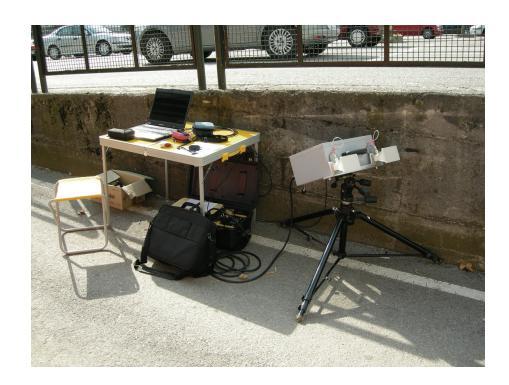
FIGURE 3: Interferometric radar in only-range configuration.

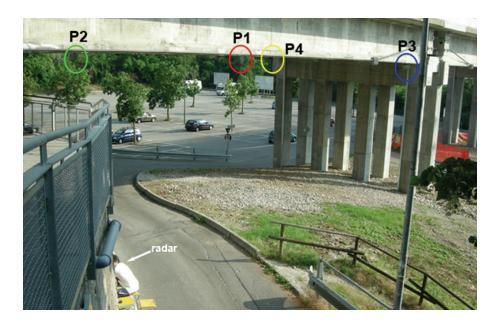
FIGURE 4: Radar measurement of the lateral span no. 8 in Figure 1.

Four dihedral corner reflectors (P1, P2, P3, and P4) have been installed on the lower side of the deck positioned as in Figures 4 and 5. These high reflectivity targets give peaks in the radar plot clearly detectable on the background. Figure 6 shows the measured radar plot where the 4 corner reflectors are labelled with their numbers.

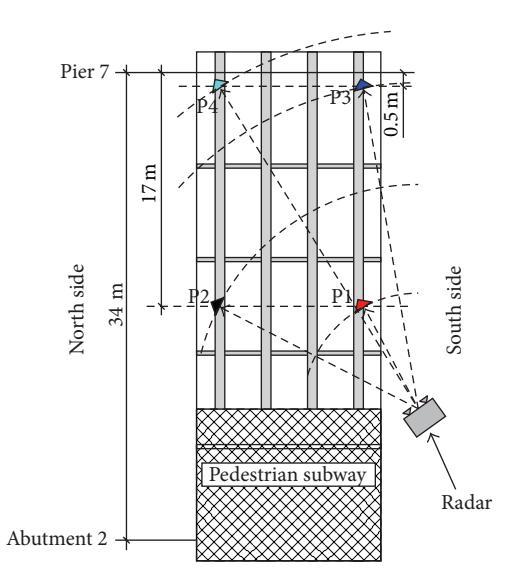
FIGURE 5: Measurement setup for the spam no. 8.

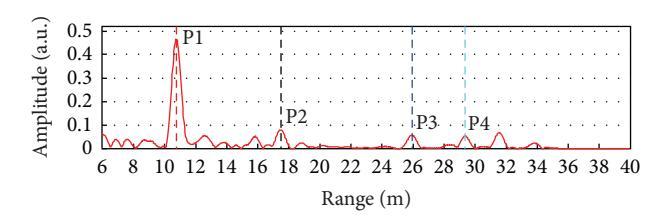
FIGURE 6: Radar plot relative to the measurement of spam no. 8.

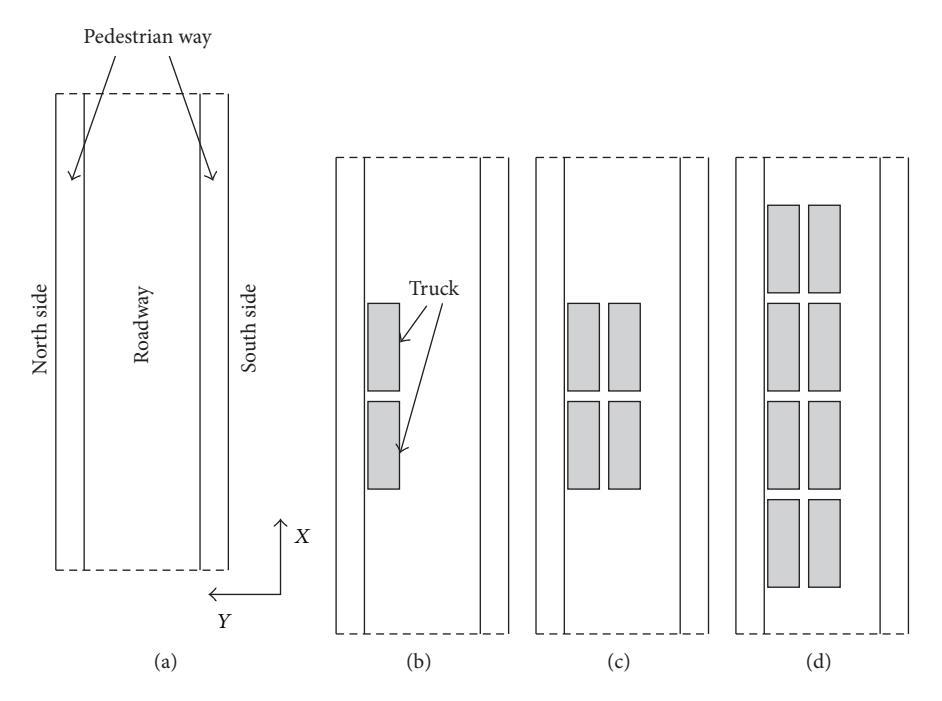
FIGURE 7: Upward view of the span which illustrates the sequence and the placing of the loads: (a) unloaded; (b) 2 truks; (c) 4 trucks; and (d) 8 trucks.

The load test was carried out by loading the span with 8 trucks. Each truck had 4 axes and was completely filled with sand for a total weight of about 40 tons. The loading procedure is sketched in Figure 7.

Figure 7(b). The load was disposed asymmetrically in order to concentrate the effort on one of the external beams. In the second phase, two other trucks were positioned as in Figure 7(c), and in the third phase, the span was loaded with eight trucks (see Figure 7(d)). Finally, the load was removed, and the residual displacement was measured. The radar was set up for acquiring 10 samples per second, so it was able to follow even the dynamic behaviour of the bridge during the different phases of the test. The maximum measured displacement was 10.30 mm \pm 0.1 mm (at the P2 point). The relative residual displacement was 1.4 mm (see Figure 8). Both are consistent with the expected values for this kind of bridge.

The static test was carried out with the loading procedure in 4 phases sketched in Figure 7. A first reference measurement was collected when the bridge was unloaded, aftermath, and image has been acquired at each phase. The radar is able to provide a complete displacement image of the lower surface of the bridge, but in order to locate precisely the vertical movement of the points of interest, six trihedral corner reflectors were installed on the external beams as shown in Figure 14.

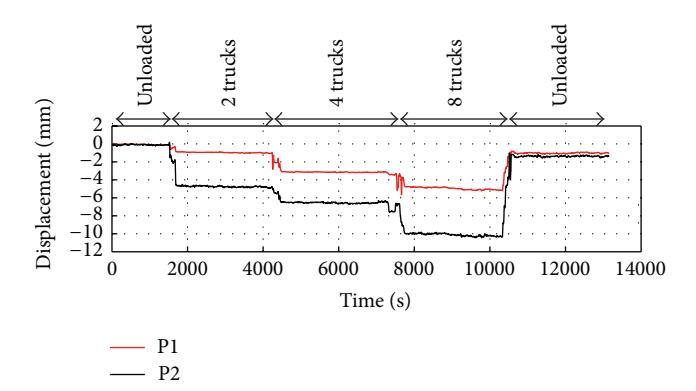
Unloaded Jnloaded trucks trucks 8 trucks Displacement (mm) 2 1.5 1 0.5 0 -0.5 2000 4000 6000 8000 10000 12000 14000 Time (s) Р3 P4

FIGURE 8: Measured displacements of P1 and P2 during the load test.

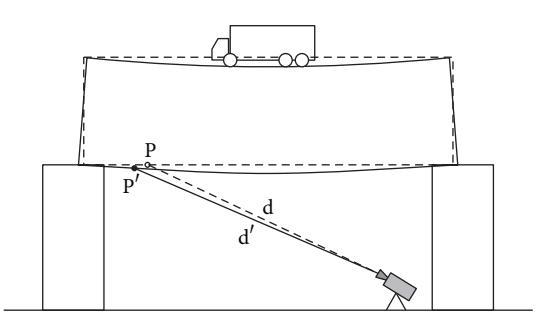
FIGURE 10: Sketch of the measurement geometry of the points P3 and P4 during the deformation of the deck.

A more interesting behaviour has been observed for points P3 and P4; they gave apparent positive displacements as shown in Figure 9. It is due to the fact that they are not at the centre of the spam but close to the piers. Therefore, during the loading, they move both vertically and horizontally, as shown in the sketch of Figure 10. But the radar see the bridge from a grazing angle, so a horizontal displacement can give a component in view direction larger then the component due to the vertical displacement. This effect is not present for the points P1 and P2 that are close to the spam centre, where there is no horizontal displacement as shown in the sketch in Figure 11.

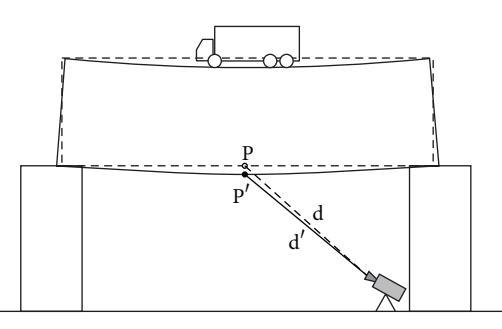
FIGURE 11: Sketch of the measurement geometry of the points P3 and P4 during the deformation of the deck.

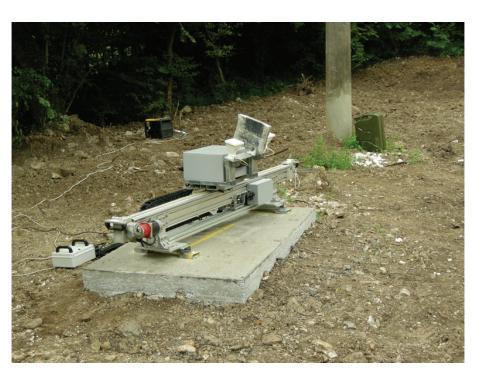
FIGURE 12: Radar installation on the riverbed.

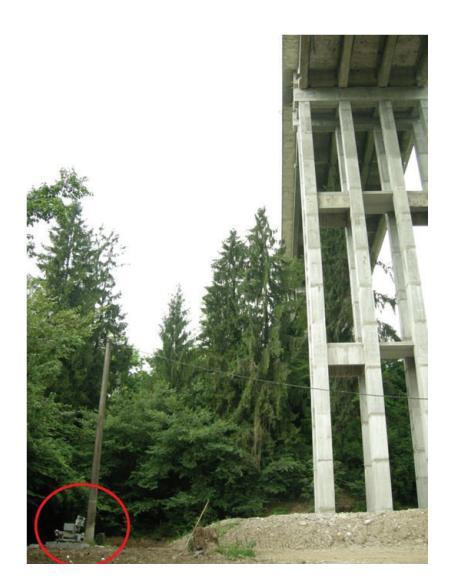
FIGURE 13: The radar (red circle) placed on a basement under the span.

As the riverbed was accessible, the radar was placed on a concrete basement at ground, 34.5 m below the bridge and 15 m off the span southwards, as shown in Figure 13. The antennas were rotated upward, and they were able to illuminate the whole lower surface of the span. During each measurement, the radar front-end was moved on the mechanical guide with 381 steps of 5 mm to cover the whole guide length of 1.9 m. The radar was set to generate 3057 equally spaced frequency tones sampling a 400 MHz bandwidth, starting from 16.55 GHz. This setting provides 0.37 m range resolution and 0.19 m cross-range resolution at 40 m.

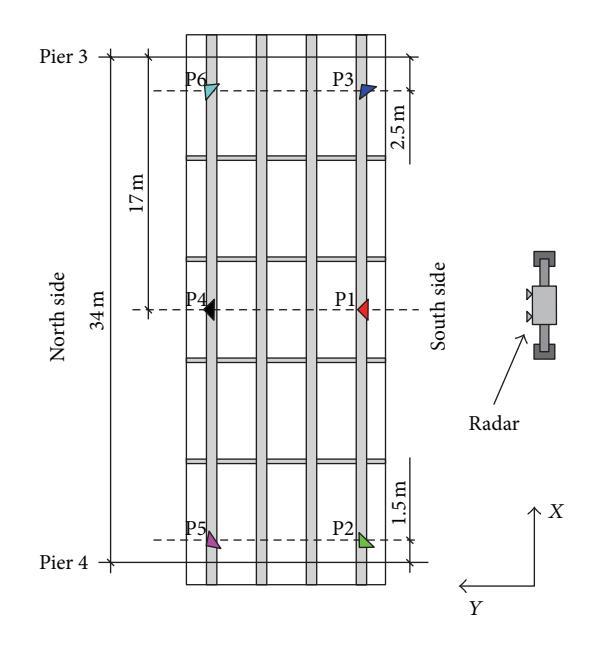
FIGURE 14: Positions of the corner reflectors (named from P1 to P6).

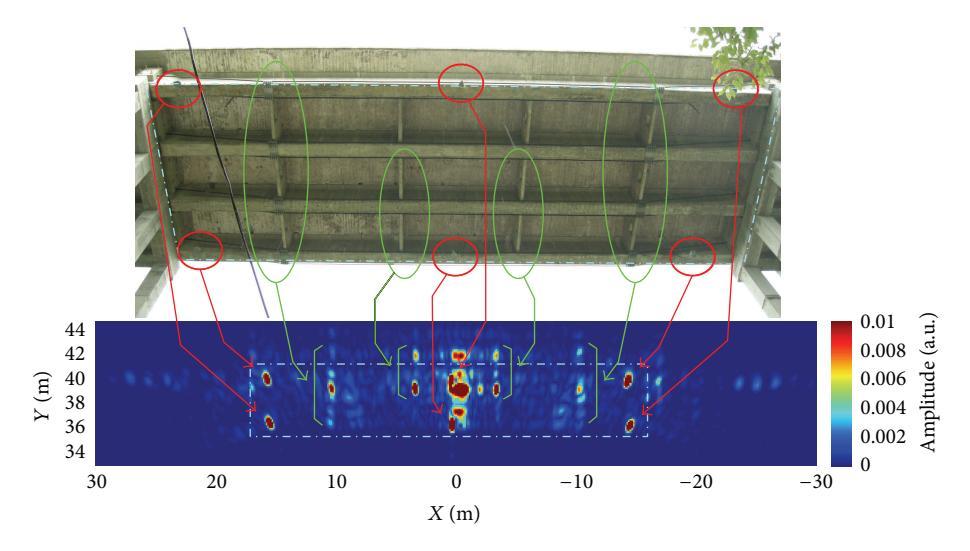
FIGURE 15: Amplitude radar image with the targets highlighted in the corresponding picture of the span.

The amplitude image of the span is shown in Figure 15. It is an image on the *XY* plane, sampled with increments $\Delta x =$ 12.5 mm and $\Delta y =$ 12.5 mm. The *Y* axis is the range, and

the *X* axis is the cross-range. The targets highlighted with red circles refer to the corner reflectors and other structural characteristics of the surface.

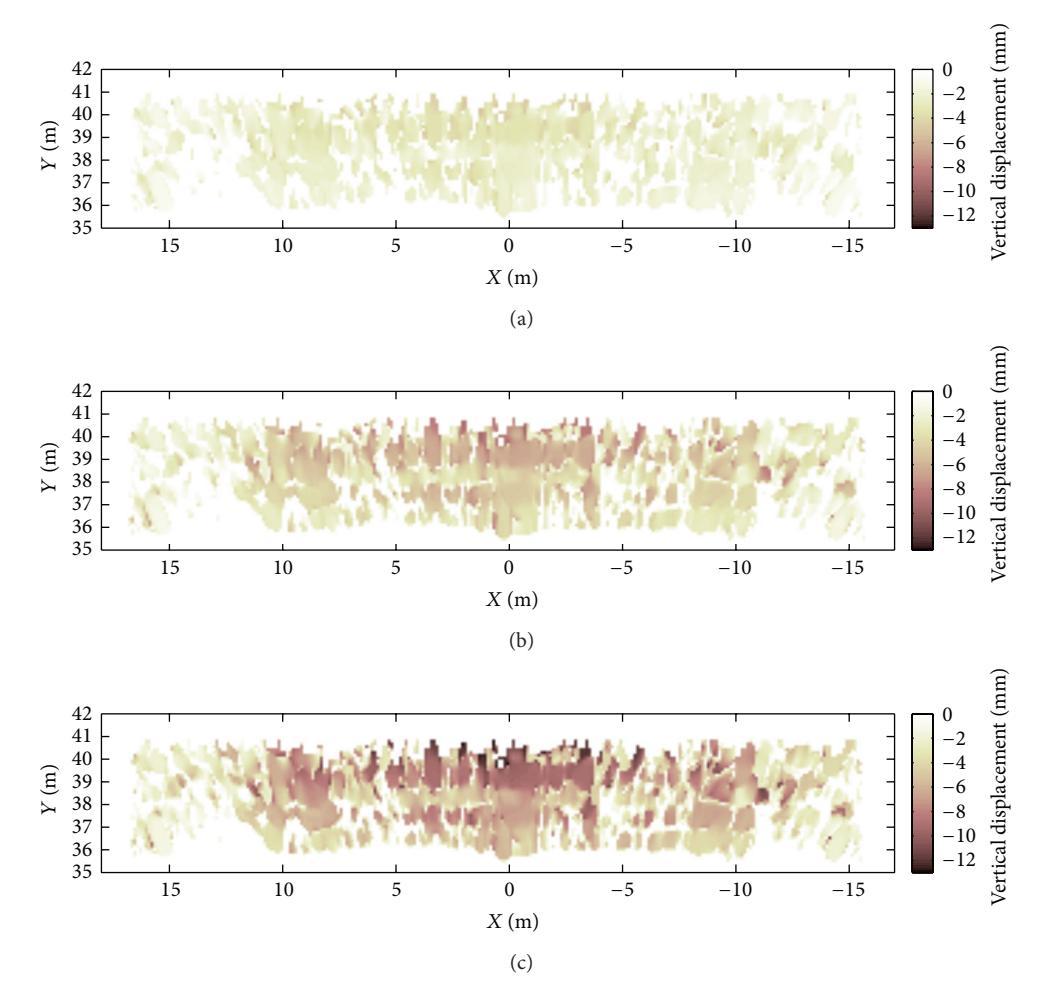
FIGURE 16: Displacement maps: (a) 2 trucks; (b) 4 trucks; and (c) 8 trucks.

The displacement maps (interferograms) between the reference image, before the loading of the span, and the three following loading phases of 2, 4, and 8 trucks are shown in Figure 16.

The radar image has been masked selecting the pixels with two criteria: (1) a geometrical mask which removes all the pixels scattered out of the surface of the span and (2) an amplitude mask which removes the pixels where the signal is lower than 0.2% of the maximum amplitude of the image. The last one is an empirical method for cutting out the noisy pixels with low backscattered signal. As the radar only detects the displacement component along the line of sight, the vertical displacement has to be calculated by supposing the horizontal component negligible. On the other part, it should be noted that usually the radar is positioned close to a pier with view direction nearly parallel to the bridge span [1, 2, 11, 12]. But in this measurement geometry, a possible horizontal displacement has a large component in the view direction, so it could not be correct to neglect it, as wellevident in the case of the testing of the lateral span reported above. On the contrary, by positioning the radar transversally and at great distance, any possible horizontal displacement in the direction of the length of the bridge has a very small component along the view direction.

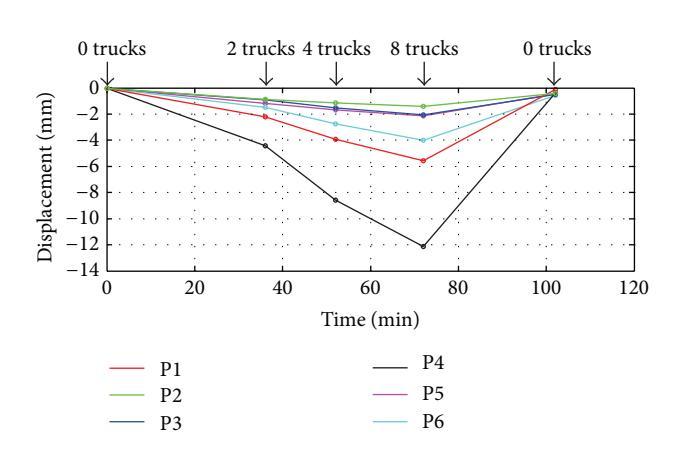
FIGURE 17: Vertical displacement of the corner reflectors during the loading and the unloading of the bridge: labels from P1 to P6 are referred to in Figure 14.

Finally, Figure 17 shows the calculated vertical displacement of the points corresponding to the corner reflectors installed on the beams, which coordinates have been identified in the amplitude image. The time between a radar acquisition and the next one was as such to allow the structure to settle.

The largest displacement was measured on the beam northward, which was the most loaded, and a residual
