An innovative approach for high-performance road pavement monitoring using black box / Meocci, M.; Branzi, V.. - In: JOURNAL OF CIVIL STRUCTURAL HEALTH MONITORING. - ISSN 2190-5452. - ELETTRONICO. - .:(2021), pp. 1-22. [10.1007/s13349-020-00463-8]

An innovative approach for high-performance road pavement monitoring using black box

Monica Meocci¹ · Valentina Branzi¹ · Andrea Sangiovanni²

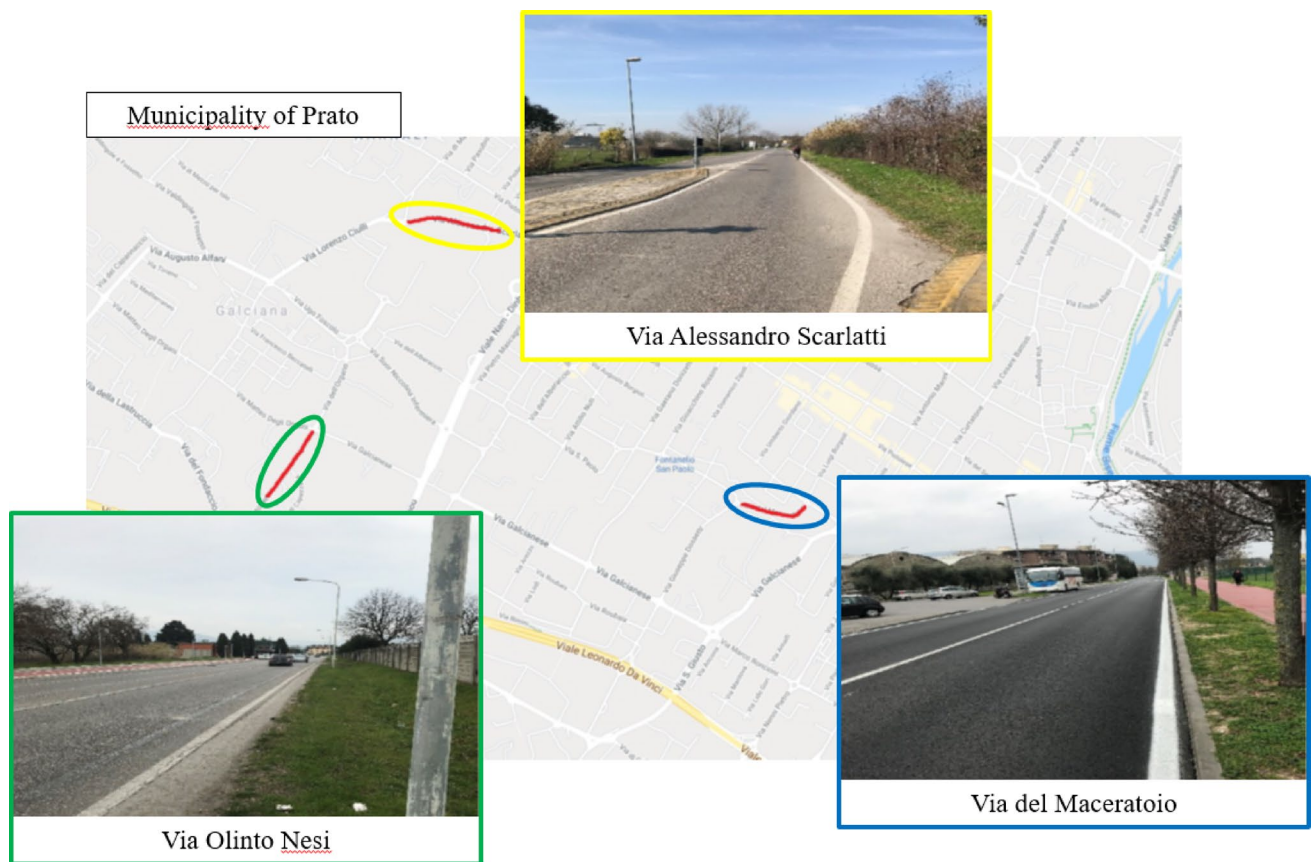
Fig. 1 Road sections selected during the development of detection algorithms

- the road section of via del Maceratoio is about 290 m long. The street was selected because it offers a good road surface condition thanks to the recent re-pavement intervention carried out no less than one month before the tests;
- the road section of via Alessandro Scarlatti is about 290 m long. The street was selected because it offers a road surface characterized by the presence of potholes, patches and alligator cracking;
- the road section of via Olinto Nesi is about 330 m long. This section was also selected due to the presence of big potholes and fatigue cracking on the road pavement.

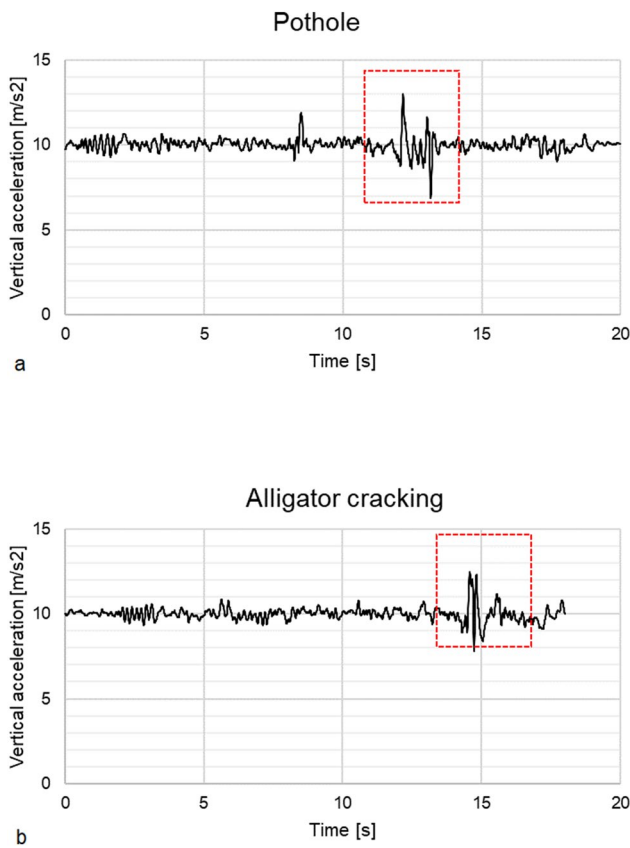
Fig. 3 Accelerograms examples (a pothole, b alligator cracking)

An example of pothole and alligator cracking accelerograms are represented in Fig. 3. In Fig. 4a, b, the moving variance corresponding to the Fig. 3a, b accelerograms are shown, respectively. It can be seen that the moving variance both reduces random noises and normalize the vertical acceleration values across the time according to the next steps.

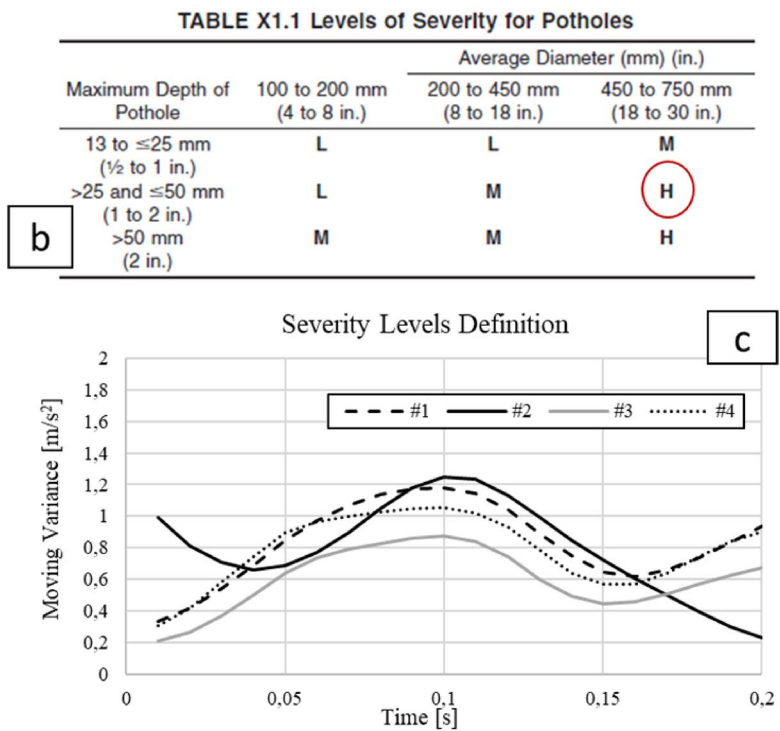
Fig. 8 Defining threshold severity levels [52]

a. To define a simple correspondence between the local damage and LPB index, each anomaly (Fig. 8a) can be analysed by the ASTM Appendix Catalogue (Fig. 8b). After this first classification, the distress was measured

in terms of vertical acceleration by black box and, therefore, was characterized in terms of moving variance peak (Fig. 8c). The minimum mean value defined for the different 100 conditions evaluated (high severity) it was taken as the threshold value. The process has been repeated for medium and low severity levels and it is described in detail in [53].

- a. each single distress was characterized in terms of severity level defined as indicated in the Appendix of the ASTM standard [52] as shown in Fig. 8;
- b. all the sample unit analysed were characterized before by the PCI value than, they were subjected to the pave box monitoring process to define an empirical correlation between the two indices used as shown in Fig. 9.

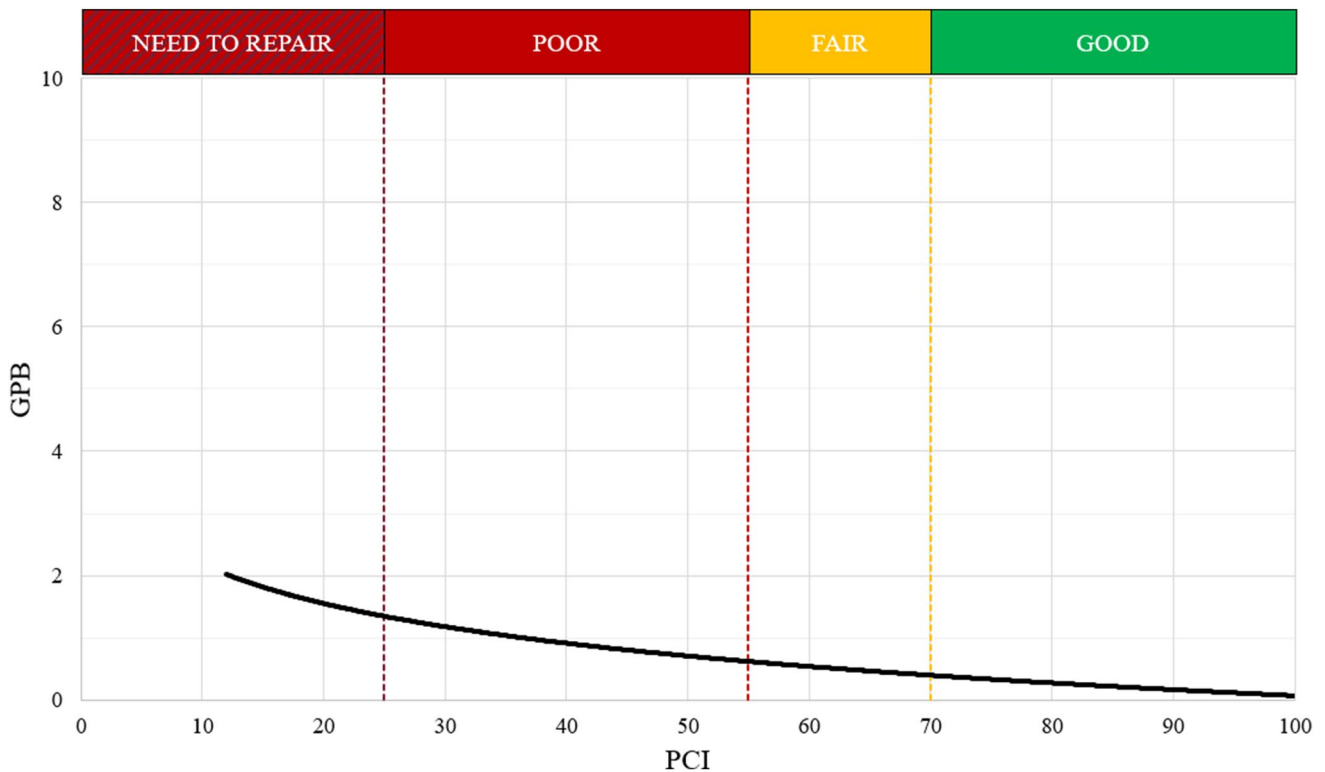
Fig. 9 PCI-GPB empirical correlation

b. To define a simple correspondence between the PCI values of each single sample unit and its global damage index (GPB) the empirical correlation defined in the following graph have been found (Fig. 9). This analysis is currently underway, in fact, an increasing in the dataset

helps to increase the goodness of fit of the mathematical function in Eq. (4) which allows to correlate PCI and DPB indices [53].

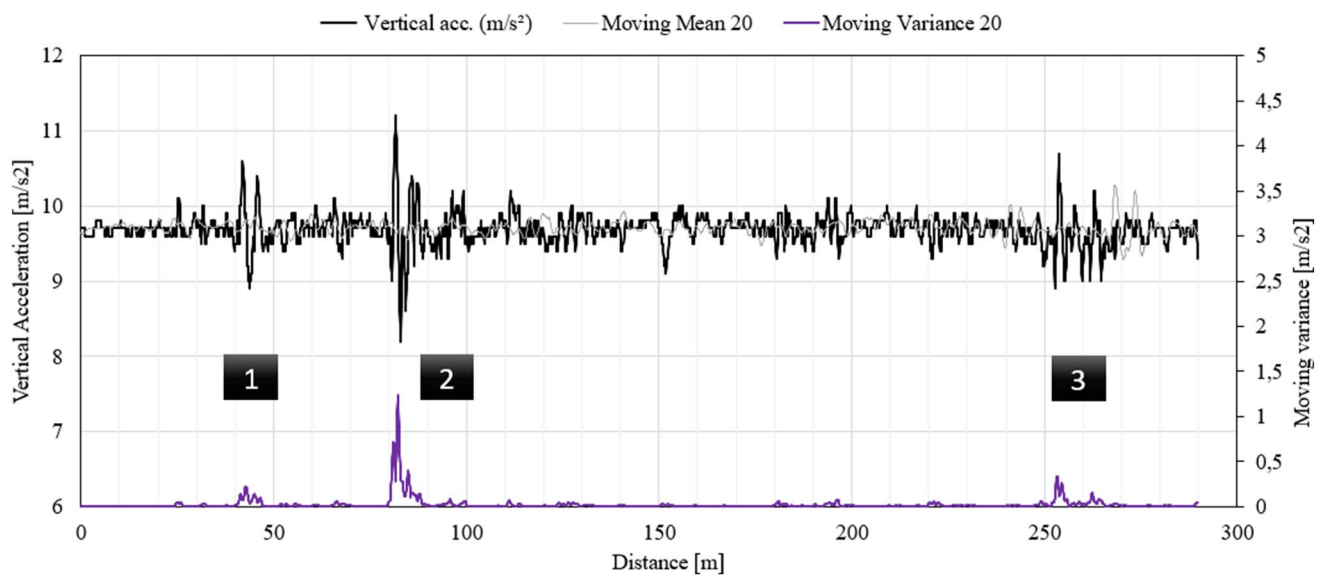
Fig. 11 Via Alessandro Scarlatti

The GPB index represents the average value of the ten surveys conducted. The GPB values shown in Table 2 for the homogeneous segments were consistent with the trend of the moving variance curve. The purple curve in Fig. 11 and the evaluation of the LPB also showed the presence on the road surface of high damage within homogeneous segments classified as fair.

According to the manual verification conducted to demonstrate the robustness of the monitoring process, the measurement carried out allows a good description of the road surface represented in Fig. 11a and in Fig. 11b. In conclusion, the comparison of the numerical values of the estimated integral (GPB index), for normalized sections over 100 m, with the visual survey carried out on the road pavement, allowed to verify the consistence of the proposed monitoring process with reference to a road section characterized by fair surface conditions.

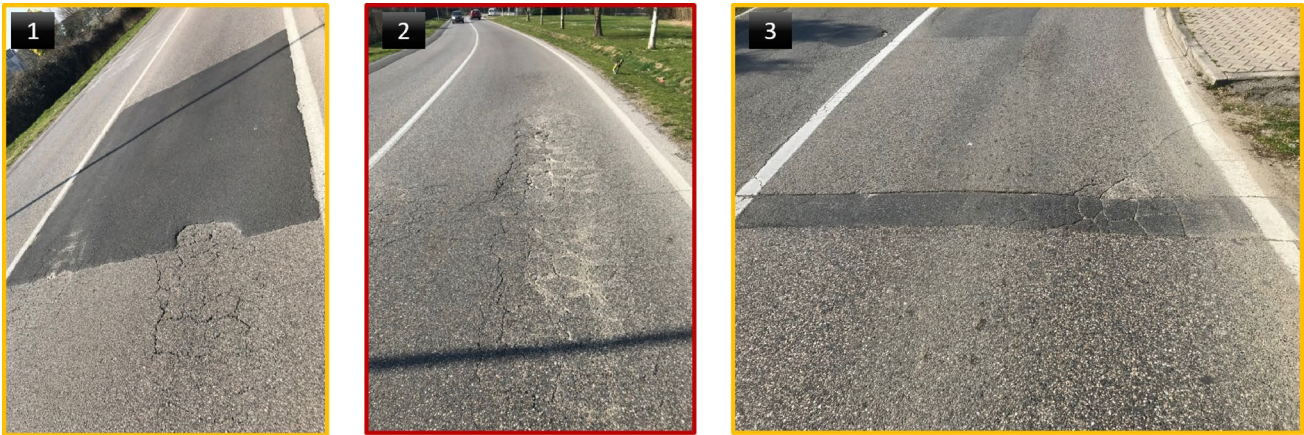
Fig. 12 Anomalies located in via Alessandro Scarlatti

To demonstrate the effectiveness of the proposal, a visual survey was carried out. The three different peaks characterized by moderate and high severity were immediately identified. In Fig. 12 these distresses and their severity levels were represented.

The mean values of the peaks located in the road section ranges from a minimum of 0.225 m/s² (anomaly n.1—Fig. 12) to a maximum of 1.244 m/s² (anomaly n.3—Fig. 12). The comparison between the visual survey and the proposed automatic detection confirms the robustness of the method to detect the distress characterized by a moderate or

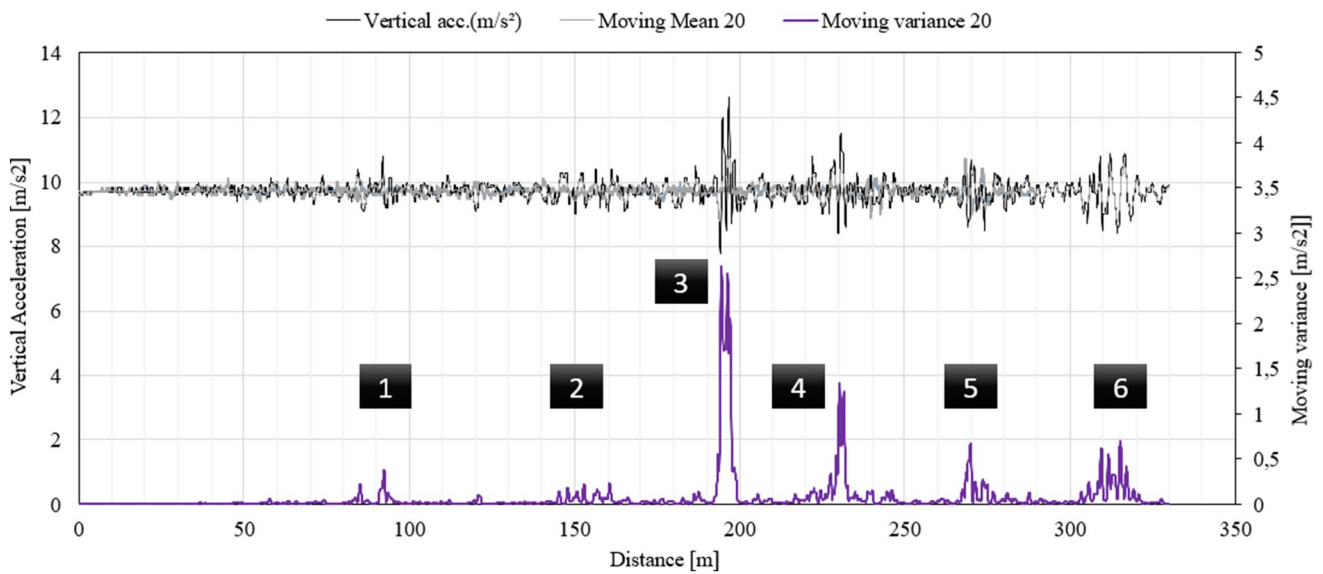
Fig. 13 Via Olinto Nesi

A total of ten surveys were carried out at 40 km/h. Figure 13 represents the result obtained. The black curve represents the mean vertical acceleration measured by black box. The grey one represents the moving mean (centred) across 0.2 s with reference to the mean value of the raw signal (a_v). The purple curve represents instead the moving variance (VAR20) along the analysed road segment.

The first 50 m of the street was characterized by a moving variance very close to 0 that indicates a good road surface condition. Instead, the remaining road segment was characterized by the presence of numerous peaks at different intensities. Peaks detected vary between the three different levels

The GPB index represents the average value of the ten surveys conducted. The GPB values shown in Table 2 for the homogeneous sections n.1 and 4 described a good global condition of the pavement analysed. The values of the global index for both section n.2 and n.3 were instead greater than 0.76; therefore, the homogeneous segment will be classified in poor condition. These findings were consistent with the trend of the moving variance curve in Fig. 13.

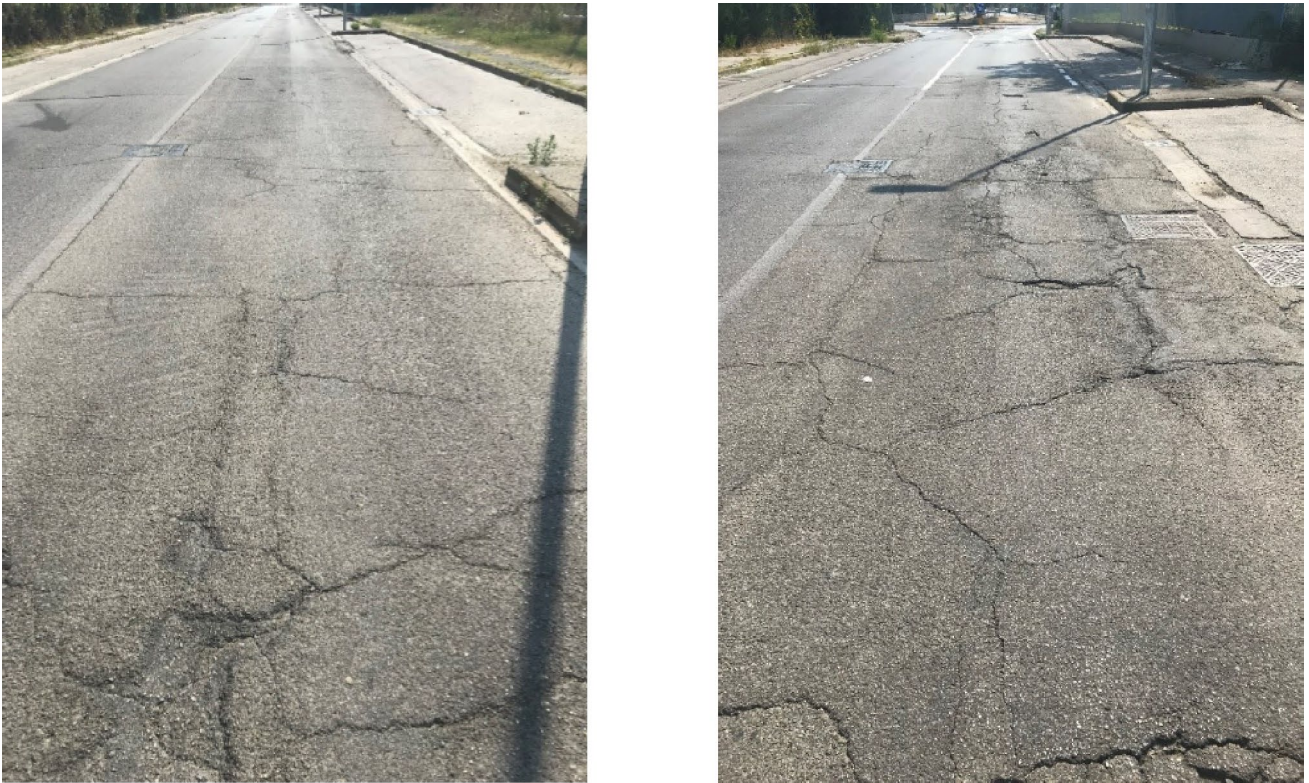
Fig. 18 Images of the segment $n.1$ and 2, respectively, on left and right

In Fig. 18, two views of the road pavement condition are shown. The figure on the left refers to the first homogeneous segment (0–100 m), the other one (100–200 m) refers to the second segment characterized by a very damaged road surface. The two images are consistent with the result obtained in terms of LPB and GPB and allowed to observe both local and widespread distress, such as cracking.
