Experimental analysis of the traffic-induced-vibration on an ancient lodge / Zini, Giacomo; Betti, Michele; Bartoli, Gianni. - In: STRUCTURAL CONTROL & HEALTH MONITORING. - ISSN 1545-2255. - ELETTRONICO. - 29:(2022), pp. 1-19. [10.1002/stc.2900]

Experimental analysis of the traffic-induced-vibration on an ancient lodge

Summary

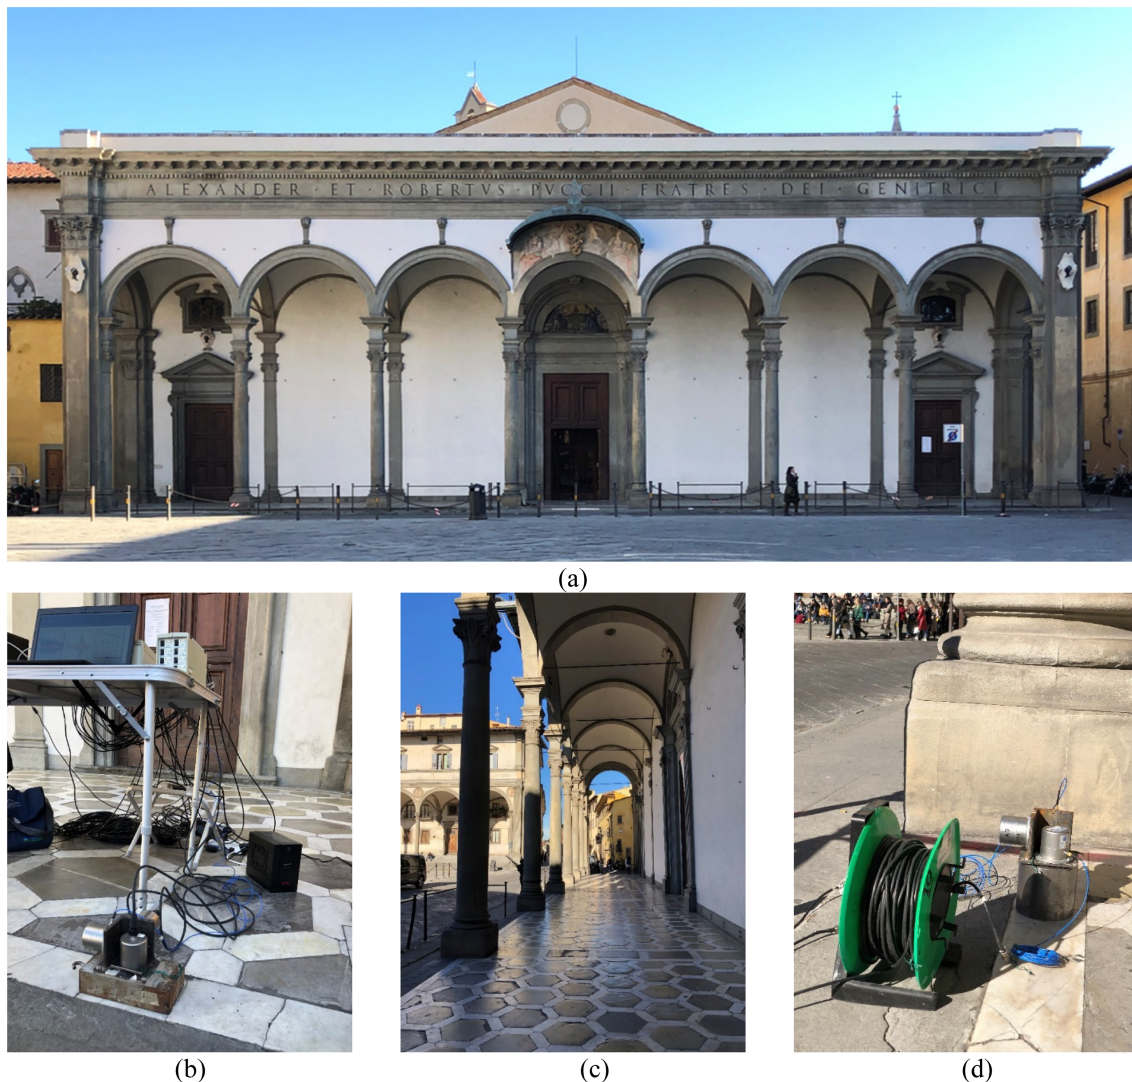
FIGURE 3 (a) Front view of the lodge from the SS. Annunziata's place (b) the DAQ system used during the test (c) lateral view inside the lodge (d) the triaxial measuring station made up with three piezoelectric accelerometers

The lodge of the SS. Annunziata's church in Florence (Italy) (Figure 3) is a stone-masonry historic structure with a rectangular shape (about 6×40 m) and an overall height of about 15 m. Eight stone columns with a height of about

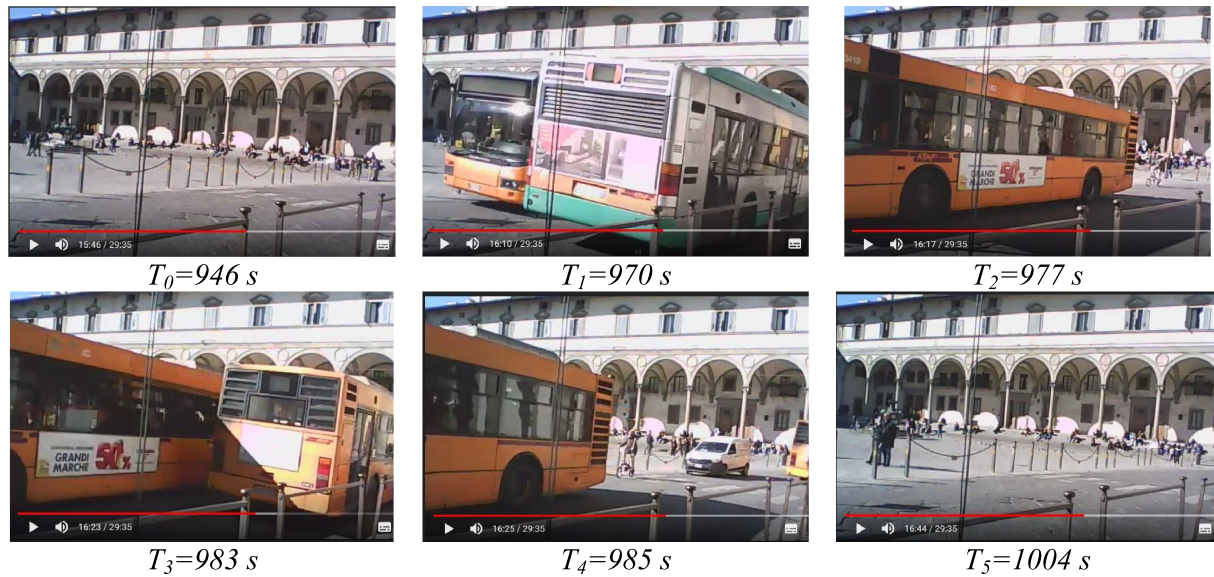
FIGURE 11 The highest-energy event corresponding to a multiple bus-passage in front of the lodge

For instance, the highest energy has been measured in a time window between 900 and 1000 s (Figure 10), corresponding to the passage of two buses in the opposite direction with the start and stop at the bus stop in front of the lodge (Figure 11).
