Experimental analysis of the traffic-induced-vibration on an ancient lodge

Experimental analysis of the traffic-induced-vibration on an ancient lodge / Zini, Giacomo; Betti, Michele; Bartoli, Gianni. - In: STRUCTURAL CONTROL & HEALTH MONITORING. - ISSN 1545-2255. - ELETTRONICO. - 29:(2022), pp. 1-19. [10.1002/stc.2900]

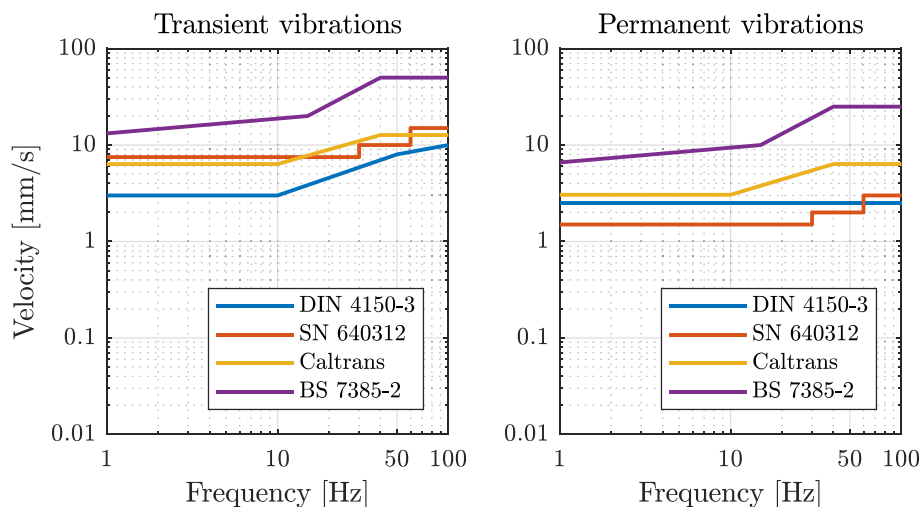
FIGURE 2 Peak Particle Component Velocity (PCPV) limits at the ground level defined by the standards: The German DIN 4150-3,¹⁶ the Swiss SN 640312,¹⁸ the limits proposed by Konon and Schuring²⁵ used by the Californian Department of Transportation (Caltrans)²⁶ and the British BS 7385-2:1993¹⁵ for the CH buildings

frequency content of the vehicular traffic is approximately between 5 and 20 Hz, the limits at the ground level range from 1.5 mm/s (SN 640312:2013¹⁸) to 3 mm/s (as suggested by the manual used by the Californian Department of Transportation (Caltrans)²⁶), up to a value of 11.5 mm/s (BS 7385-2¹⁵). In some studies (e.g., Domenichini et al.²⁷) a lower threshold equal to 1 mm/s for the permanent vibrations to avoid damage effects in the CH buildings is proposed.

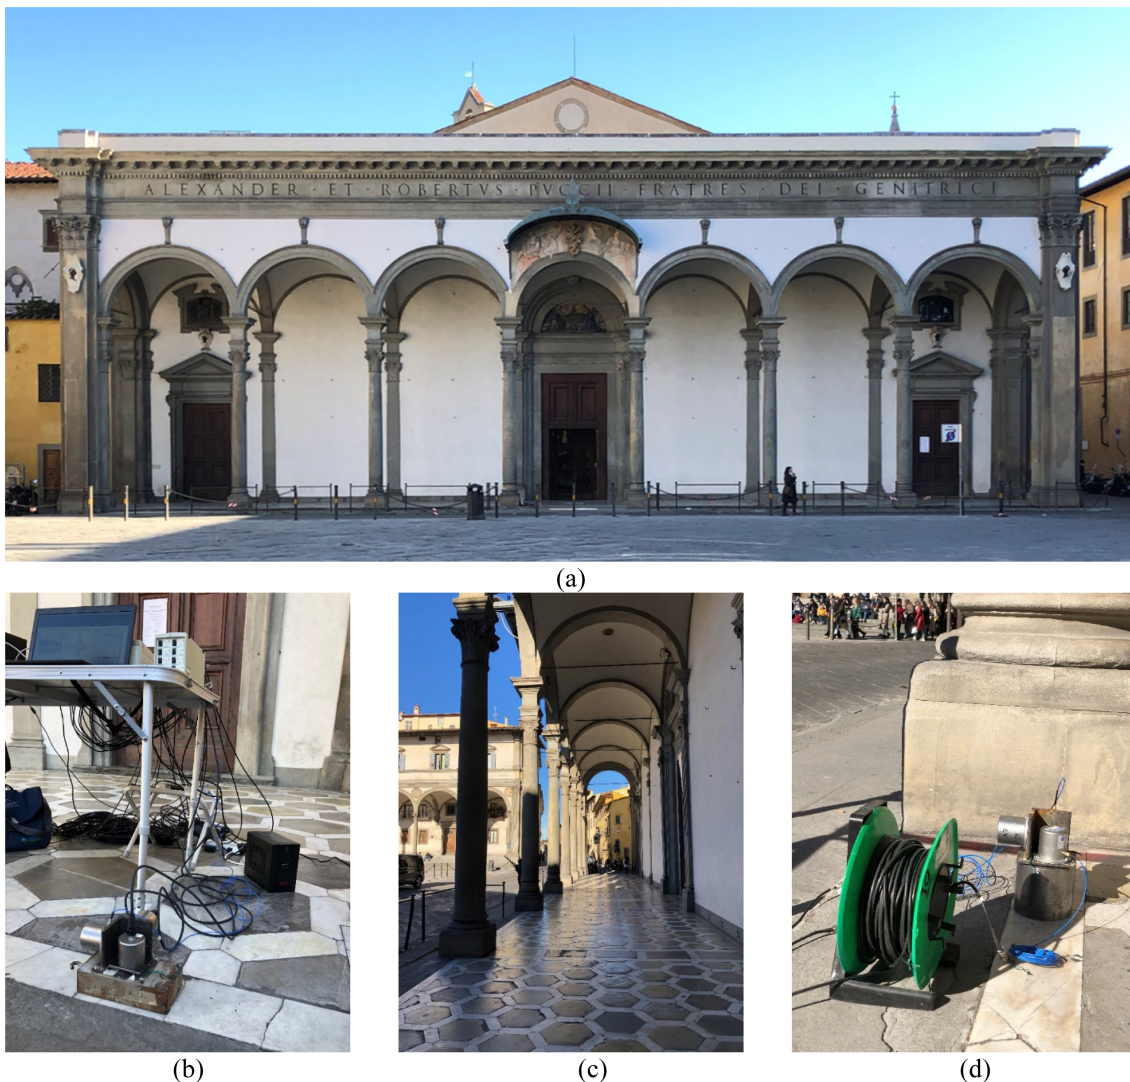
FIGURE 3 (a) Front view of the lodge from the SS. Annunziata's place (b) the DAQ system used during the test (c) lateral view inside the lodge (d) the triaxial measuring station made up with three piezoelectric accelerometers

The lodge of the SS. Annunziata's church in Florence (Italy) (Figure 3) is a stone-masonry historic structure with a rectangular shape (about 6×40 m) and an overall height of about 15 m. Eight stone columns with a height of about

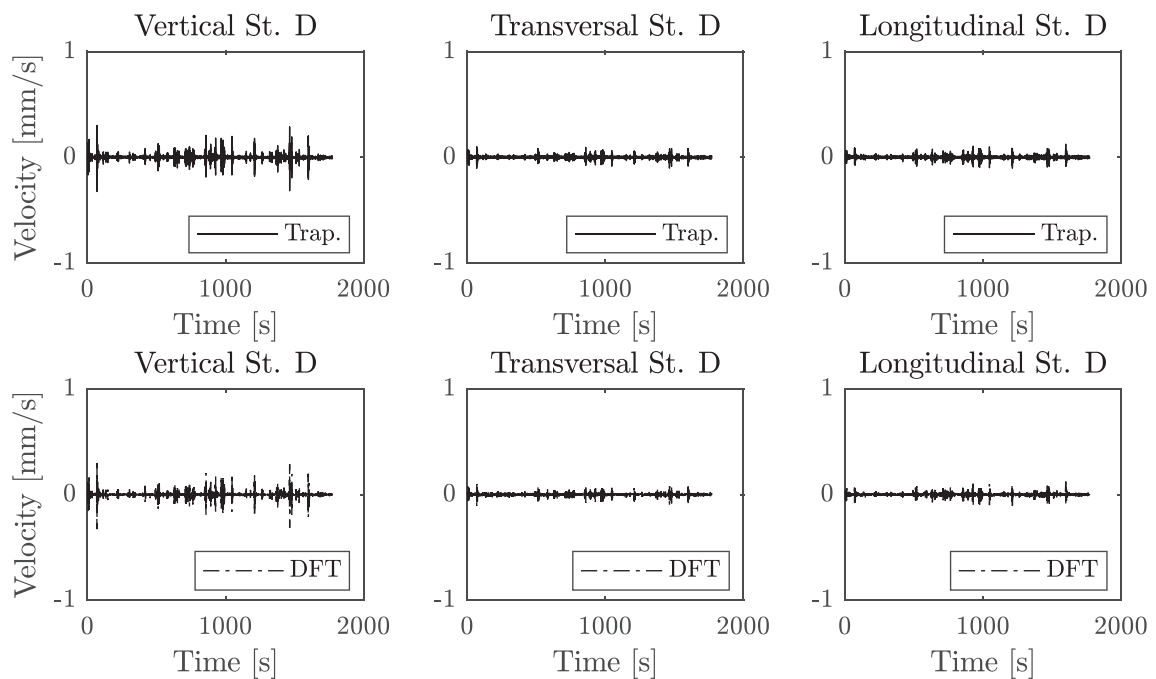
FIGURE 9 The velocities in station D obtained with the trapezoidal rule and the long Discrete Fourier Transform (DFT) method setting the cut-off frequency with a high-pass filter equal to 2 Hz

Once the cut-off frequency is selected, a direct comparison of the results obtained with both the numerical integration methods is possible. For instance, the magnitude of the vibrations is very similar giving satisfactory results for both integration methods. As shown in Figure 8 and Figure 9 the integrated signals computed with both methods in the stations at the first level are quite close.
