Characterization of stream meanders for stream restoration

Characterization of stream meanders for stream restoration / Rinaldi M.; Johnson P.A.. - In: JOURNAL OF HYDRAULIC ENGINEERING. - ISSN 0733-9429. - STAMPA. - 123 (6):(1997), pp. 567-570.

STREAM MEANDER RESTORATION¹*Massimo Rinaldi and Peggy A. Johnson²*

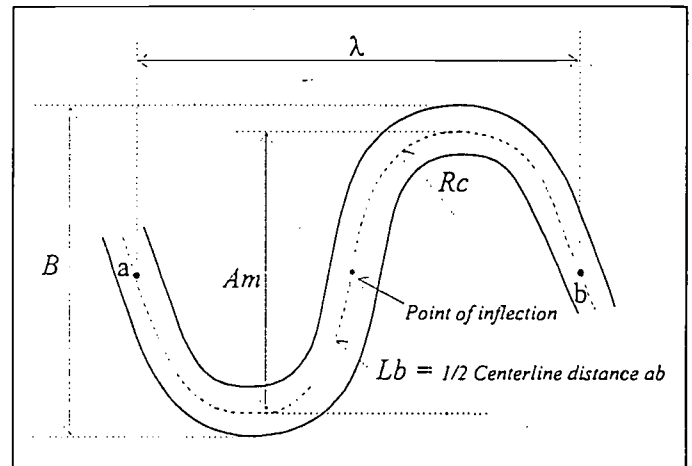
Figure 2. Sketch of Idealized Meander (Leopold & Wolman, 1960, modified).

TABLE 2. Meander Parameters of the Study Streams (see Figure 2 for parameter definition). λ = wavelength; Rc = radius of curvature; Am = amplitude; Lb = bend length; B = belt width; SI = sinuosity index.

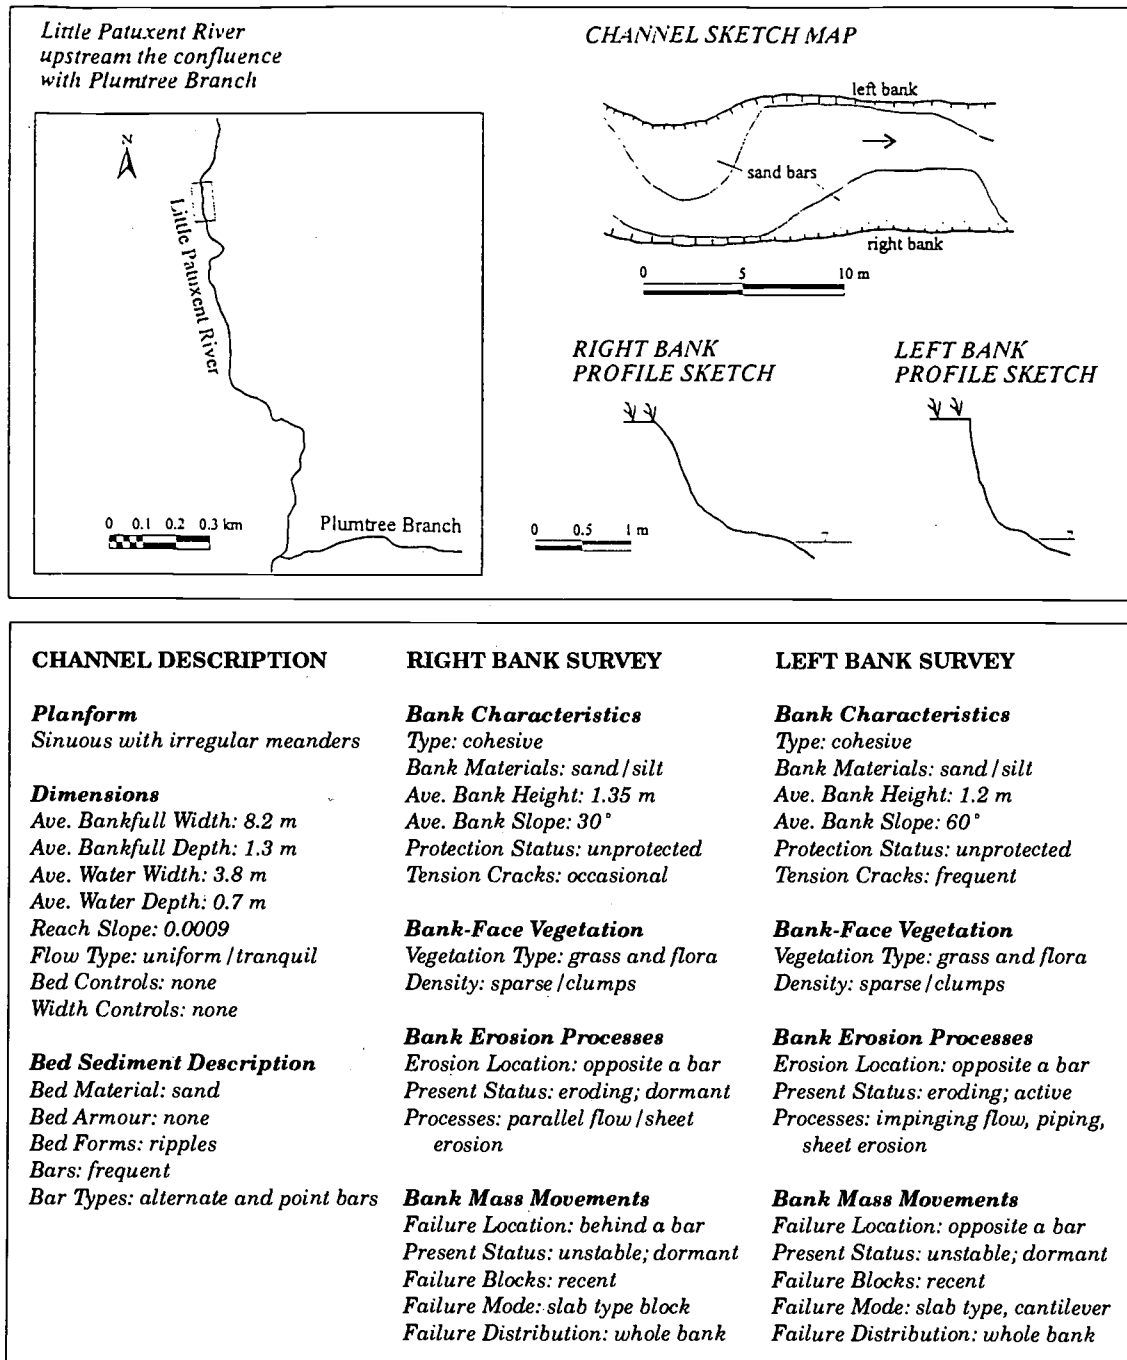
Examples of detailed stream reconnaissance were carried out on streams in the study area. Figure 4 shows the main elements and observations collected during a detailed stream reconnaissance. In this example, based on the stream reconnaissance, bank erosion appears to be the most important problem within the reach. Dominant processes are fluvial entrainment at the basal area, planar failure and cantilever on the upper portion of the bank. Bank failure appears to be a very important source of sediment, producing high quantities of fine material, facilitating accretion and construction of bars. Bank erosion on both the banks is also evident, causing a significant widening of the reach. Based on the stream reconnaissance, meander creation in that site appears to be a possible way to dissipate energy and to reduce erosion and sediment supply. Alternatively, control of bank erosion through stabilization efforts and maintenance of channel width could be used to prevent additional widening and to reduce the supply of fine sediments.

Figure 4. Example of Detailed Stream Reconnaissance: Main Observations Extracted by the Field Reconnaissance Sheet.
