Characterization of stream meanders for stream restoration

Characterization of stream meanders for stream restoration / Rinaldi M.; Johnson P.A.. - In: JOURNAL OF HYDRAULIC ENGINEERING. - ISSN 0733-9429. - STAMPA. - 123 (6):(1997), pp. 567-570.

STREAM MEANDER RESTORATION¹*Massimo Rinaldi and Peggy A. Johnson²*

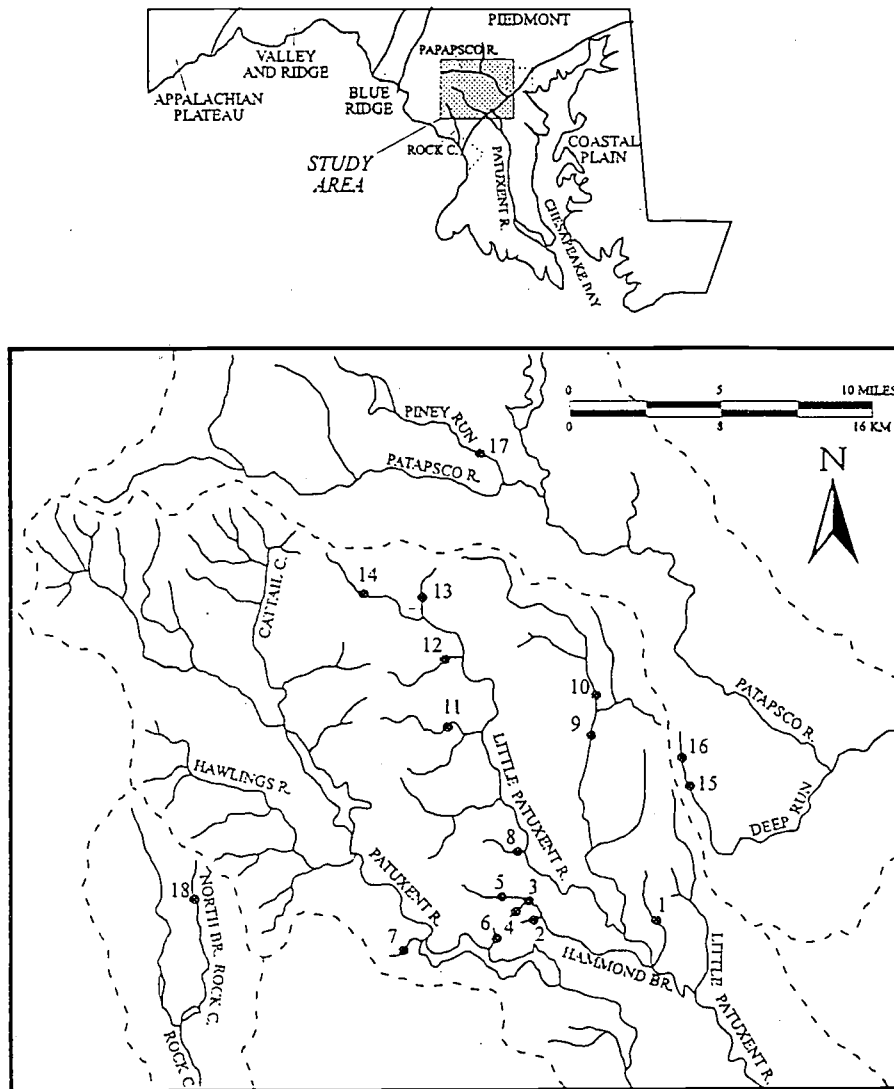
Figure 1. Study Area Location and Selected Stream Sites.

The study area is located in the Piedmont Province, one of five distinct physiographic regions of Maryland, and includes the upper and middle portions of the Patuxent River, Patapsco River and Rock Creek basins (see Figure 1). Bedrock in this region is

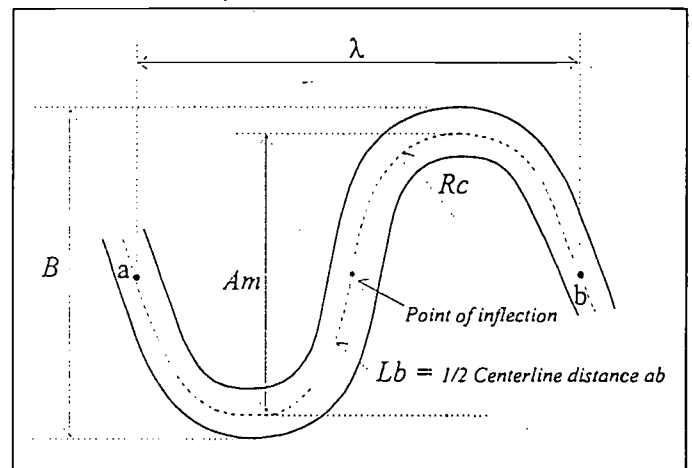
Figure 2. Sketch of Idealized Meander (Leopold & Wolman, 1960, modified).

TABLE 2. Meander Parameters of the Study Streams (see Figure 2 for parameter definition). λ = wavelength; R_c = radius of curvature; A_m = amplitude; L_b = bend length; B = belt width; SI = sinuosity index.

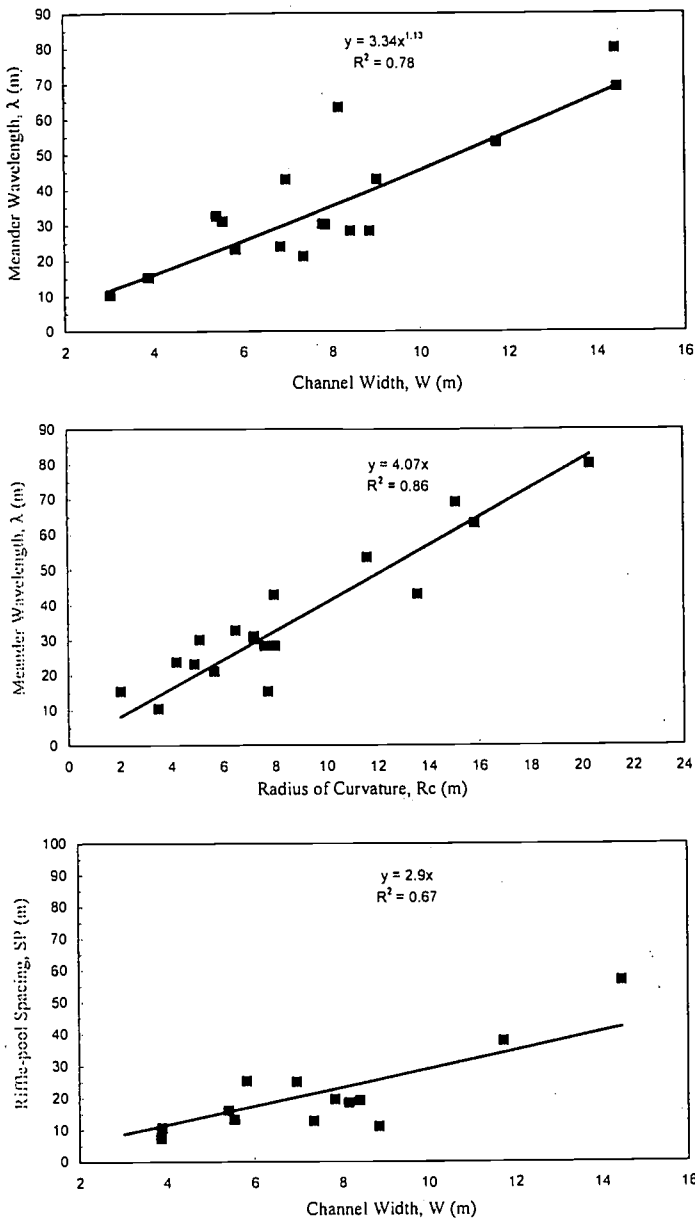
Figure 3. Regression Equations for Maryland Streams.

Relationships between cross-sectional parameters (channel width and area) and meander parameters (Equations 1 and 2 in Table 5) are typically power functions, while linear regressions between meander parameters (Equations 3 and 4) result in the higher values of R^2 . Although Leopold and Wolman (1960) originally proposed a power function between meander wavelength and radius of curvature, the equations representing interrelations between meander features included in Williams (1986) are typically linear. The channel width and riffle-pool spacing relationship is given by Keller and Melhorn (1978) as a power function. However, in the case of the Maryland data, the value of R^2 for linear regression is significantly greater in comparison to the power function. The ranges over which the equations apply are indicated in Table 5 for each equation. The equations provided in Table 5 are intended to be applied for preliminary planning of streams in the study area only.

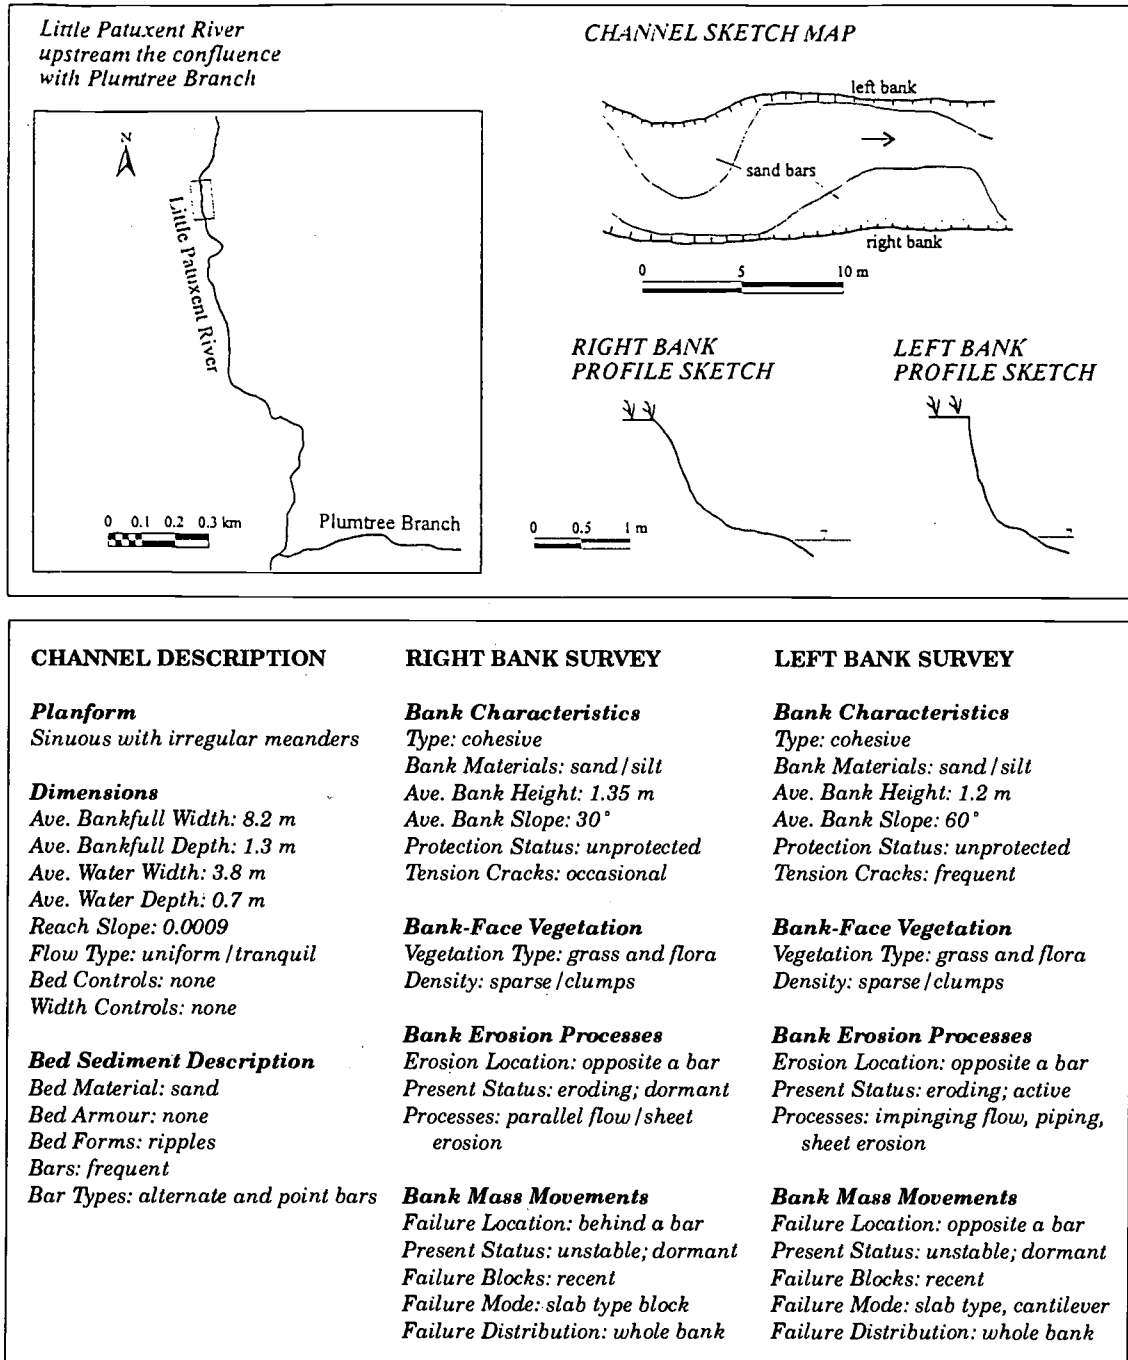
Examples of detailed stream reconnaissance were carried out on streams in the study area. Figure 4 shows the main elements and observations collected during a detailed stream reconnaissance. In this example, based on the stream reconnaissance, bank erosion appears to be the most important problem within the reach. Dominant processes are fluvial entrainment at the basal area, planar failure and cantilever on the upper portion of the bank. Bank failure appears to be a very important source of sediment, producing high quantities of fine material, facilitating accretion and construction of bars. Bank erosion on both the banks is also evident, causing a significant widening of the reach. Based on the stream reconnaissance, meander creation in that site appears to be a possible way to dissipate energy and to reduce erosion and sediment supply. Alternatively, control of bank erosion through stabilization efforts and maintenance of channel width could be used to prevent additional widening and to reduce the supply of fine sediments.

Figure 4. Example of Detailed Stream Reconnaissance: Main Observations Extracted by the Field Reconnaissance Sheet.
