# Rebuilding of an ancient castle including a base-isolated museum hall

S. Sorace<sup>1</sup> & G. Terenzi<sup>2</sup>

A design hypothesis to rebuild the main wing of the medieval castle of Prampero, devastated by a violent earthquake in Friuli in 1976, is presented in this paper. The intervention suggests that the building be used as a museum to exhibit the artistic heritage of the owners. This new destination prompted some architectural rearrangements of the interiors of the building as compared to its original configuration, while preserving the global volume and the interstory heights, as well as the outer appearance of the castle, including its façades, the roof and all finishes. The structural design includes some updated traditional solutions for the masonry walls, the wooden floors and the roof. At the same time, a non-conventional solution is adopted for the floor accommodating the main exhibition hall, consisting in the incorporation of a base isolation seismic protection system. Details of the design analyses carried out, with special regard to the numerical enquiry developed on the base-isolated floor, are provided in this paper. Selected drawings of the technical sol

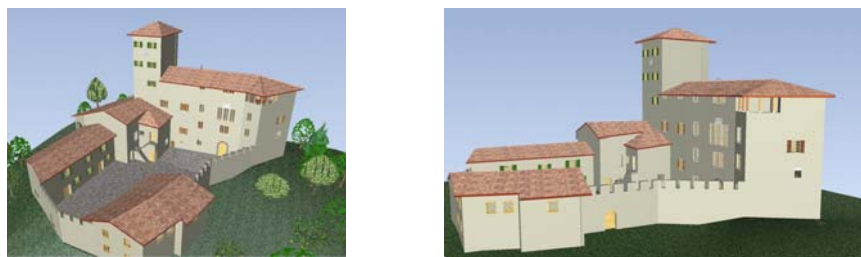
Figure 1. Renderings of the castle before the 1976 earthquake

The architectural renderings of the castle before the 1976 earthquake, and in its current conditions, are drawn in Figures 1 and 2, respectively. As highlighted in the second figure, only the farthest wing, named northern tower, was rebuilt, whereas the remaining zones are either totally destroyed, or reduced to a heap of ruins. Only some stumps of the ground floor and walls on the first floor also remain for the central portion of the castle, adjacent to the northern tower.

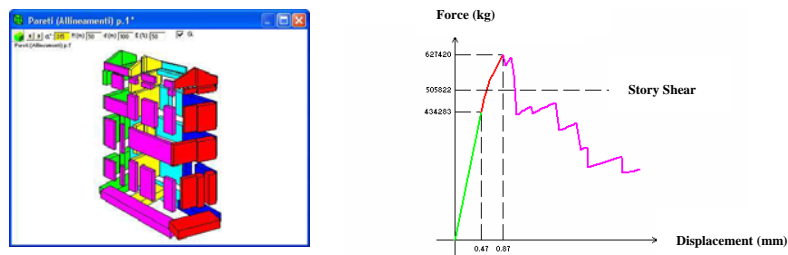
Figure 7. Structural model for the seismic analysis and typical response diagram of a building story

The structural model for the POR-like analysis, performed with a commercial software [3], is shown in Figure 7, where different colours are used to identify the different alignments of the walls. In order to correctly simulate the actual structural conditions of the building, its connections with the walls of the northern tower were also modelled in the analysis. In Figure 7, a typical force-displacement response diagram for a story (in particular, the first story for the analysis in the transversal direction), is also demonstratively reproduced. The structural verification is satisfied when, as shown in the graph, the maximum reactive force resulting from the contributions of all the panels at the examined level is greater than the corresponding story shear.

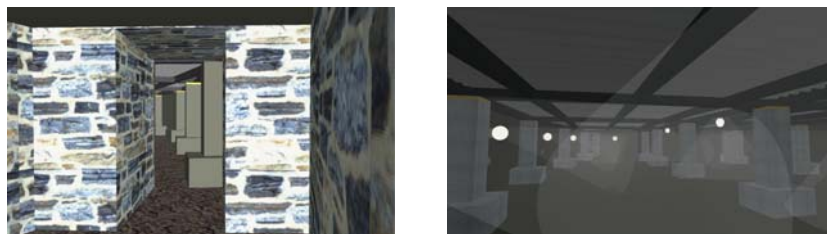
Figure 10. Views of the basement level

Two views of the basement level are reported in Figure 10, showing the main entrance and the complete volume created below the floor, to be used for the necessary inspection, check and maintenance activities of the isolation system.

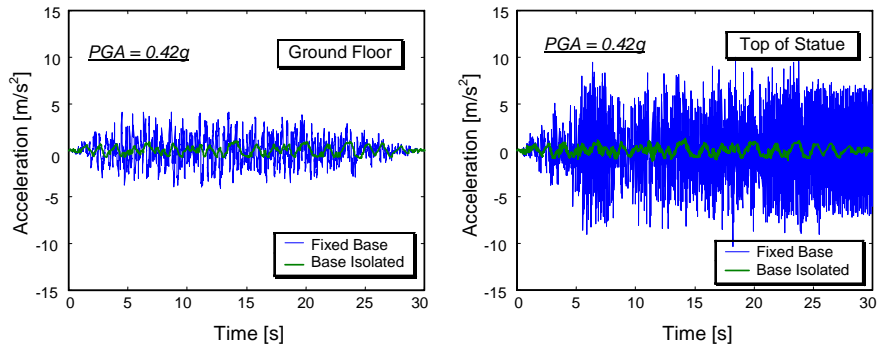
Figure 15. Response time-histories of the floor and a statue in fixed-base and base-isolated conditions

A synthesis of the analyses performed is offered in Figure 15, where the response acceleration time-histories obtained from the most demanding of the five artificial accelerograms, for the ground floor and the top of one of the two statues, in base-isolated and fixed-base conditions, are plotted. The benefits induced by the protection system as compared to a conventional structural solution, are expressed by a fall in maximum response accelerations equal to 3.92 for the floor ( $0.105 \text{ m/s}^2$  instead of  $0.41 \text{ m/s}^2$ ), and 7.53 for the statue ( $1.36 \text{ m/s}^2$  instead of  $10.25 \text{ m/s}^2$ ), when passing from unprotected to protected configurations. As a consequence, the statues would be undamaged under the basic design earthquake, in base-isolated conditions, whereas they would collapse in the case of a fixed-base solution. Moreover, it is noted that, in the latter case, the first rocking of the bases of the statues would be attained at a PGA of only 0.13 g, inducing a peak acceleration of  $9.9 \text{ m/s}^2$  at the top of the statues. Such further unacceptably high value, which is shown by the time-histories in Figure 16, would require robust and ugly-looking anchoring of the bases to the floor. On the contrary, rocking is totally absent also far beyond the design PGA of 0.42 g, in base-isolated conditions.

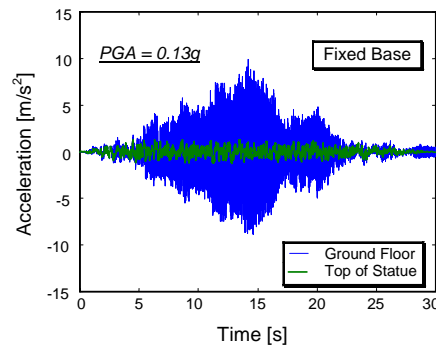
Figure 16. Response time-histories of the floor and a statue in fixed-base conditions at the PGA inducing the first rocking effects
