Timber Strengthening Systems operated on the Vasari's Ceiling in Palazzo Vecchio

ABSTRACT: The structural analysis started for the trusses designed by Giorgio Vasari in 1563 for the Sala Nova in Palazzo Vecchio proves that they became suitable to support not only the roof but the false ceiling as well only when a significant alteration to the original design was made, i.e. the rigid connection of the kingpost to the chord. The deformation of the ceiling are therefore due to lack of structural consistency of the unit, excessive (for the ceiling) bay, creep. The numerical analysis of the new series of trusses added by Domenico Giraldi in 1854 to strengthen the vasarian system gives evidence of the perfect sizing and efficacy of these units; also the slight deformations occurred fit with the theoretic behaviour of the system.

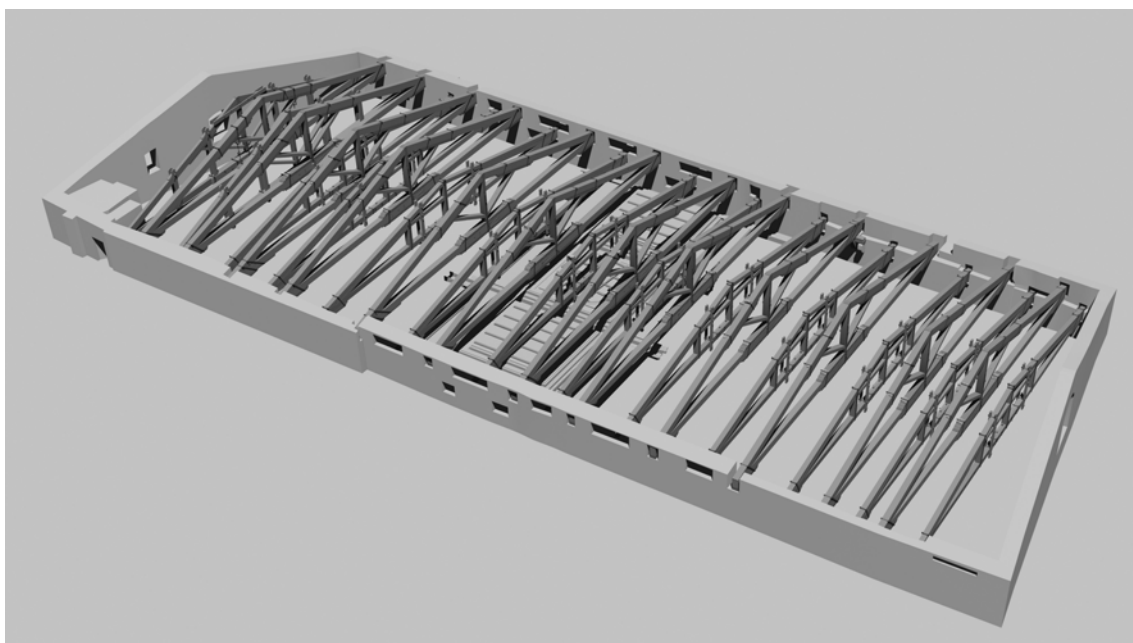
Figure 1: “Salone dei 500”. Perspective view of the garret.

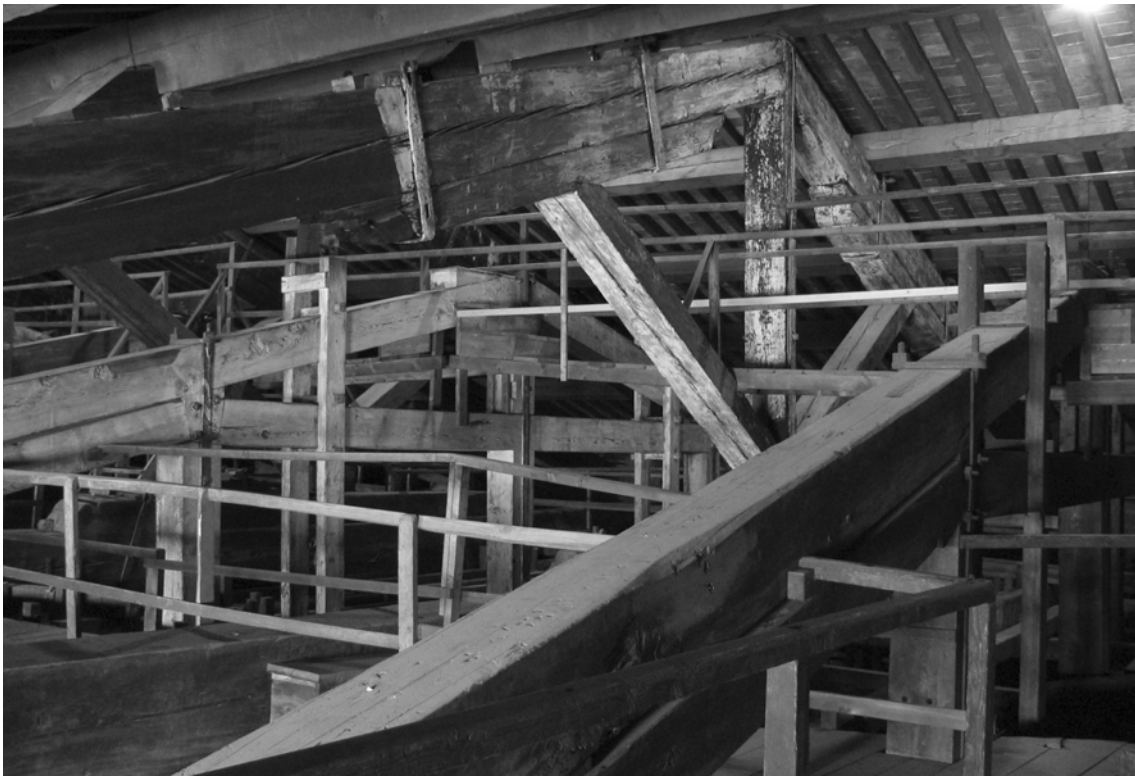
Figure 2: Panoramic view of the “Salone dei 500” garret, in the middle the vasarian trusses.

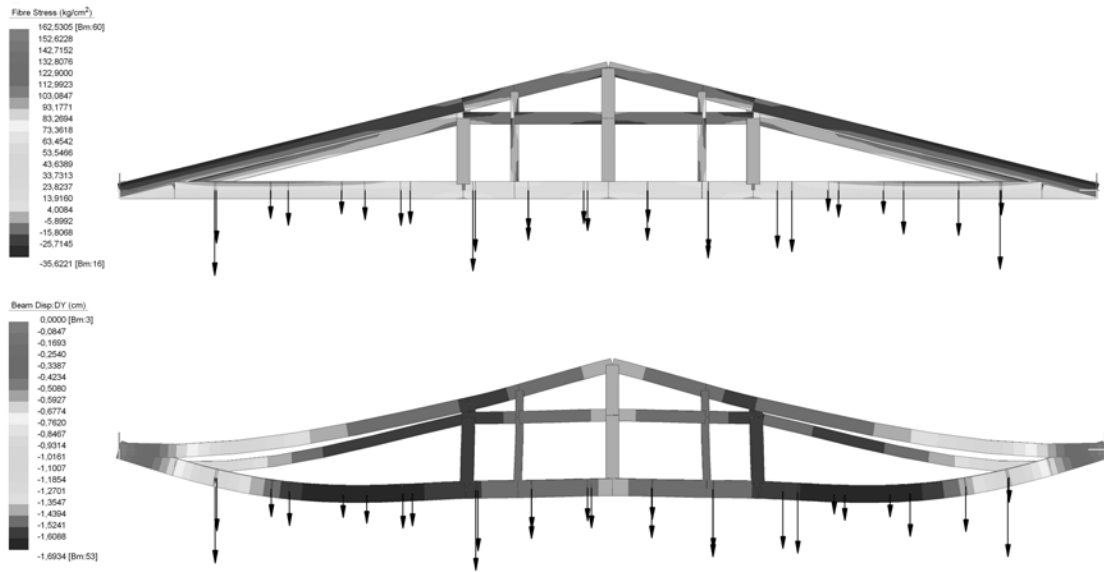
Figure 3: Numerical model of the 7th Graldi's truss. The painted ceiling is suspended from this truss. Structural unit subjected to static loads. Stresses (up). Vertical displacements (down).

The structural analysis for the Giraldi's trusses shows that the stresses in the wood vary in a very narrow range and the values are small (see Table 4). A deformation curve of the rafter different from that of the under rafter and a tendency of these members to share have been observed.

Table 4: Domenico Giraldi's 7th truss positioned in 1854.

| With internal fixed joints | | With internal joints like hinges | |
| Stress | Displacement max (y) | Stress | Displacement max (y) |
| N/cm ² | cm | N/cm ² | cm |
| 1593.88 (metallic elements) | -1.7 | 1650.18 (metallic elements) | -2.5 |
| -349.33 | | -480.45 | |

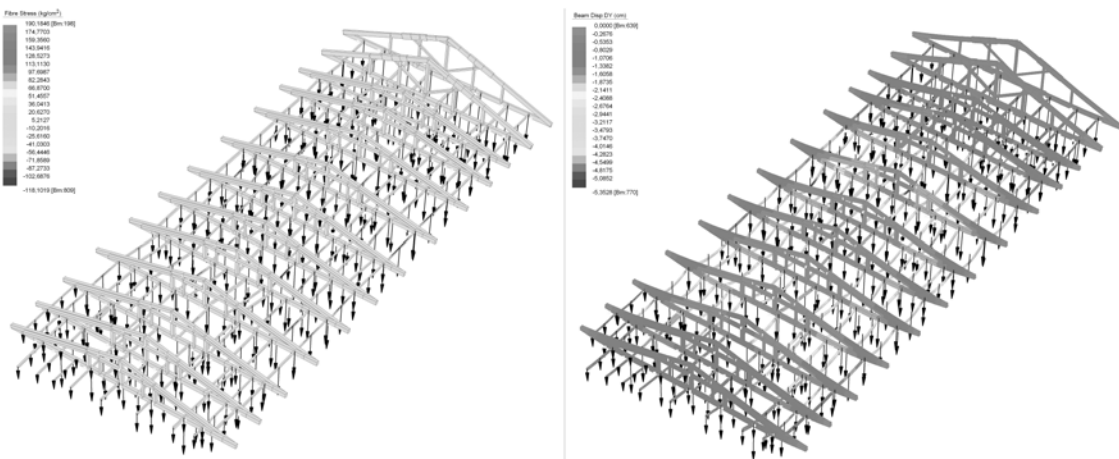
Figure 4: Numerical model of the trusses which sustain the false ceiling and of the interposed joists. Structural system subjected to static loads. Stresses (right). Vertical displacements (left).

In the complete structural model, defined by the parallel collection of wooden trusses, a system of the wooden joists has been considered arranged among the singles structural units. Both the self weighth load of the ceiling and the loads trasmitted by the metallic and timber suspension devices have been applied directly to the wooden joists.

Table 3: Trusses sustaining the false celing.

| Maximun overload (5 th wooden truss) | Minimun overload (1 th wooden truss) |
| kN | kN |
| 82 | 29 |

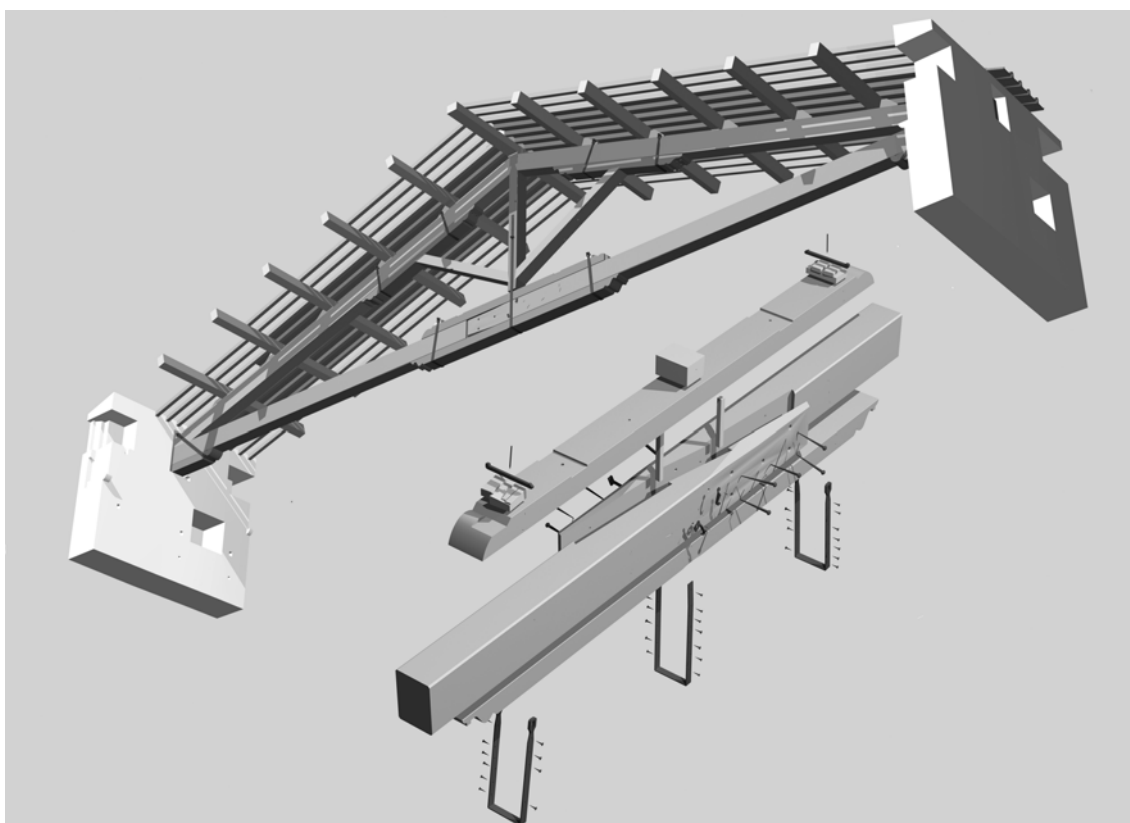
Figure 5: The vasarian truss; exploded view of the chord.

The chords are made, in account of the length, 24 m average, of two elements connected in the middle by a seal joint (a simplified “Jupiter’s arrow joint”) the contact surfaces of which are resting in vertical planes, also inclusive of a superior and a slightly longer inferior element. These, acting as brackets, are intended to stiffen the connection and to make it suitable to resist also to bending moment: this is generated by the not negligible self weight of the chord and by the weight of the false ceiling. The central connection is completed with nails and bolts of various type set untidily (a sign of multiple interventions) which stop any mutual motion and do not allow adjustment; very sophisticated the bolts, which are to be attributed to the Vasari’s time. Besides the four pieces are tightened by two end iron ties. These have no wedges (today) but a single upper horizontal connector and they can be tightened to the woods only inserting wooden thicknesses.
