XVIIth World Congress of the International Commission of Agricultural and Biosystems Engineering (CIGR)

FLUSH SYSTEMS FOR DAIRY MANURE REMOVAL: THE ALLEY ROUGHNESS VALUE

CSBE100442 – Presented at Section II: Farm Buildings, Equipment, Structures and Livestock Environment Conference

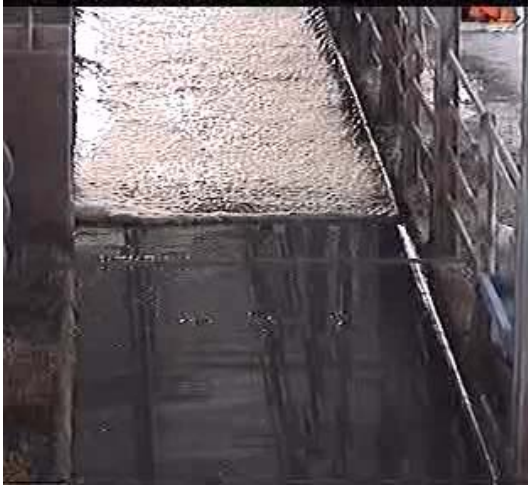
Figure 1. Flush wave on the clean freestall alley (barn 2).

Figures 1 and 2 show the movement of the flush wave on the freestall alley flooring, for the barn 2. It clearly appears how the front wave is moving regularly on the clean floor compared with the wave flow along the dirty floor of the alleys. The roughness obtained values justify this behavior.

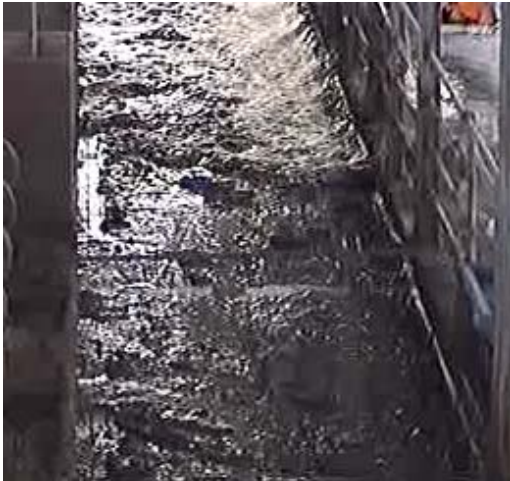
Figure 2. Flush wave on the dirty freestall alley (barn 2).

With reference to the barn 2, the roughness values for the clean alleys are 0.012 and 0.011, confirming the previous values calculated for the alleys of barn 1, presenting similar groove type. For the freestall alley, the obtained n value is 0.018 representing an increase of 39% with respect to the clean situation. This percentage is lower than that one obtained for the same type of alley of barn 1, but it may be justified by considering that the presence of litter (type and quantity) influences the roughness. In barn 2, the feeding alley presents some differences in comparison with barn 1 as it is wider (4.2 vs 3.3 m) and gives access to a single row of freestalls. The obtained value for the roughness is equal to 0.027, showing an increase of 52% with reference to the clean value. It is obvious that this value cannot be compared with any other among those belonging to the other freestall barns. It can be observed that this roughness value is the maximum obtained and it may be justified by the fact that the amount of manure present will be greater. As regards the barn 3, the 0.017 n value for the feeding alley is comparable with the previous ones.

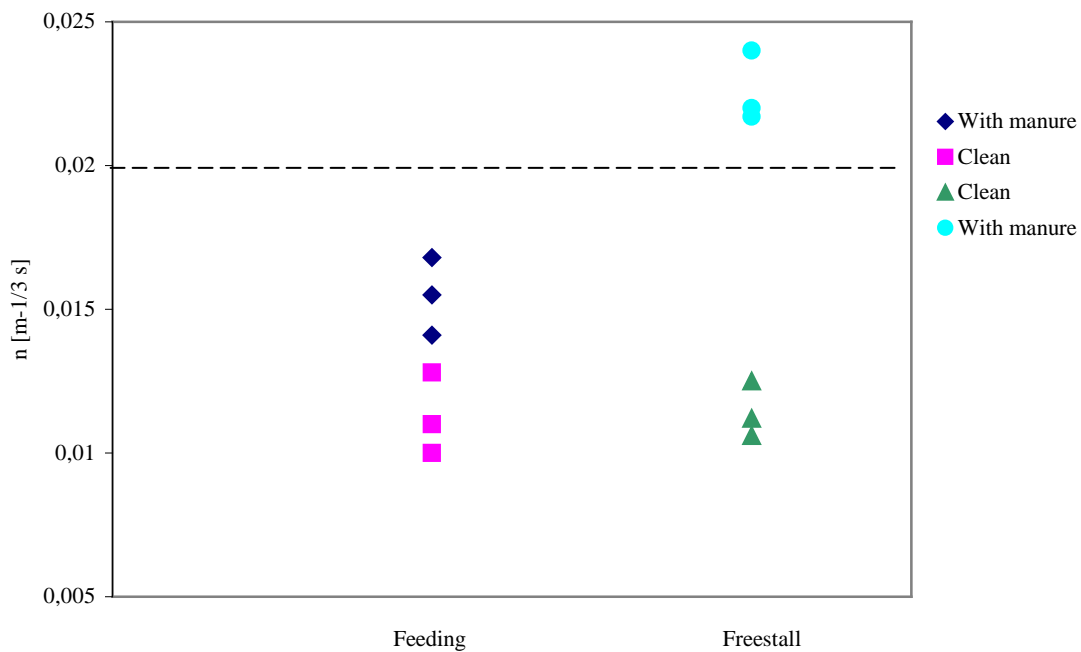
Figure 3. Manning coefficient (n) for the different alleys under normal and clean conditions for the freestall barn 1 (dash line represents the n value equal to 0.02 as suggested in literature).

RESULTS AND DISCUSSION The values of the Manning coefficient n are obtained from the Chezy formula substituting the measured velocity and the surveyed flow depth for each trial. Data elaboration has been made both separately for each freestall barn and then grouped for alley type. The barn 1 and 2 have in fact the same alley grooves. In figure 3, n values for the barn 1 are shown, with the reference value of 0.02 as suggested in literature, separated between feeding and freestall alley types. The repeated trials on the clean alley of both types show comparable values included in the interval 0.010-0.013, thus a value of 0.01 (cut at the third digit) may be considered as the typical roughness number for an alley made of concrete with longitudinal grooves, 0.02 m wide and deep and 0.1 m spaced. As regards the feeding alley, the range is 0.014-0.017, showing an increase of 27% compared with the n value for the clean alley. The freestall alley presents values in the interval 0.022-0.024, showing an increase of 46% compared with n value for the clean alley. The higher value calculated for the freestall alley, compared with the value obtained for the feeding alley, may be justified by the presence on the alley of both manure and litter material. From the graph, it is clear how all the values are under the 0.02 line with the exception of values for the freestall alley.

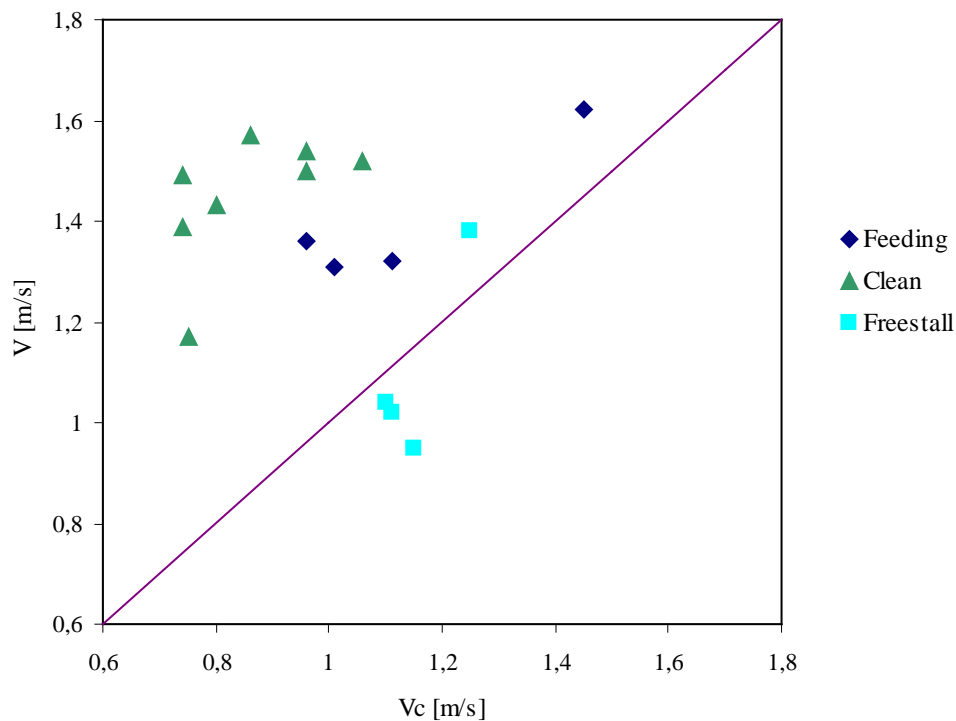
Figure 4. Measured velocities (V) and calculated velocities (Vc) for different alleys.

In figure 4, the velocity values, calculated with the Chezy formula using a n value equal to 0.02 and the measured ones, are reported for all the investigated barns. Points close or on the straight line are those whose calculated and measured velocity values are similar, resulting in n values close or equal to 0.02. All the points are above the line with the exception of those corresponding to the freestall alley for barn 1. For those points, the n value equal to 0.02 would result into a weak over estimation of the velocity. The value of n equal to 0.02 may be considered representative for a situation which is not the current one in the surveyed barns. The only point belonging to the freestall alley over the straight line is for the barn 2 and this may be justified by observing that the freestall alley may be strongly influenced by the litter type and quantity. In this case, the obtained n value is less than 0.02. For the other freestall points, the obtained n value is bigger than 0.02.

As regards the feeding alley, it clearly appears that the n value equal to 0.02 involves an under-estimation of the velocity value. The value far from the other three corresponds to the barn 3, which was characterized by a different type of grooves compared to the other two, thus influencing the roughness value both for the clean and the dirty conditions.

As regards the clean alley case, all the points are far from the line resulting in higher measured velocity than those calculated with the 0.02 n value. The under estimation may be strong for this situation and n value equal to 0.02 is too high for that situation.
