### **Seismic Analysis of Historic Masonry Buildings: The Vicarious Palace in Pescia (Italy)**

## **Seismic Analysis of Historic Masonry Buildings: The *Vicarious Palace* in Pescia (Italy)**

**Michele Betti \* and Luciano Galano**

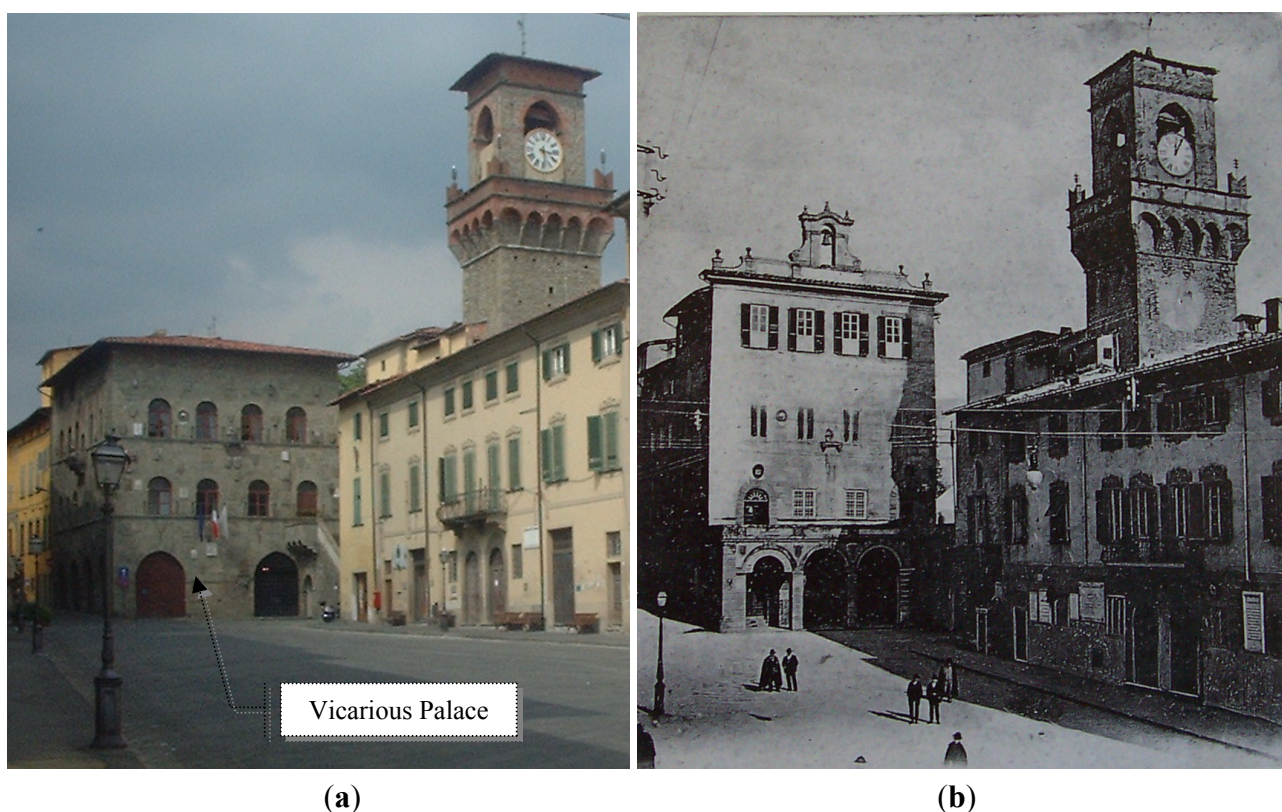
**Figure 1.** (a) The Vicarious Palace as is today; (b) the Vicarious Palace at the beginning of XX century.

The Vicarious Palace is located in the main square (*Piazza Mazzini*) of the city of Pescia. Figure 1a shows the front view of the building. The research started with the analysis of historic data. The material was found in the archive of the Ministry Institution for Environmental and Architectural Heritage of Florence, Prato and Pistoia (the institution employed to preserve the cultural heritage in the Florence metropolitan area).

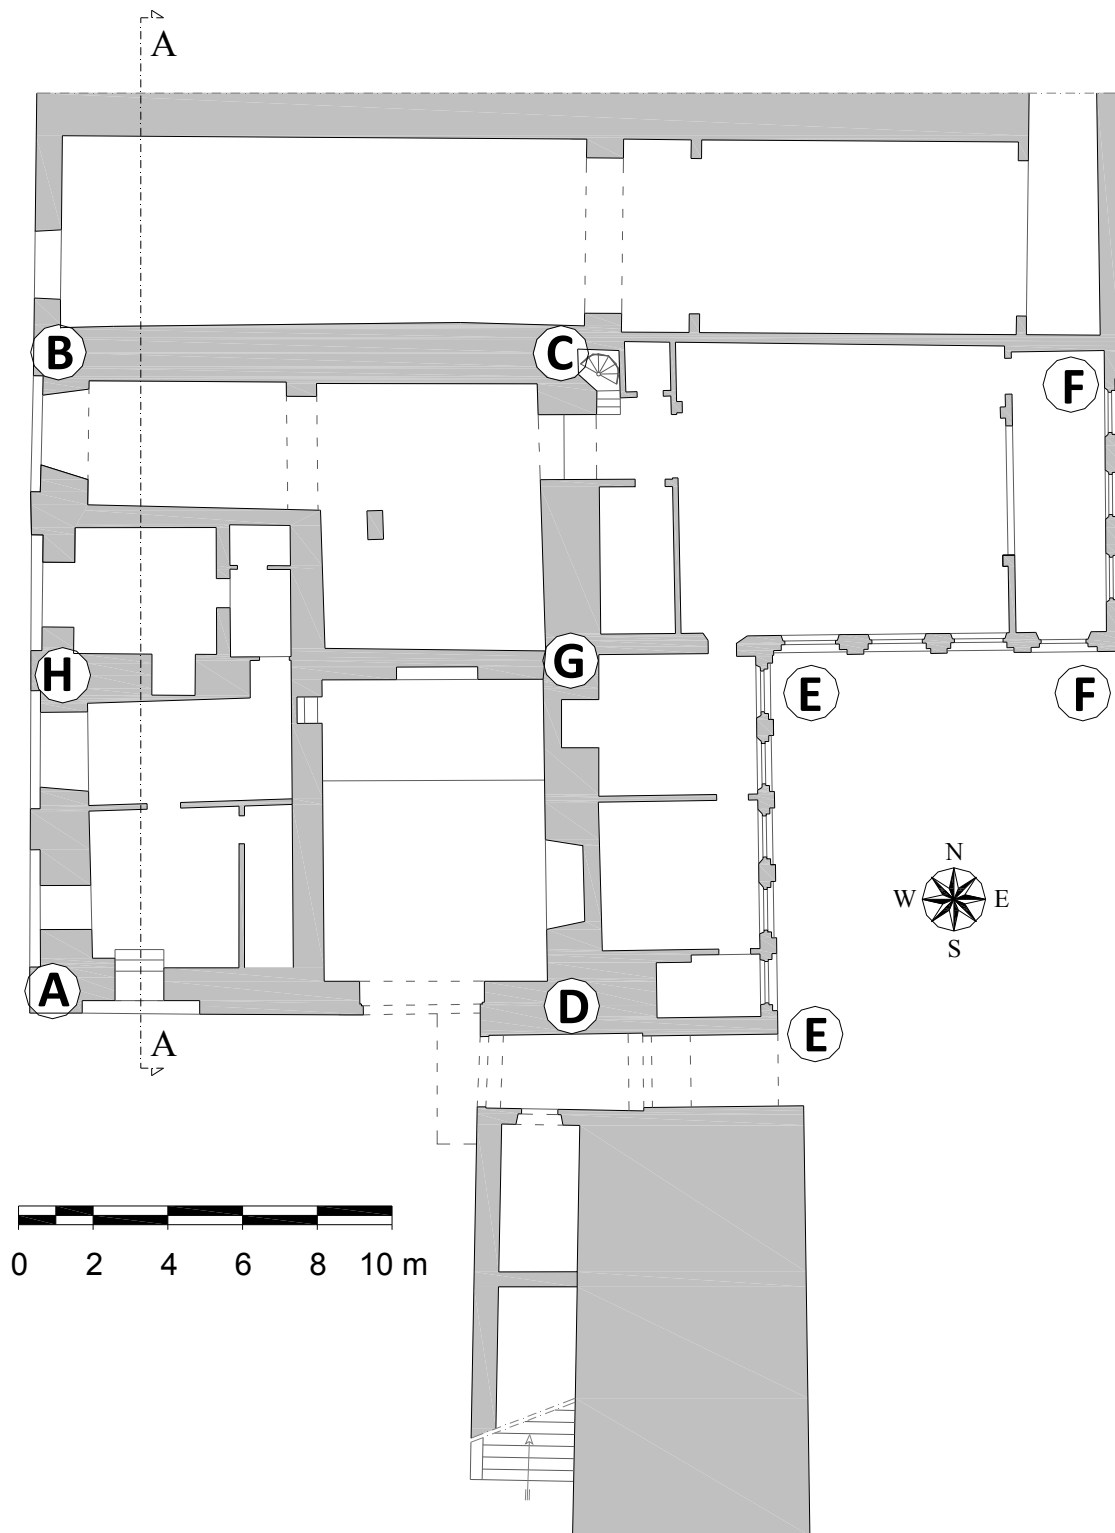
**Figure 2.** Plan layout of the ground floor (ABCD is the original medieval square nucleus; EE-FF is a twentieth century addition).

The plan layout of the ground floor of the Palace is reported in Figure 2. It is possible to recognize the original medieval square nucleus, delimited by the walls indicated with AB, BC, CD and DA, whose dimensions are about  $18\text{ m} \times 15\text{ m}$ . In particular, the wall CD probably corresponded to the main city walls [20]. This square ground floor was an open space (as a loggia) used for public administrative activities. The adjoining walls EE, EF and FF were added during the last intervention in the thirties of the last century. The actual height of the Palace, after the demolition of the fourth storey, is about 17 m as reported in the section represented in Figure 3. The horizontal structures of the first floor are made of masonry vaults, while the upper floors and the roof are timber structures. Views of the main façades of the building are reported in Figures 4, 5 and 6.

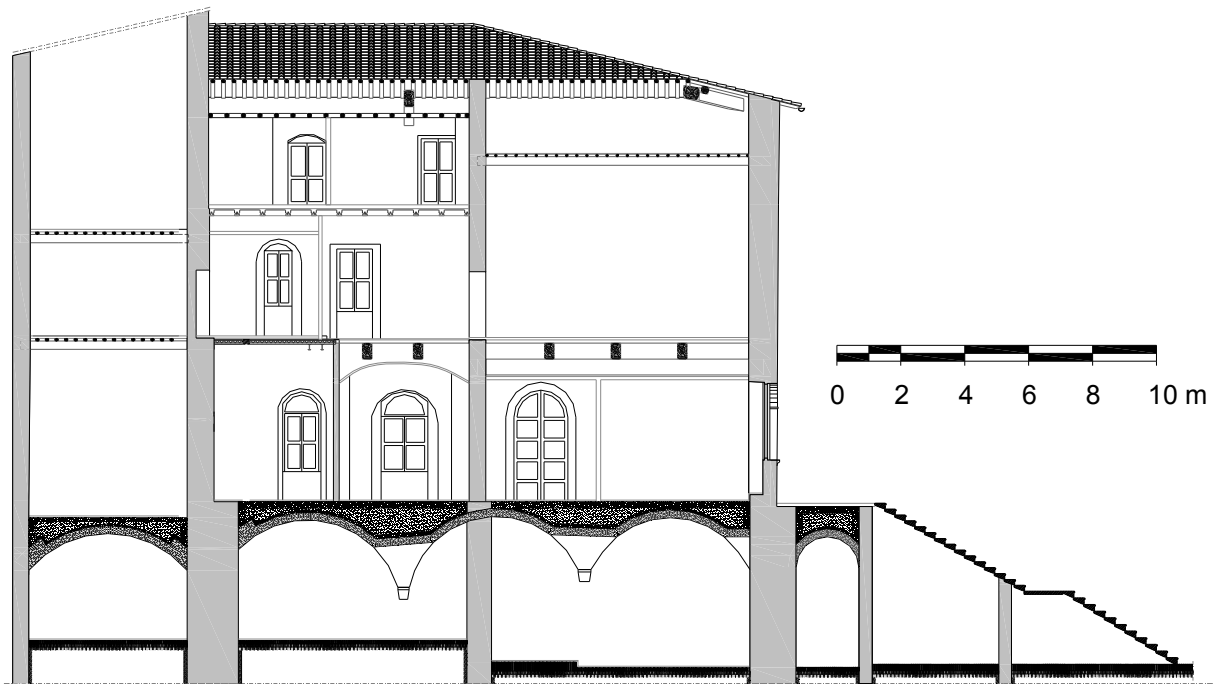
Figure 3. Section A-A of the Palace.

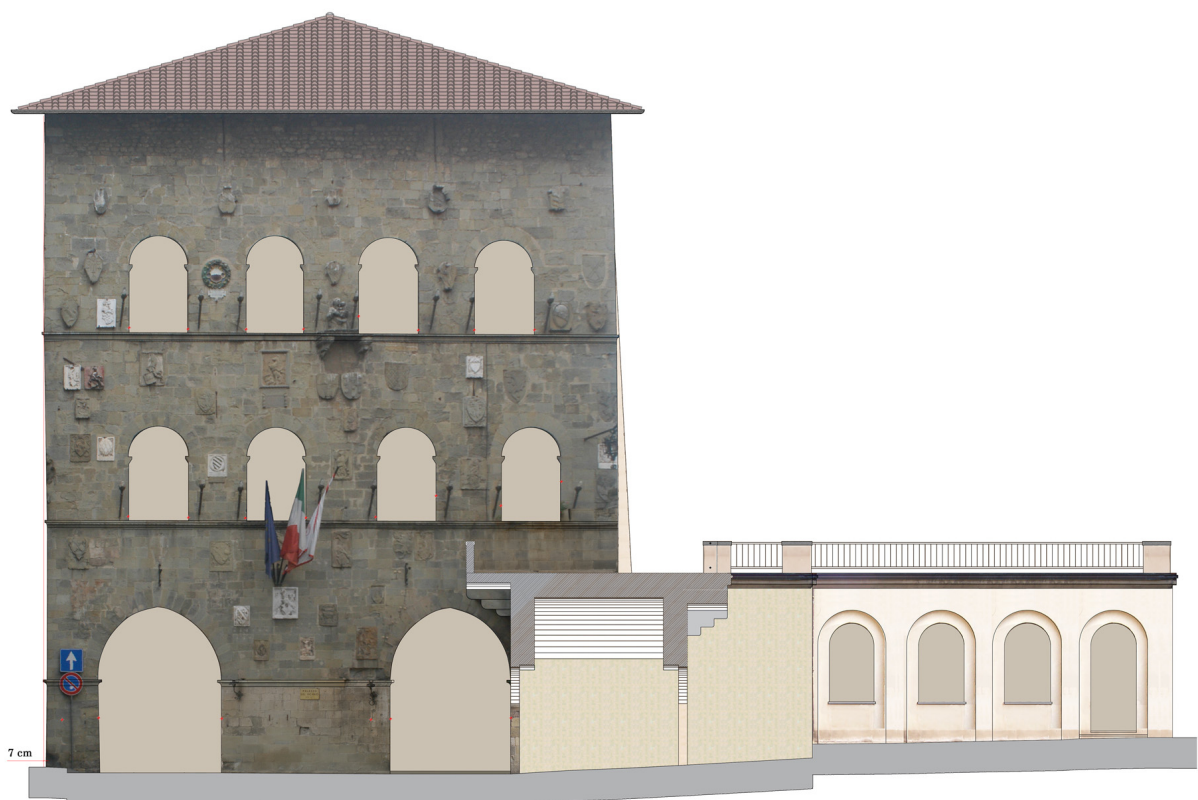
Figure 4. View of the Southern façade.

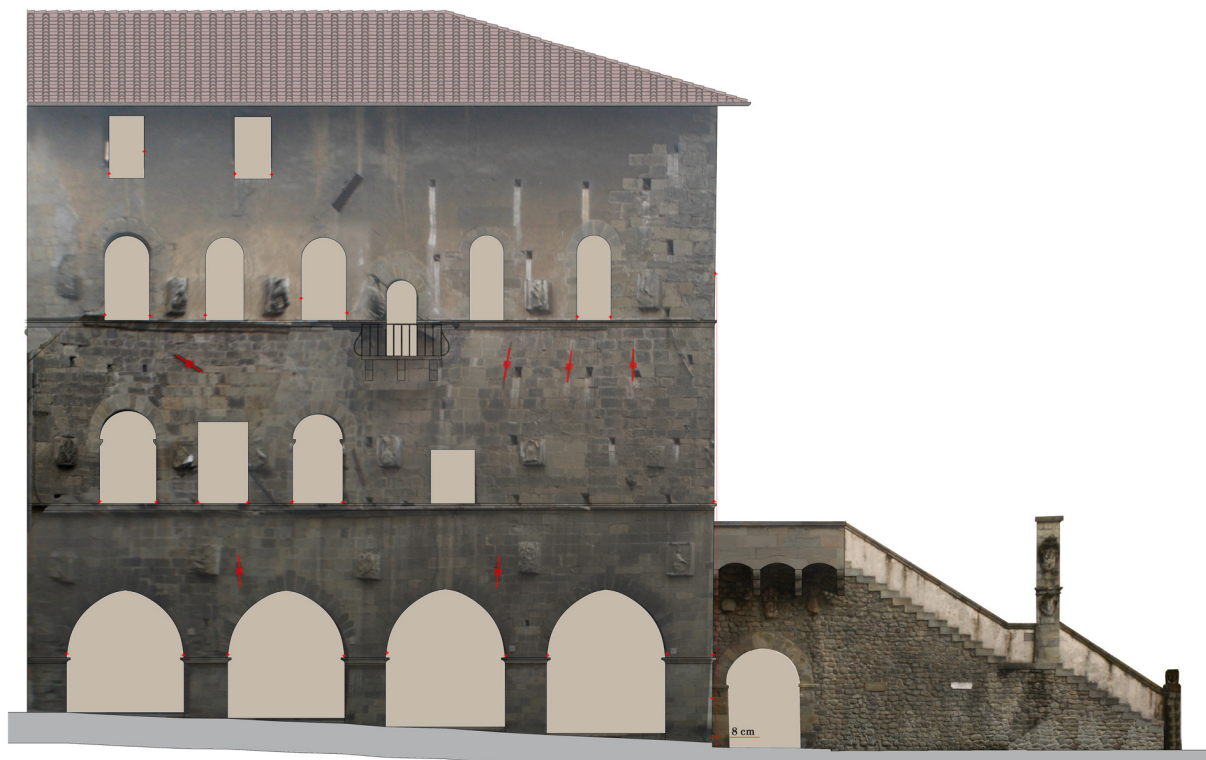
Figure 5. View of the Western façade.

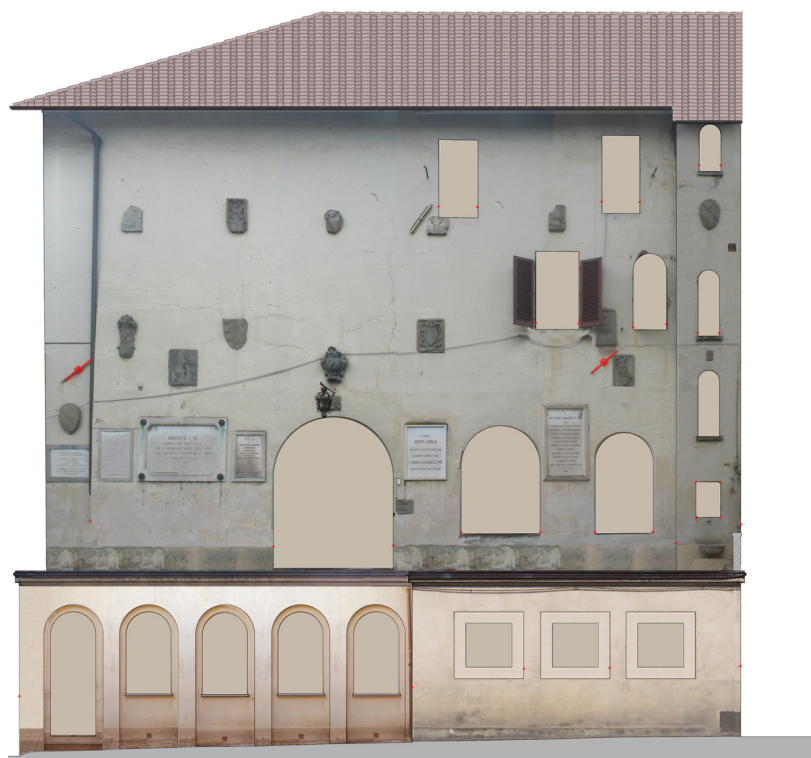
Figure 6. View of the Eastern façade.

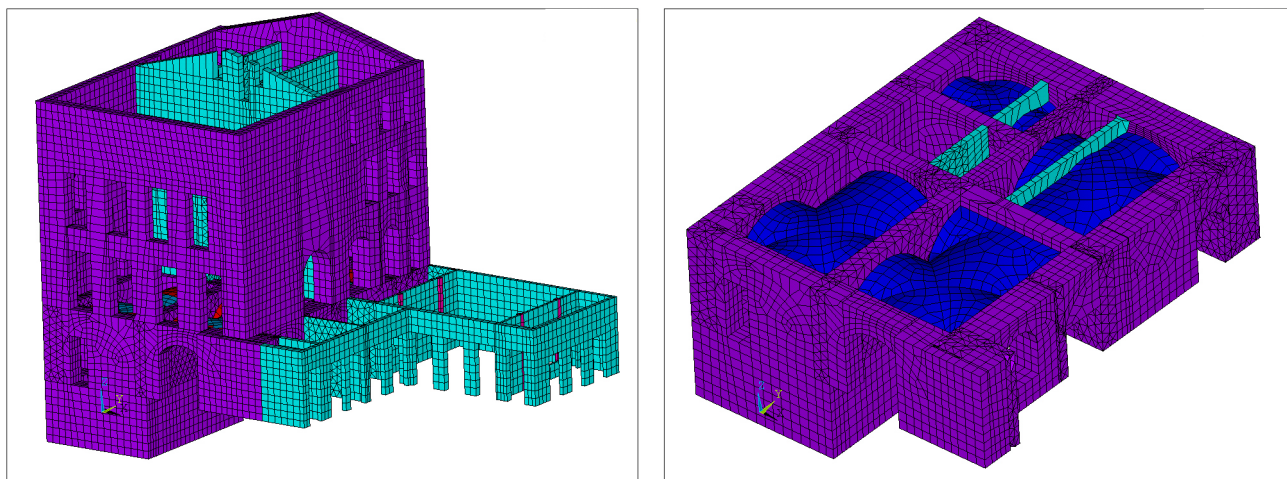
**Figure 7.** Finite element model of the Vicarious Palace.

The structural analysis of the Palace was approached by a 3D finite element model based on the concepts of homogenized material and smeared crack modeling using the ANSYS code v.11.0 [25]. The masonry walls were discretized with *Solid65* elements (isoparametric three-dimensional eight node elements), whereas the ground floor vaults were discretized with *Shell63* elements (isoparametric two-dimensional four node elements). The wooden floors and timber roof were not considered in the model and their own weights were applied on the bearing walls by means of vertical concentrated loads.

An *in-situ* survey of the building was made to accurately reproduce the geometry, the structural details and the irregularities of the Palace. This investigation consisted of a geometrical relief aimed at characterizing the masonry texture and to check up the quality of wall-to-wall, wall-to-floors and wall-to-roof connections. The 3D model is represented in Figure 7. It consists of 37,402 nodes, 36,557 *Solid65* elements and 813 *Shell63* elements, corresponding to 108,399 DOFs.

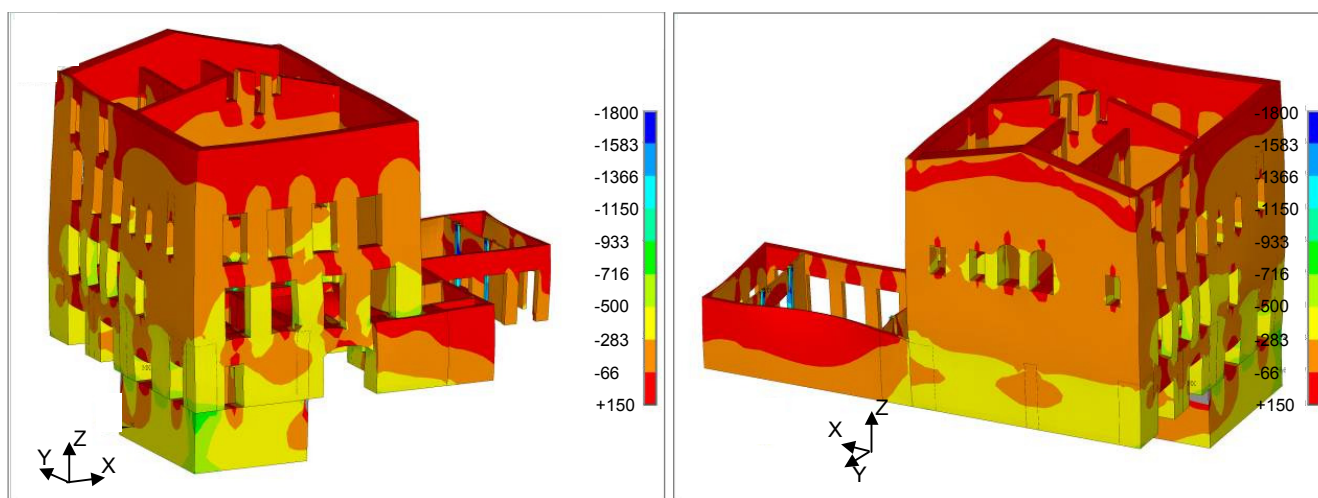
**Figure 8.** Static analysis: vertical compressive stresses (units are  $\text{kN/m}^2$ ).

Results in terms of vertical stresses are reported in Figures 8 and 9. The average compressive stress at the base of the walls is about  $0.5 \text{ N/mm}^2$  with small tensile stresses located on the top surface of the walls. These tensile stresses are produced by the local numerical effect depending on the concentrated loads of the roof. The maximum compressive stress (about  $1.7 \text{ N/mm}^2$ ) is reached in a column close to an arch opening in the internal wall (Figure 9). Even if this value is high it is much less than the crushing limit of the masonry (local sandstone). Results of the analysis illustrate that the Palace is adequate to withstand the vertical loads under exercise conditions. This is a common result for this typology of buildings designed by skilled manufacturers.

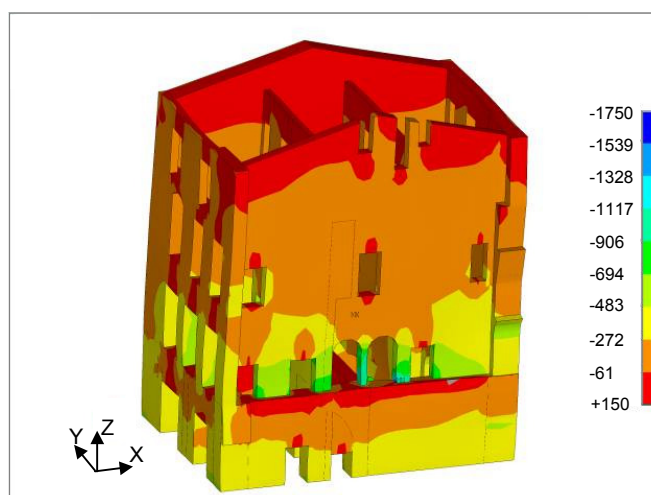
**Figure 9.** Static analysis: vertical compressive stresses, detail of the internal wall (units are  $\text{kN/m}^2$ ).

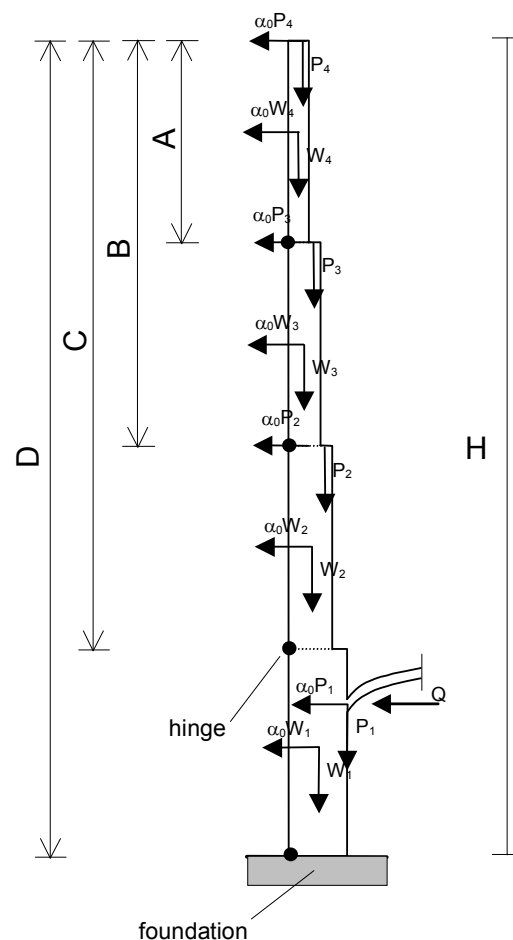
**Figure 10.** Out-of-plane mechanisms;  $P_i$  are the vault or the floor vertical loads;  $W_i$  are the own weights of the walls;  $\alpha_0 P_i$  and  $\alpha_0 W_i$  are the seismic loads.

The mechanisms considered in this study concern partial and global overturns of the main façades, and the collapse multipliers  $\alpha_0$  are evaluated according to Eq. (1) (see the general scheme reported in Figure 10; A, B, C and D identify different mechanisms):

In Equation (1)  $W_i$  are the dead weights of the elements involved in the mechanism;  $P_i$  are the weights transmitted at the selected macro-element by vault, floors or roof;  $\delta_{xi}$  are the horizontal virtual displacements of the points of application of  $W_i$  and  $P_i$ ;  $\delta_{yi}$  are the vertical virtual displacements of the points of application of  $W_i$  and  $P_i$ ;  $Q$  is the static drift of the vault;  $\delta_{xq}$  is the corresponding horizontal virtual displacement and  $L_{fi}$  is the virtual work of the internal forces, here assumed equal to zero. After the evaluation of the collapse multiplier  $\alpha_0$ , the corresponding seismic spectral acceleration  $a_0^*$  is given by:

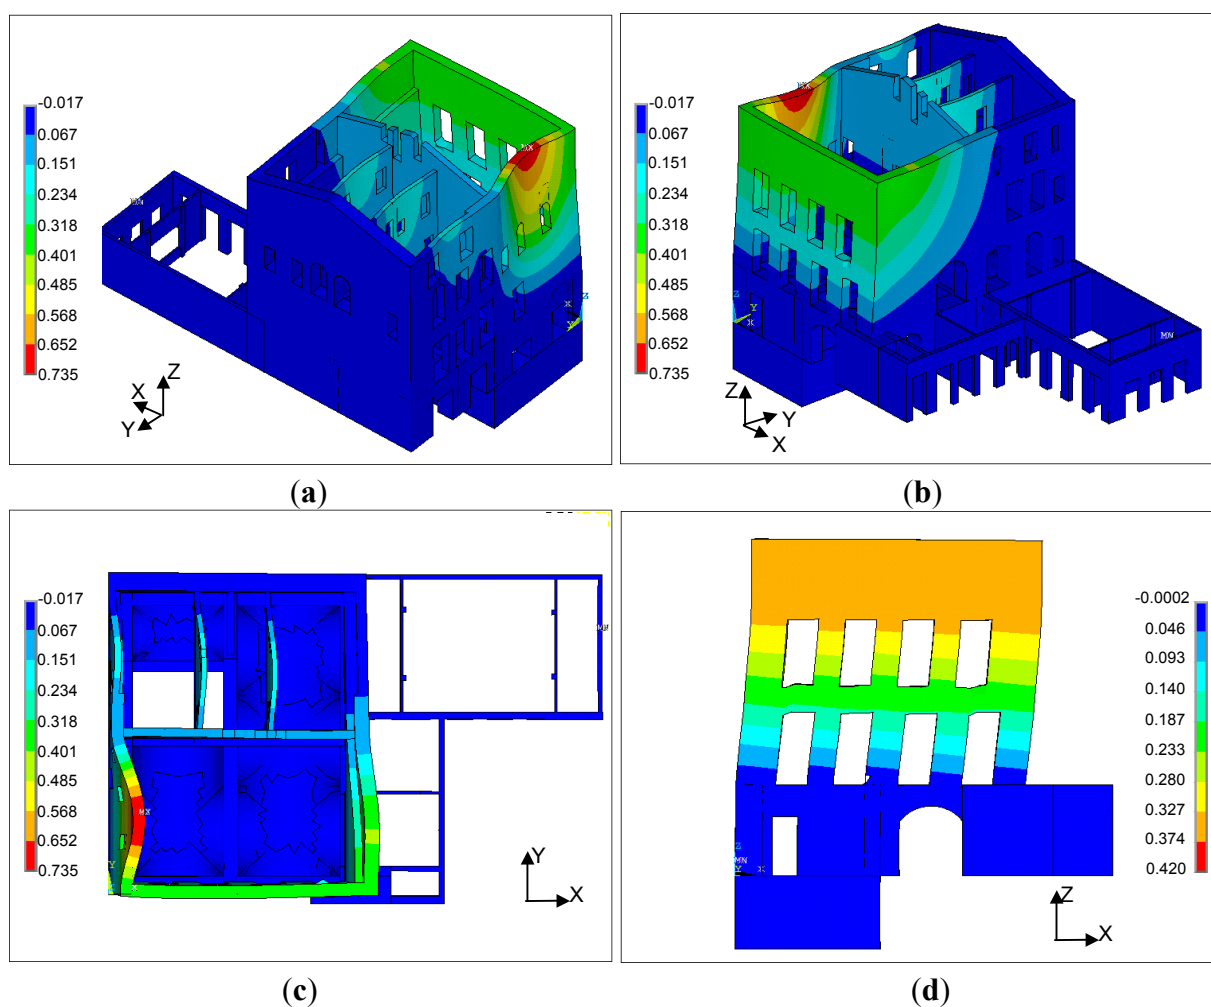
**Figure 11.** Pushover analysis results (+X direction): (a), (b), (c) and (d) horizontal displacement in X direction (units are m).

Results of pushover analysis in terms of displacements and crack and crushing patterns are reported in Figures 11 to 14. Figures 11 and 12 report the final configuration of the Palace for seismic loading acting in the transversal direction (+X and -X). In both cases there is a remarkable out-of-plane deformation of the wall AH, that confirms the results obtained with the kinematic analysis. Figures 13 and 14 show the Palace configuration for seismic loading acting in the longitudinal direction (+Y and -Y). Again it is possible to find a good agreement in terms of failure process between pushover and kinematic analysis, both confirming the overturning of the wall DA.

In case of seismic loading acting in the transversal direction (+X and -X) the analyses stop at a horizontal load corresponding to about 28–30% of the overall weight of the Palace; in case of seismic loading acting in the longitudinal direction (+Y and -Y) the analyses stop at a horizontal load corresponding to about 35–37% of the overall weight of the Palace.

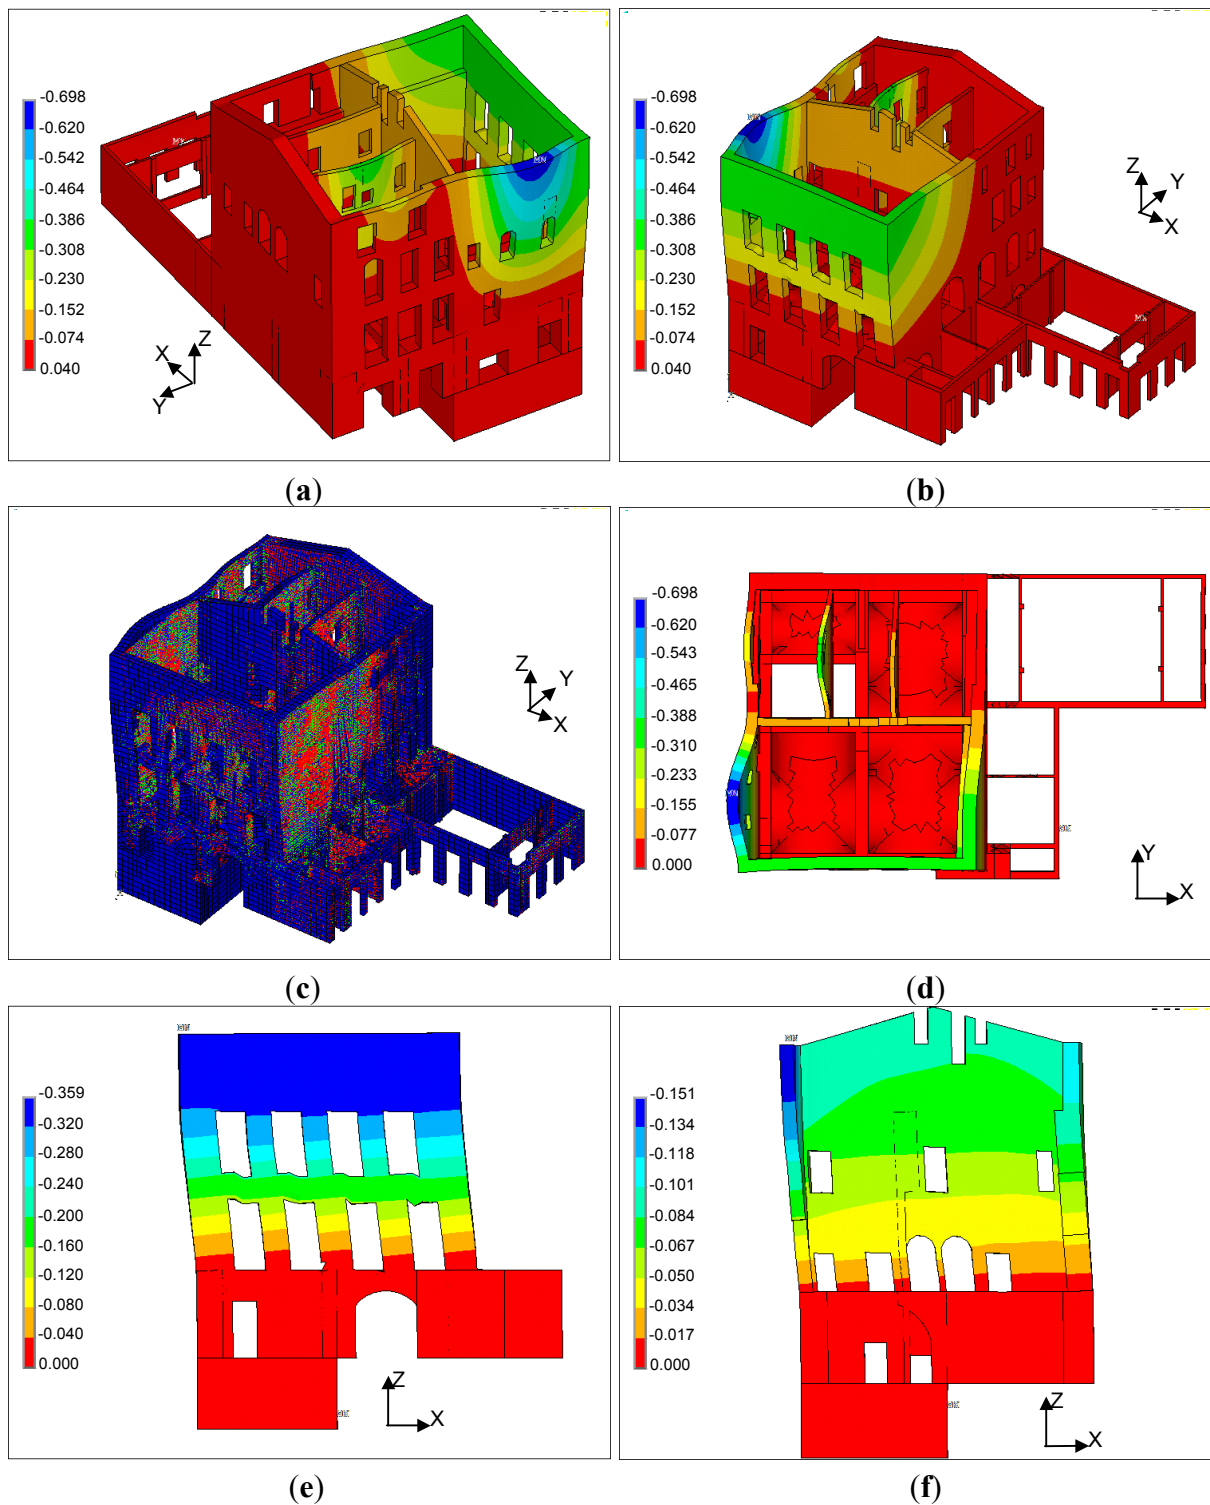
**Figure 12.** Pushover analysis results (−X direction): (a), (b), (d), (e) and (f) horizontal displacement in X direction (units are m), (c) final cracking and crushing patterns.

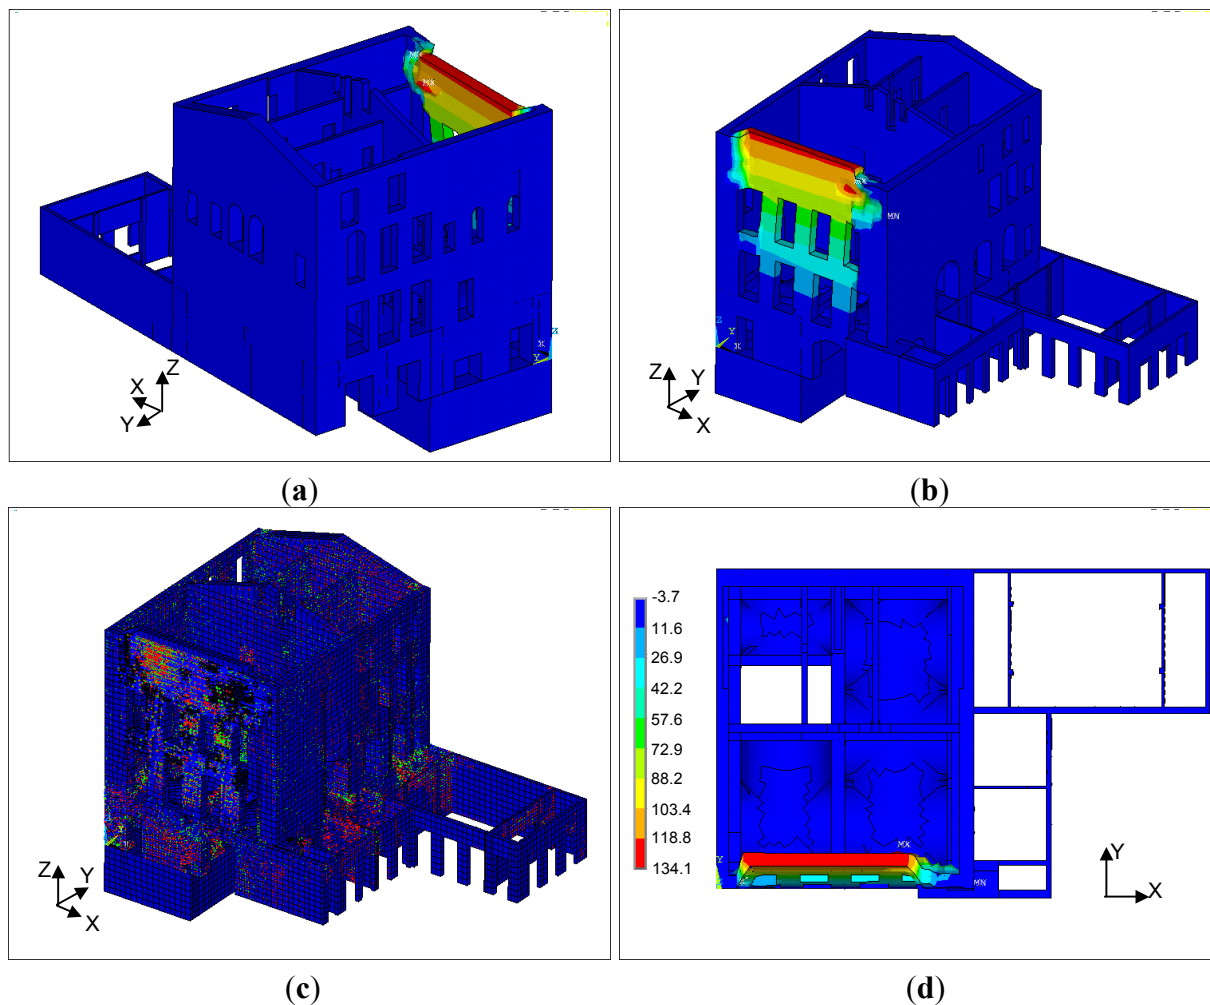
**Figure 13.** Pushover analysis results (+Y direction): (a), (b) and (d) horizontal displacement in Y direction (units are m), (c) final cracking and crushing patterns.

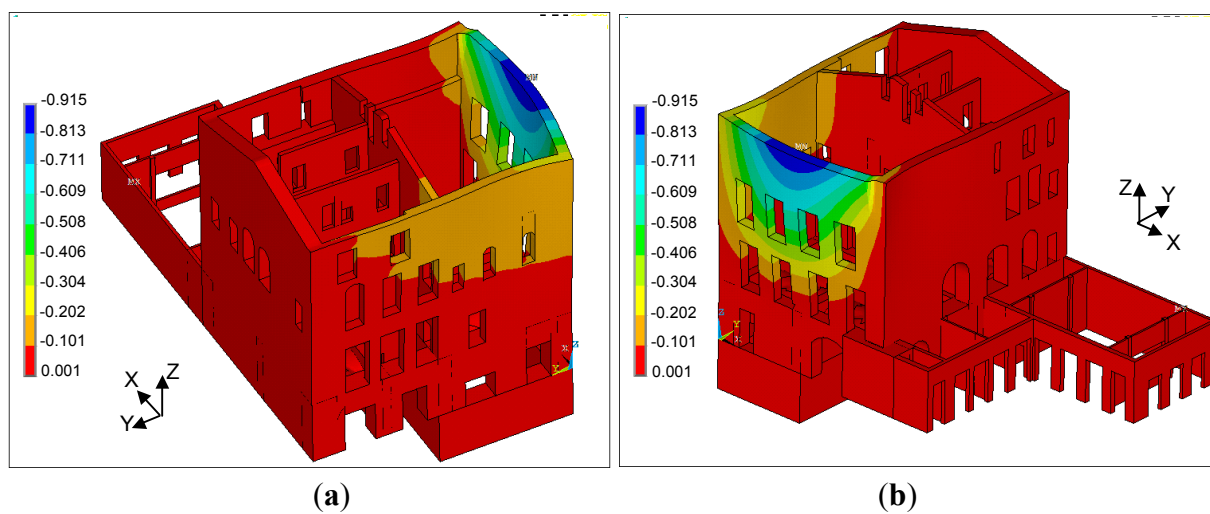
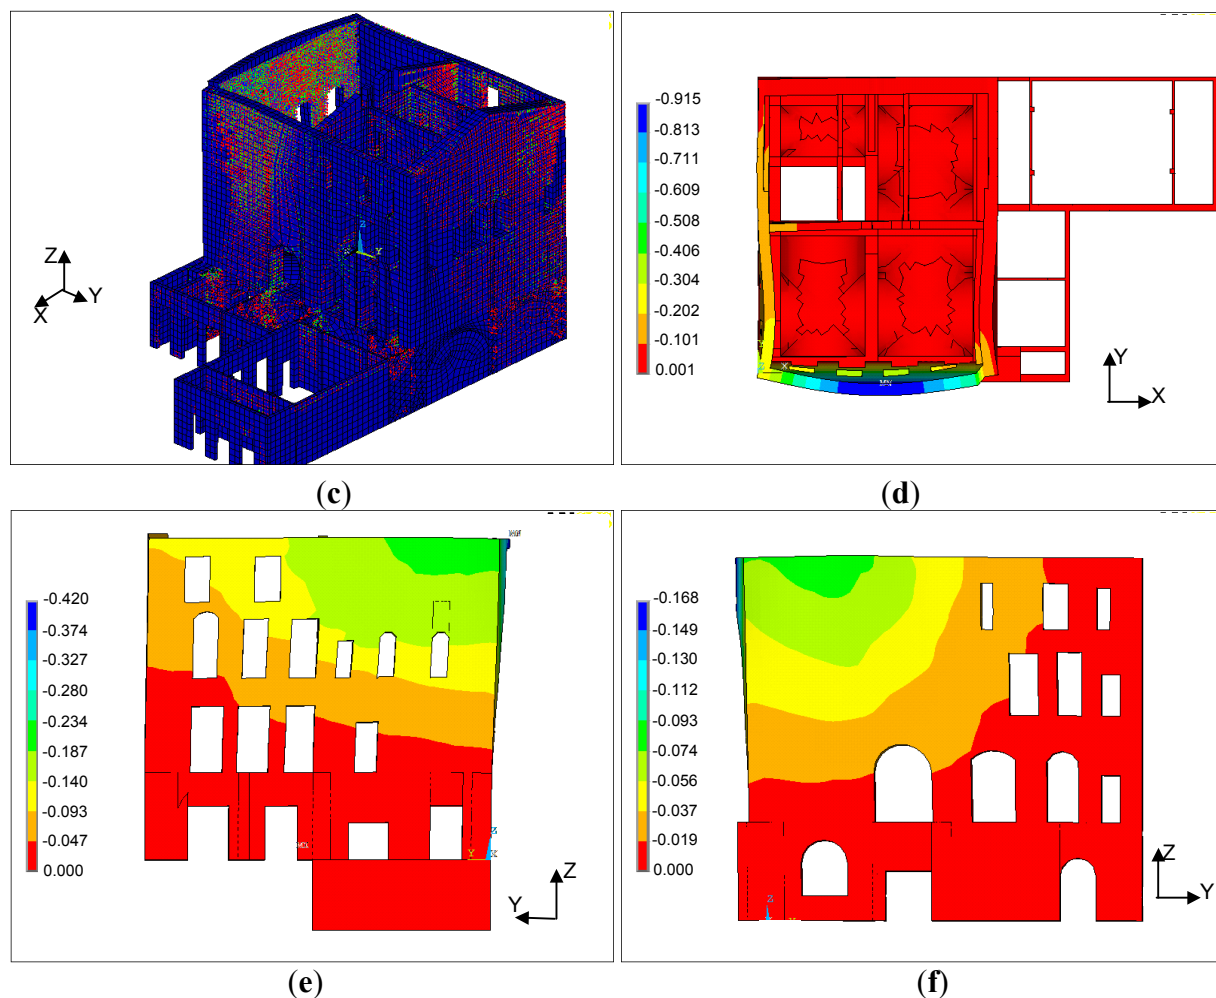
Figure 14. Cont.

**Figure 14.** Pushover analysis results (-Y direction): (a), (b), (d), (e) and (f) horizontal displacement in Y direction (units are m), (c) final cracking and crushing patterns.
