Timber Strengthening Systems operated on the Vasari's Ceiling in Palazzo Vecchio

Timber Strengthening Systems operated on the Vasari's Ceiling in Palazzo Vecchio / P.P.Derinaldis; G. Tampono; G. Tempesta. - STAMPA. - (2006), pp. 421-428. (Intervento presentato al convegno Structural Analysis of Historical Constructions. Possibilities of numerical and experimental techniques tenutosi a New Delhi).

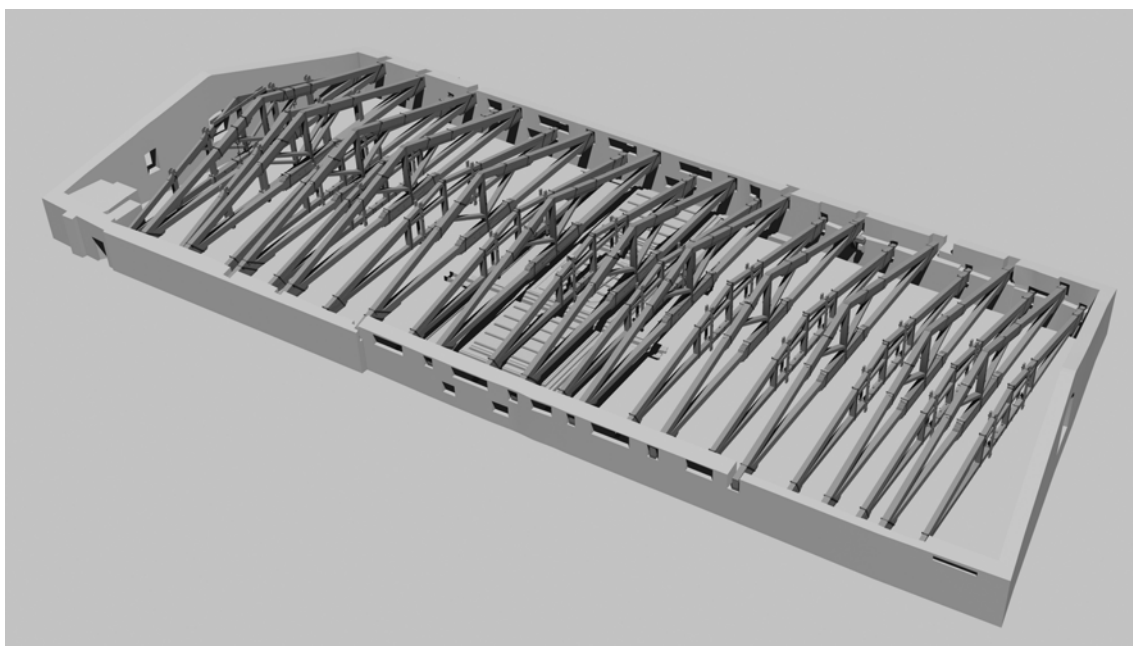
Figure 1: “Salone dei 500”. Perspective view of the garret.

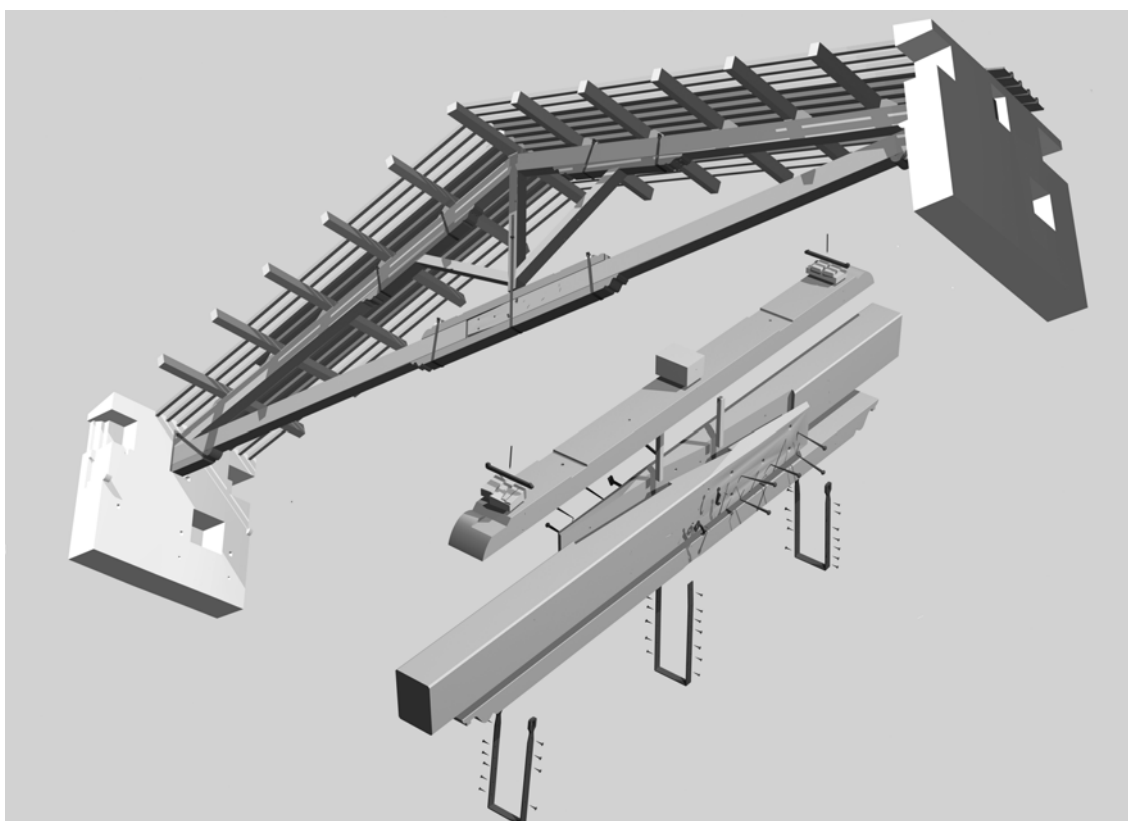
Figure 5: The vasarian truss; exploded view of the chord.

The chords are made, in account of the length, 24 m average, of two elements connected in the middle by a seal joint (a simplified “Jupiter’s arrow joint”) the contact surfaces of which are resting in vertical planes, also inclusive of a superior and a slightly longer inferior element. These, acting as brackets, are intended to stiffen the connection and to make it suitable to resist also to bending moment: this is generated by the not negligible self weight of the chord and by the weight of the false ceiling. The central connection is completed with nails and bolts of various type set untidily (a sign of multiple interventions) which stop any mutual motion and do not allow adjustment; very sophisticated the bolts, which are to be attributed to the Vasari’s time. Besides the four pieces are tightened by two end iron ties. These have no wedges (today) but a single upper horizontal connector and they can be tightened to the woods only inserting wooden thicknesses.

We can deduce that the two rulers of the chords have been nailed at their connection at several times: there are many chances that the nailing of the kingposts to the chord is the extreme act of

the stiffening attempts, posterior to the last unsuccessful nailing of the two rulers. All we can say is that this happened before modern era. The structural analysis in the new configuration shows that the stresses are rather low and anyhow absolutely admissible for fir tree.
