### **Performance analysis of seismically excited statues in fixed-base and base-isolated conditions**

Performance analysis of seismically excited statues in fixed-base and base-isolated conditions / Sorace, S; Terenzi, G. - STAMPA. - 8:(2015), pp. 6860-6871. (Intervento presentato al convegno Second European Conference on Earthquake Engineering and Seismology tenutosi a Istanbul nel 25-29 August 2014).

## PERFORMANCE ANALYSIS OF SEISMICALLY EXCITED STATUES IN FIXED-BASE AND BASE-ISOLATED CONDITIONS

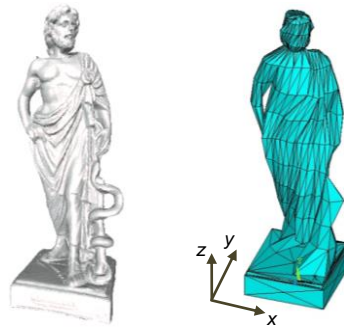
The statue examined in this study, a view of which is shown in Figure 1, is a 17<sup>th</sup> century marble copy of a Hellenistic sculpture reproducing the Greek philosopher Socrates. The statue is constituted by a monolithic block including a thin parallelepiped pedestal, with square base section of 650 mm per side and height of 180 mm. The total height of the statue is about 1850 mm. Its aspect ratio is rather similar to the sculpture displayed on the left in Fig. 1, although with greater overall dimensions. On the other hand, due to the incorporation of the pedestal, global stability conditions are more favorable, and sensitivity to rocking is lower.

Figure 1. View of case study statue and relevant finite element model

The statue is made of greyish Carrara marble, with fine average grain size (below 1000  $\mu\text{m}$ ) and in good conservation state. As no characterization tests were carried out on the material, its mechanical properties were established by referring to the following typical ranges of variation suggested in literature (Scesi et al. 2006): uniaxial compressive strength  $f_c=40\text{--}70$  MPa; uniaxial tensile strength  $f_t=1.5\text{--}4$  MPa; Young modulus  $E=50,000\text{--}60,000$  MPa; specific weight  $\gamma=25\text{--}27$  kN/m<sup>3</sup>. In consideration of the ageing and creep-related strength decay occurring throughout the structural life of marbles and stones (Sorace 1996, 1998), the lowest values of the  $f_c$  and  $f_t$  ranges above, i.e.  $f_c=40$  MPa and  $f_t=1.5$  MPa, were assumed as basic choices in the analysis. However,  $f_t$ , whose value is the most critical parameter in smeared-crack computation, was raised to 3 MPa, in order to evaluate its influence on the performance of the statue, as discussed in section 4 below.

The finite element model of the statue was generated by the ANSYS calculus program (Swanson Analysis Systems 2012), widely used in research studies dedicated to structural systems made of small tensile strength materials. The model consists of a full mesh of about 15,800 solid octahedral isotropic elements, reproducing the real geometry with reasonable accuracy (image on the right in Figure 1, where the reference coordinate system of the model is displayed too). A smeared-crack “concrete”-type constitutive model was assigned to each isotropic element. In this model, the Willam-Warnke triaxial failure domain (Willam and Warnke 1974) is adopted to simulate the ultimate compressive, tensile and mixed compressive–tensile triaxial ultimate response of the material. The classical Drucker-Prager yield criterion (Drucker and Prager 1952) is assumed by the program to reproduce plastic deformations. The main mechanical parameters of the “concrete”-type model are as follows:  $st_o$ =shear transfer coefficient for open crack;  $st_c$ =shear transfer coefficient for closed crack;  $f_{crus}$ =uniaxial crushing design stress, coinciding with compressive strength  $f_c$ ;  $f_{crus,b}$ =biaxial crushing stress;  $f_{crak}$ =uniaxial cracking stress, coinciding with tensile strength  $f_t$ ;  $E$ =Young modulus; and  $\nu$ =Poisson ratio. The parameters defining the surface of Drucker-Prager domain are:  $c$ =cohesion;  $\phi$ =friction angle; and  $\psi$ =dilatancy angle. The following basic values were adopted in the analysis:  $st_o=0.15$ , and  $st_c=0.8$ , which are typical choices for fine-grained materials, like the greyish Carrara marble constituting the case study sculpture;  $f_{crus}=40$  MPa,  $f_{crus,b}=1.2 \cdot f_{crus}=48$  MPa,  $f_t=1.5$  MPa,  $E=55,000$  MPa and  $\nu=0.2$ , according to the characteristics of the material illustrated above; and  $c=2.12$  MPa,  $\phi=30^\circ$  and  $\psi=0^\circ$  (associated flow rule), from literature suggestions concerning the plasticity domain for concrete and stone-type elements (Chen 1982).

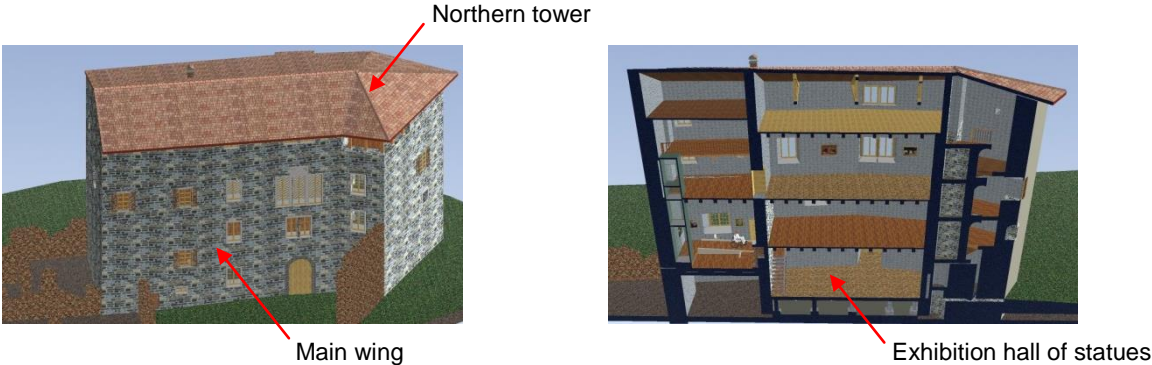
Figure 2. Renderings of the main wing and the northern tower of the castle of Prampero

The case study statue belongs to the art collection of the owners of the castle of Prampero, sited in Magnano in Riviera, province of Udine, which is one of the oldest and most famous examples of a medieval stronghold in the region of Friuli, Italy. The castle was severely damaged by an earthquake in 1976. After a long time of neglect, the first restoration intervention, concerning the northern tower, has been recently completed. A second restoration is expected soon, and it will concern the main wing of the castle, which partly collapsed after the earthquake, and for which a new destination as a museum has been suggested. According to the traditional exhibition settings in Italian museums, the statues will be accommodated on the ground floor. The renderings of the main façade and the longitudinal cross section of the building, which also incorporate the restored northern tower, are drawn in Figure 2. A total of eight marble and terracotta statues, with smaller or comparable dimensions to the case study one, will be placed on the ground floor, which covers the basement of the building. Stationary mount solutions were excluded by the art consultants of the exhibition planning, since they are extraneous to the common practice for small to medium scale non-metallic sculptures in Italy, due to the intrusion and possible local damage caused by mechanical connectors to their small base section(s). Adhesive glueing was not considered either, as it would be difficult to separate the sculptures from their pedestal or the floor in case of future changes in exhibition layouts.

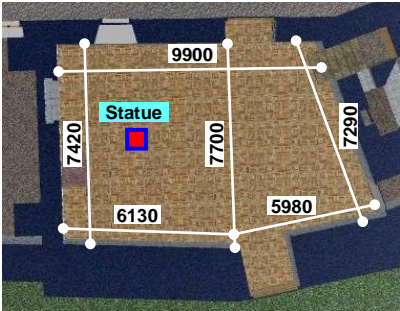
The ground floor design plan is illustrated by the drawing in Figure 3, where the position of the case study statue in the exhibition set is highlighted with a square.

Figure 3. Architectural plan of the ground floor (dimensions in millimeters) and position of the case study statue

The plan is shaped as an irregular pentagon, with a surface area of about 85 m<sup>2</sup>. The floor is made of 55 mm-high HI-bond corrugated steel sheets, with a 55 mm-thick on-site cast reinforced concrete (R/C) slab on top. The main structure consists of primary and secondary beams in HEB 180 and HEB 100 Italian profiles, respectively, made of S235JR grade steel. Each primary beam spans over the shorter (transversal) dimension in plan, ranging from about 7.3 m to about 7.7 m, as shown in Figure 3, and is supported approximately at its midspan by a R/C column built on the basement level. This allows strongly reducing the bending moment, shear and vertical displacements induced by gravitational loads, and thus the cross section of the beams. This solution is mutually adopted for the fixed-base and base-isolated layouts of the floor. In the former case, each beam is joined to the

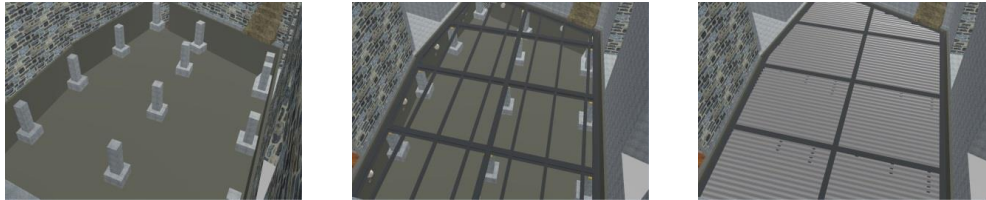
relevant midspan column by a horizontal steel plate bolted to the column top section, and is borne at both ends by the perimeter masonry walls of the hall. In base-isolated configuration, two other rows of R/C columns are built, for a total of 15 columns, to support 15 DFP sliders to be placed below the five main beams. These additional ten columns represent the only difference between the two design hypotheses for the floor. Renderings of the construction steps of the floor steel structure for the base-isolated solution, before casting the R/C slab, are illustrated in Figure 4.

Figure 4 Construction steps of the ground floor steel structure in base-isolated configuration, before the casting of the R/C slab

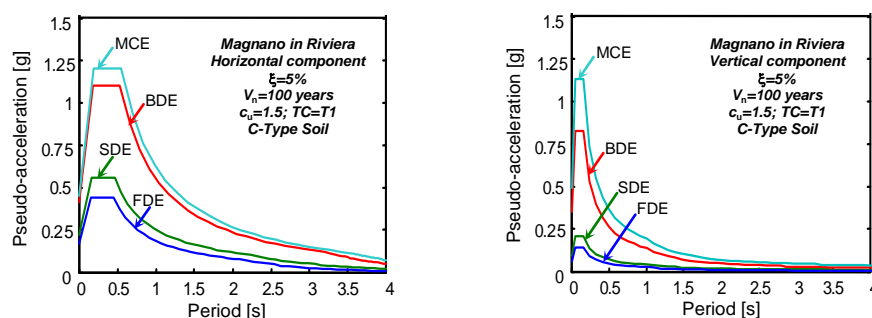
A visual representation of the normative response spectra at 5% linear viscous damping ratio  $\xi$  for Magnano in Riviera is offered in Figure 5, showing the graphs relevant to the horizontal and vertical components for the four seismic hazard design levels established by the Italian Standards, i.e. Frequent Design Earthquake (FDE, with  $P_{VR}=81\%$ ); Serviceability Design Earthquake (SDE, with  $P_{VR}=63\%$ ); Basic Design Earthquake (BDE, with  $P_{VR}=10\%$ ); and Maximum Considered Earthquake (MCE, with  $P_{VR}=5\%$ ). By referring to topographic category (TC) equal to T1 — flat surface — and C-type soil — deep deposits of dense or medium-dense sand, gravel or stiff clay from several ten to several hundred meters thick — for the site of the castle, the peak ground acceleration (PGA) values for the four seismic levels are as follows: 0.183 g (FDE), 0.229 g (SDE), 0.448 g (BDE), and 0.491 g (MCE), for the horizontal component; and 0.058 g (FDE), 0.083 g (SDE), 0.339 g (BDE), and 0.465 g (MCE), for the vertical component, with  $g$ =acceleration of gravity.

Figure 5. Normative pseudo-acceleration elastic response spectra for the horizontal and vertical components – Magnano in Riviera – FDE, SDE, BDE and MCE levels,  $\xi=5\%$ ,  $V_n=100$  years,  $c_u=1.5$ , TC=T1, and C-type soil

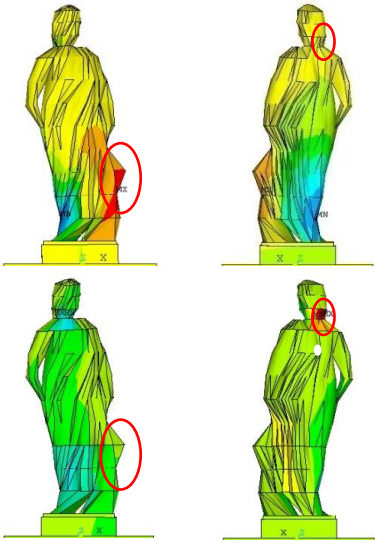
The peak tensile stress values in the plots of Figure 6 are equal to about 0.8 MPa (Rest) and 1.2 MPa (No rocking), both lower than  $f_t$ . These values quantitatively confirm the uncracked response for these two PLs. The mean values obtained from the response to the seven groups of accelerograms are only slightly lower (about 0.76 MPa and 1.14 MPa, respectively), highlighting the limited scattering of response for the suites of artificial ground motions used as input in the analysis. The plots in Figure 7 outline a noticeable set of cracks that would be clearly visible in the real statue, both in the leg and the neck, also figuratively showing the attainment of Damage control/Artistic value safety PL. The activation of cracks is recorded in 5.6% of Gauss points of the model, for the most demanding group

Figure 6. Normal stress distributions for the limit conditions of Rest (upper two images) and No rocking obtained from the most demanding among the seven groups of accelerograms

As way of example of the responses obtained at the limit conditions of the four PLs, the following drawings and graphs are reproduced in Figures 6 through 9, for the most demanding among the seven groups of accelerograms used in the analysis: for Rest and No rocking, the normal stress distribution in the model, with the two areas subjected to the highest tensile stresses, that is, the left leg knee and the rear portion of the neck, highlighted by red ellipses (Figure 6); the cracked configuration of the same two critical zones, plotted in zoomed view and coloured in light grey, for Damage control/Artistic value safety (Figure 7); the ultimate cracked configuration of the front and rear portions of the neck, again in zoomed view, for Collapse prevention (Figure 8); and the vertical displacement time-histories of the joint situated on the rear left corner of the pedestal, for No rocking and Collapse prevention (Figure 9).

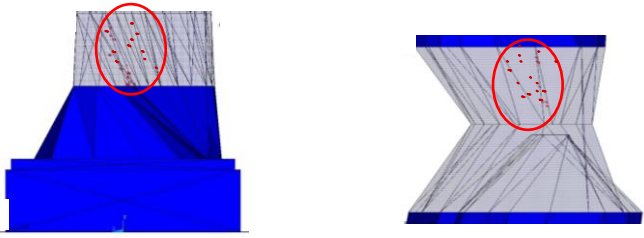
Figure 7. Cracked configurations of the left leg knee (left image) and the rear portion of the neck for the limit conditions of Damage control/Artistic value safety obtained from the most demanding among the seven groups of accelerograms

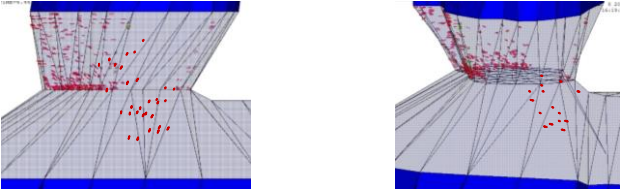
The cracked configuration depicted in Figure 8 clearly illustrates that numerical collapse, and thus the achievement of the limit condition for Collapse prevention PL, is caused by the local failure of the base section of the neck, which is the most vulnerable area of the model.

Figure 8. Cracked configurations of the front (left image) and rear portion of the neck for the limit conditions of Collapse prevention obtained from the most demanding among the seven groups of accelerograms

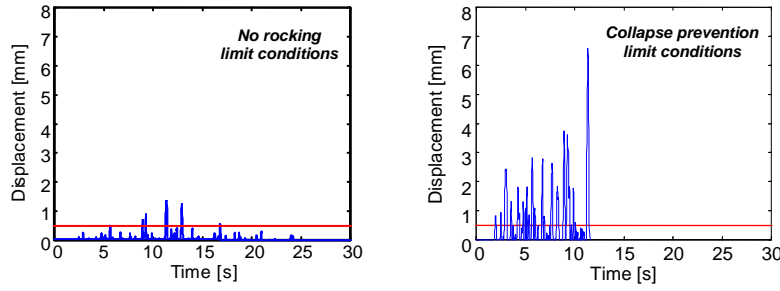
The vertical displacement time-history corresponding to the achievement of the limit conditions for No rocking, plotted in the left graph of Figure 9, shows six peaks greater than the assumed threshold of 0.5 mm (highlighted by a red horizontal segment in the graph), with a maximum of 1.3 mm. Each of the remaining six groups of input motions produced five peaks greater than 0.5 mm, giving rise to a mean maximum peak of 1.1 mm over the seven groups. As illustrated in the right graph of Figure 9, the time-history relevant to the limit conditions of Collapse prevention stopped immediately after the attainment of the maximum uplift, equal to 6.6 mm, as a consequence of the

Figure 9. Vertical displacement time-histories of the joint situated on the rear left corner of the pedestal for the limit conditions of No rocking and Collapse prevention obtained from the most demanding among the seven groups of accelerograms

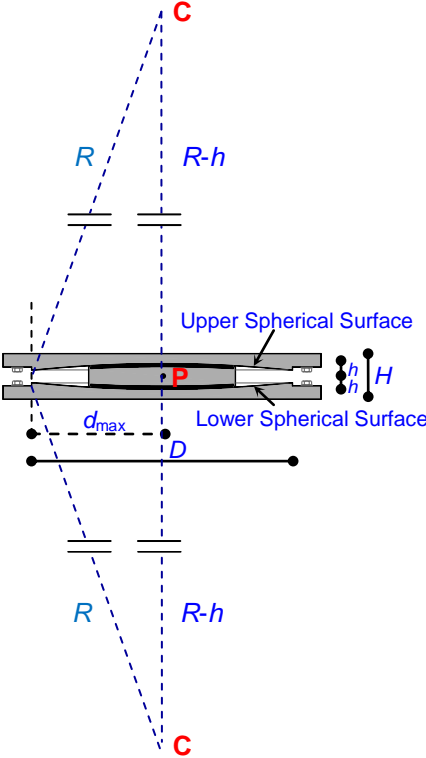
As shown in the drawing in Figure 10, the double-friction pendulum sliders (Fenz and Constantinou 2006, Christopoulos and Filiatrault 2006) selected as isolating devices for this design hypothesis consist of two facing spherical concave surfaces, separated by an articulated double friction slider, which produce two independent pendulum response mechanisms. The DFP devices in standard production are characterized by identical properties of the two surfaces, and namely, by referring to the nomenclature in Figure 10: radius  $R$ ; slider center-to-surface distance  $h$  (i.e. the distance between the “pivot point”  $P$  of the articulated slider and the face of each spherical surface); effective pendulum length  $R-h$  (i.e. the distance between  $P$  and the center  $C$  of each surface); diameter of the horizontal projection of the spherical surface  $D$ ; and friction coefficient  $\mu$ . The resulting effective pendulum length  $L_{DFP}$  of the isolator is equal to twice the effective pendulum length of each surface, i.e.  $L_{DFP} = 2 \cdot (R-h) = 2R-2h$ .

Figure 10. Cross section of a DFP isolator with equal sliding surfaces

isolators, as derived from the reference manufacturer’s catalogue (FIP 2013):  $L_{DFP}=3125$  mm;  $d_{max}=250$  mm;  $\mu=0.025$ ;  $D=490$  mm;  $T_e=3.1$  s; and  $\xi_e=15.2\%$ . The height  $H$  (Figure 10) is equal to 94 mm.

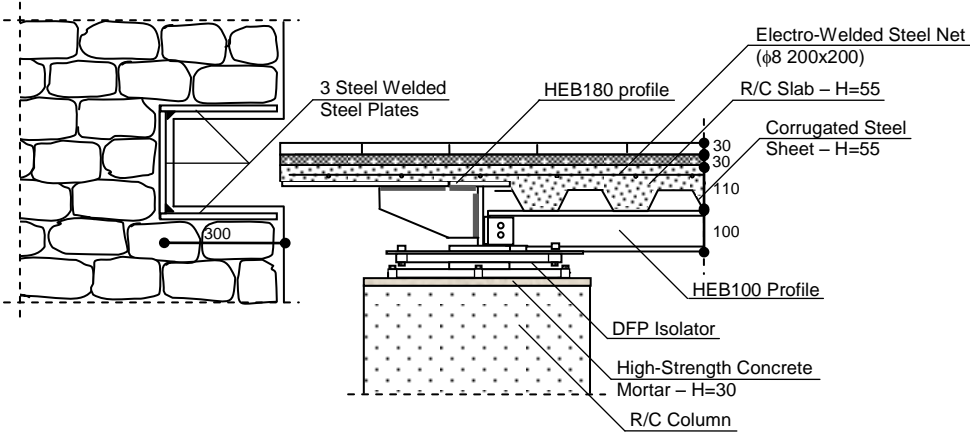
A drawing illustrating the details of installation of an isolator placed on top of a lateral column is presented in Figure 11. The depth of the continuous carving of the perimeter walls of the hall, reinforced by a C-shaped steel beam composed of three welded plates, was dimensioned in order to accommodate  $d_{max}$ . The only equipment situated on the floor is the power installation. To safely accommodate  $d_{max}$  too, power cables are arranged in a circular winding prior to connecting them to the floor structure, according to a classical and inexpensive installation layout adopted for base-isolated buildings (Sorace and Terenzi 2001, 2008).

Figure 11. Installation details of a DFP isolator situated on top of a lateral column (dimensions in mm)

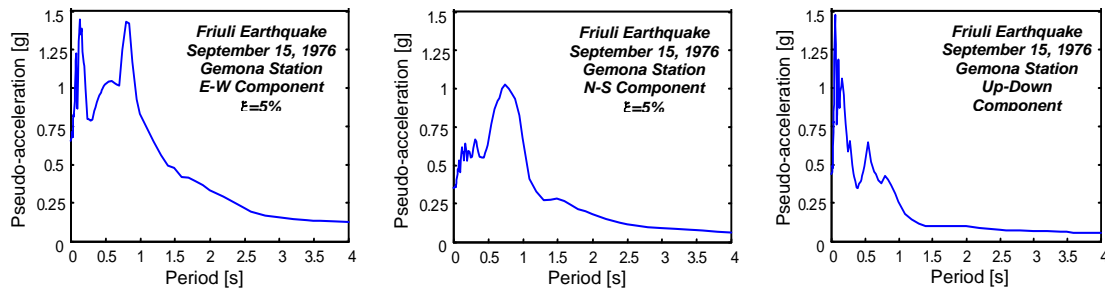
A supplementary control was carried out by developing a further set of time-history analyses with the most demanding real ground motions recorded in Gemona, a neighbor town to Magnano in Riviera, during the Friuli earthquake in 1976. These ground motions, characterized by a distance of 6.2 km from the surface projection of the causative fault, a fault-thrust mechanism, and moment magnitude  $M_w=5.9$ , are the E-W, N-S and up-down (vertical) components of the main shock recorded on September 15, with PGAs of 0.642 g, 0.329 g and 0.485 g, respectively, and the pseudo-acceleration elastic response spectra at 5% linear viscous damping ratio plotted in Figure 12. As observed in the Introduction, these ground motions caused very severe damage and partial disruption to the castle of Prampero, situated at about 1.5 km from Gemona recording station, which had been already partly damaged by a comparably demanding ground motion sequence occurred on May 6.

Figure 12. Pseudo-acceleration elastic response spectra at  $\xi=5\%$  of the E-W and N-S horizontal components, and the vertical component recorded in Gemona station on September 15, 1976

The application of the real motions produced a slightly lower response of the redesigned structure of the castle as compared to the normative MCE-scaled groups of artificial accelerograms. Indeed, the two spectral peaks of the E-W component, situated at about 0.8 s and 0.1 s, and the peaks of the N-S and up-down components, nearing 0.75 s and 0.1 s, respectively, are outside the range [0.3 s – 0.6 s] of the main vibration periods of the masonry structure of the castle. All remaining ordinates, up to about 2 s, are lower for the real motions.

On the other hand, the spectral ordinates of the latter are higher than the MCE ones in the period range [3 s–3.5 s], which includes the fundamental vibration period of the base-isolated floor. The results of the analysis in this configuration highlight peak displacements of 241 and 226 mm along the longitudinal and transversal directions in plan, that is, 8% and 7% greater than the values found for the most demanding MCE-scaled accelerograms, respectively, but still lower than the maximum available displacement  $d_{\max}$  of the isolators.
